**Preservation Department – Item 1, LPC-26-03280**

**138-154 St. Felix Street, aka 11-21 Hanson Place –  
Brooklyn Academy of Music Historic District  
Borough of Brooklyn**

# **144 ST. FELIX STREET**

## **ADAPTIVE-REUSE & ENLARGEMENT**

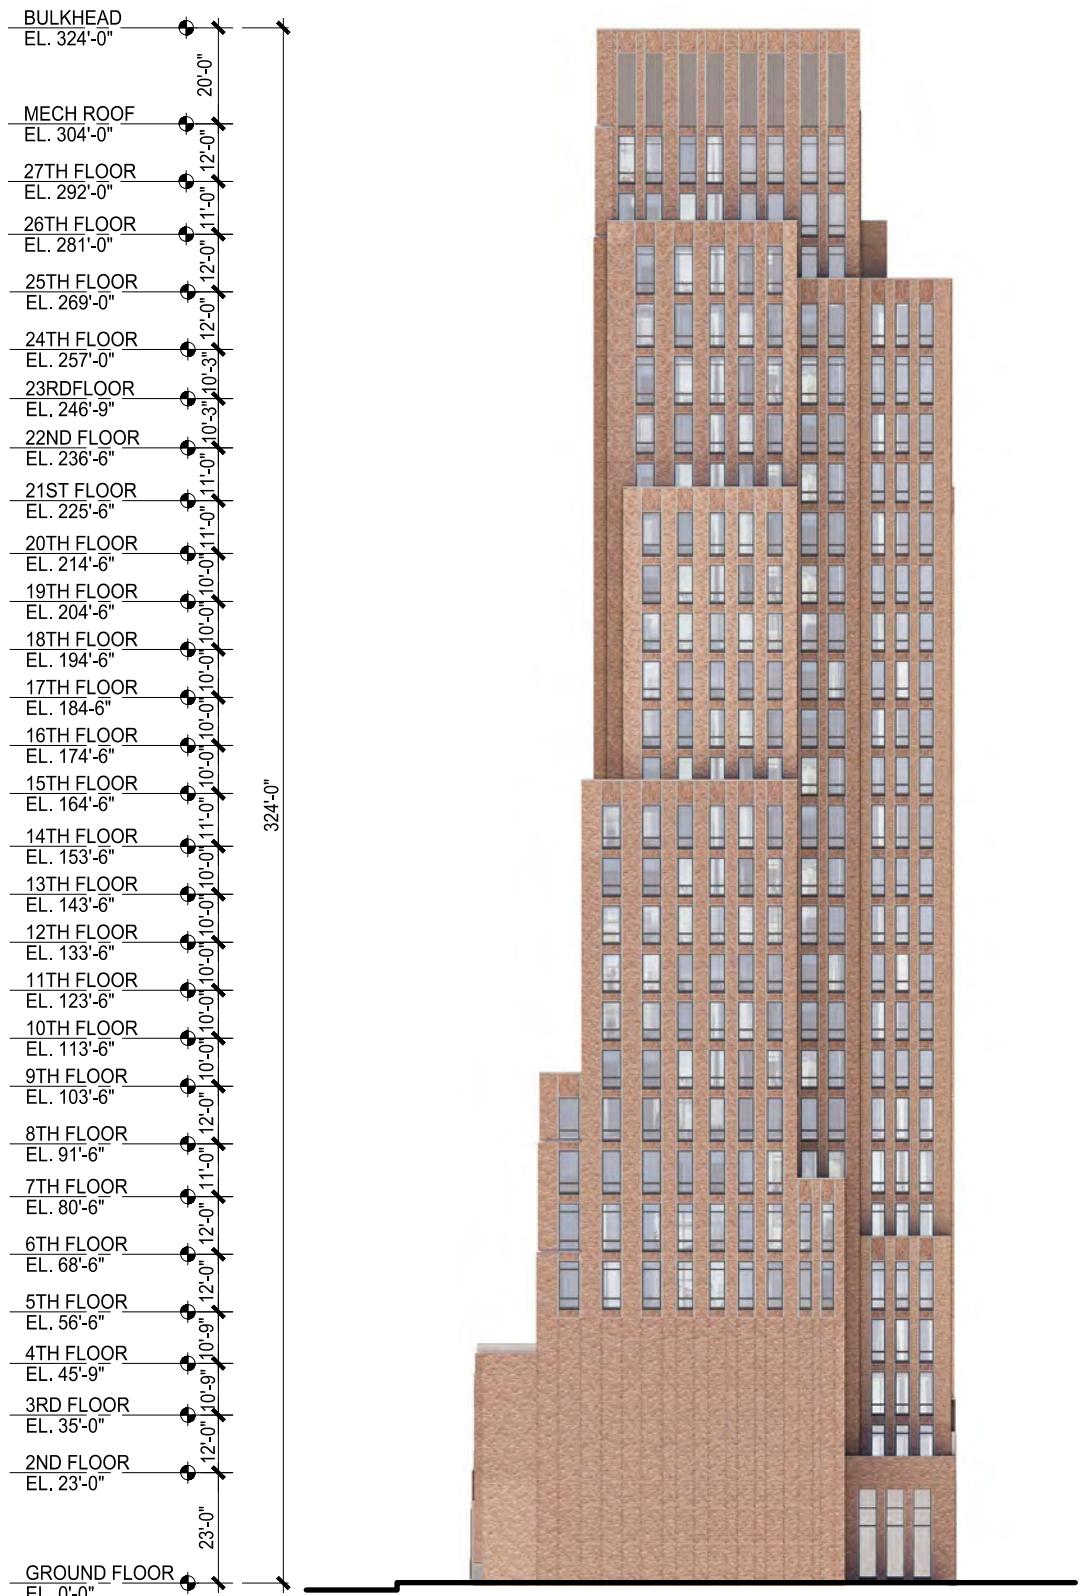
North

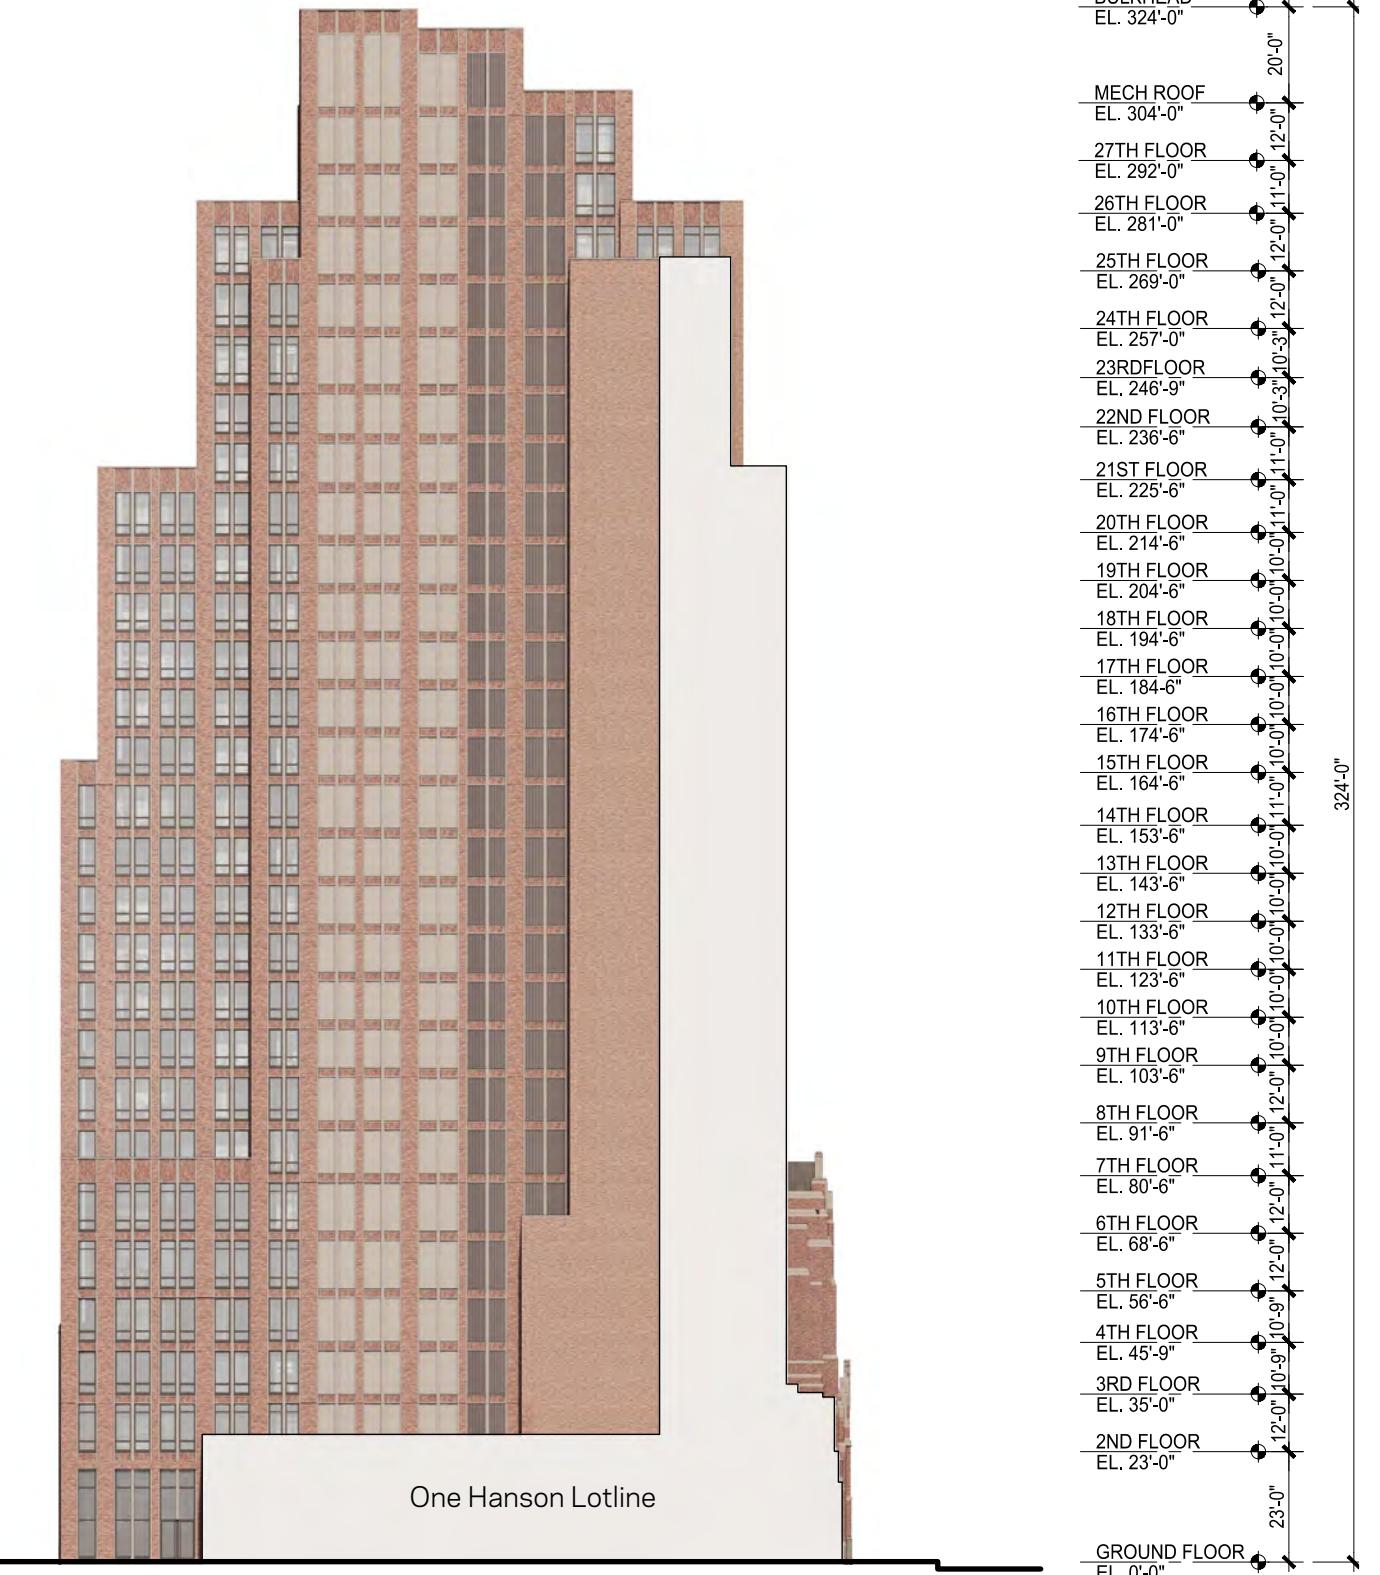
West

SCALE : 1 / 40 " = 1' - 0"

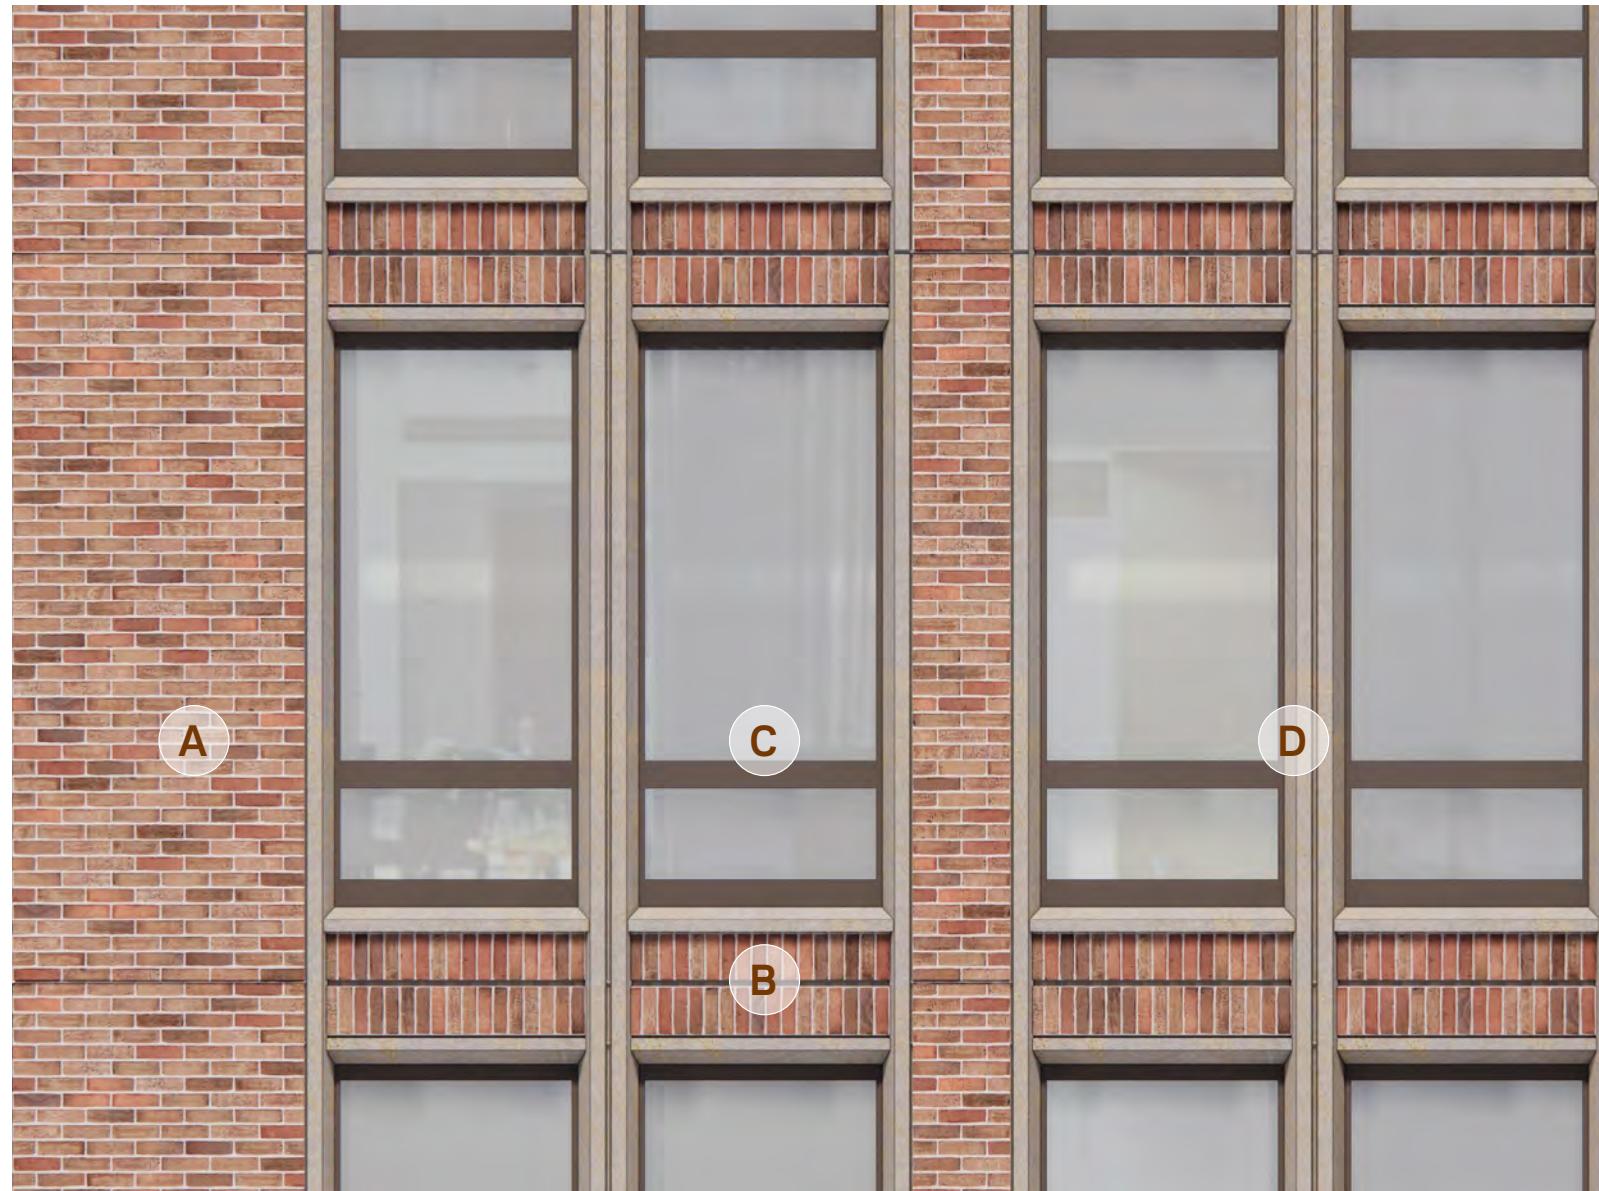
1 ELEVATION  
3/8" = 1'-0"

## Building Elevations

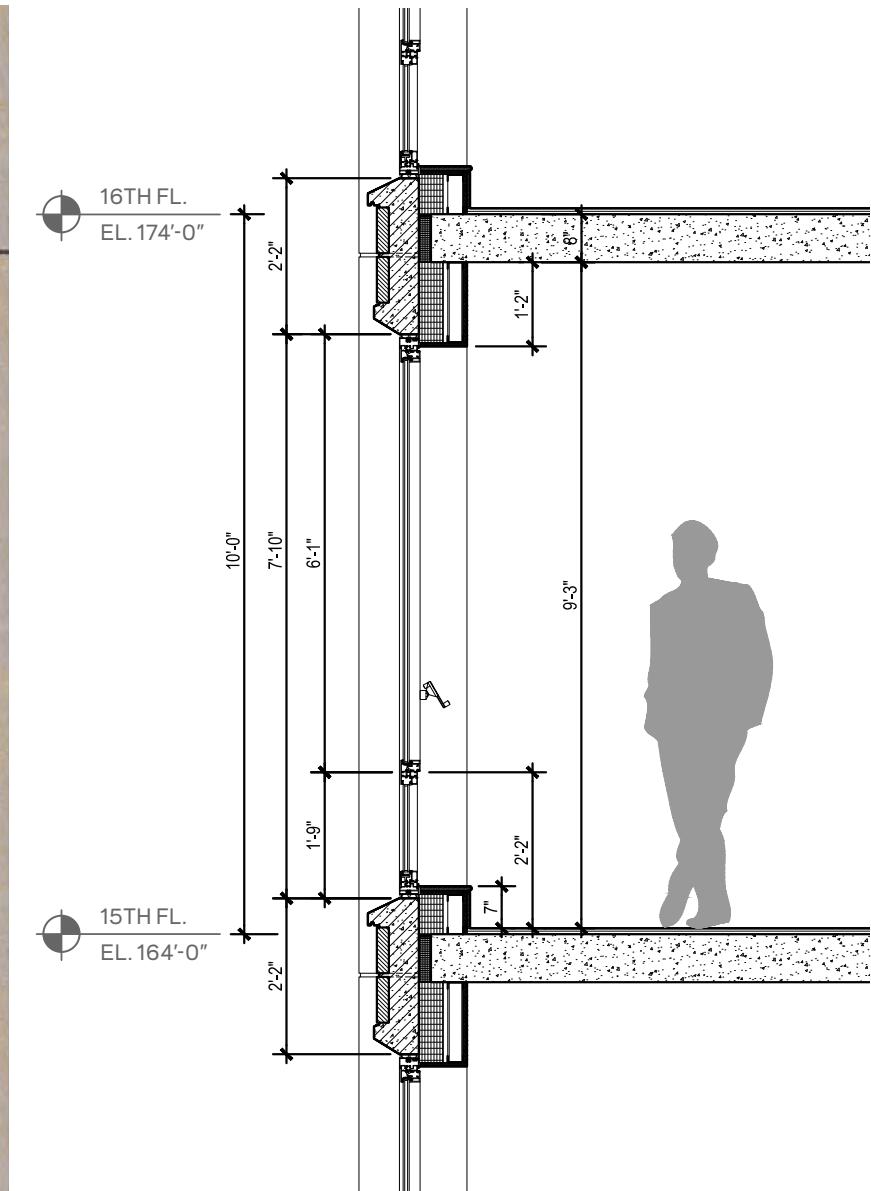
2 SECTION  
3/8" = 1'-0"

## EXTERIOR MATERIALS

- A** Brick on Precast in a Running Bond
- B** Brick on Precast in a Stack Bond
- C** Painted Aluminum Fixed & Operable Window
- D** Precast Concrete with a Limestone Finish

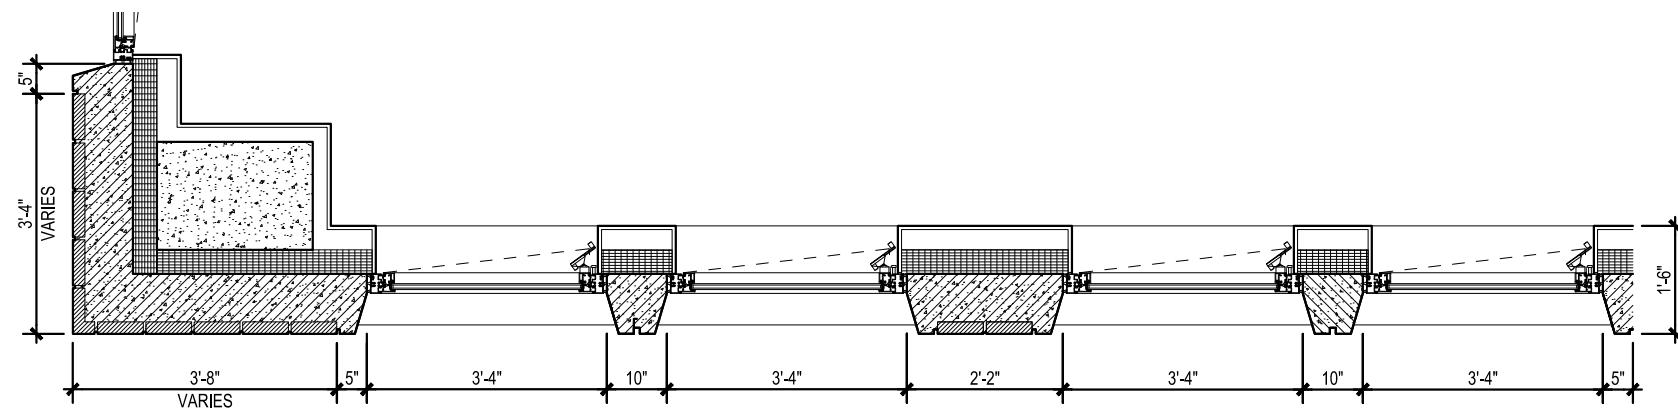
3 PLAN  
3/8" = 1'-0"

## EXTERIOR MATERIALS

- A** Brick on Precast in a Running Bond
- B** Brick on Precast in a Stack Bond
- C** Painted Aluminum Fixed & Operable Window
- D** Precast Concrete with a Limestone Finish

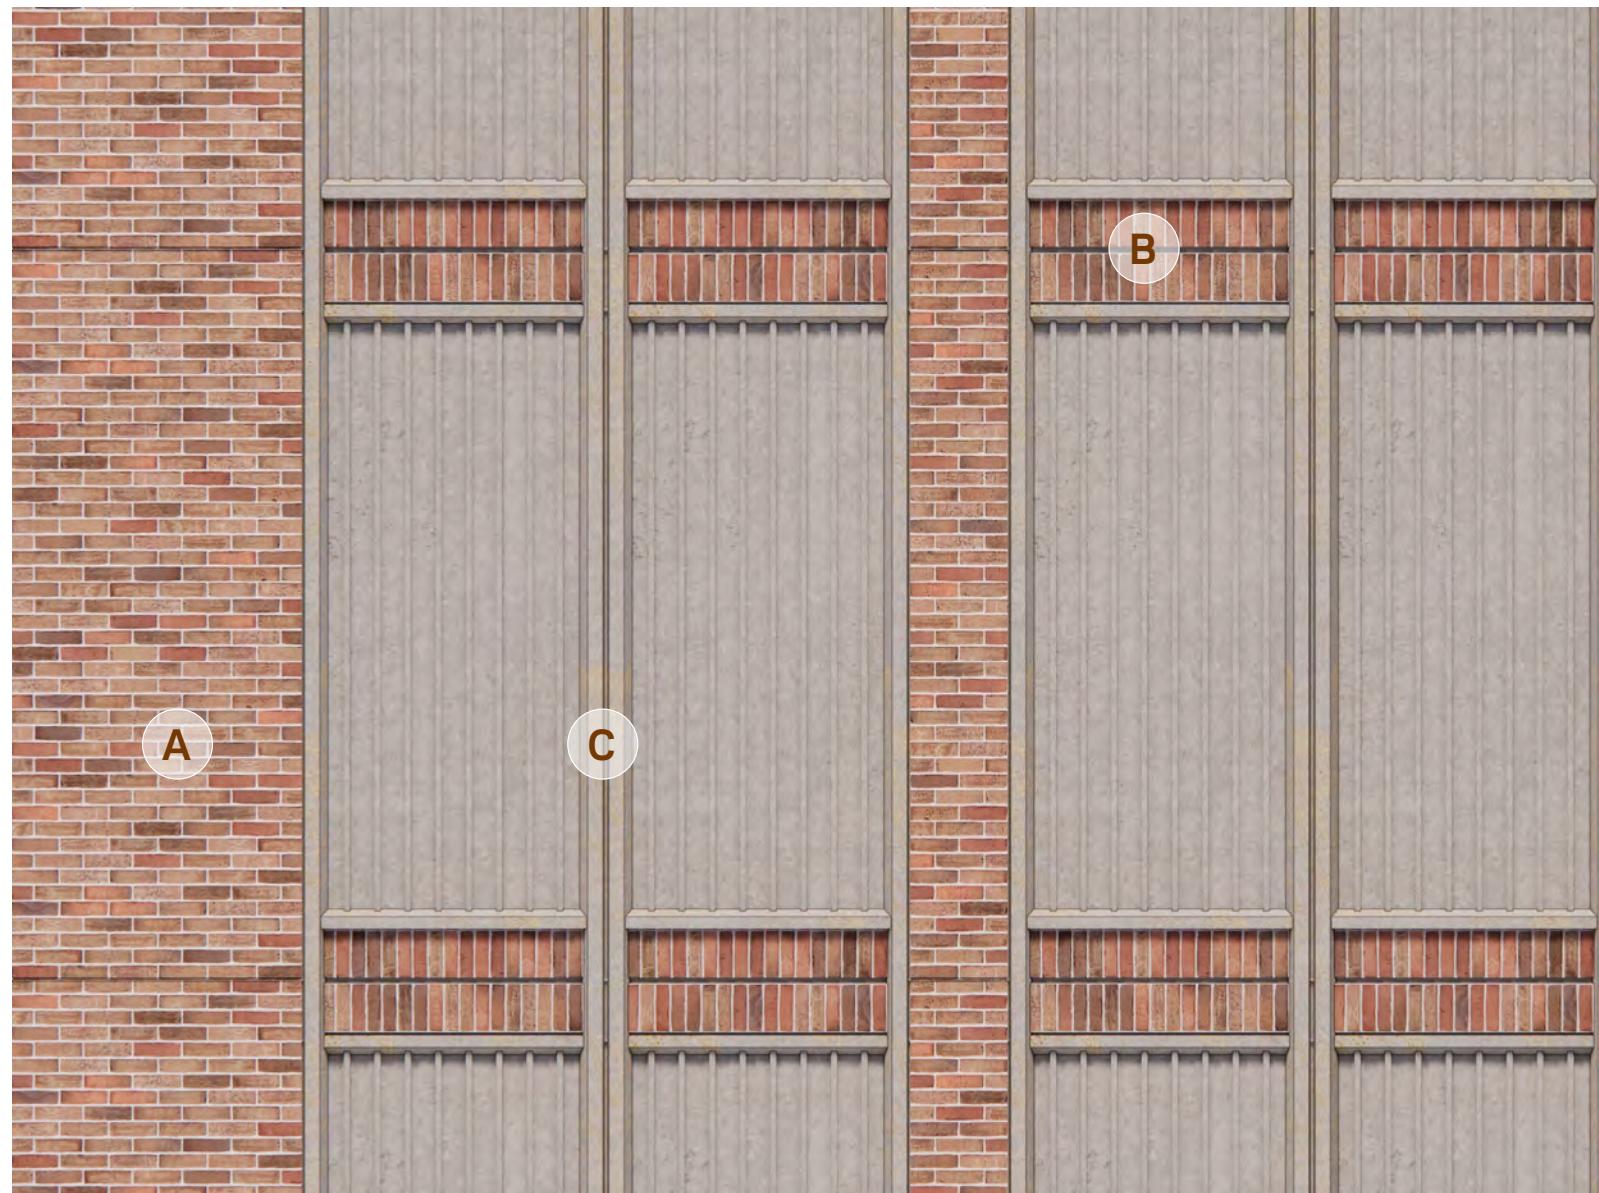
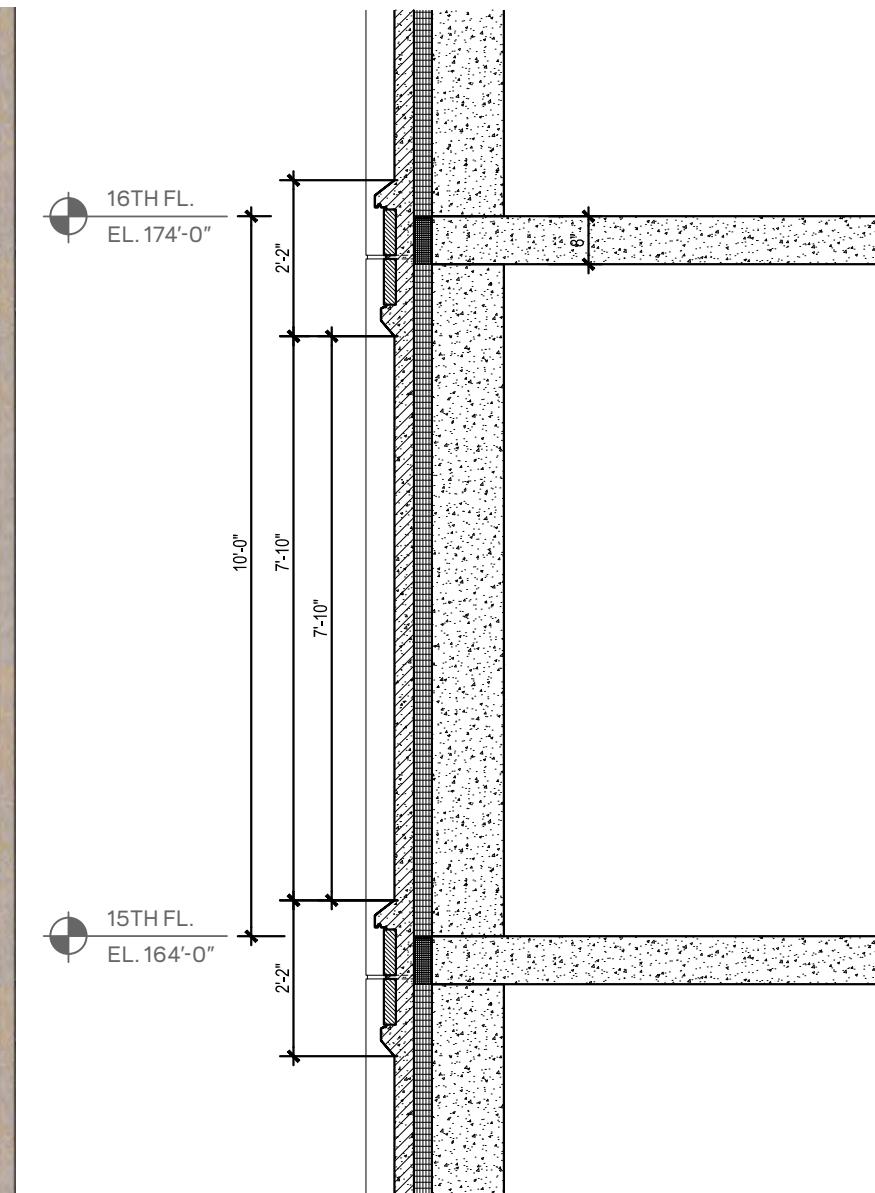
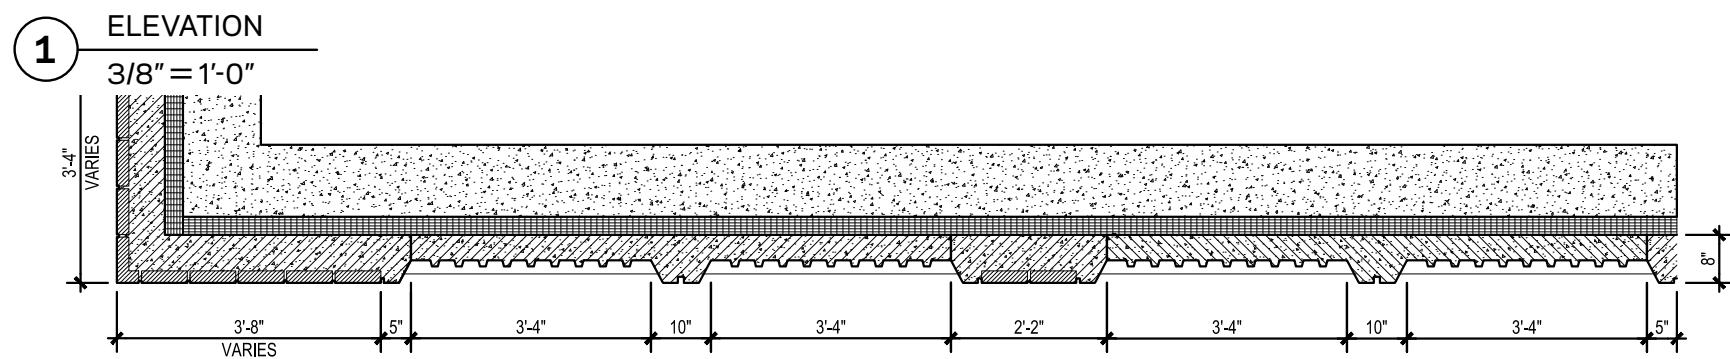
## EXTERIOR MATERIALS

- A** Brick on Precast in a Running Bond
- B** Brick on Precast in a Stack Bond
- C** Precast Concrete with a Limestone Finish

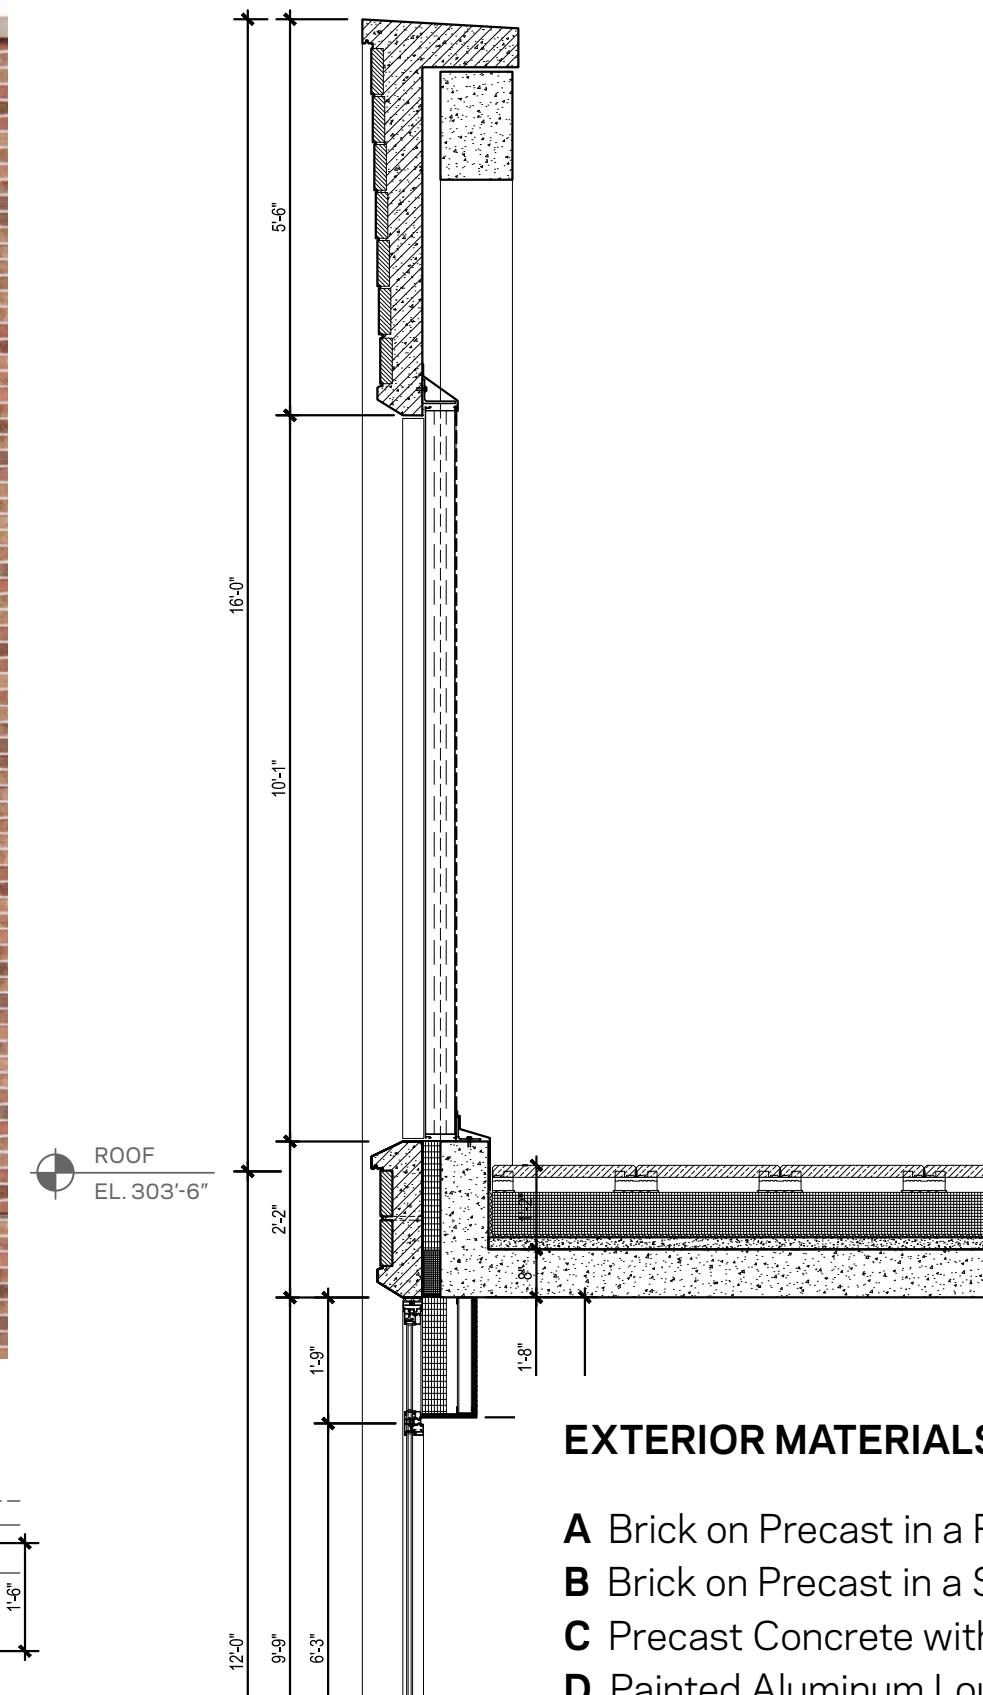
## EXTERIOR MATERIALS

- A** Brick on Precast in a Running Bond
- B** Brick on Precast in a Stack Bond
- C** Precast Concrete with a Limestone Finish
- D** Painted Aluminum Louvers with Vertical Fin

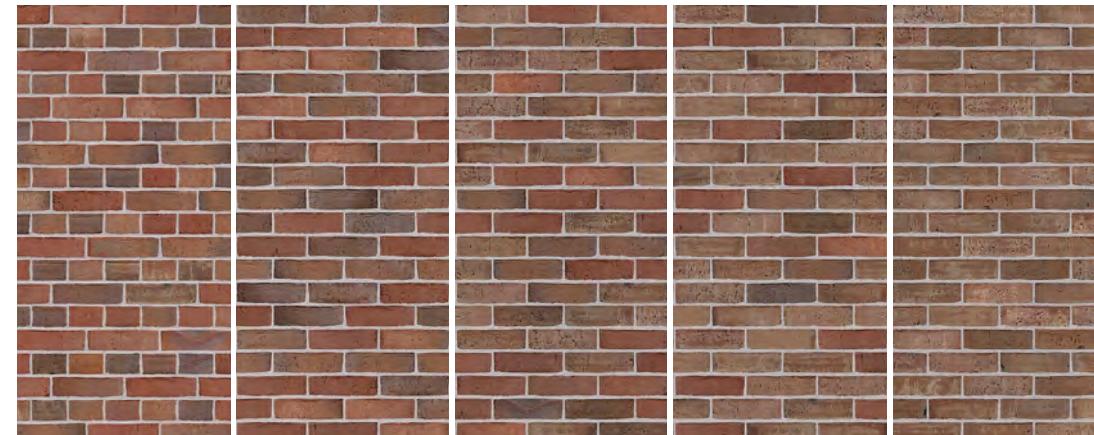
## Brick

Blends to match existing ironspot colors with a range to create subtle variations between facade steps

**BR-1**   **BR-2**   **BR-3**   **BR-4**   **BR-5**

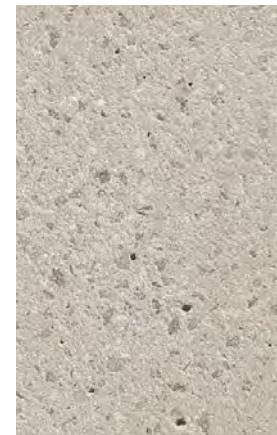
### PC-1

**Limestone Finish**  
Precast Concrete & Caststone to Match Existing

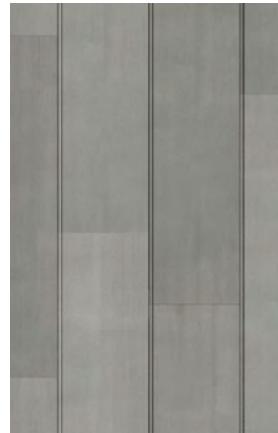
### M-3

**Zinc Gray Tone Low-Gloss**  
Church Building, Roof Replacement

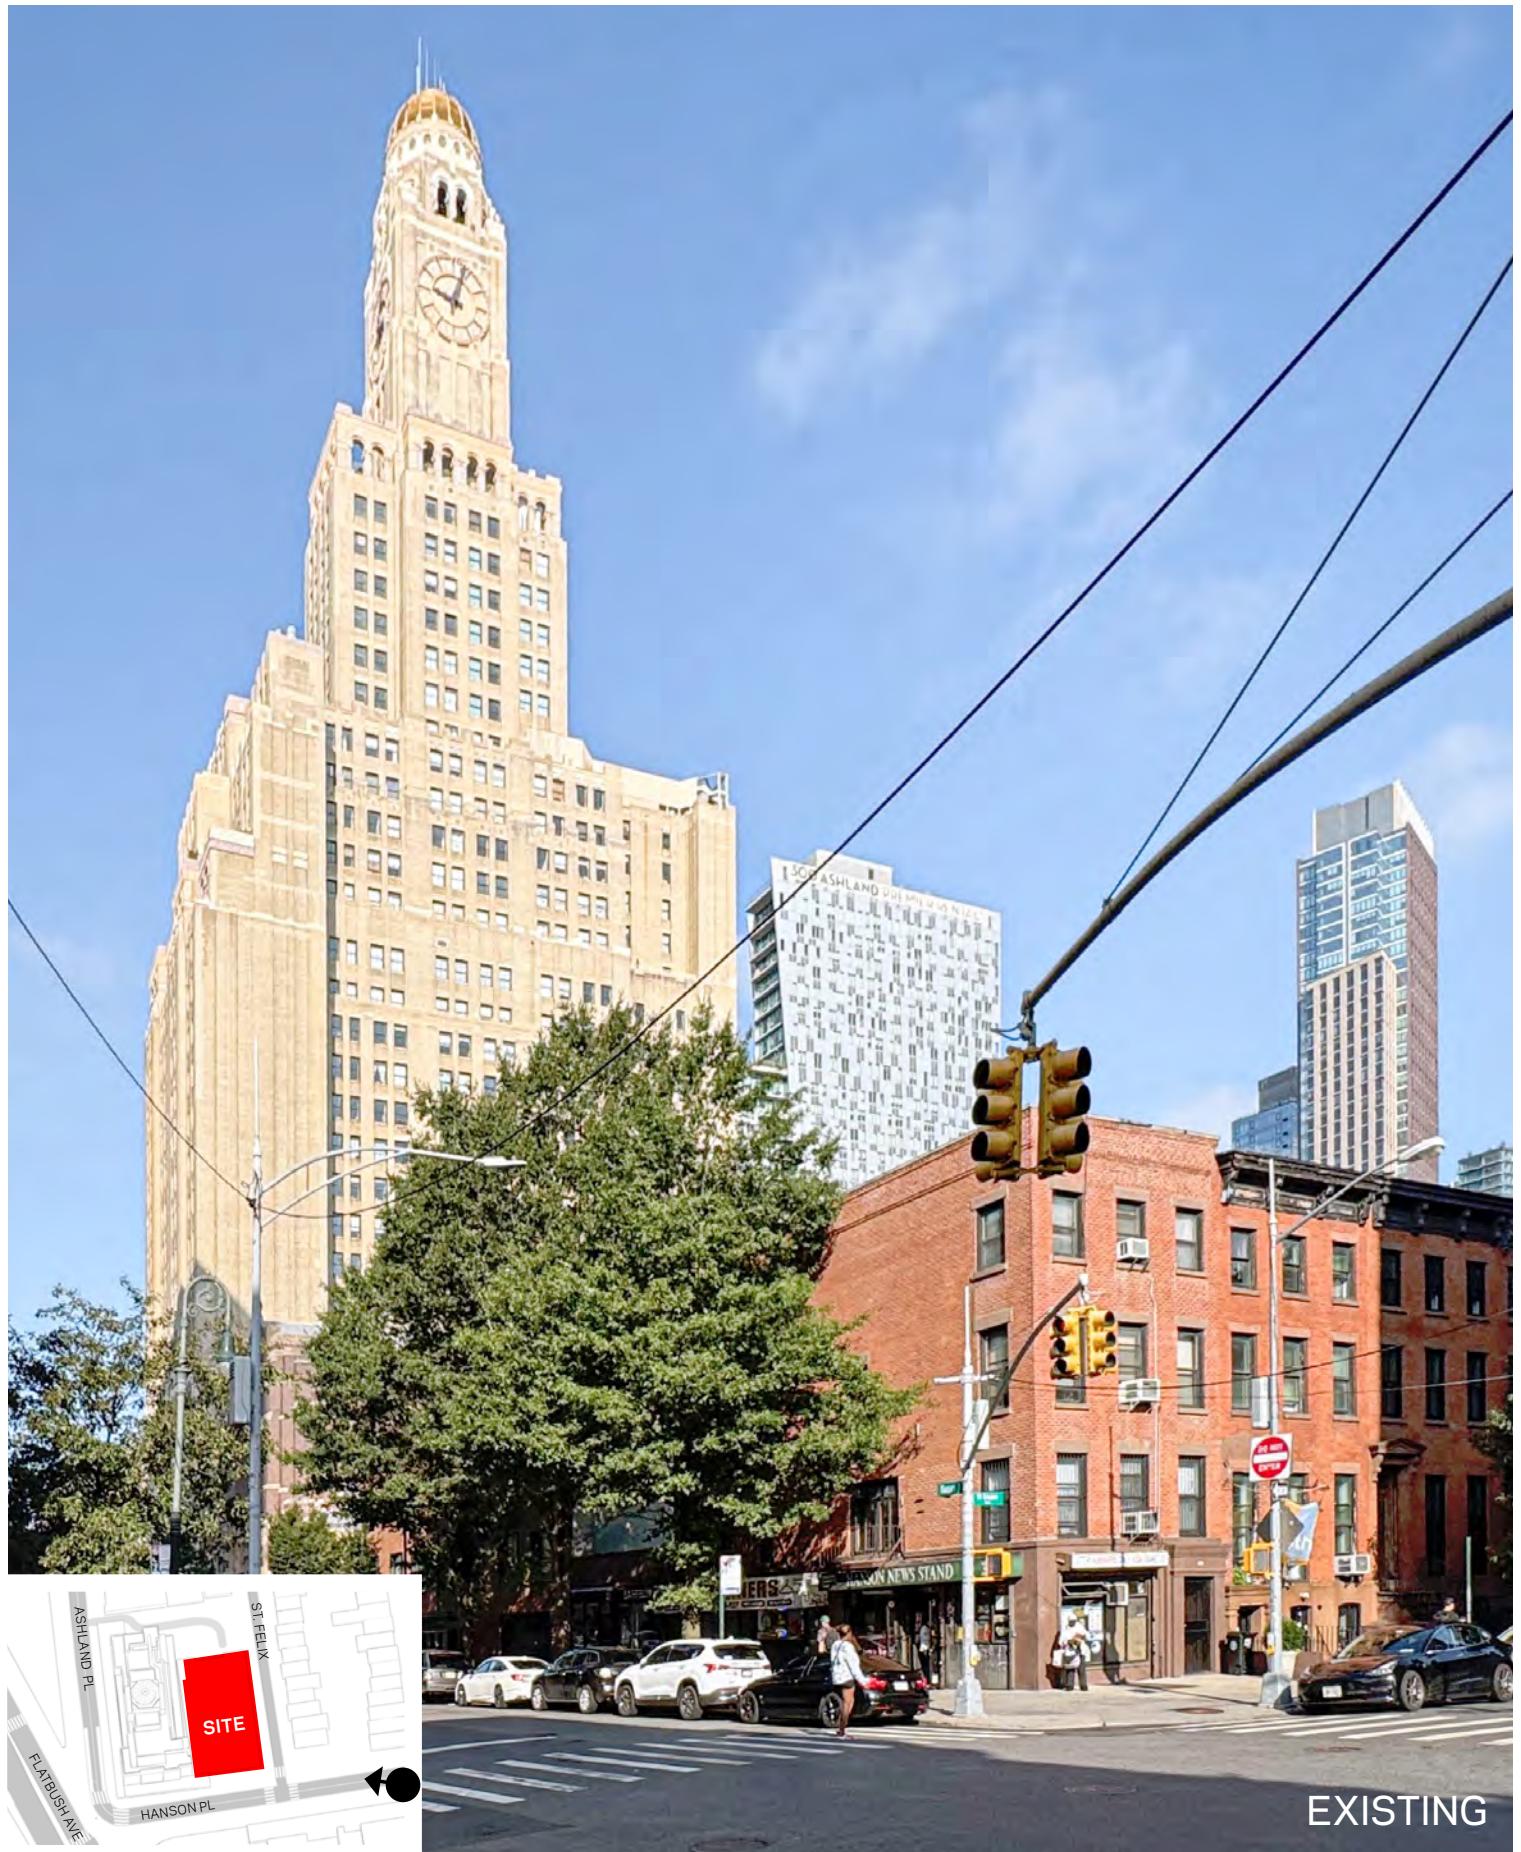
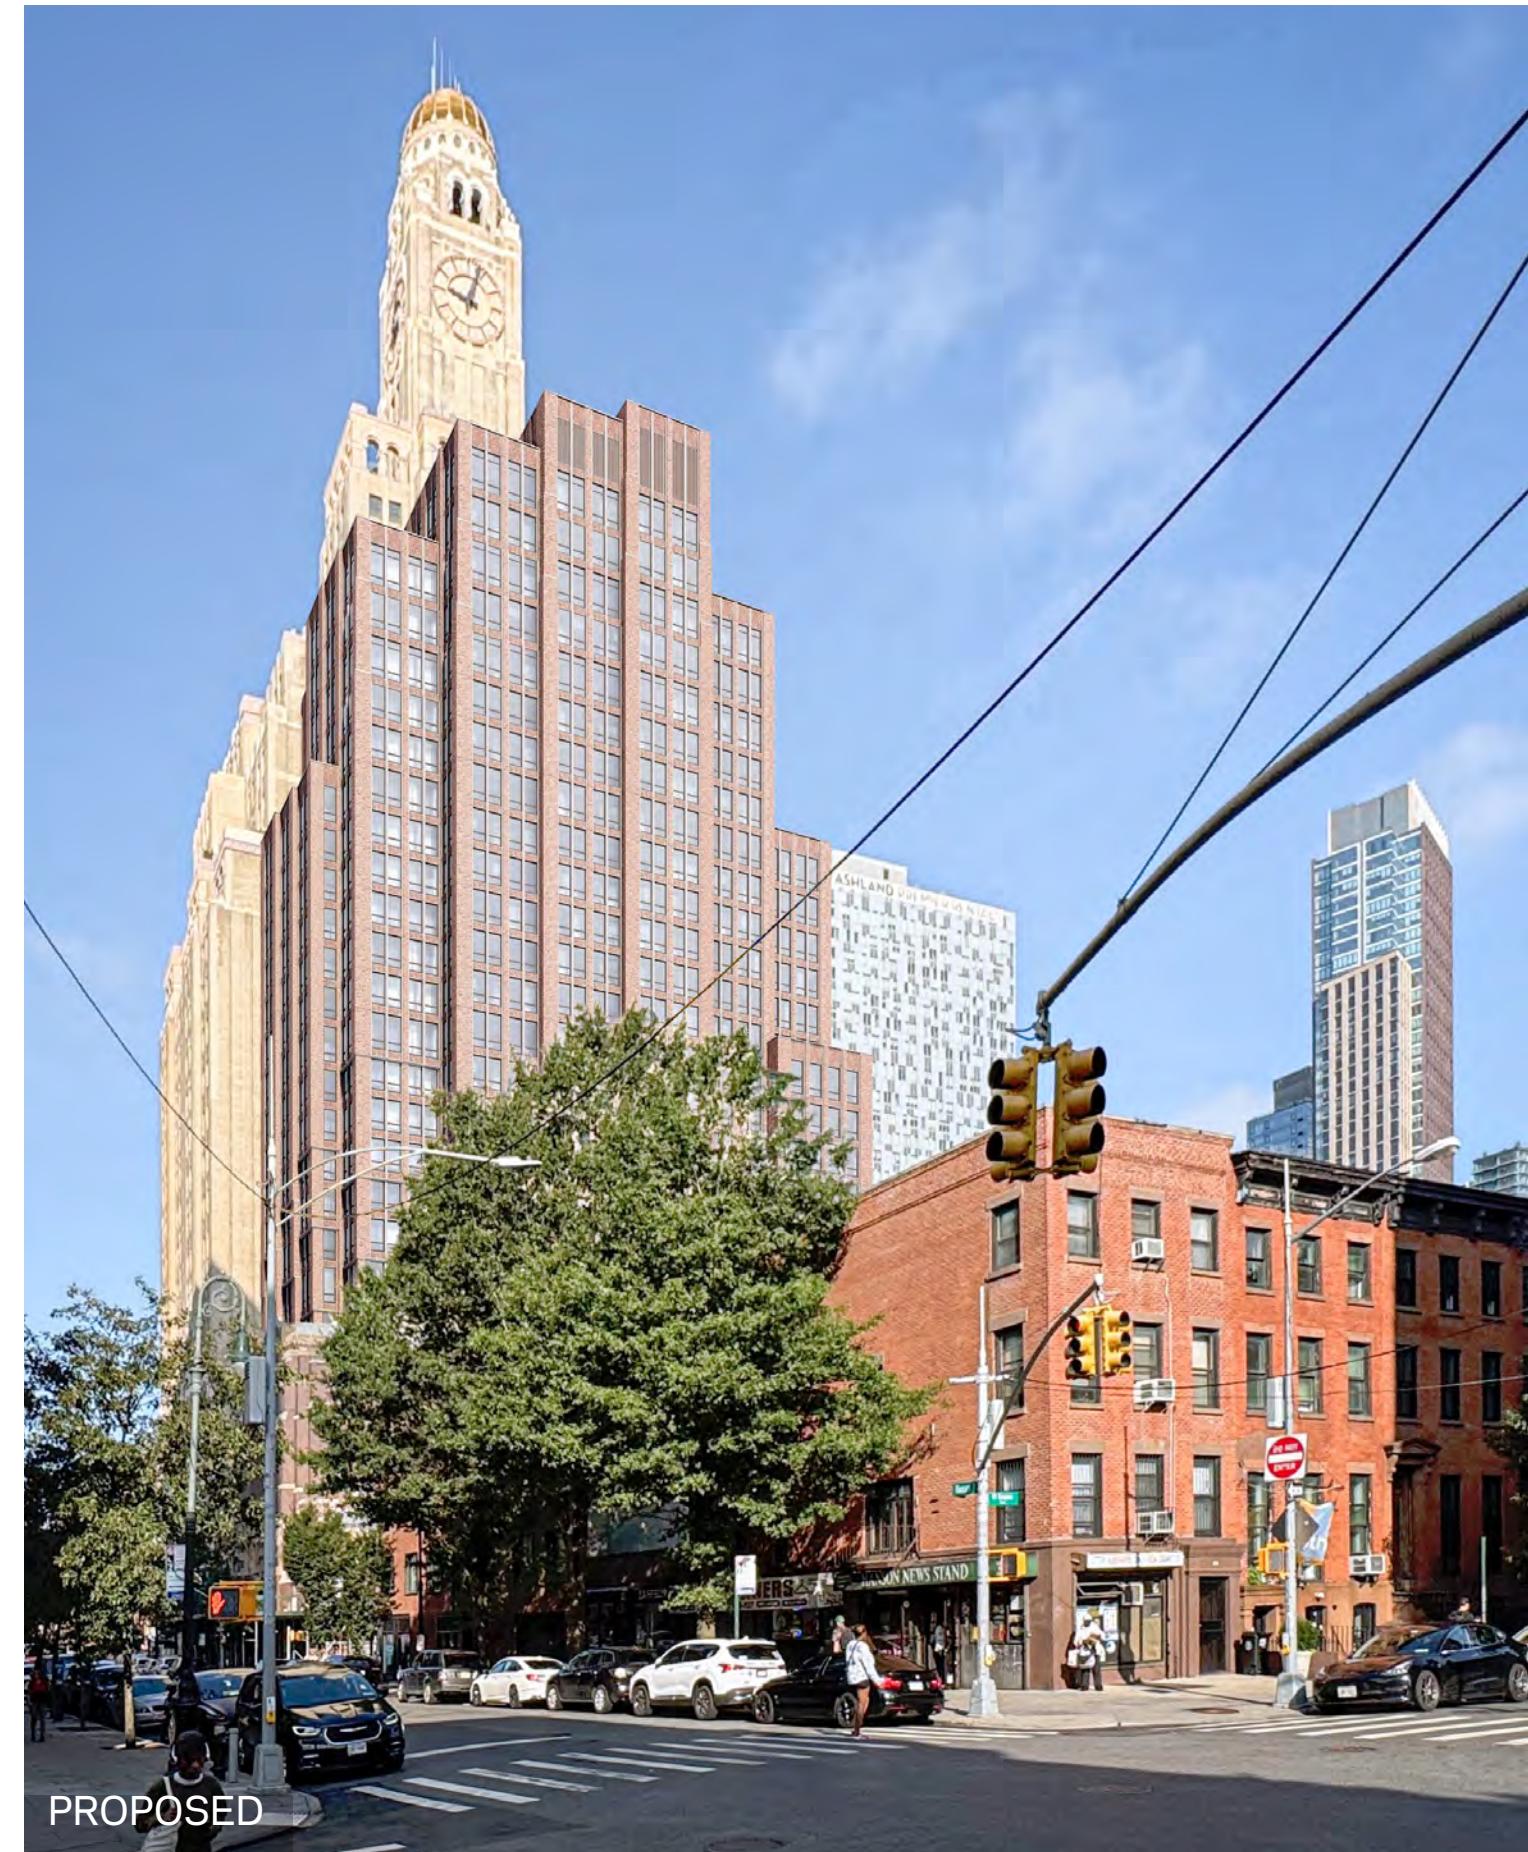
## Ashland Pl & Fulton Looking South

Composition with 130 St. Felix Approved Building

EXISTING

PROPOSED

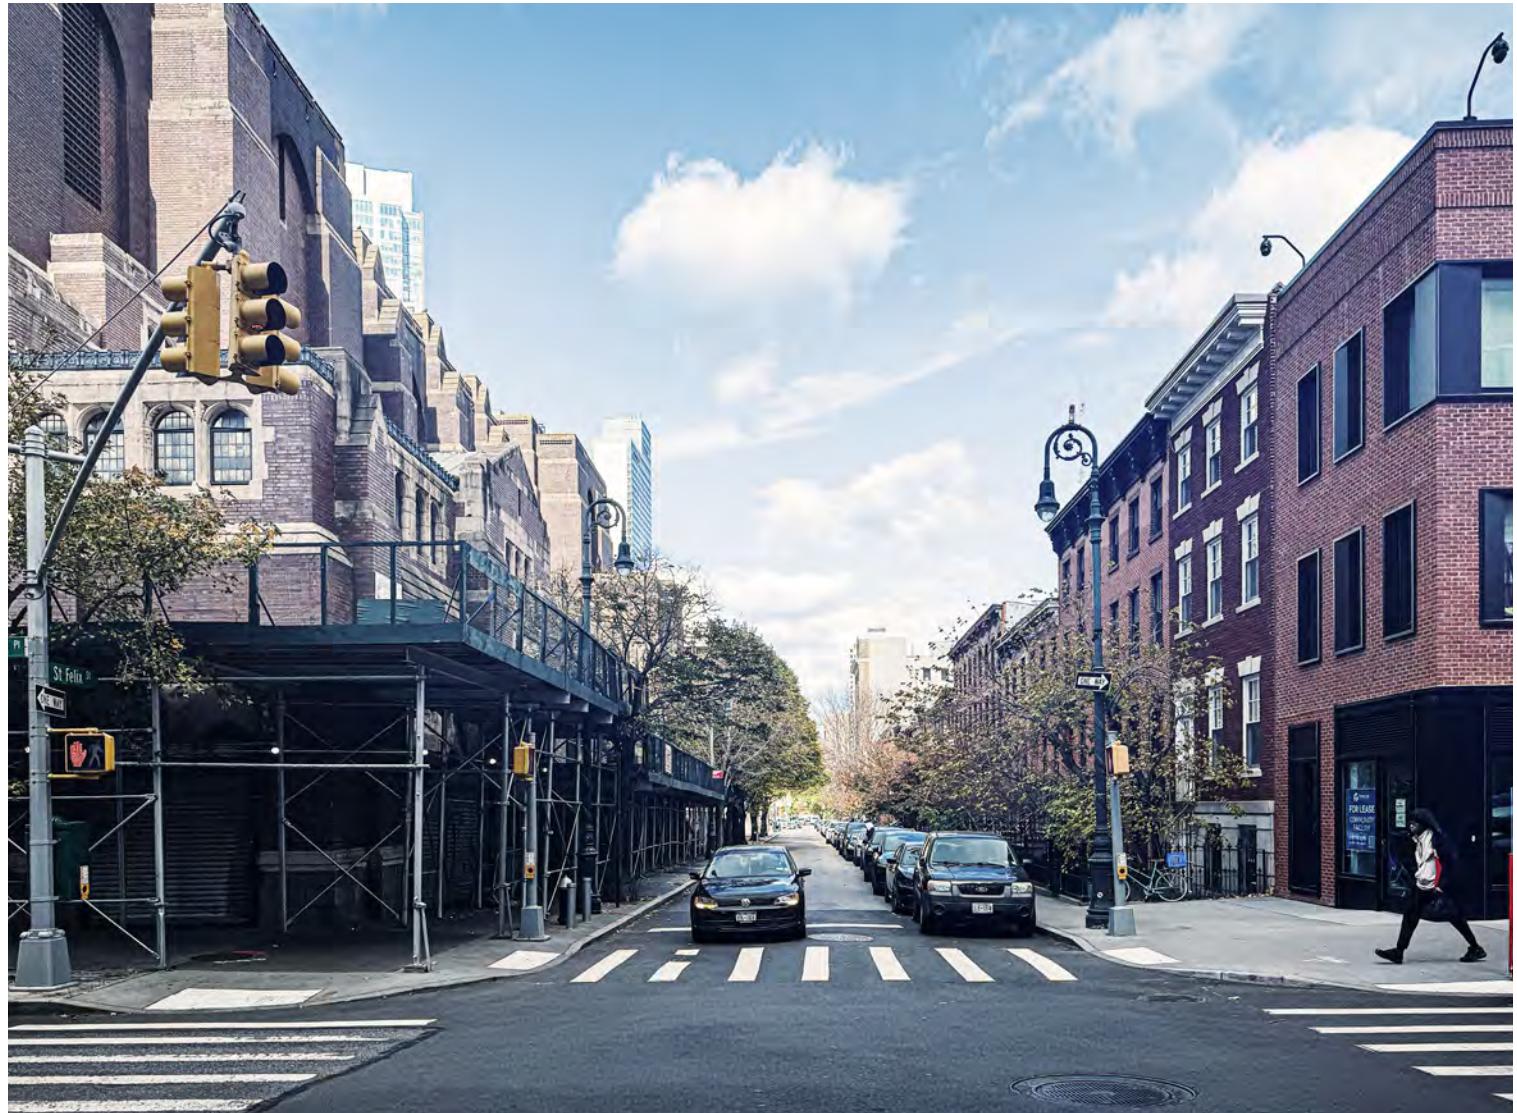
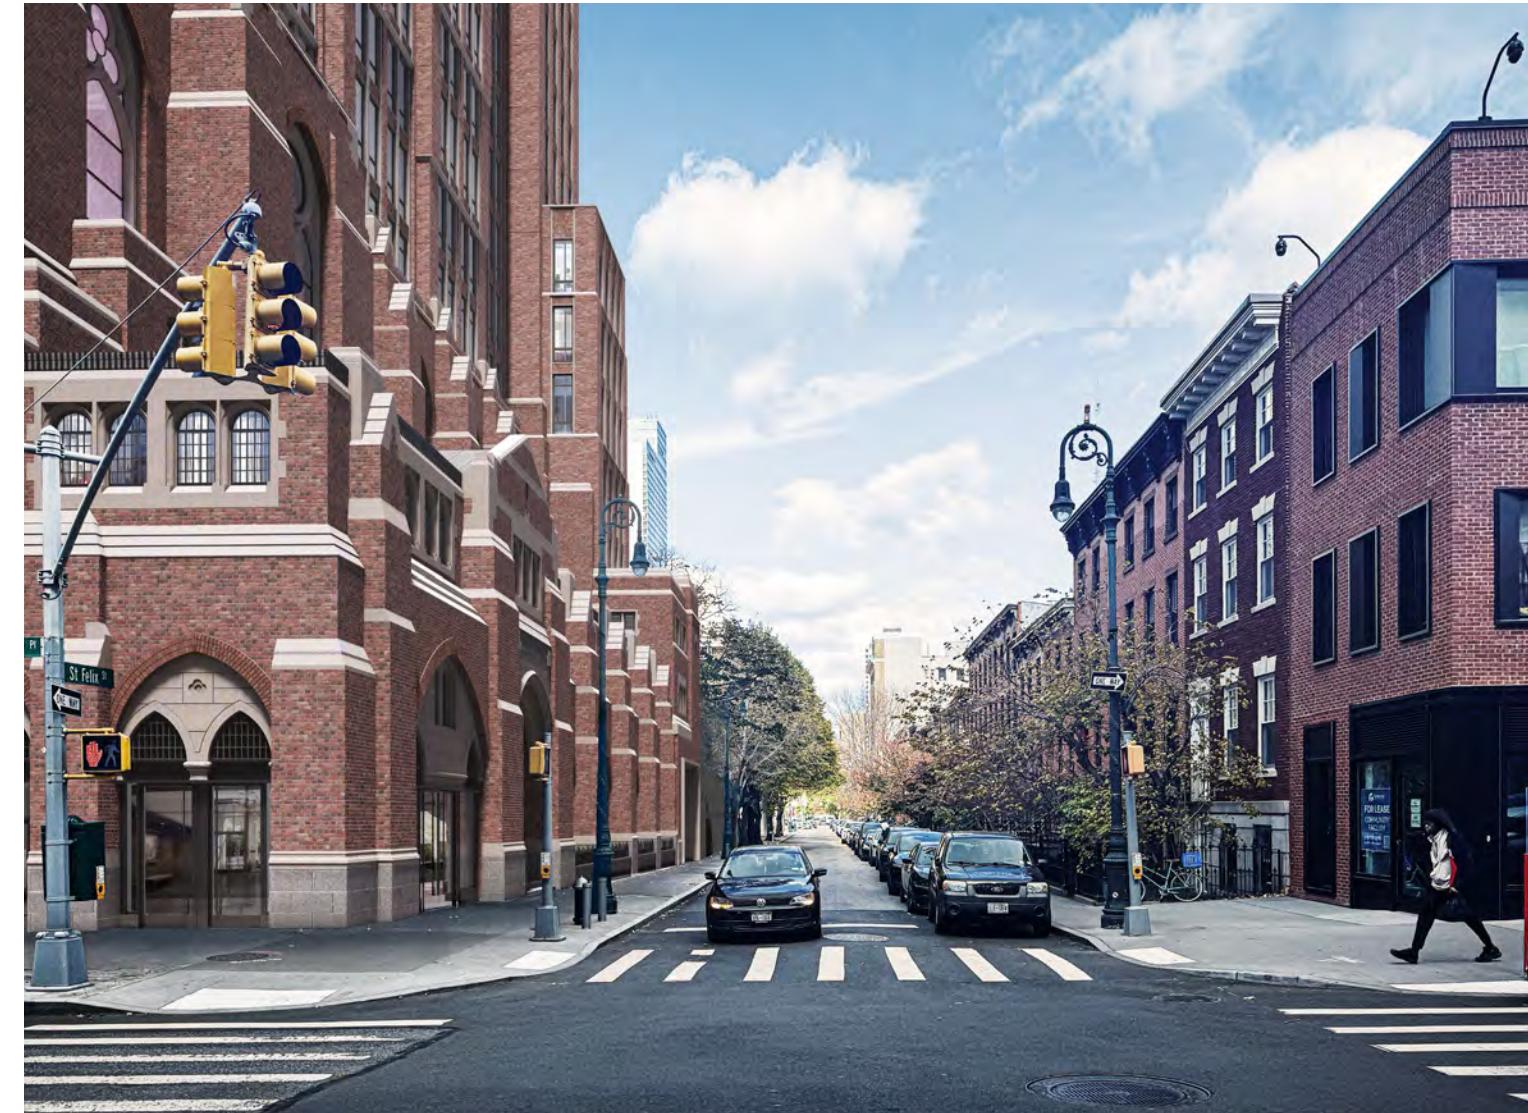
## Hanson Pl & St. Felix Looking West

EXISTING

PROPOSED
