**Preservation Department – Item 1, LPC-26-03280**

**138-154 St. Felix Street, aka 11-21 Hanson Place –  
Brooklyn Academy of Music Historic District  
Borough of Brooklyn**

# **144 ST. FELIX STREET**

## **ADAPTIVE-REUSE & ENLARGEMENT**

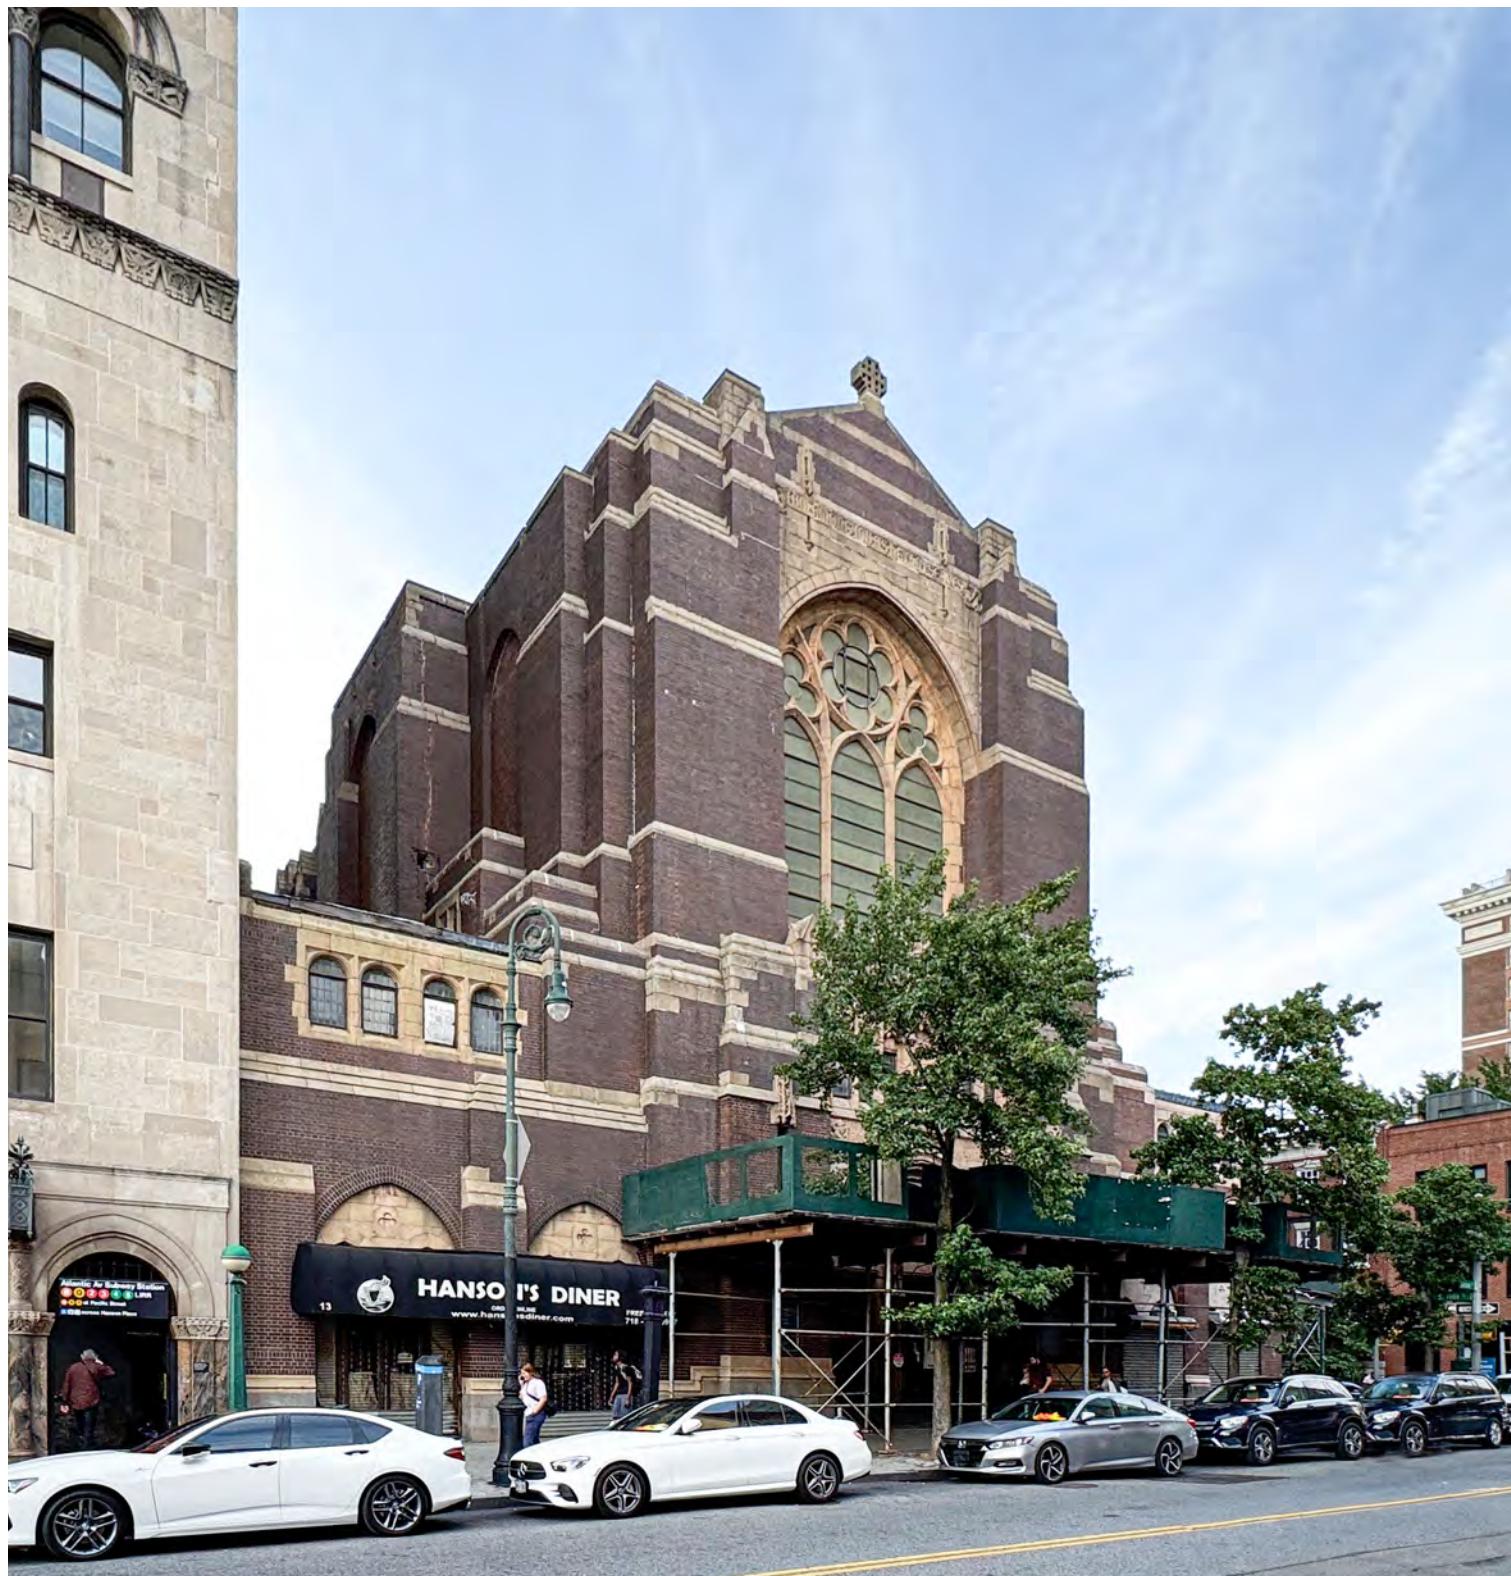
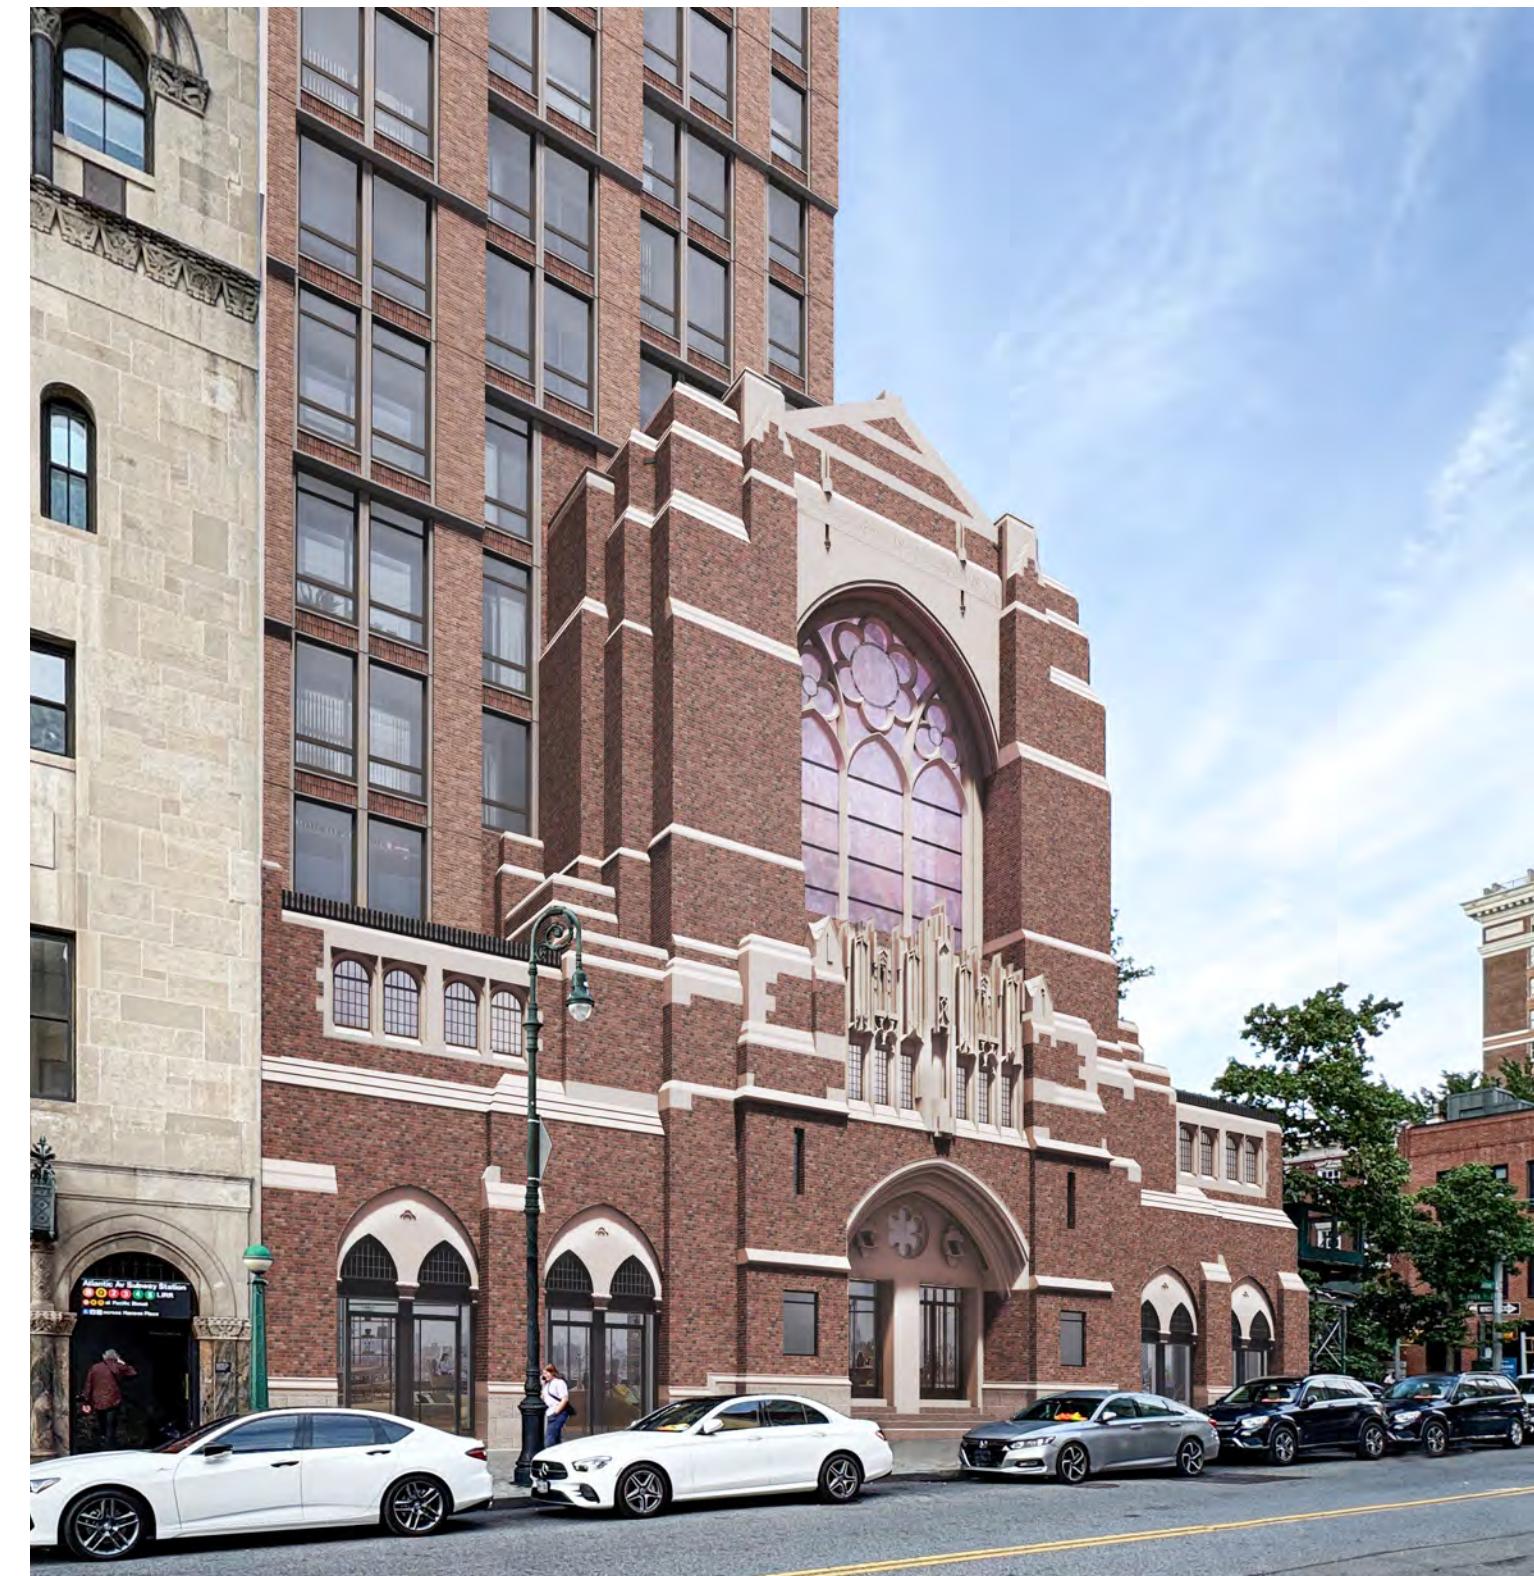
## Hanson Pl & St. Felix Looking North

EXISTING

PROPOSED

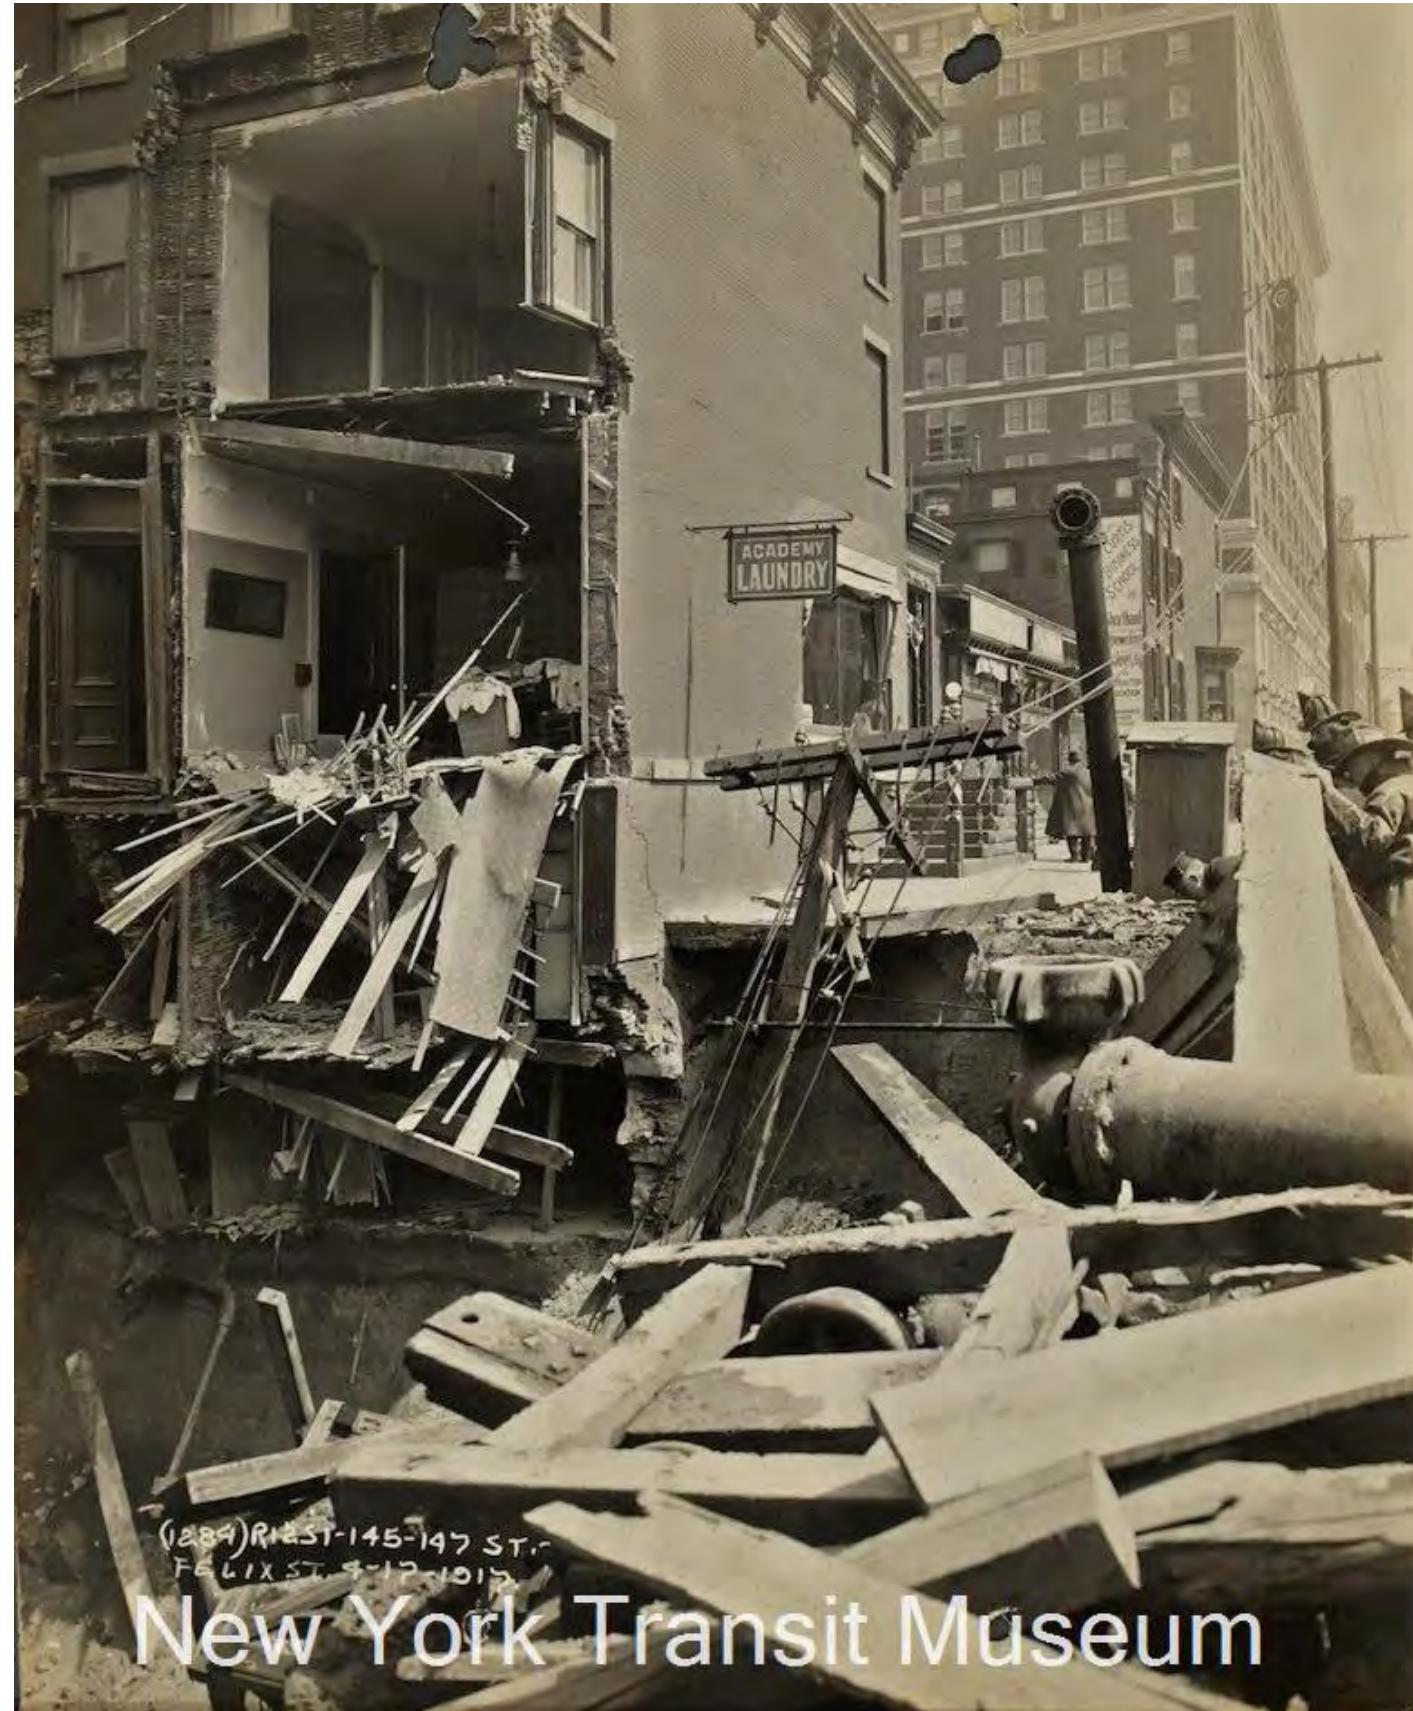
Shows condition of fronts of buildings 145 and 147 St. Felix Street after cave-in.  
The camera is set at the northwest corner of Hanson Place and St. Felix Street, looking east.

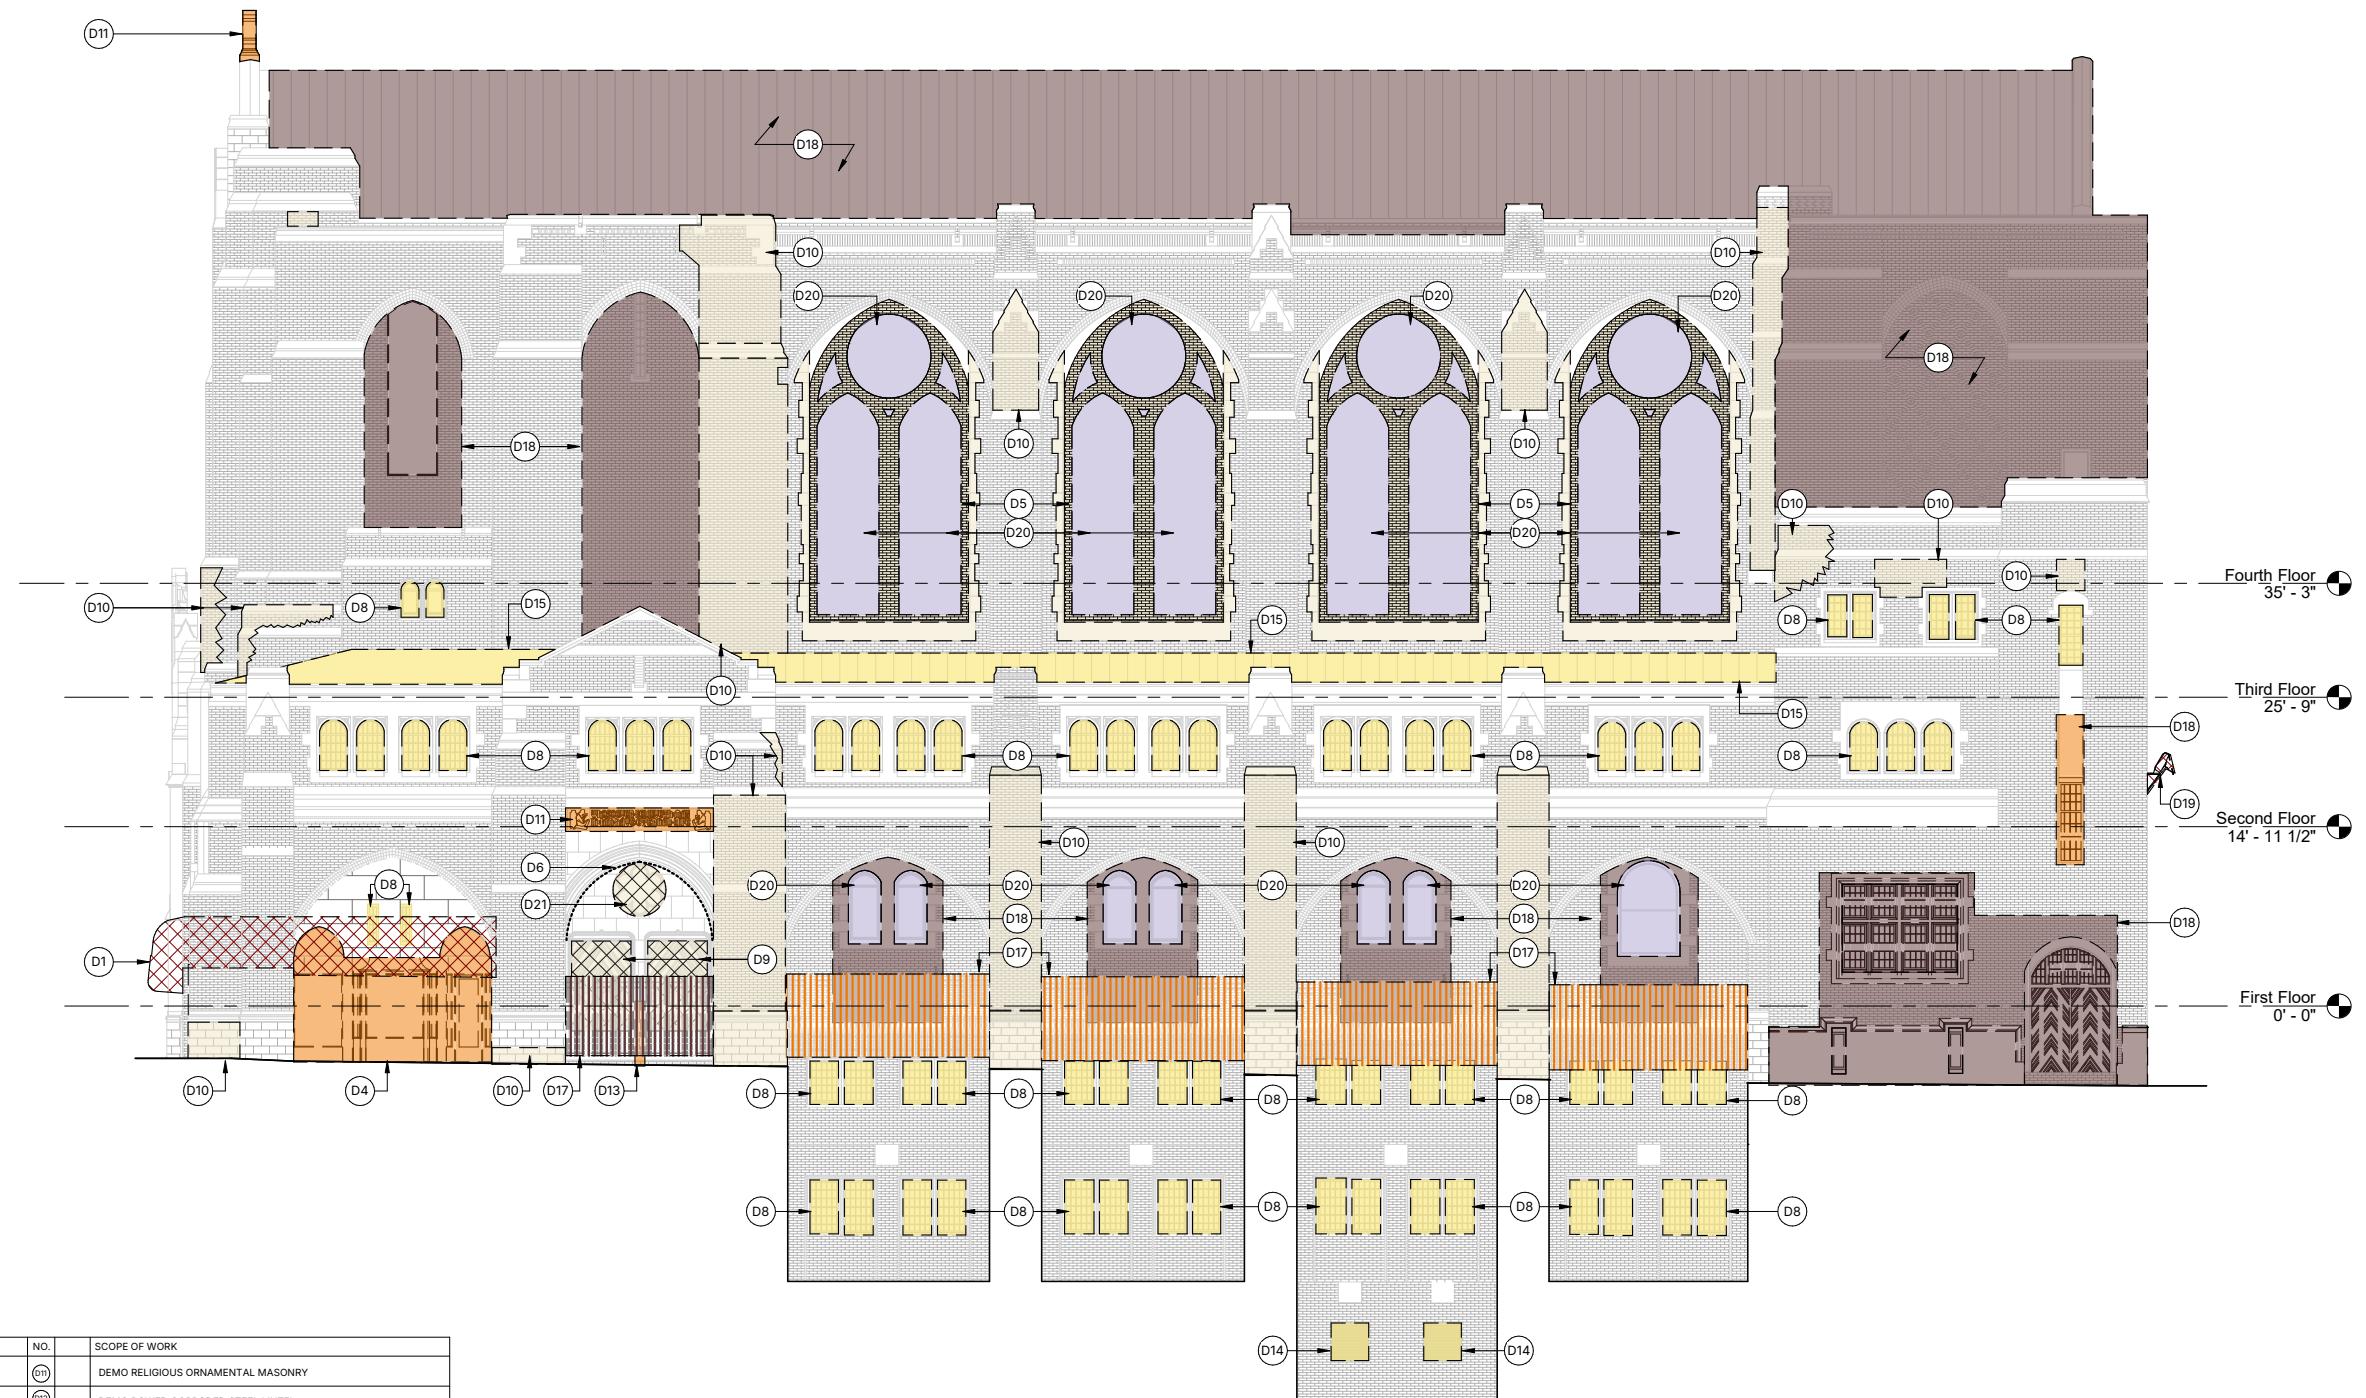
# Restoration Demolition: East Elevation

NO.	SCOPE OF WORK	NO.	SCOPE OF WORK
(b1)	DEMO NON-ORIGINAL OVERHEAD DOOR AND AWNING	(D11)	DEMO RELIGIOUS ORNAMENTAL MASONRY
(b2)	DEMO NON-ORIGINAL DOOR AND FRAME	(D12)	DEMO BOWED CORRODED STEEL LINTEL
(b3)	DEMO NON-ORIGINAL WINDOW COVER	(D13)	DEMO METAL HANDRAIL
(b4)	DEMO EXISTING STOREFRONTS	(D14)	DEMO CORRODED LOUVER
(b5)	RESTORE TRACERY	(D15)	DEMO ROOF AND FLASHING
(b6)	DEMO LIGHTS	(D16)	REMOVE NON-ORIGINAL PAINT
(b7)	DEMO READERBOARD	(D17)	DEMO CORRODED WROUGHT IRON FENCING
(b8)	DEMO EXISTING STEEL CORRODED WINDOWS AND FRAMES	(D18)	DEMO PORTION OF BUILDING FOR NEW CONSTRUCTION
(b9)	DAMAGED WOOD ENTRY DOORS	(D19)	REMOVE AND SALVAGE STAINED GLASS FOR DONATION
(b10)	DAMAGED MASONRY	(D20)	REMOVE AND SALVAGE WINDOW AND TRACERY FOR RESTORATION

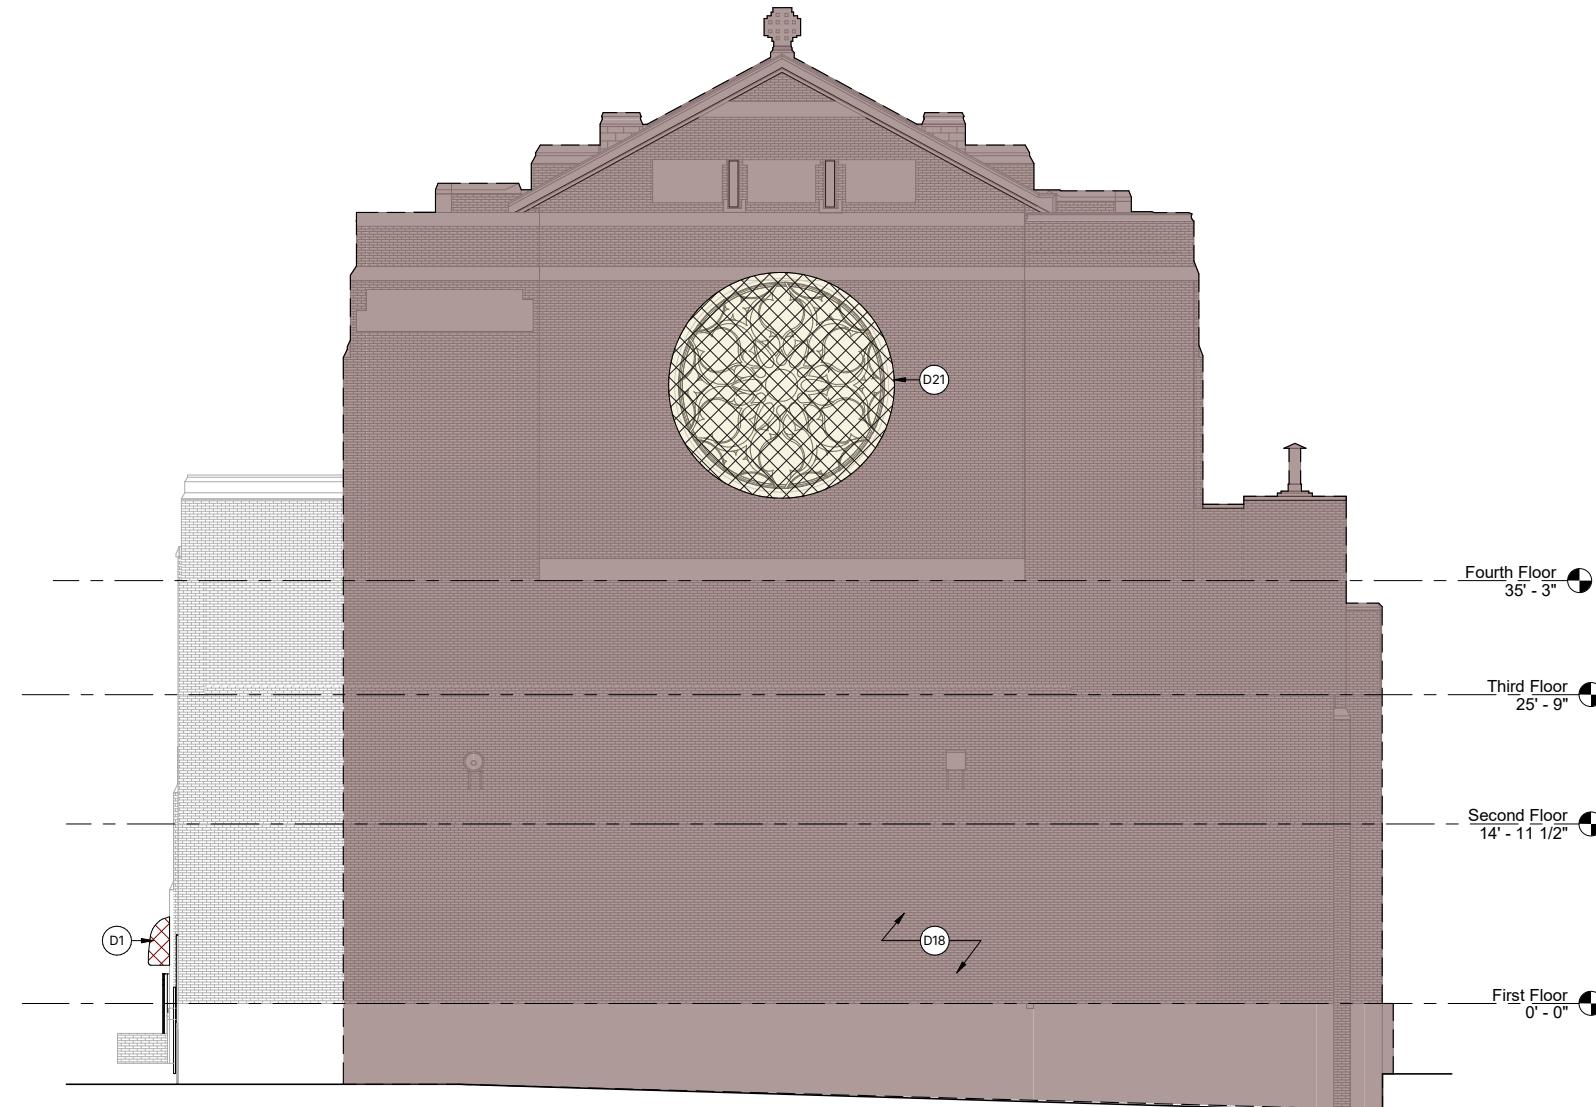
# Restoration Demolition: North Elevation

NO.	SCOPE OF WORK	NO.	SCOPE OF WORK
(b1)	DEMO NON-ORIGINAL OVERHEAD DOOR AND AWNING	(b11)	DEMO RELIGIOUS ORNAMENTAL MASONRY
(b2)	DEMO NON-ORIGINAL DOOR AND FRAME	(b12)	DEMO BOWED CORRODED STEEL LINTEL
(b3)	DEMO NON-ORIGINAL WINDOW COVER	(b13)	DEMO METAL HANDRAIL
(b4)	DEMO EXISTING STOREFRONTS	(b14)	DEMO CORRODED LOUVER
(b5)	RESTORE TRACERY	(b15)	DEMO ROOF AND FLASHING
(b6)	DEMO LIGHTS	(b16)	REMOVE NON-ORIGINAL PAINT
(b7)	DEMO READERBOARD	(b17)	DEMO CORRODED WROUGHT IRON FENCING
(b8)	DEMO EXISTING STEEL CORRODED WINDOWS AND FRAMES	(b18)	DEMO PORTION OF BUILDING FOR NEW CONSTRUCTION
(b9)	DAMAGED WOOD ENTRY DOORS	(b19)	REMOVE AND SALVAGE STAINED GLASS FOR DONATION
(b10)	DAMAGED MASONRY	(b20)	REMOVE AND SALVAGE WINDOW AND TRACERY FOR RESTORATION

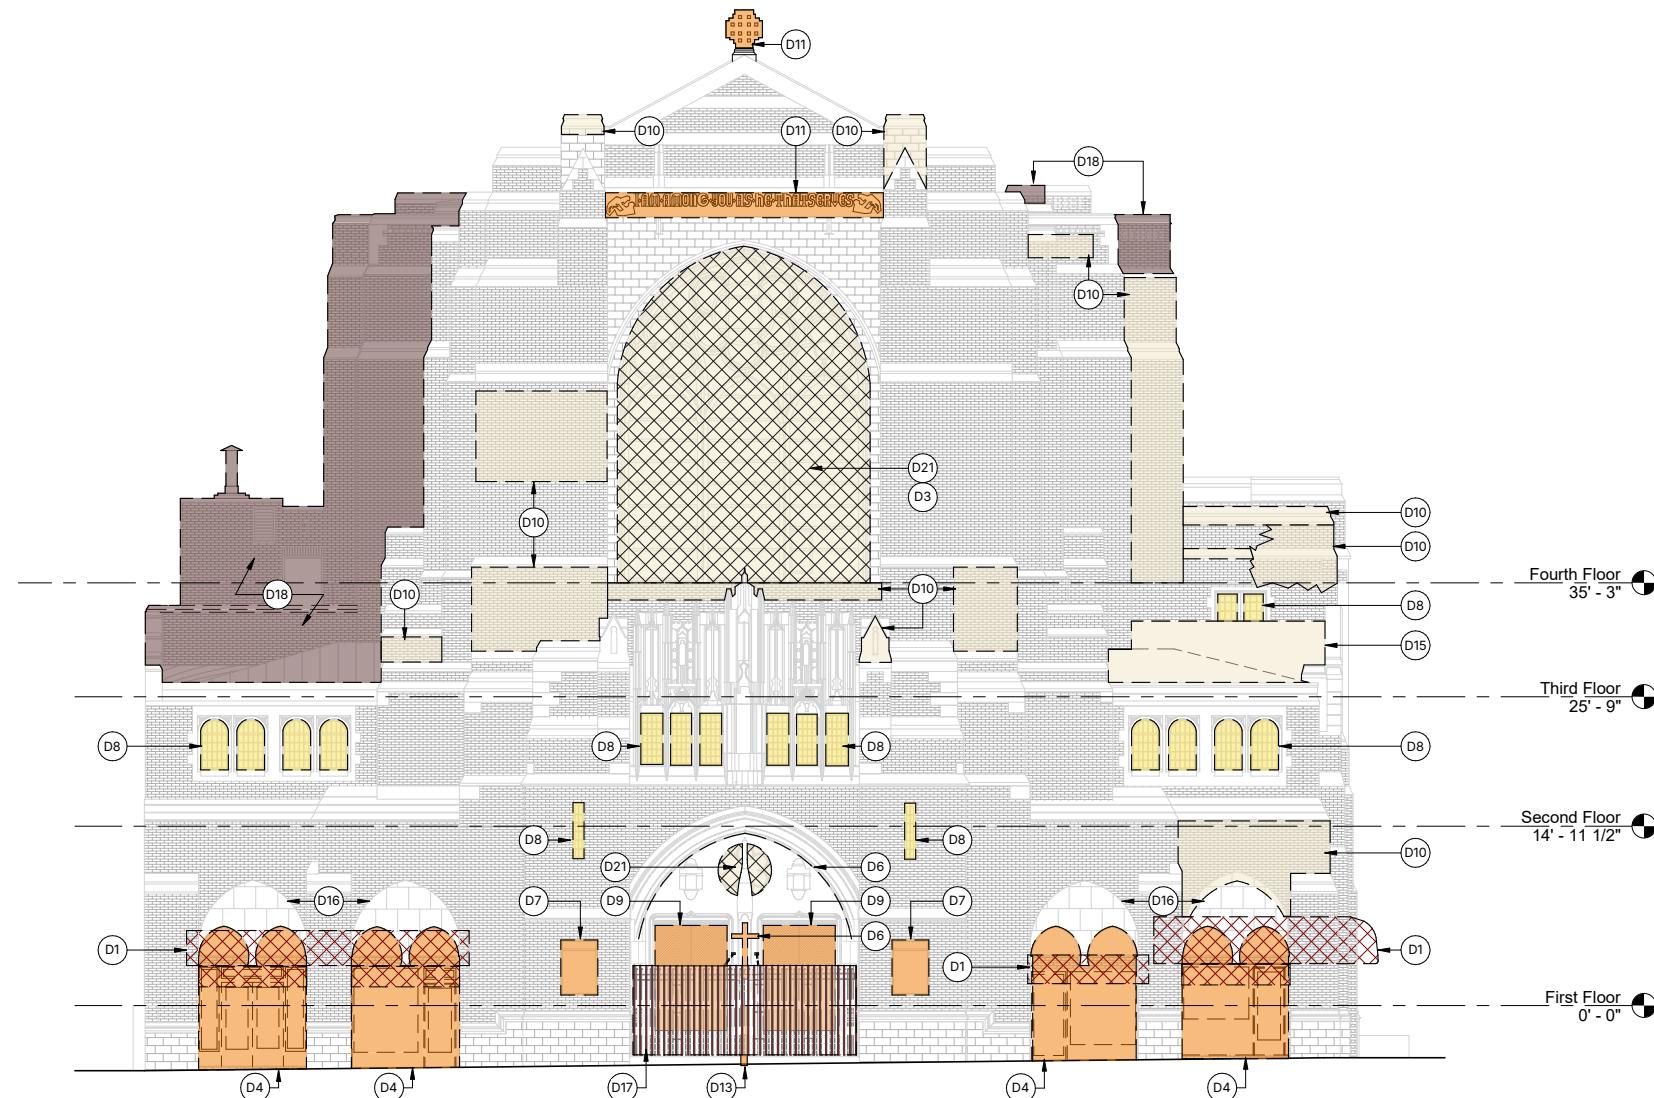
# Restoration Demolition: South Elevation

NO.	SCOPE OF WORK	NO.	SCOPE OF WORK
(b1)	DEMO NON-ORIGINAL OVERHEAD DOOR AND AWNING	(D1)	DEMO RELIGIOUS ORNAMENTAL MASONRY
(b2)	DEMO NON-ORIGINAL DOOR AND FRAME	(D2)	DEMO BOWED CORRODED STEEL LINTEL
(b3)	DEMO NON-ORIGINAL WINDOW COVER	(D3)	DEMO METAL HANDRAIL
(b4)	DEMO EXISTING STOREFRONTS	(D4)	DEMO CORRODED LOUVER
(b5)	RESTORE TRACERY	(D5)	DEMO ROOF AND FLASHING
(b6)	DEMO LIGHTS	(D6)	REMOVE NON-ORIGINAL PAINT
(b7)	DEMO READERBOARD	(D7)	DEMO CORRODED WROUGHT IRON FENCING
(b8)	DEMO EXISTING STEEL CORRODED WINDOWS AND FRAMES	(D8)	DEMO PORTION OF BUILDING FOR NEW CONSTRUCTION
(b9)	DAMAGED WOOD ENTRY DOORS	(D9)	REMOVE AND SALVAGE STAINED GLASS FOR DONATION
(b10)	DAMAGED MASONRY	(D10)	REMOVE AND SALVAGE WINDOW AND TRACERY FOR RESTORATION

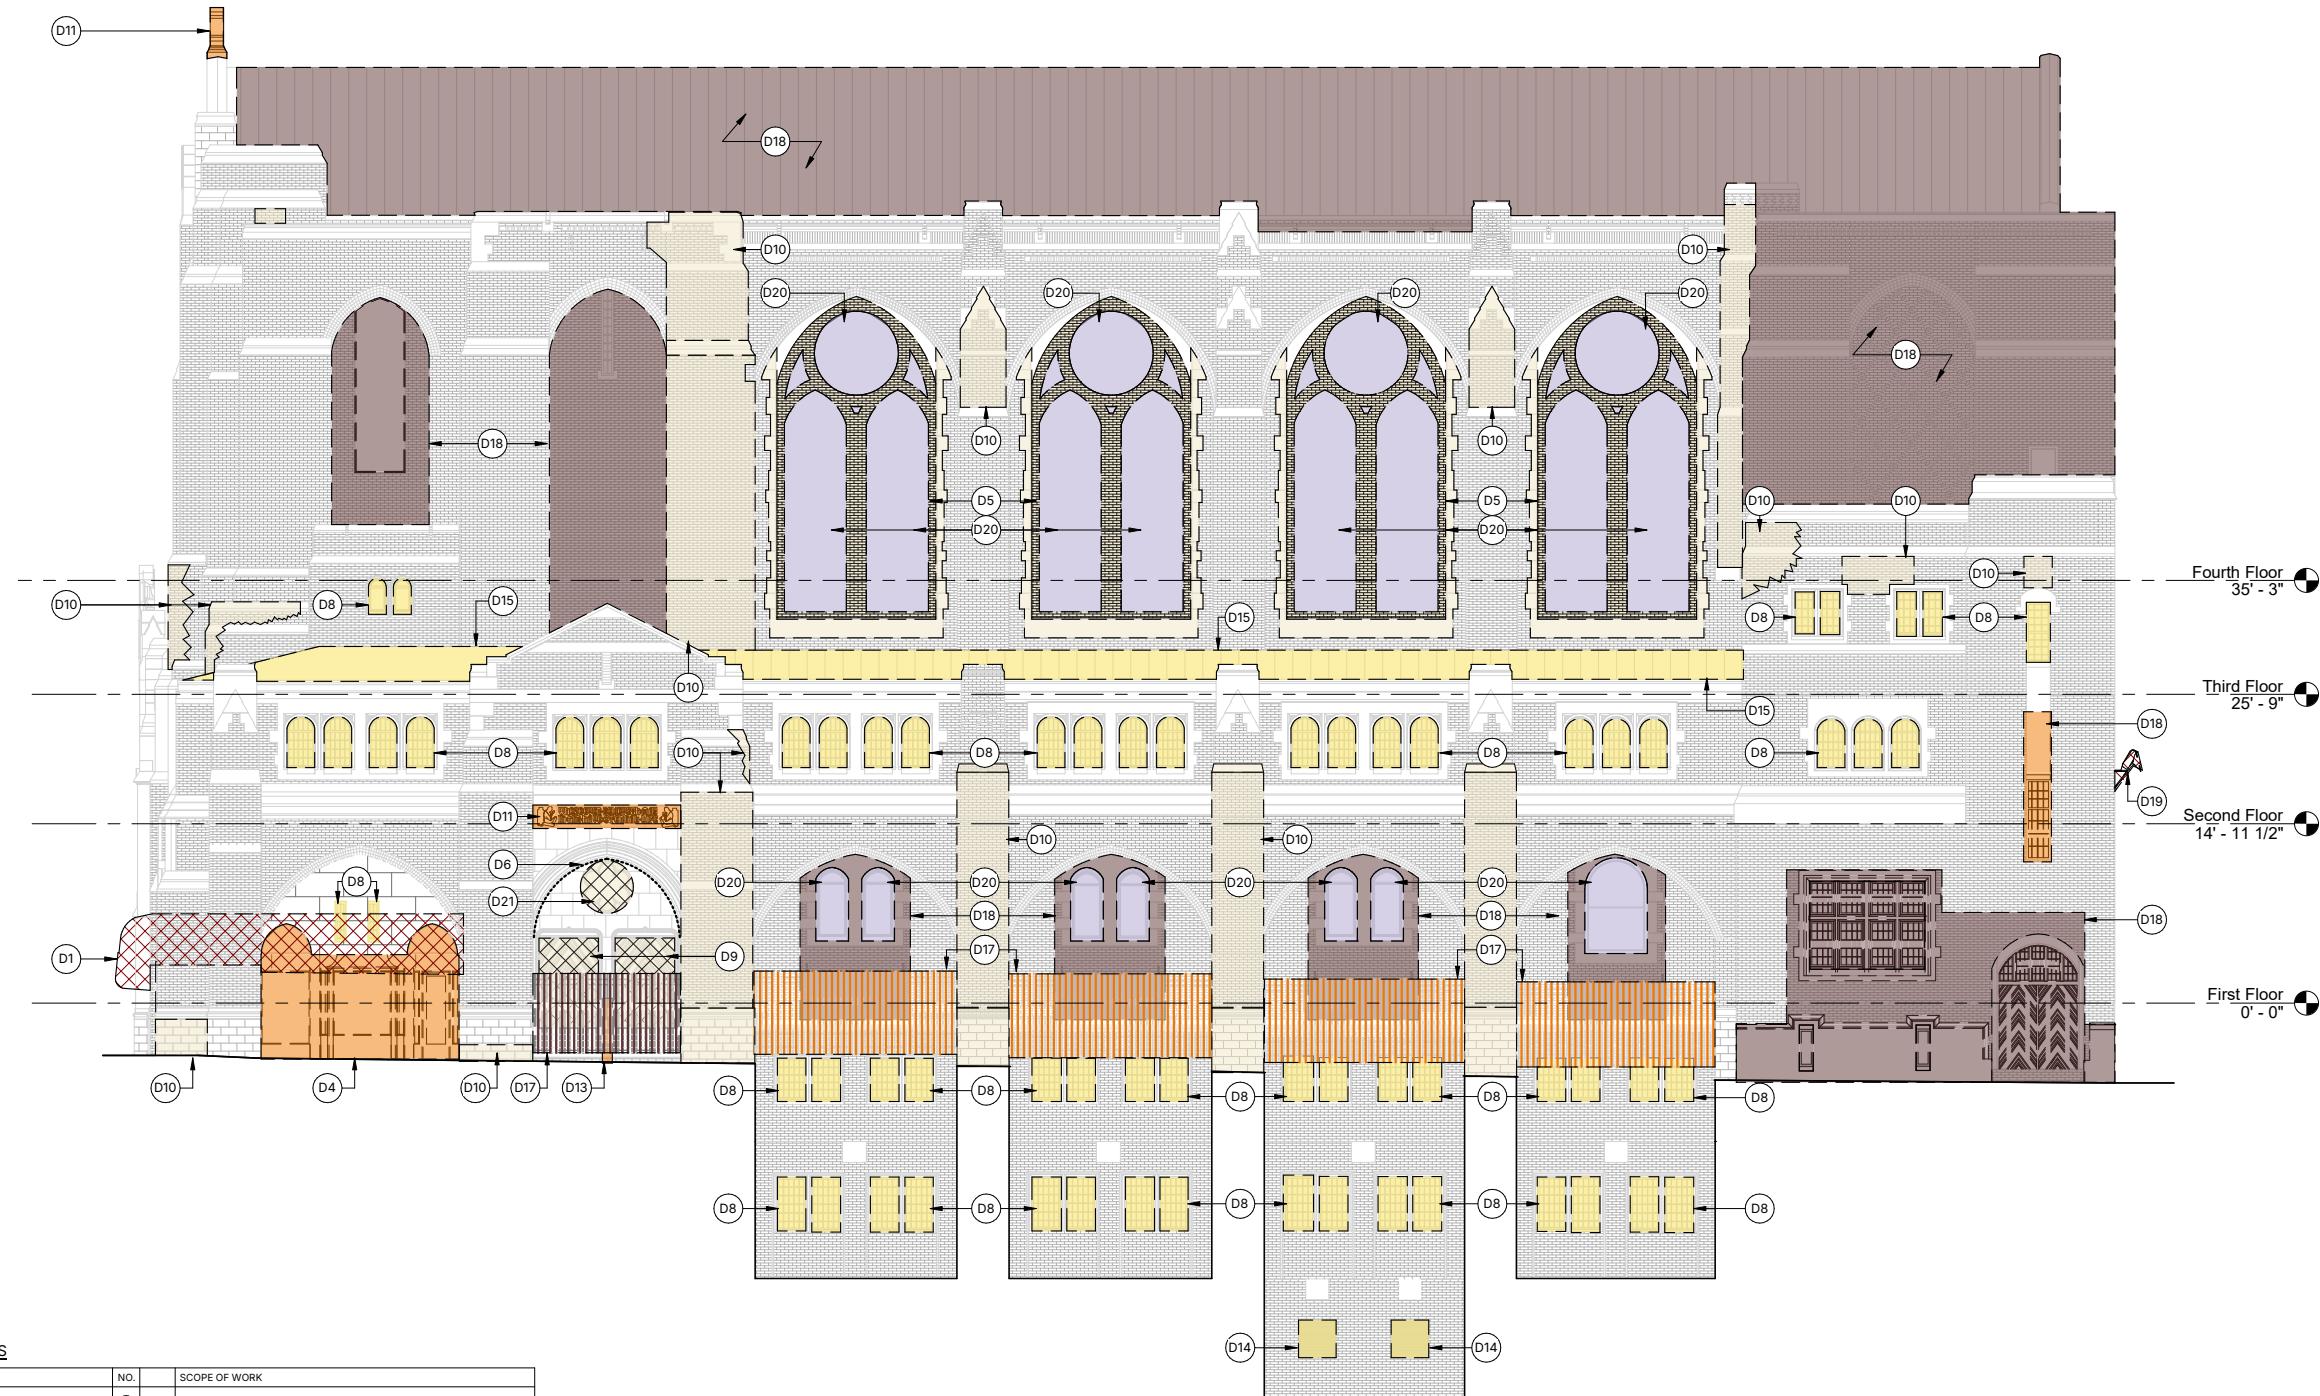
# Restoration Demolition: West Elevation

NO.	SCOPE OF WORK	NO.	SCOPE OF WORK
D1	DEMO NON-ORIGINAL OVERHEAD DOOR AND AWNING	D11	DEMO RELIGIOUS ORNAMENTAL MASONRY
D2	DEMO NON-ORIGINAL DOOR AND FRAME	D12	DEMO BOWED CORRODED STEEL LINTEL
D3	DEMO NON-ORIGINAL WINDOW COVER	D13	DEMO METAL HANDRAIL
D4	DEMO EXISTING STOREFRONTS	D14	DEMO CORRODED LOUVER
D5	RESTORE TRACERY	D15	DEMO ROOF AND FLASHING
D6	DEMO LIGHTS	D16	REMOVE NON-ORIGINAL PAINT
D7	DEMO READERBOARD	D17	REPLACE IN-KIND
D8	DEMO EXISTING STEEL CORRODED WINDOWS AND FRAMES	D18	REPLACE WITH MODIFICATIONS
D9	DAMAGED WOOD ENTRY DOORS	D19	REMOVE AND SALVAGE STAINED GLASS FOR DONATION
D10	DAMAGED MASONRY	D20	REMOVE AND SALVAGE WINDOW AND TRACERY FOR RESTORATION

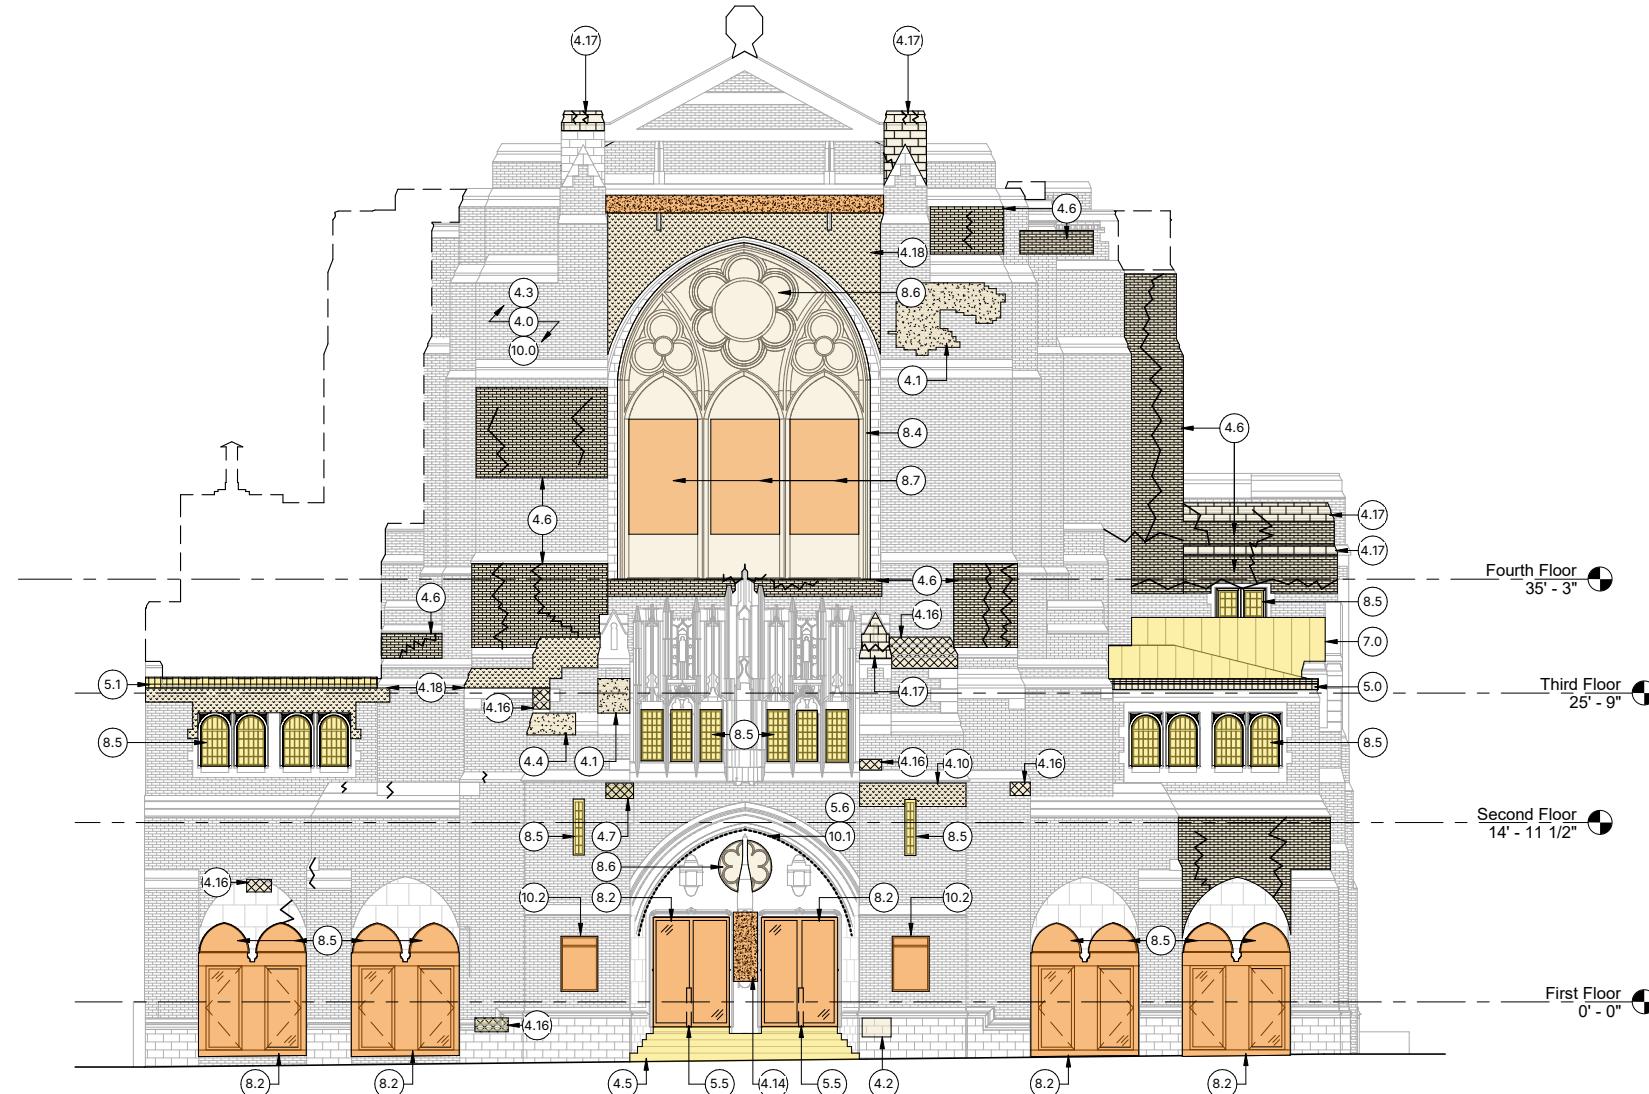
# Restoration Construction: South Elevation

NO.	SCOPE OF WORK	NO.	SCOPE OF WORK	NO.	SCOPE OF WORK	NO.	SCOPE OF WORK
4.1	CLEAN MASONRY, TYP.	4.13	PROVIDE NEW NON-DENOMINATIONAL ORNAMENTATION	4.1	PROVIDE NEW ROOFING AND FLASHING AT FLAT ROOF	4.10	PROVIDE NEW BIRD PROTECTION FOR ENTIRE BUILDING, TYP.

4.2	CLEAN EFFLORESCENCE AT BRICK	4.14	REPAIR/RESURFACE CRACKED/CHIPPED CAST STONE	4.2	DRAIN PONDING WATER AT ROOF. INVESTIGATE EXISTING DRAINAGE SYSTEM, REPAIR AS REQUIRED	4.11	PROVIDE NEW LIGHTS AT ENTRY ARCH

4.3	CLEAN HISTORIC DATESTONE	4.15	REPAIR SPALLED CAST STONE	4.3	PROVIDE NEW DOOR AND FRAME	4.12	PROVIDE NEW SIGNAGE
4.4	CLEAN CAST STONE, TYP.	4.16	REPAIR DAMAGED CAST STONE IN-KIND	4.4	RESTORE EXISTING HISTORIC ENTRY DOORS	4.13	PROVIDE NEW 18" HIGH WROUGHT IRON FENCE WITH CAST STONE CURB AND SKYLIGHT BEHIND

4.5	CLEAN EFFLORESCENCE AT CAST STONE	4.17	RAKE AND REPOINT DETERIORATED CAST STONE JOINTS IN-KIND	4.5	PROVIDE NEW STOREFRONTS	4.14	PROVIDE NEW OPERABLE STEEL WINDOWS WITH CLEAR GLASS

4.6	PROVIDE NEW GRANITE STOREFRONT TO MATCH EXISTING	4.18	ASSESS CONDITION OF CAST STONE ENCASED TIE BEAM, REPAIR STRUCTURE AS NEEDED IN-KIND	4.6	PROVIDE NEW TRANSPARENT WINDOW COVER	4.15	PROVIDE NEW STEEL WINDOWS AND FRAMES TO MATCH HISTORIC

4.7	ASSESS CONDITION OF EXISTING STRUCTURE, REBUILD AS REQUIRED, REPAIR IN-KIND, STITCH AND PIN TO EXISTING	4.19	CLEAN AND REPAIR ORNAMENTAL PARAPET COPING	4.7	PROVIDE NEW ORNAMENTAL PARAPET COPING TO MATCH EXISTING	4.16	RESTORE AND REINSTALL WINDOW AND TRACERY

4.8	REPLACE SPALLED BRICK IN-KIND	4.20	SCRAPE AND REFINISH CORRODED STEEL LINTEL	4.8	RESTORE WATER STAINED BRICK IN-KIND	4.17	RESTORE WINDOW AND REPLACE RELIGIOUS STAINED GLASS PANES WITH RELOCATED SECULAR STAINED GLASS PANES

4.9	REPLACE CRACKED/CHIPPED BRICK IN-KIND	4.21	PROVIDE NEW STEEL LINTEL	4.9	PROVIDE NEW GRILL VENT	4.18	PROVIDE NEW CLEAR GLASS WINDOWS TO MATCH EXISTING WITH LOWERED SILLS

4.10	REPLACE DETERIORATED WATER STAINED BRICK IN-KIND	4.22	RESTORE BRICK MORTAR JOINTS IN-KIND	4.10	PROVIDE NEW METAL HANDRAIL	4.19	RELOCATE SECULAR STAINED GLASS PANES TO NEW WINDOW

4.11	RAKE AND REPOINT DETERIORATED BRICK MORTAR JOINTS IN-KIND	4.23	ASSESS CONDITIONS AT PREVIOUSLY REPLACED BRICK, REPAIR IN-KIND AS REQUIRED	4.11	RELOCATE WINDOW	4.20	RELOCATE WINDOW

4.12	ASSESS CONDITIONS AT PREVIOUSLY REPLACED BRICK, REPAIR IN-KIND AS REQUIRED	4.24	LEAVE AND REPAIR CONTINUOUS CRACK AT BRICK, STITCH AND PIN TO EXISTING	4.12	CLEAN, PATCH, AND REPAIR METAL AT ARCHED DOORWAY	4.21	CLEAN, PATCH, AND REPAIR METAL AT ARCHED DOORWAY

4.13	LEAVE AND REPAIR CONTINUOUS CRACK AT BRICK, STITCH AND PIN TO EXISTING	4.25	PROVIDE NEW TRACERY, MATCH EXISTING PROFILE	4.13	PROVIDE NEW STANDING SEAM ROOFING AND FLASHING	4.22	PROVIDE NEW TRACERY, MATCH EXISTING PROFILE
