**Preservation Department – Item 1, LPC-26-03280**

**138-154 St. Felix Street, aka 11-21 Hanson Place –  
Brooklyn Academy of Music Historic District  
Borough of Brooklyn**

# **144 ST. FELIX STREET**

## **ADAPTIVE-REUSE & ENLARGEMENT**

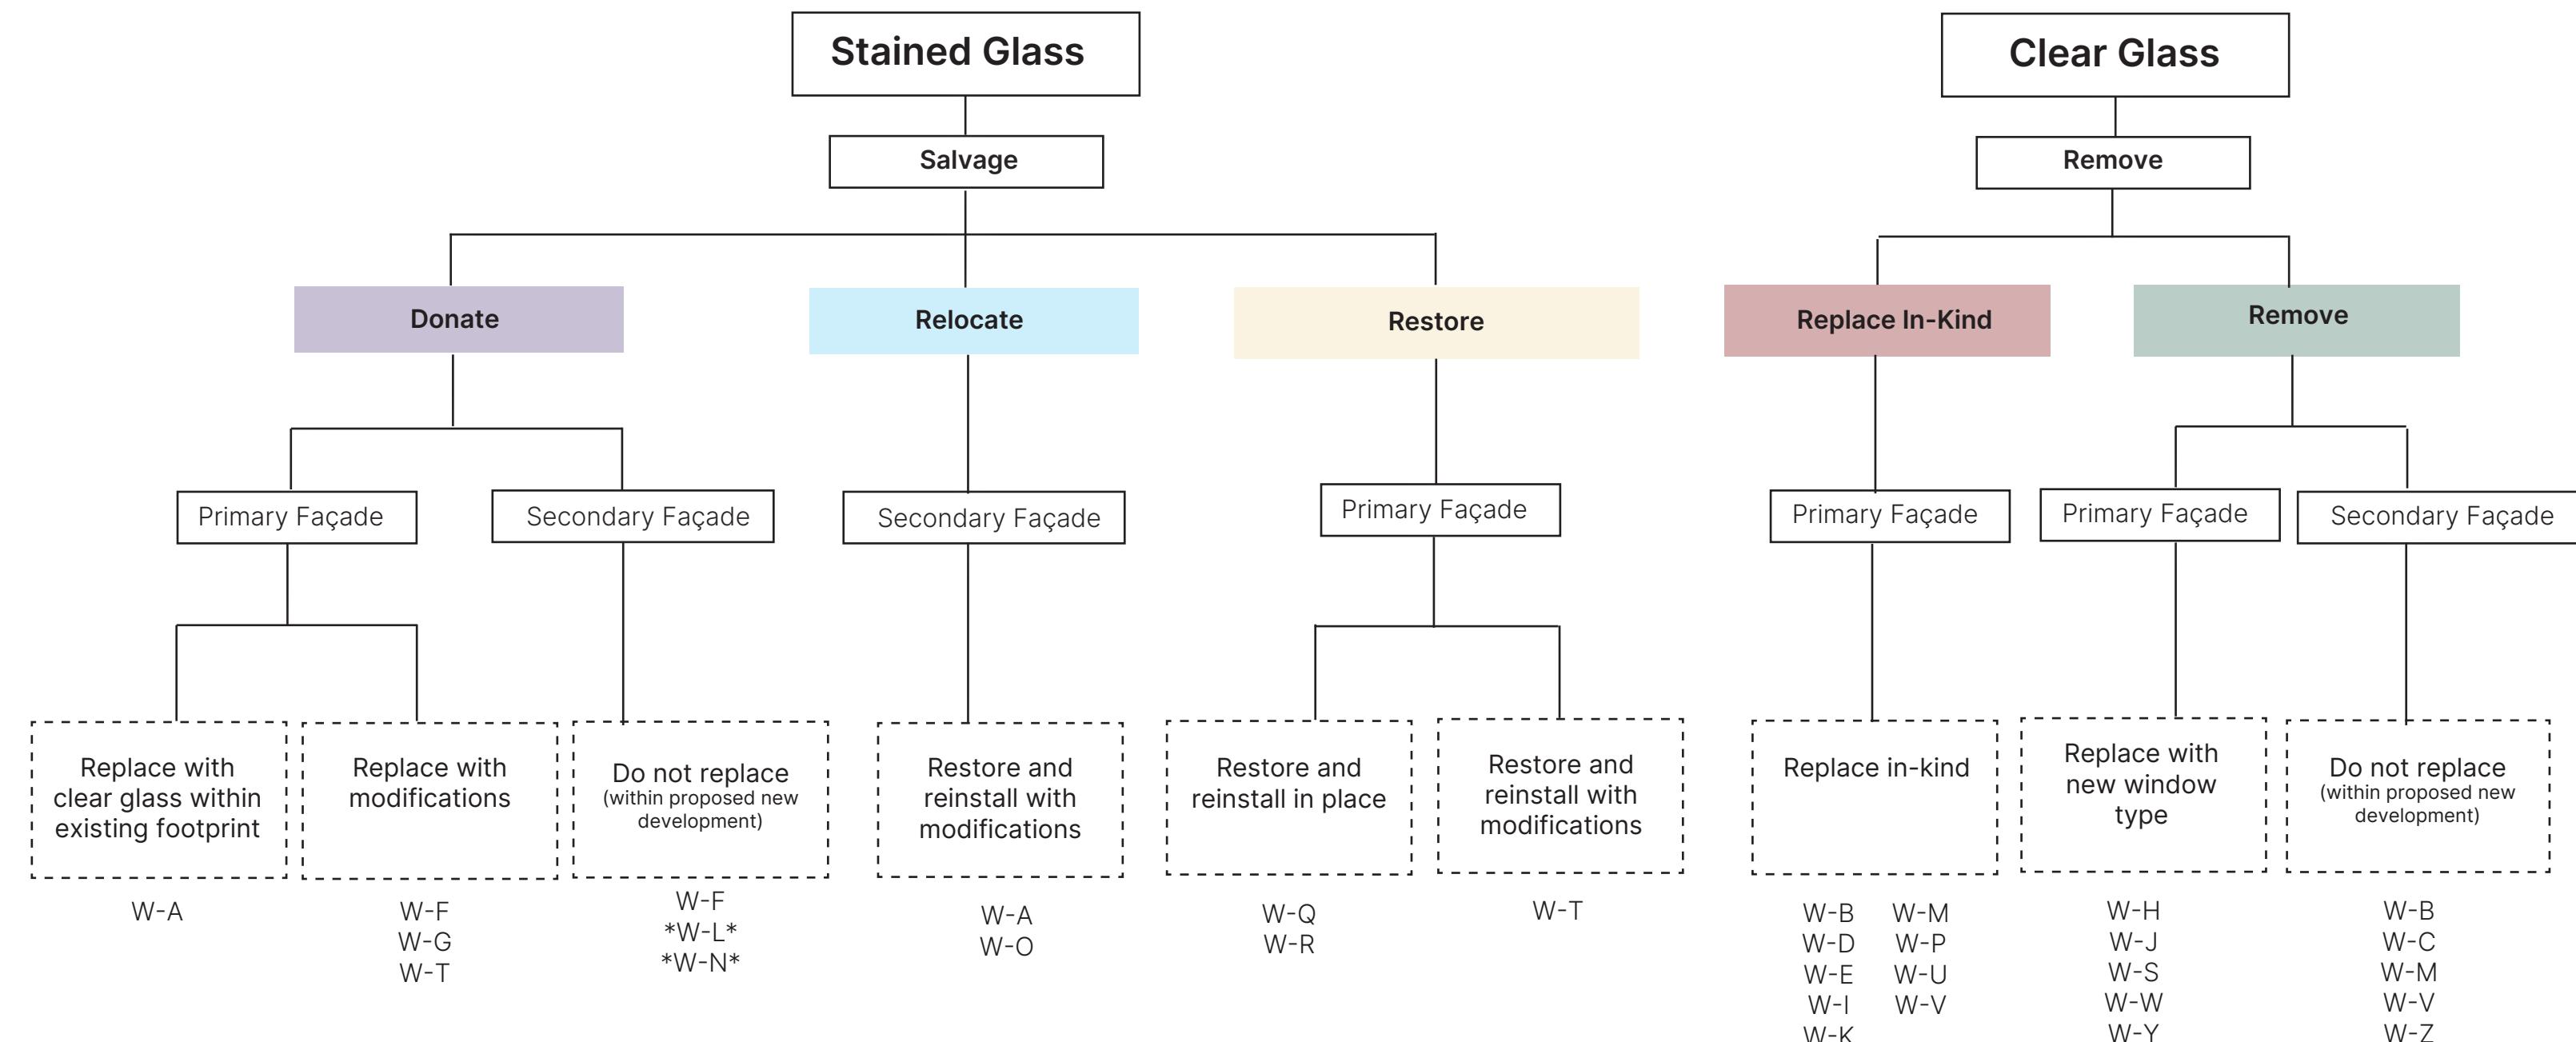
# Window Restoration & Replacement Strategy:

## \*\* Historic Tiffany Windows

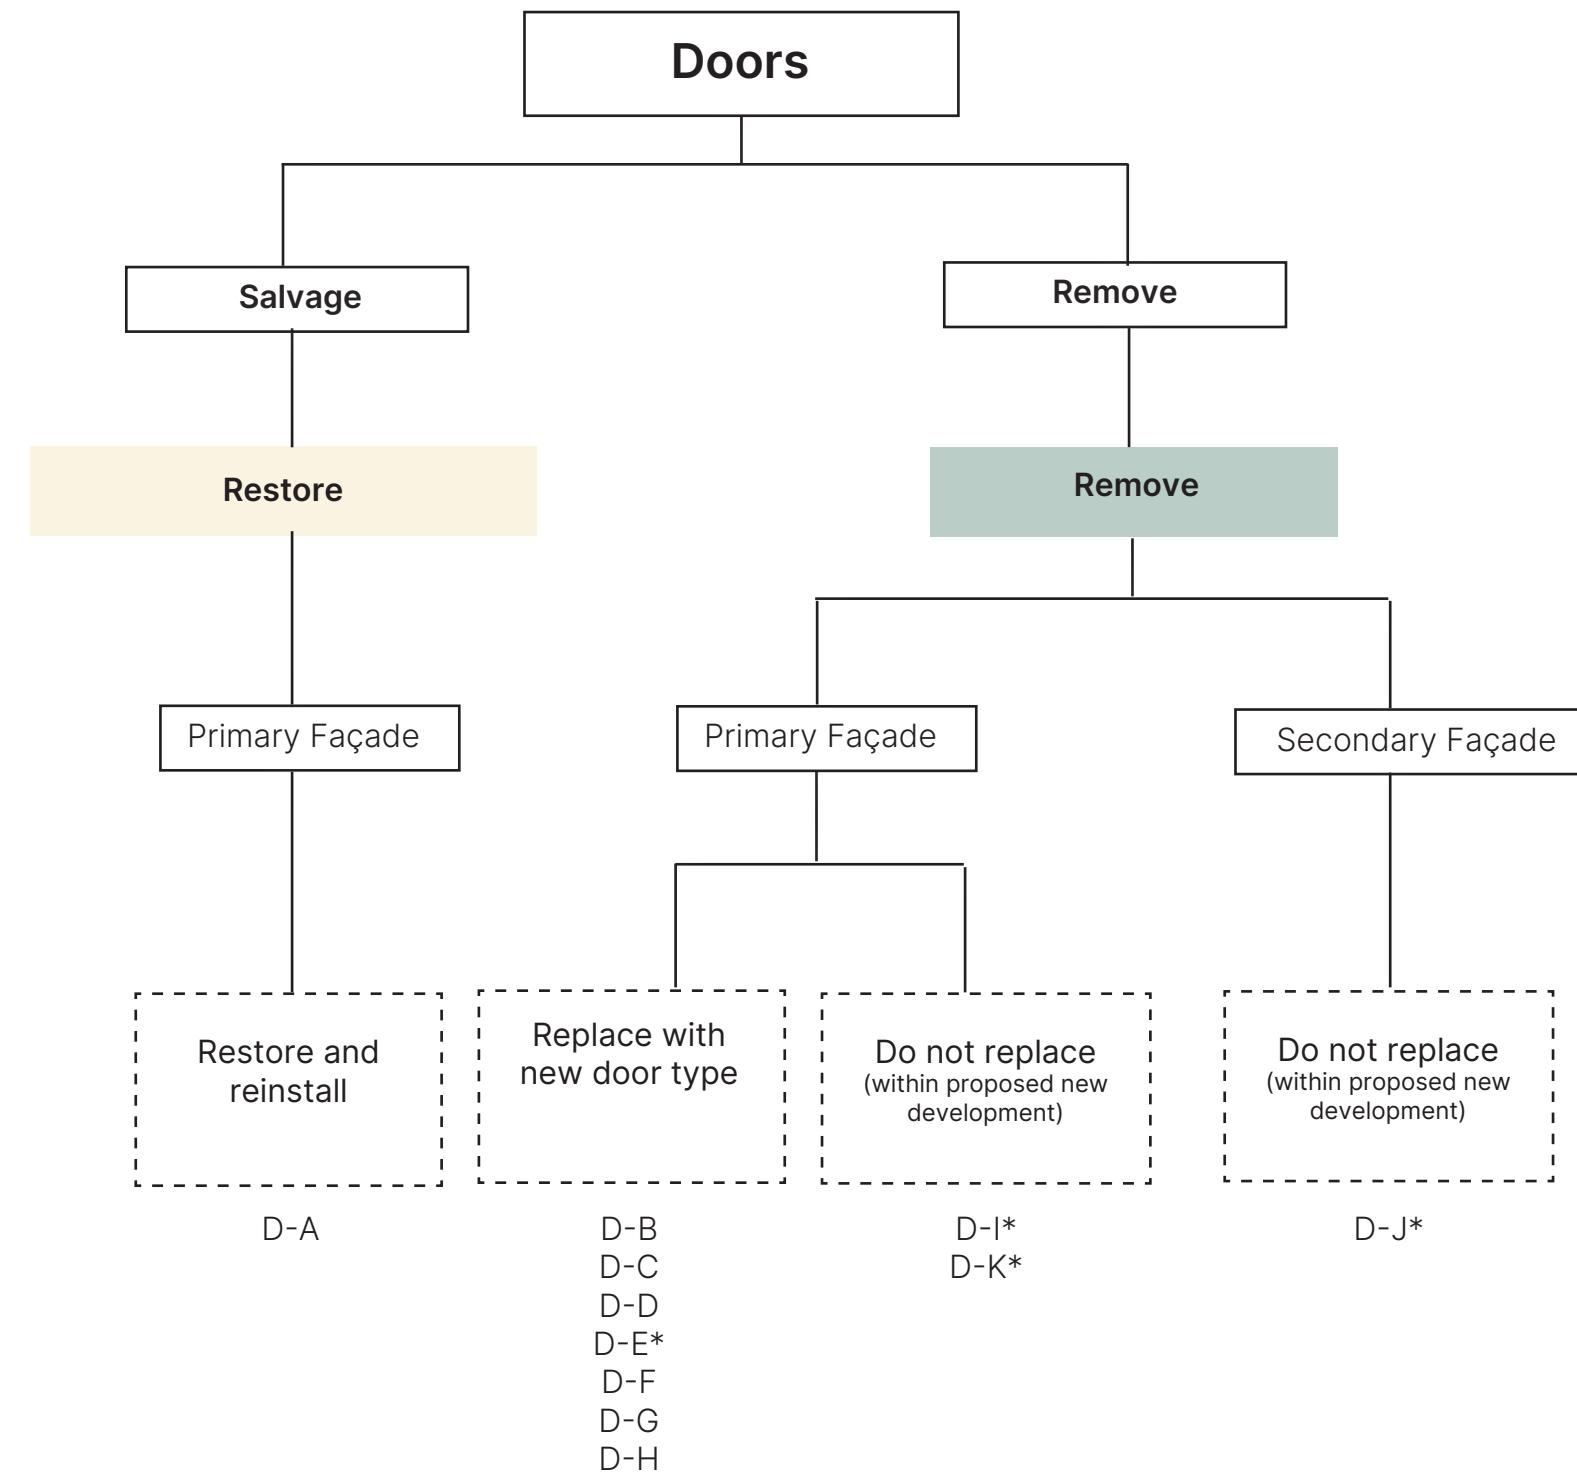
# Door Restoration & Replacement Strategy:

\* Not Special

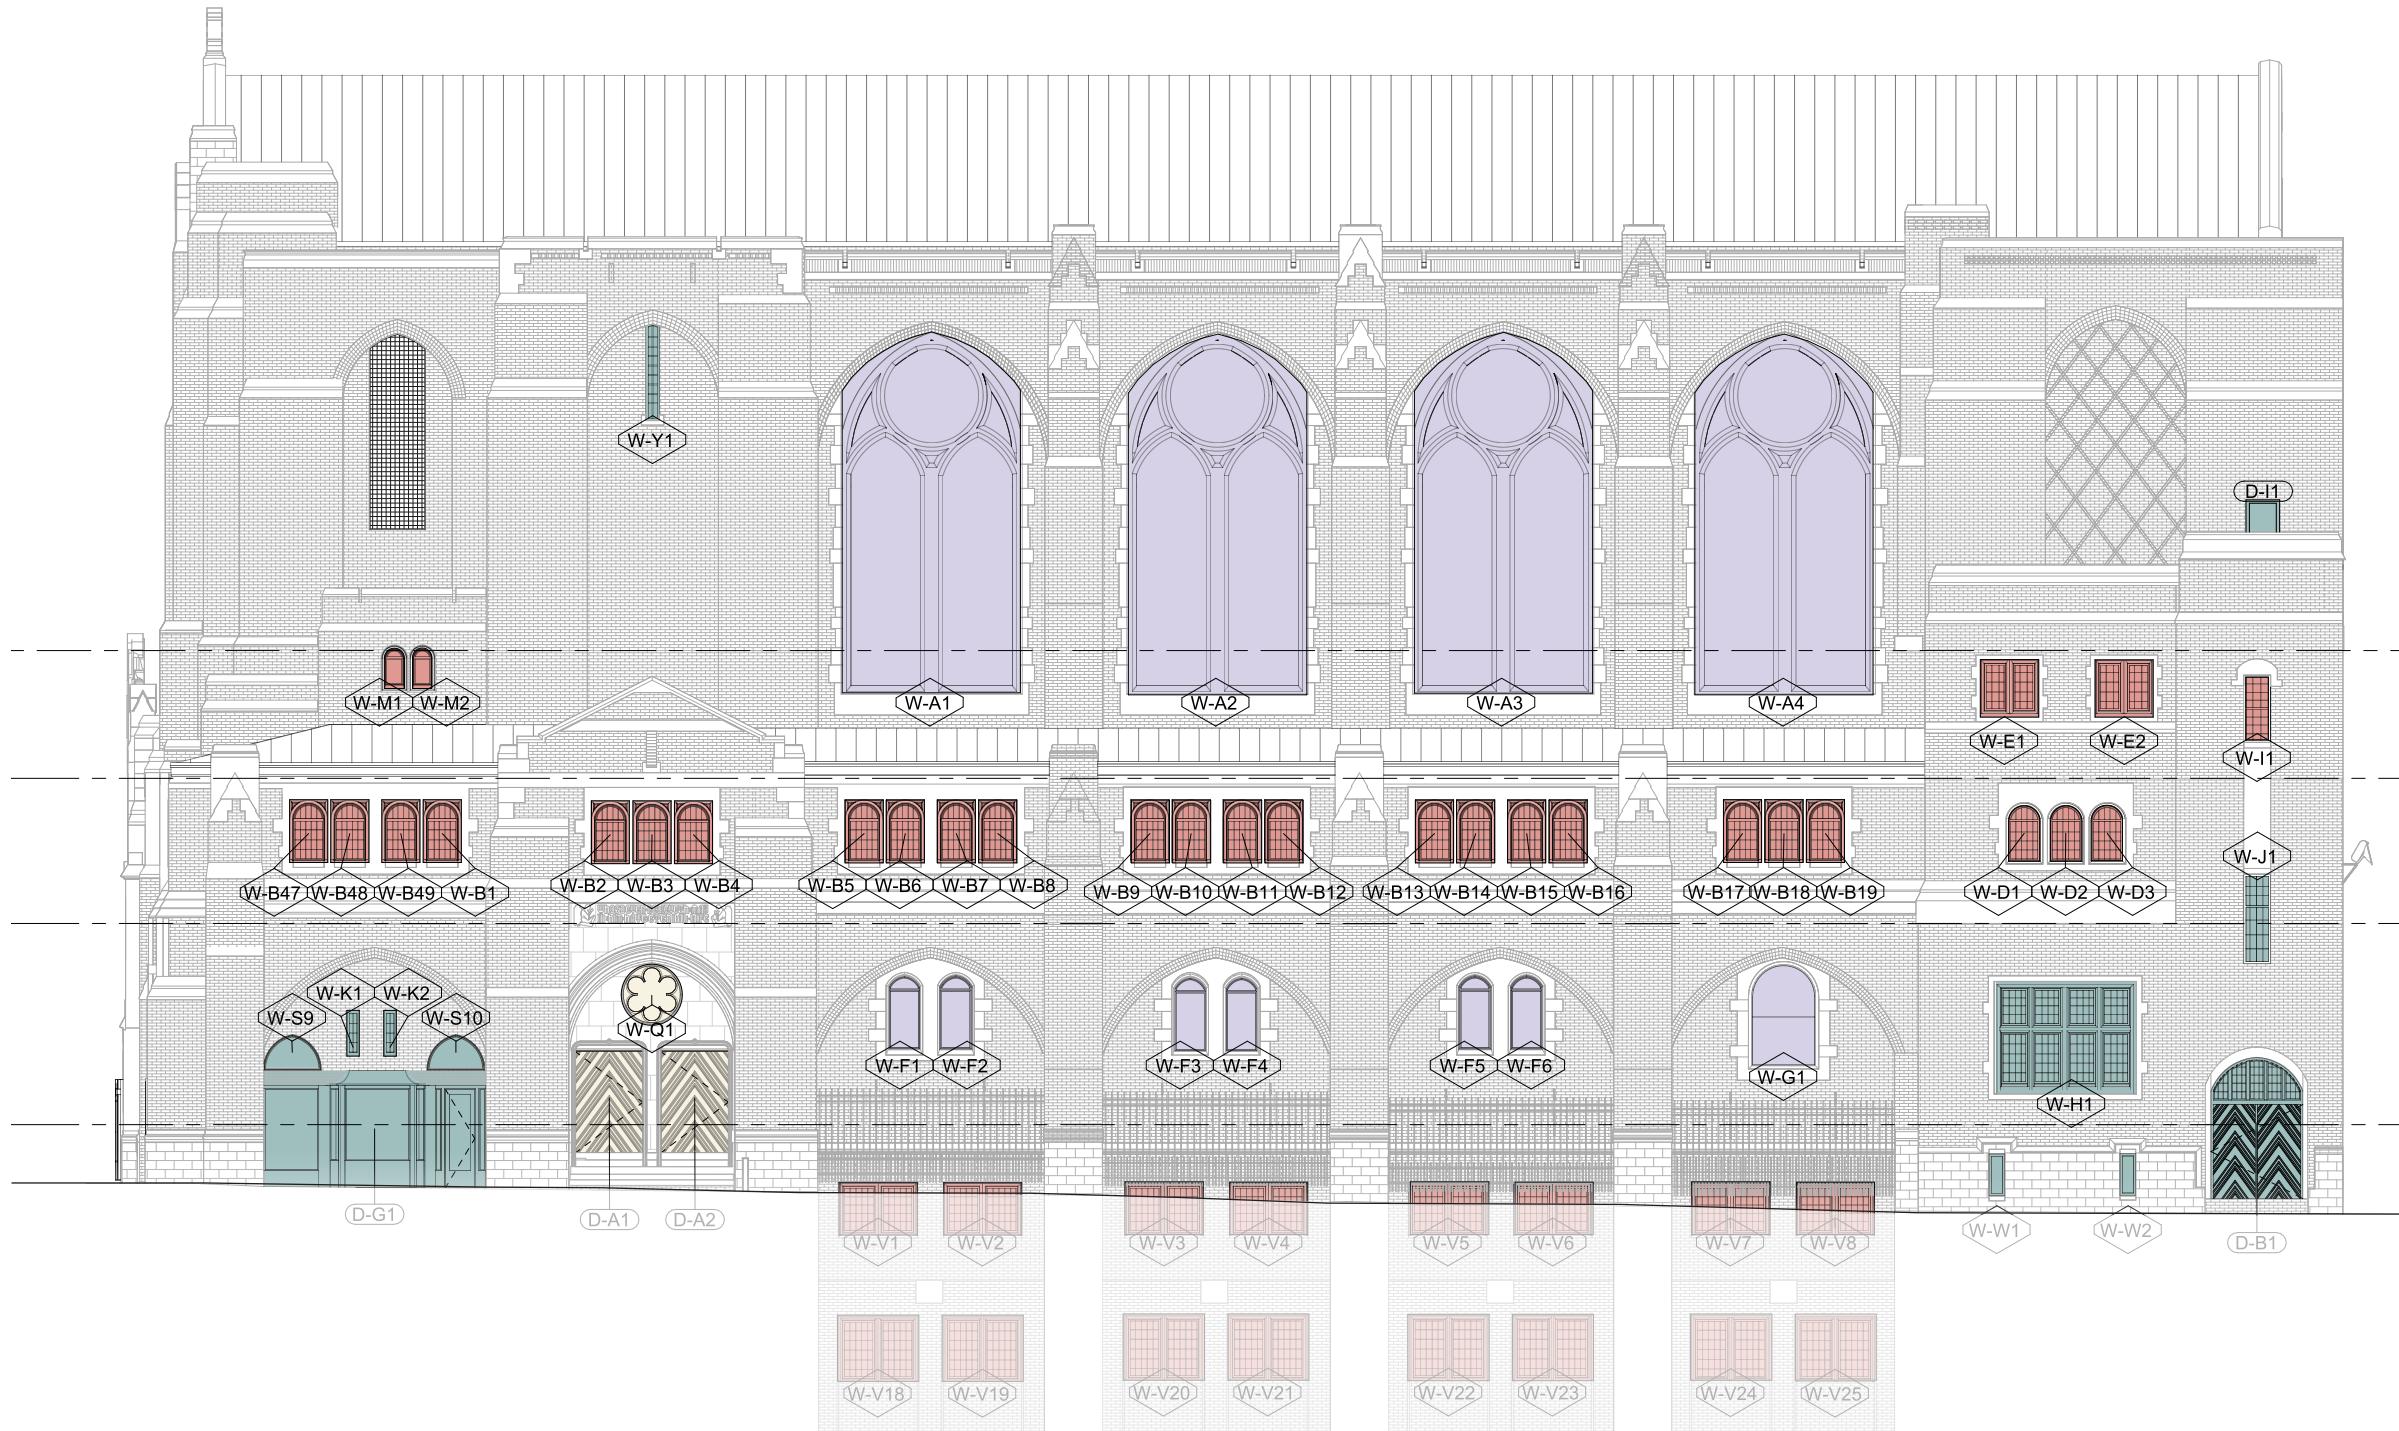
# East Elevation

## PRIMARY FAÇADE: Windows

A-1 B-1 B-8 B-15 B-49 D-1 E-1 F-1 G-1 H-1 I-1 J-1 M-1 Q-1 S-9 V-1 W-1 Y-1  
 A-2 B-2 B-9 B-16 D-2 E-2 F-2 M-2 S-10 V-2 W-2  
 A-3 B-3 B-10 B-17 D-3 F-3  
 A-4 B-4 B-11 B-18 F-4  
 B-5 B-12 B-19 F-5  
 B-6 B-13 B-47 F-6  
 B-7 B-14 B-48 F-8

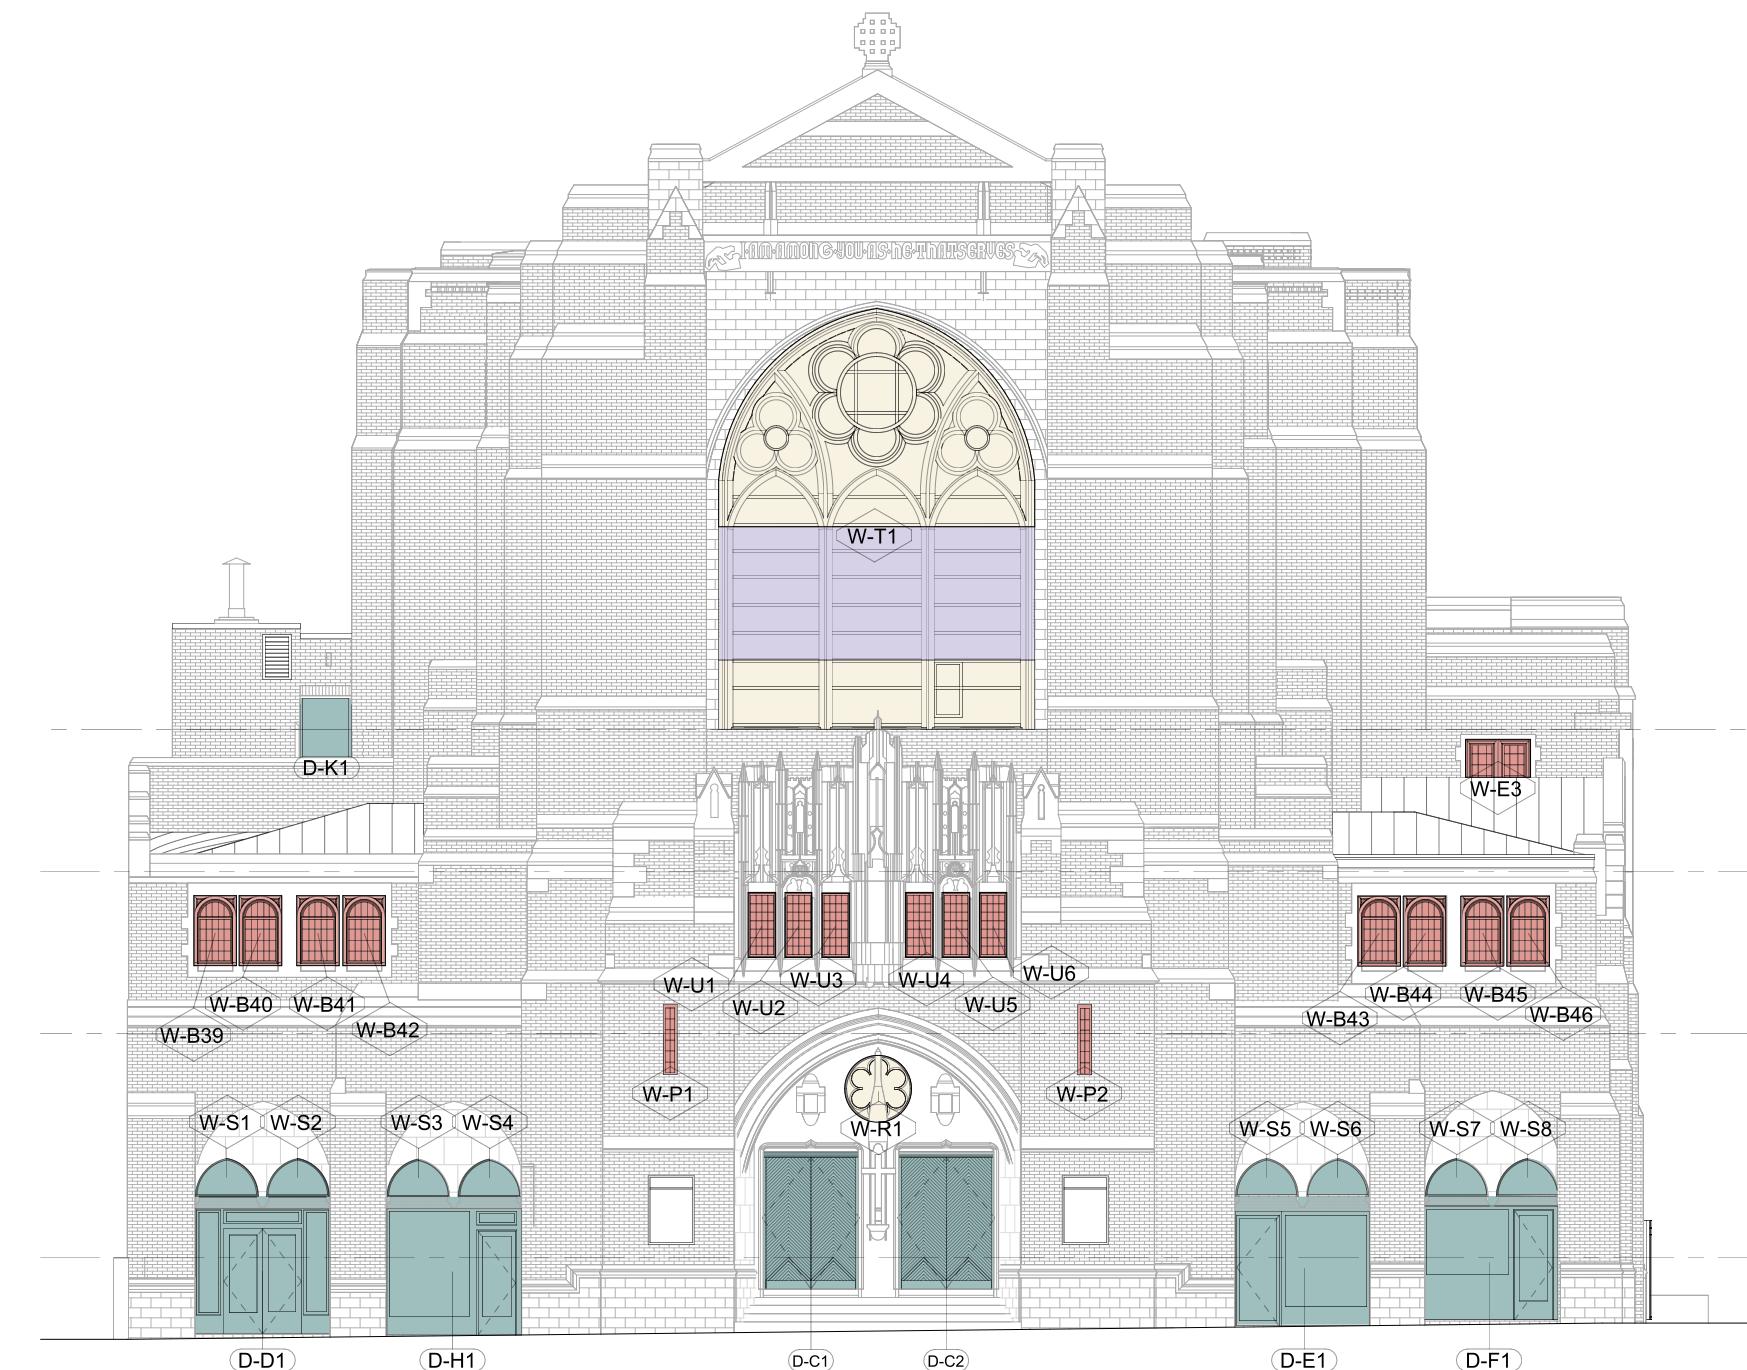
# South Elevation

## PRIMARY FAÇADE: Doors & Storefront

C-1 D-1 E-1 F-1 H-1 K-1  
 C-2

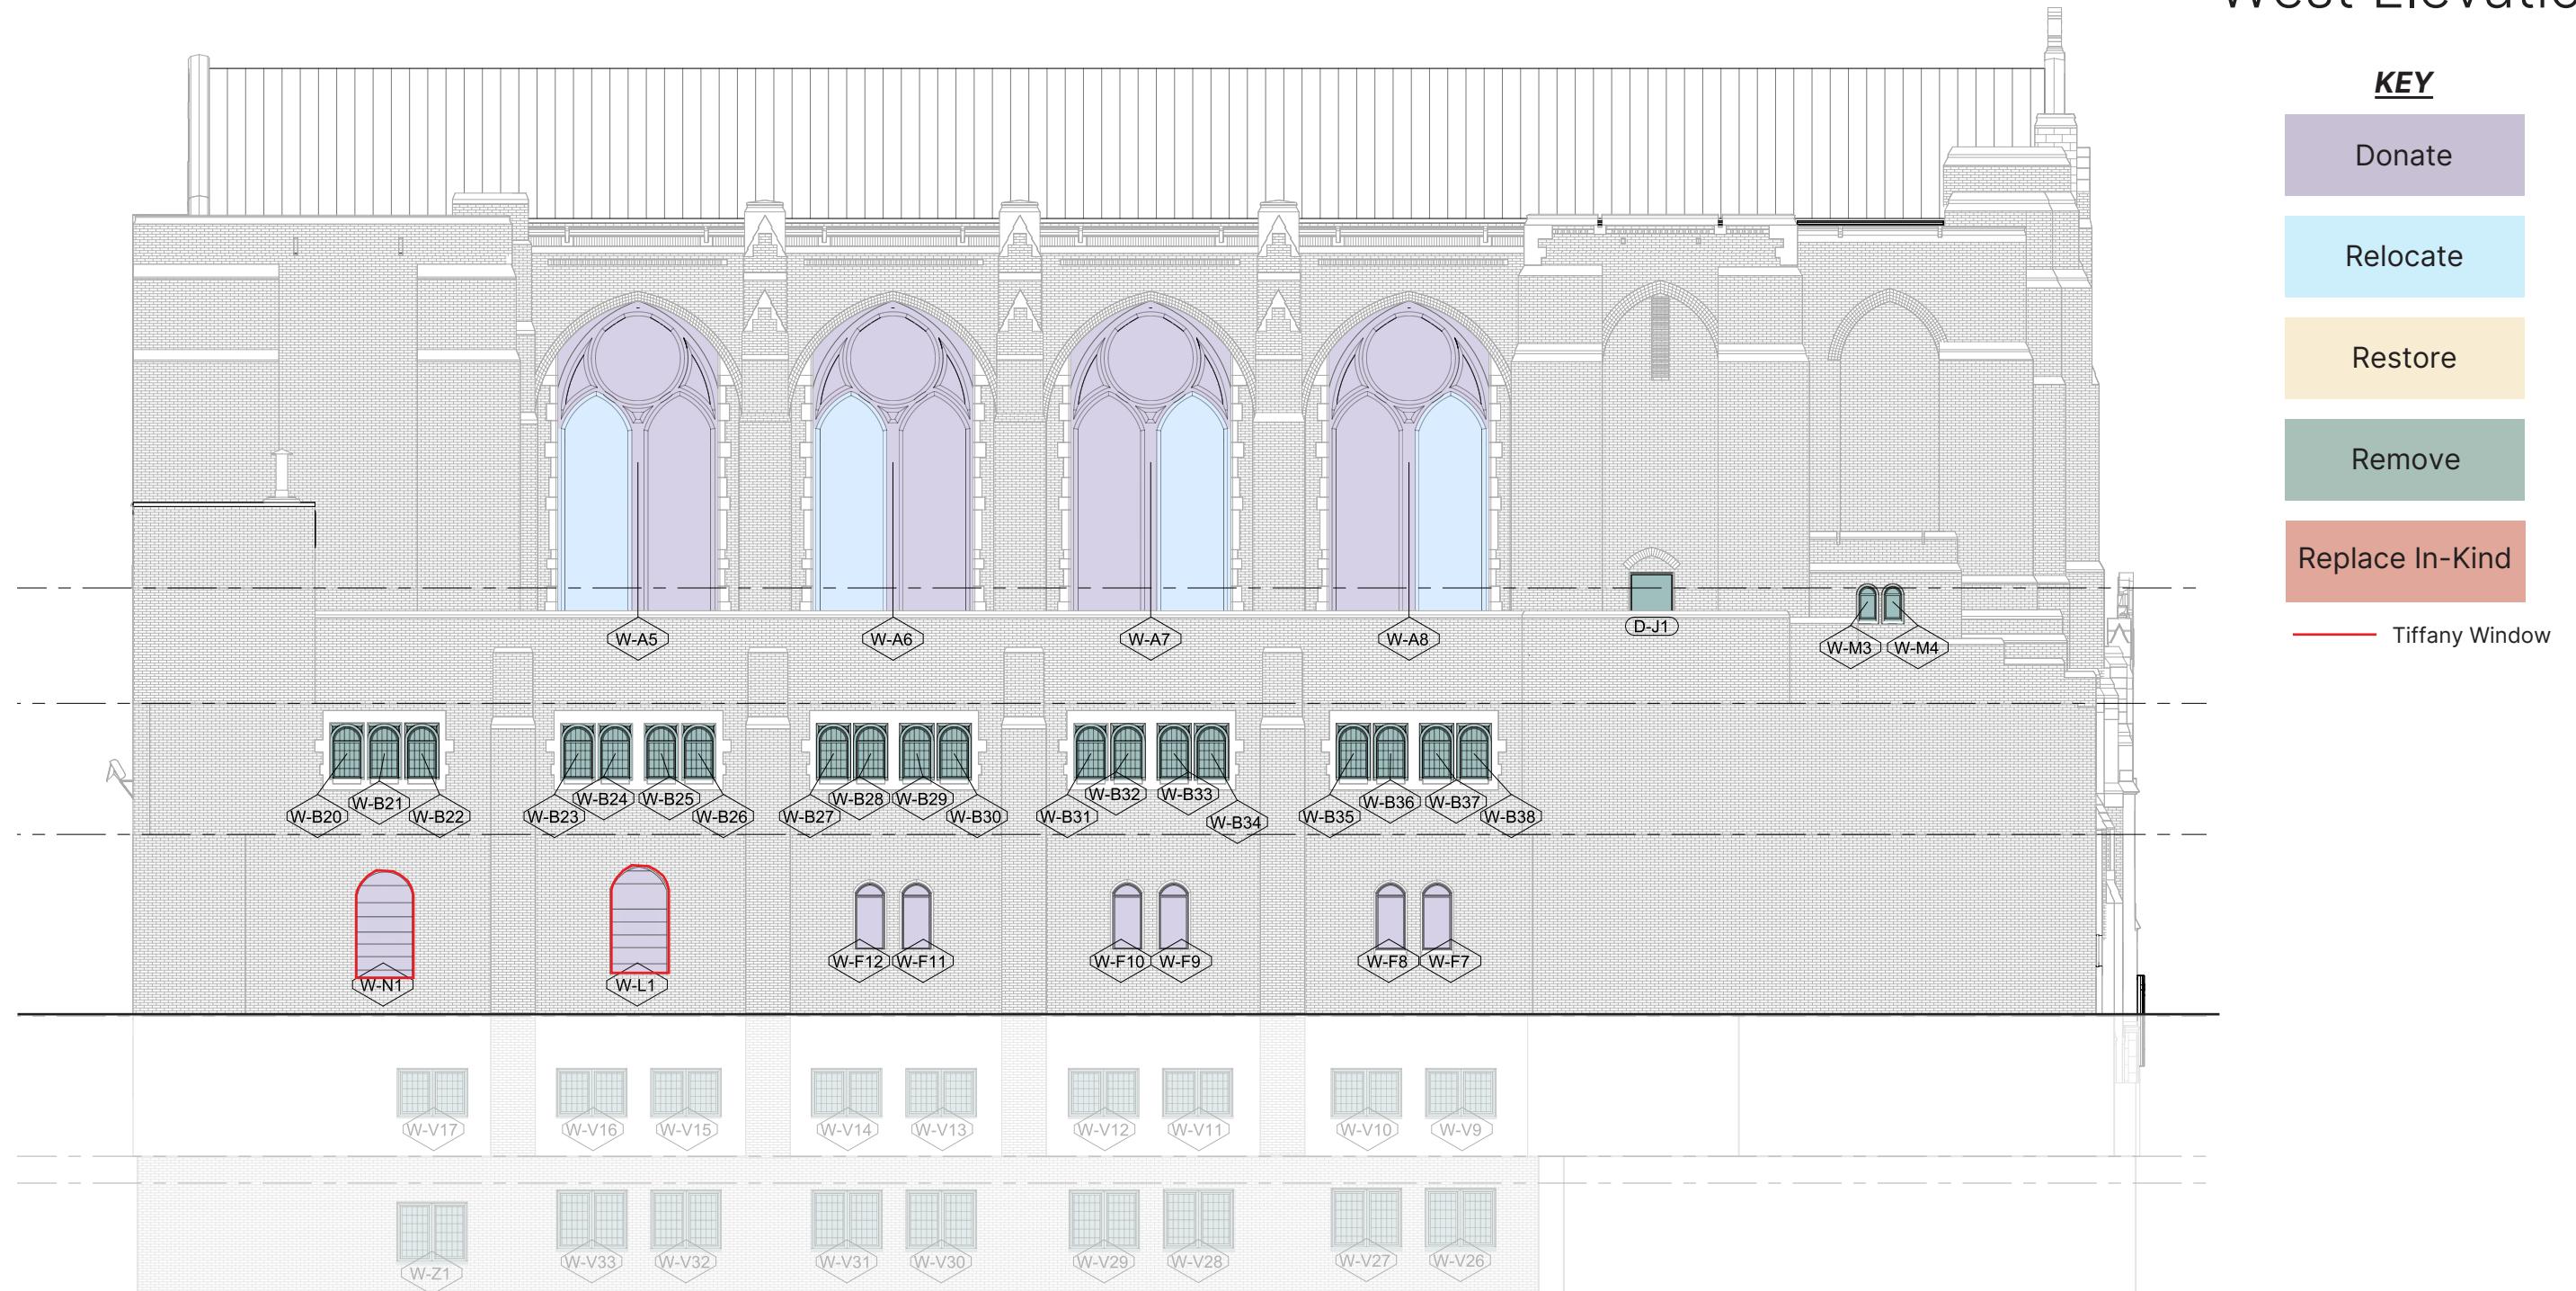
## SECONDARY FAÇADE: Windows

A-5	B-20	B-27	B-34	F-7	L-1	M-3	N-1	V-9	V-17	Z-1
A-6	B-21	B-28	B-36	F-8		M-4		V-10		
A-7	B-22	B-29	B-37	F-9			V-11			
A-8	B-23	B-30	B-38	F-10			V-12			
	B-24	B-31		F-11			V-13			
	B-25	B-32		F-12			V-14			
	B-26	B-33					V-15			
							V-16

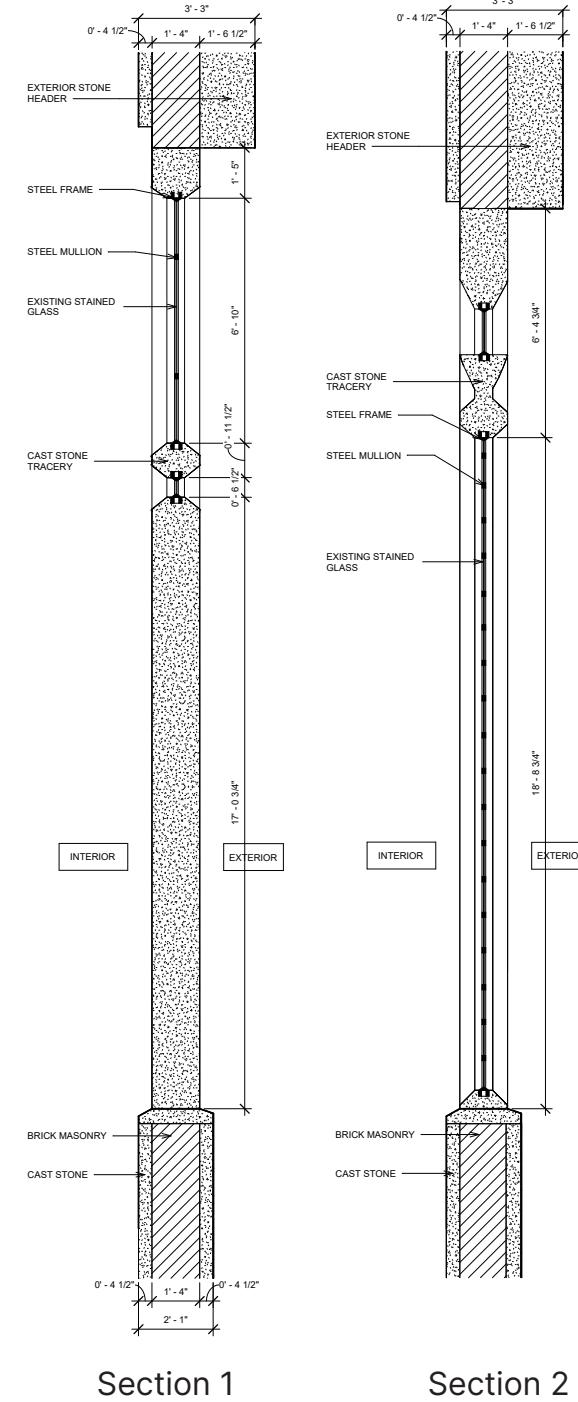
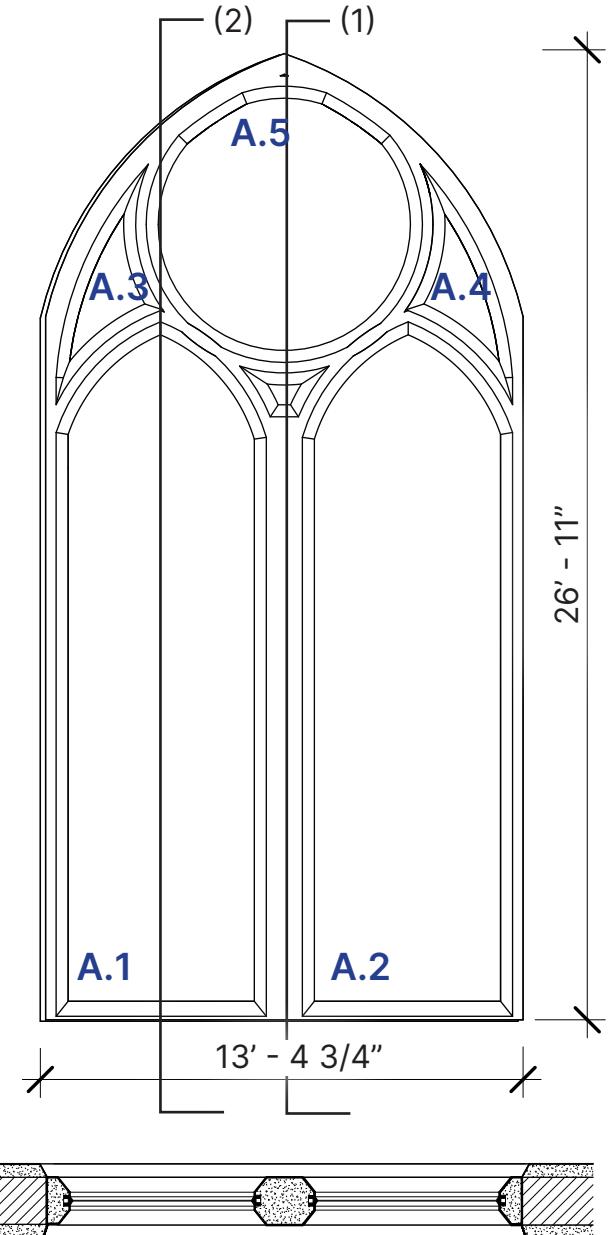
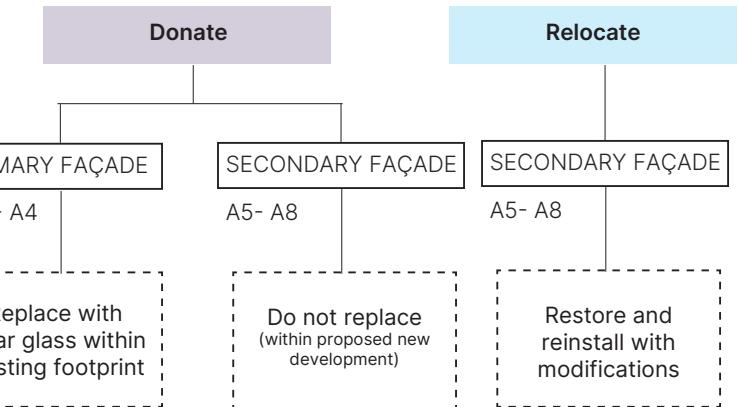
# Stained Glass:

- Quantity: 8
- Fixed
- Visibility from street: Yes
- Date: 1931 (Original), Protective glazing (Ca. 1978)
- Condition: Fair
- Manufacturer: D'Ascenzo Studios

- Steel frame with lead caming and decorative stained glass
- Gothic style openings with plate and Y-tracery elements
- Windows inset in cast-stone opening with cast stone tracery
- Non-original protective glazing added to the exterior surface

- Minor bowing of stained glass panels
- Minor rusting of steel window frame
- Shattered protective glazing at several instances has exposed original stained glass to the exterior
- Glazing panels A.1, A.2, and A.5 display religious iconography
- Windows A-1 through A-4 represent all Biblical figures while windows A-5 through A-8 represent types of human personalities through whom God has revealed His will (Brooklyn Historic Society, 1958).

The three approaches to this window type are as follows: 1. Windows on the East facade shall be salvaged and donated/returned to the church due to fair condition and historic value. Replacement windows shall be installed with new, clear, operable steel windows to meet required light and air standards for residential use. Windows shall match the existing aesthetic, size, and shape not including the religious iconography or stained glass. Tracery shall be salvaged to create casts for new tracery. 2. On the West facade, four of the existing eight stained glass panes shall be salvaged and donated/returned to the church. Since the building is proposed to be demolished on this facade, no new windows are proposed. 3. On the West facade the secular stained glass panes shall be salvaged and modified to be relocated into the South stained glass window to remain.

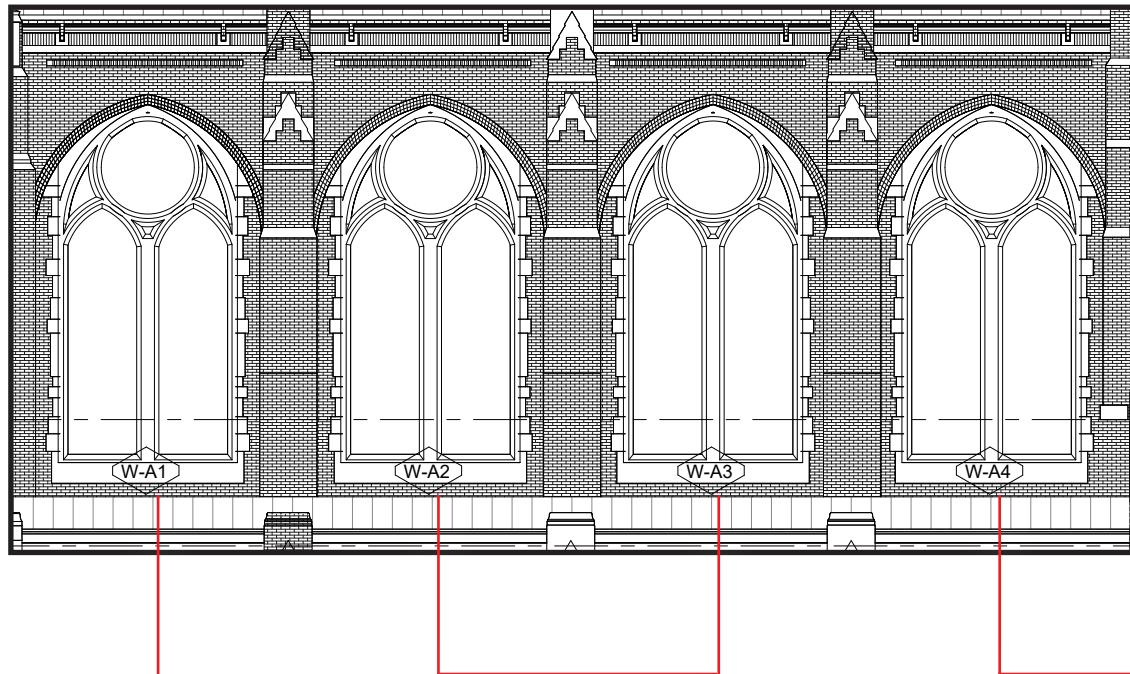
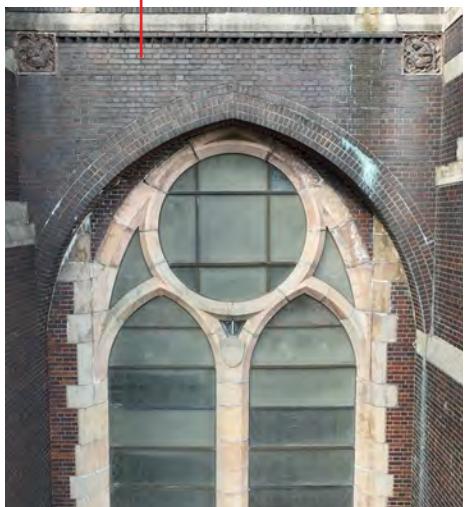
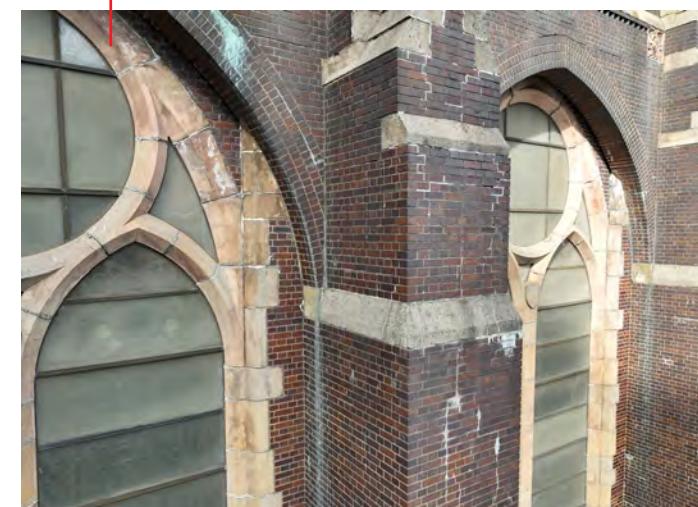
EAST ELEVATION (PRIMARY FAÇADE)

# Exterior Conditions East: Type W-A

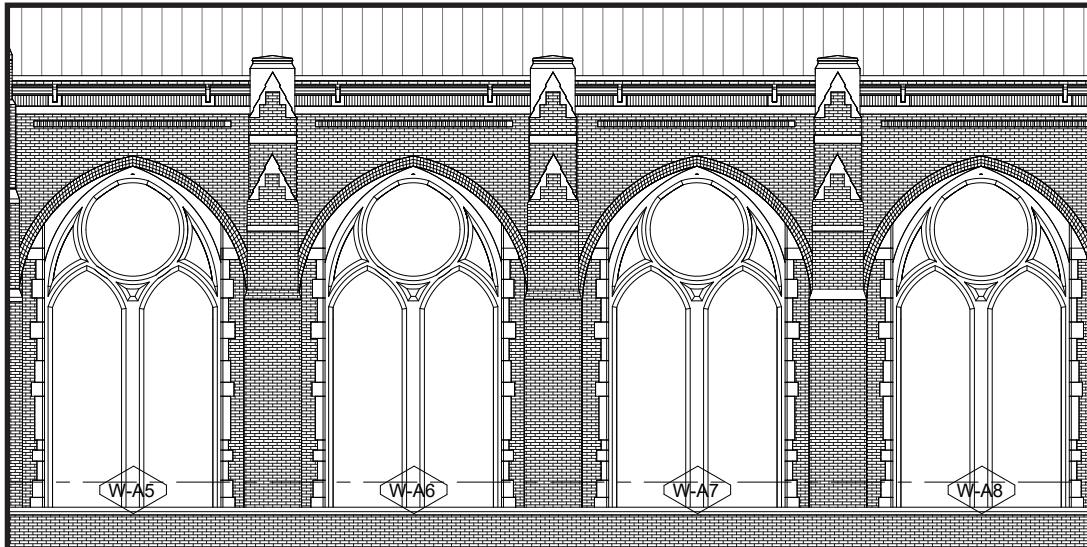
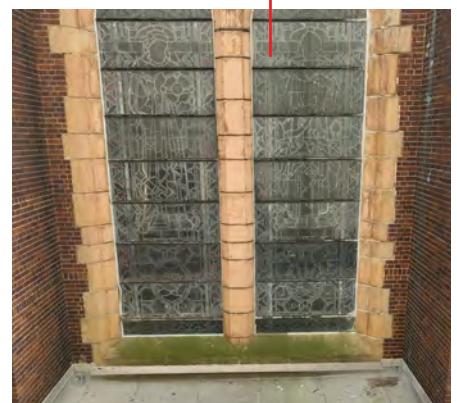
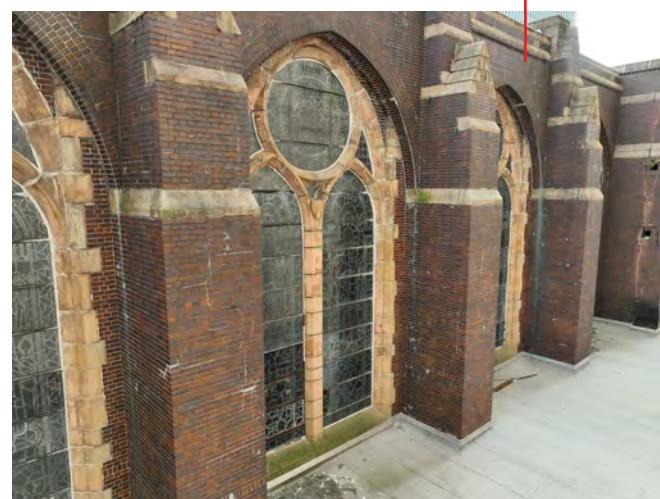
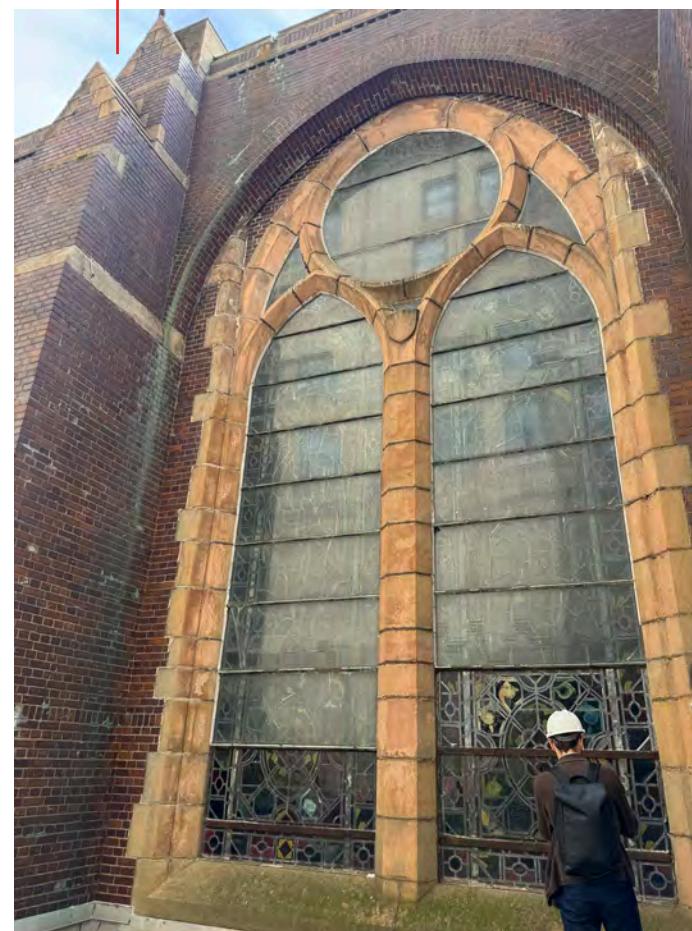
WEST ELEVATION (SECONDARY FAÇADE)

# Exterior Conditions West: Type W-A

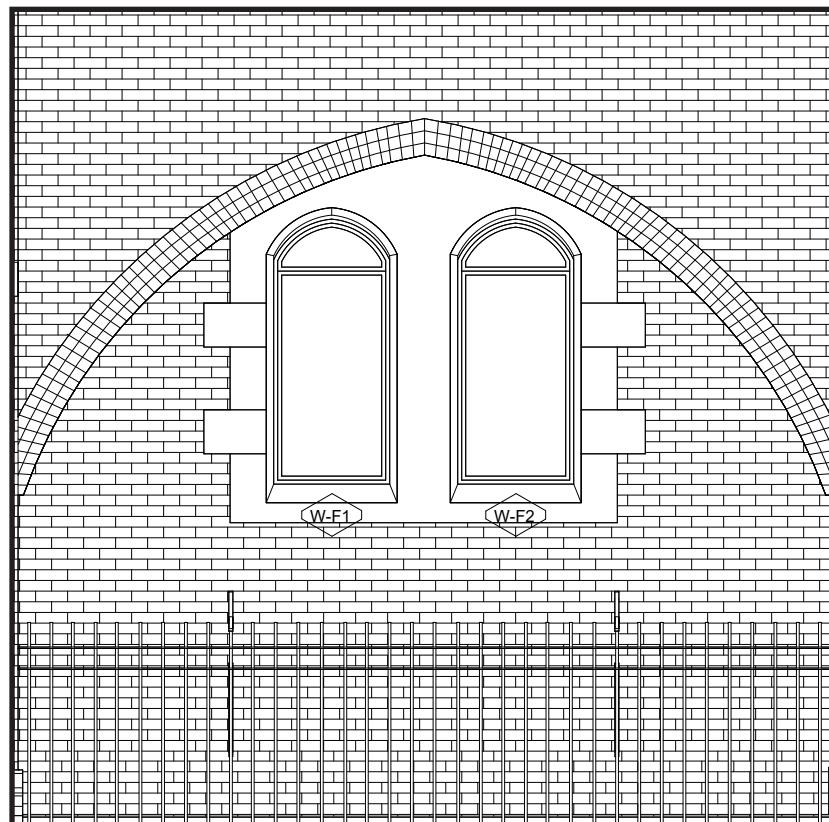
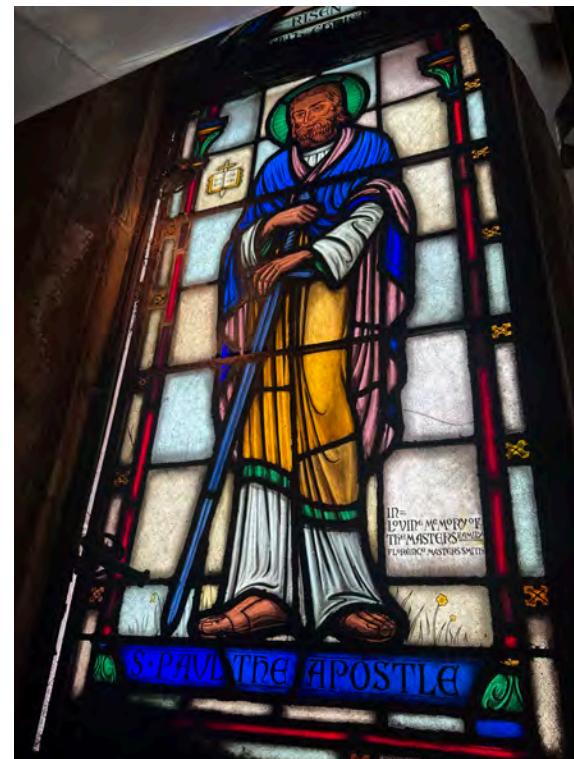
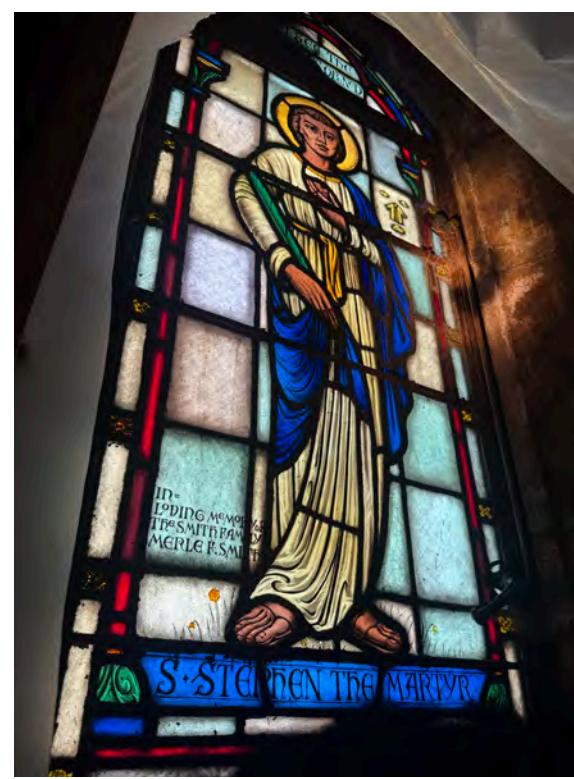
**W-F1:** St. Paul the Apostle

- Paul the Apostle is known for spreading Christian teachings and his contributions to the New Testament
- Dedicated to the Masters Family
- Condition is fair

**W-F2:** S. Stephen the Martyr

- Known for being a deacon in Jerusalem and for his charitable acts
- Dedicated to the Smith Family
- Condition is fair

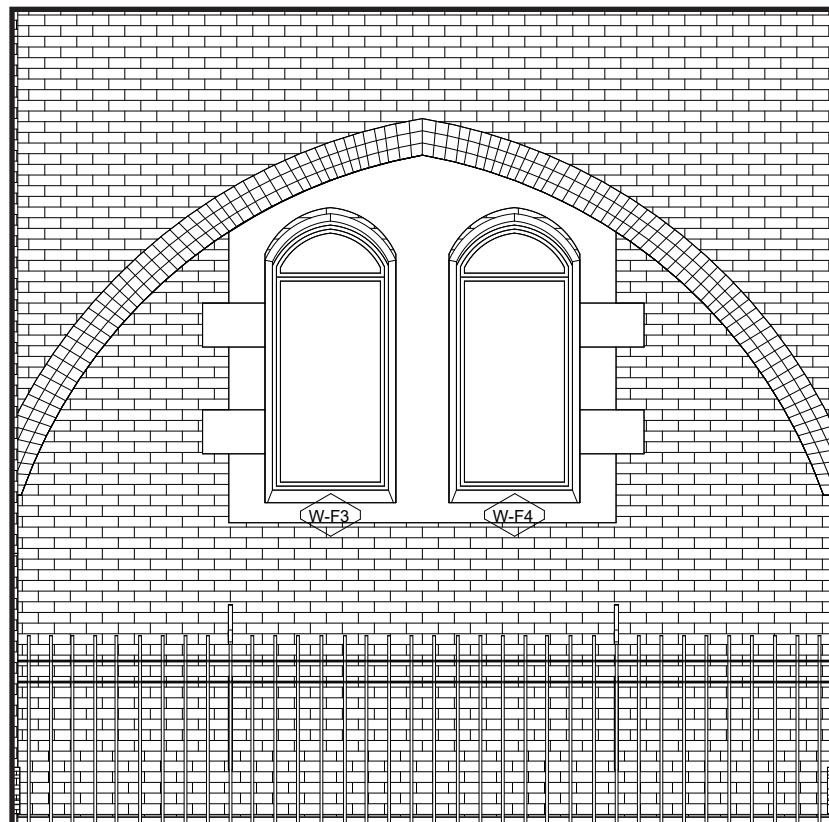
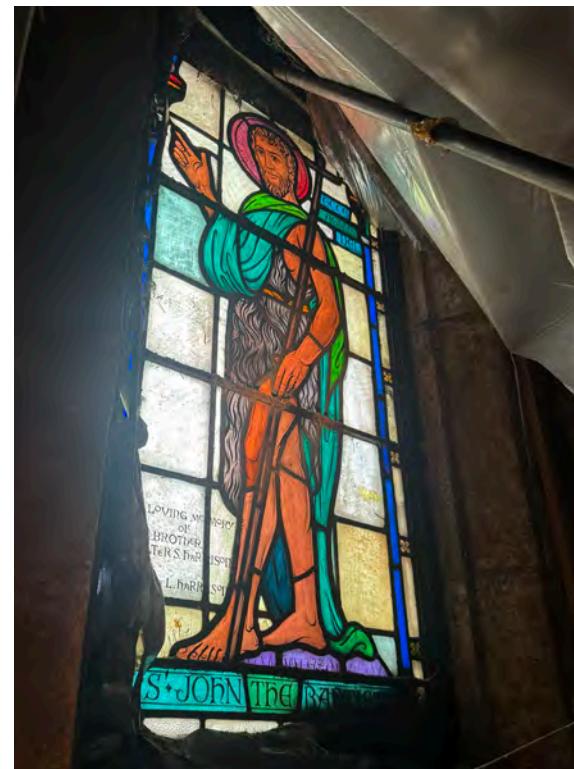
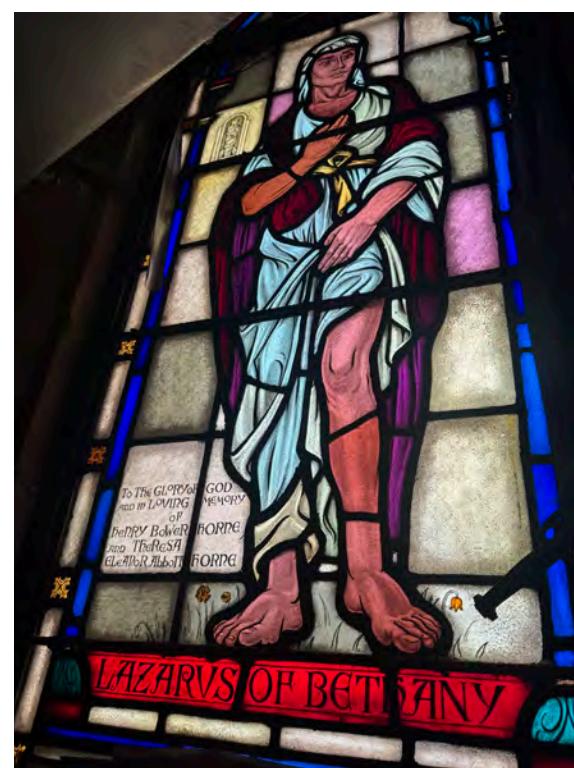
**W-F3:** St. John the Baptist

- Known for being a preacher and for baptizing Jesus
- Dedicated to Walter S. Harrison
- Condition is fair

**W-F4:** Lazarus of Bethany

- Known for being raised from the dead by Jesus
- Dedicated to Henry Bower Horne and Theresa Eleanor Abbott Horne
- Condition is fair
