**Preservation Department – Item 1, LPC-26-03280**

**138-154 St. Felix Street, aka 11-21 Hanson Place –  
Brooklyn Academy of Music Historic District  
Borough of Brooklyn**

# **144 ST. FELIX STREET**

## **ADAPTIVE-REUSE & ENLARGEMENT**

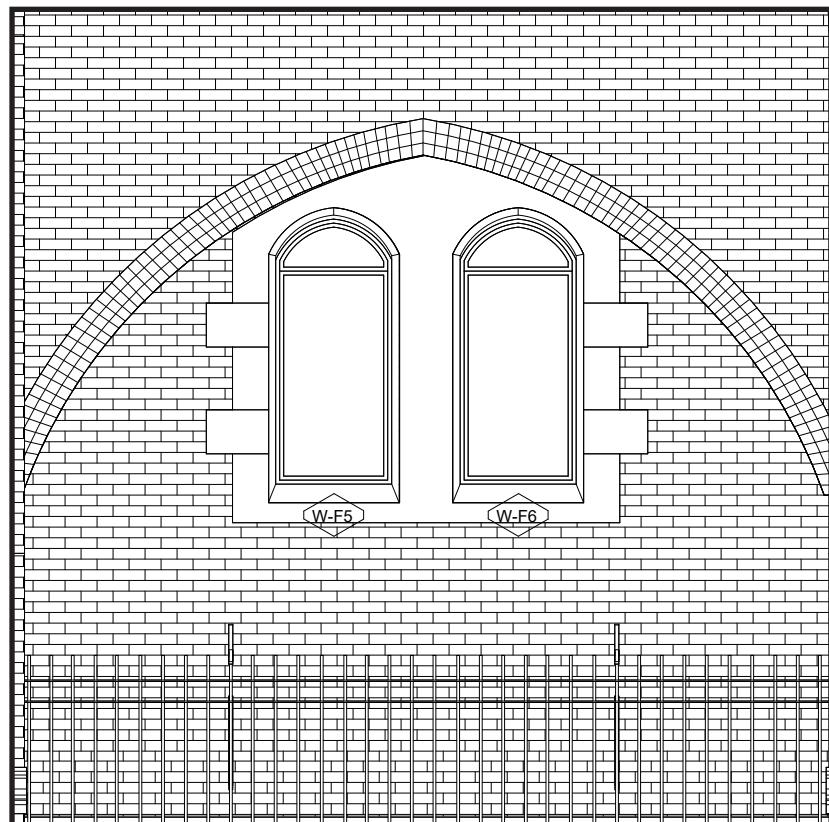
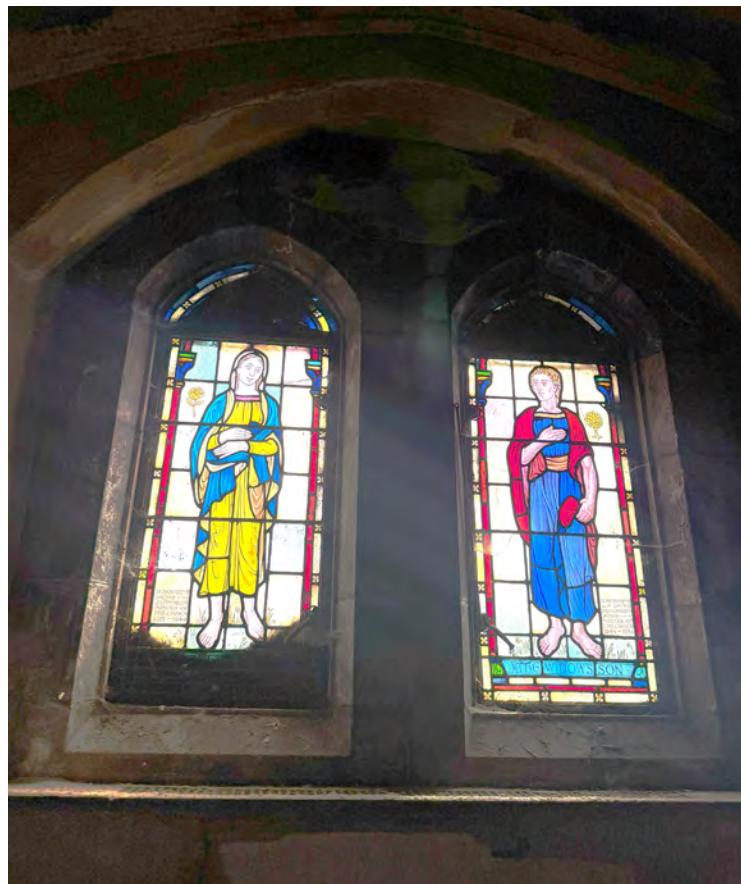
**W-F5: The Widow's Son**

- Dedicated to Doctor John Emerson Zeiter, the minister of the Church from 1944-1956
- Condition is fair

**W-F6: \*Title Illegible - VIF\***

- Dedicated to Doctor J. Lane Miller, the minister of the Church from 1922-1944
- Condition is fair

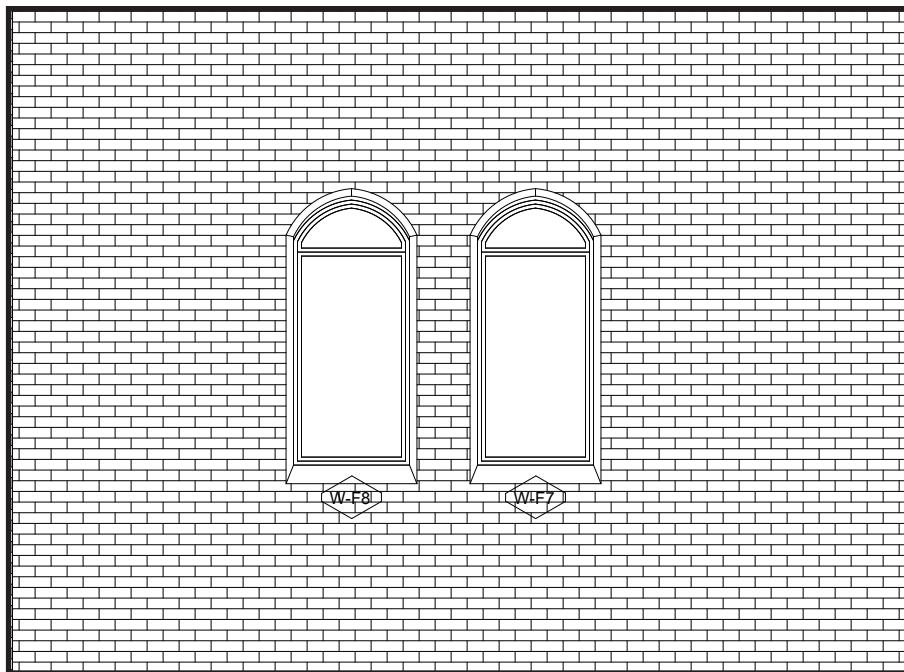
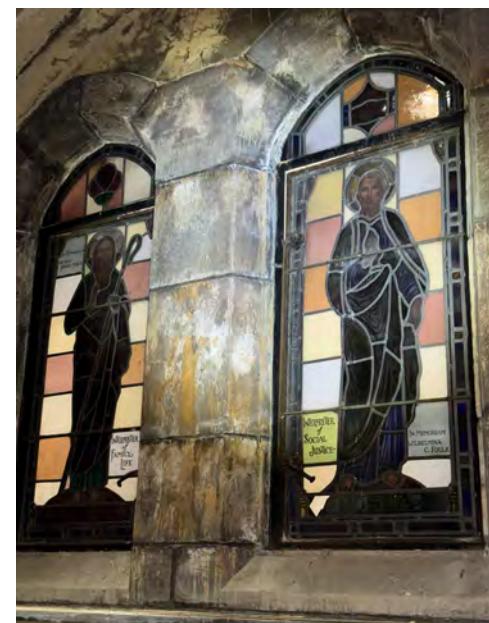
**W-F7: Hosea**

- Interpreter of Social Justice
- In memory of George Pierce Foulk
- Condition is fair

**W-F8: Amos**

- Interpreter of Family Life
- Condition is fair

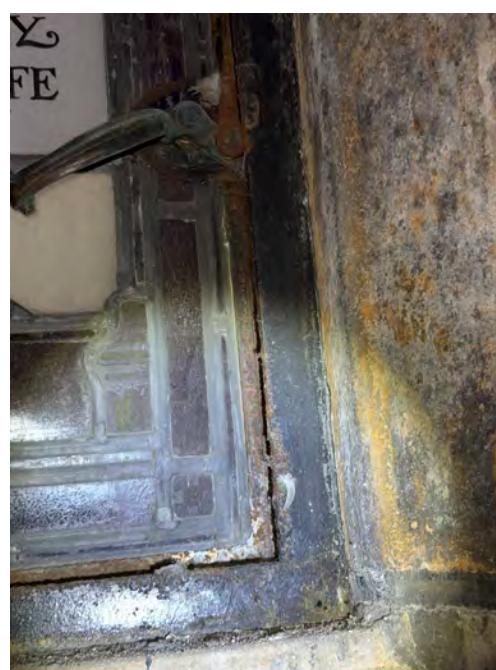
Rusting Frame

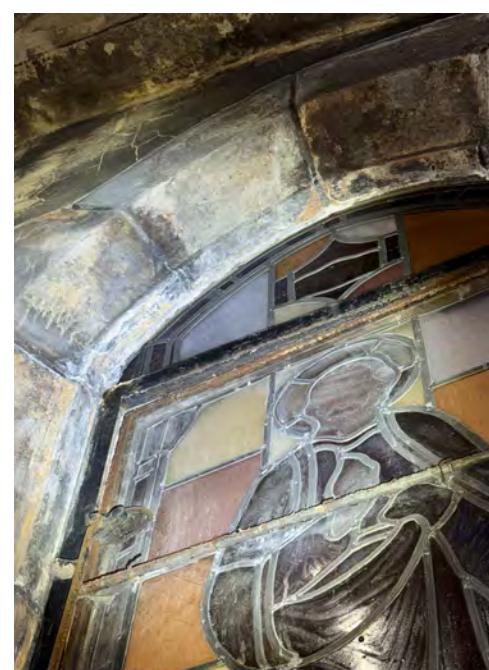
Pane Separation

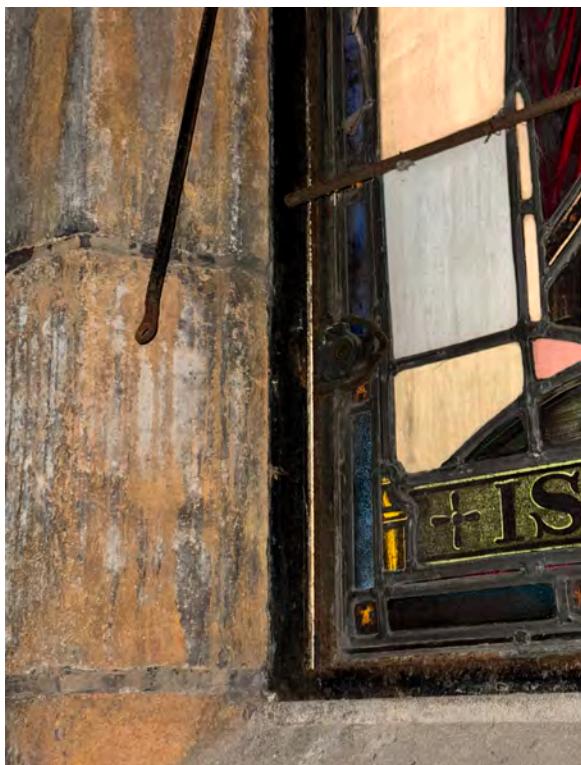
Broken Closure

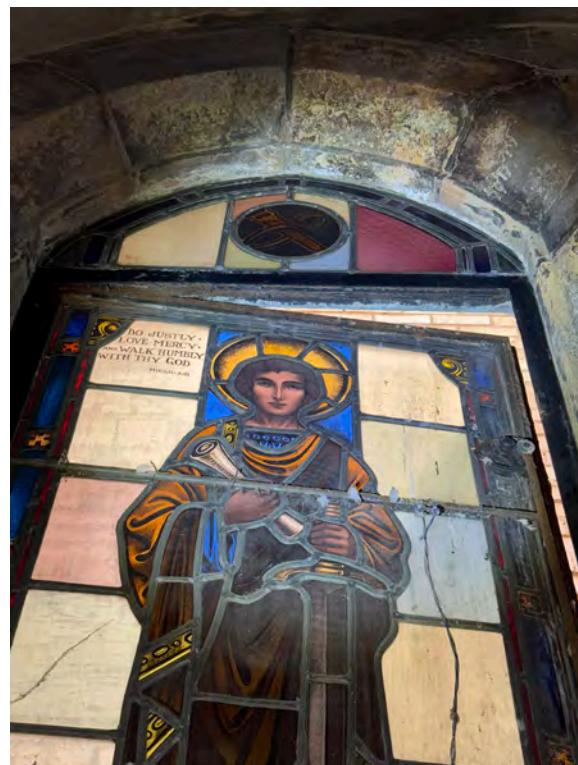
Pane Cracking and Separation

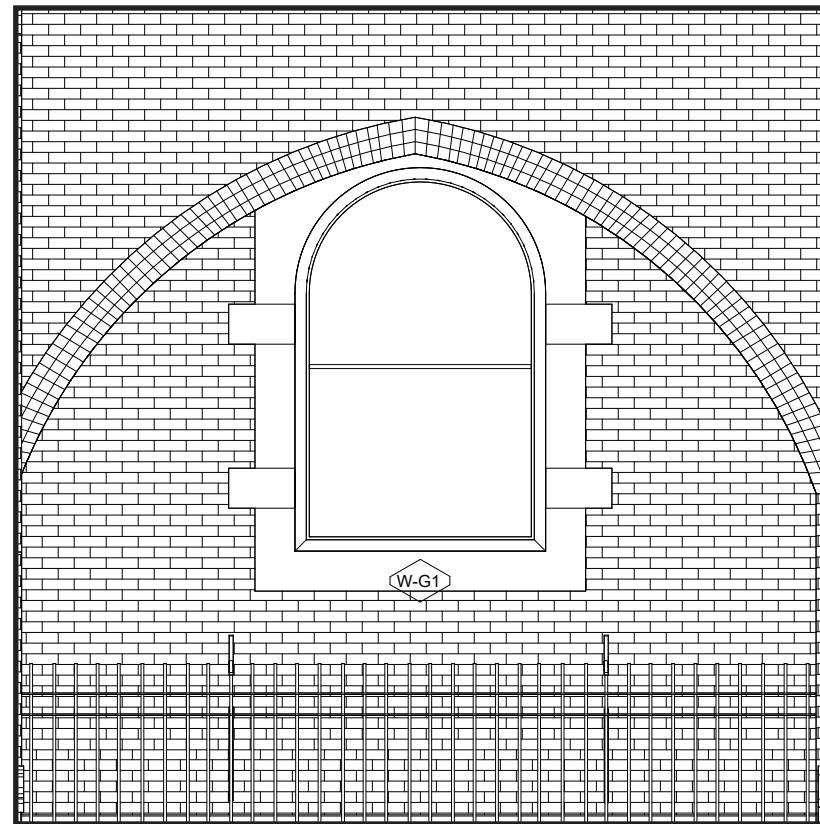
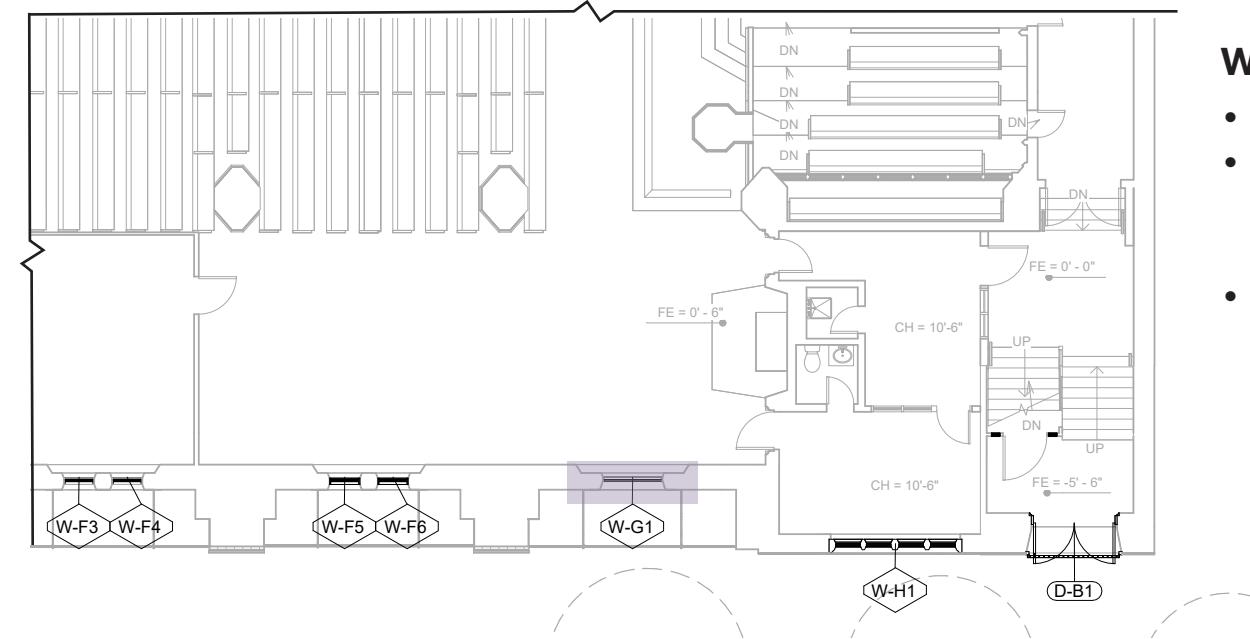
DESCRIPTION

**W-G1:**

- Depiction of Jesus in a garden of flowers
- Description panel stating: "From First Church Brooklyn, TO HANSON PLACE CENTRAL CHURCH 1947, The Children of Thy Elect Sister Greet Thee"
- Condition is good

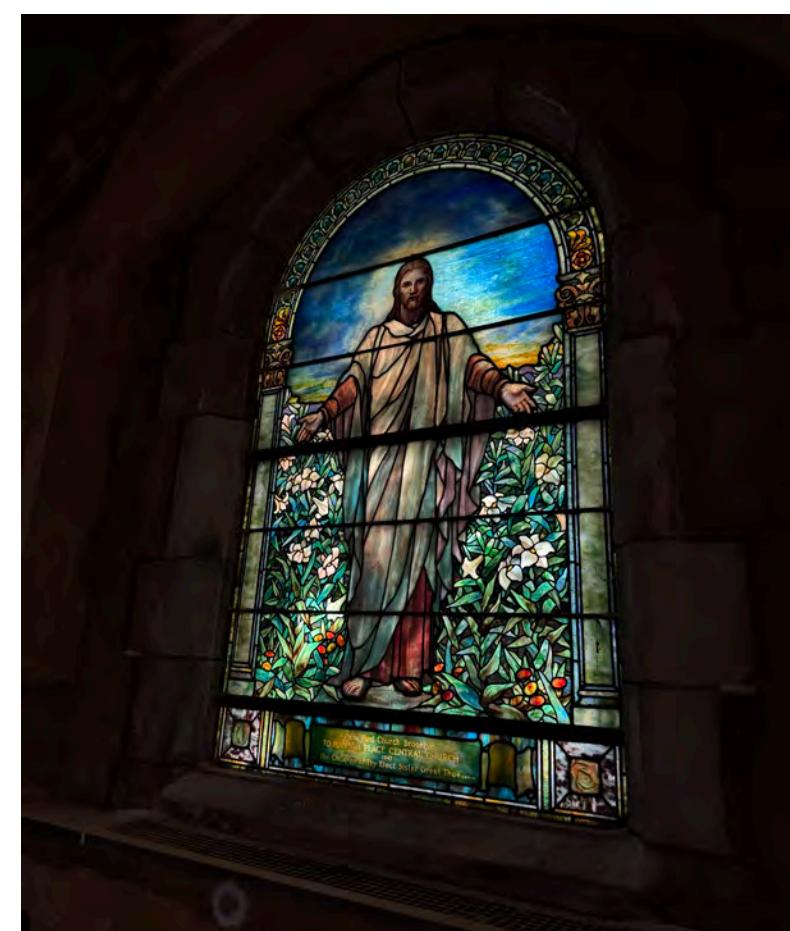
INTERIOR VIEW

- Quantity: 1
- Fixed
- Visibility from street: No
- **Historic Tiffany Window:** Booth Memorial Window
- Date: 1904 (Predates Building)
- Condition: Fair

- Steel frame with lead caming and decorative stained glass
- Round-headed fixed window
- Windows inset in cast-stone opening

- Minor rusting on steel framing and mullions
- Panels containing religious iconography

The Tiffany Window has historic value that dates back to church completion in 1931. While the stained glass is in good condition, religious iconography makes the window unsuitable for present day and future use.

Window shall be salvaged and donated/returned to the church due to good condition and historic value from the original school that was founded in 1858. Since the window is a historic Tiffany window, it could instead be sold to a Tiffany collection. On the west secondary façade, windows shall be donated and not replaced because of the proposal to demolish this area of the building to accomodate new development.

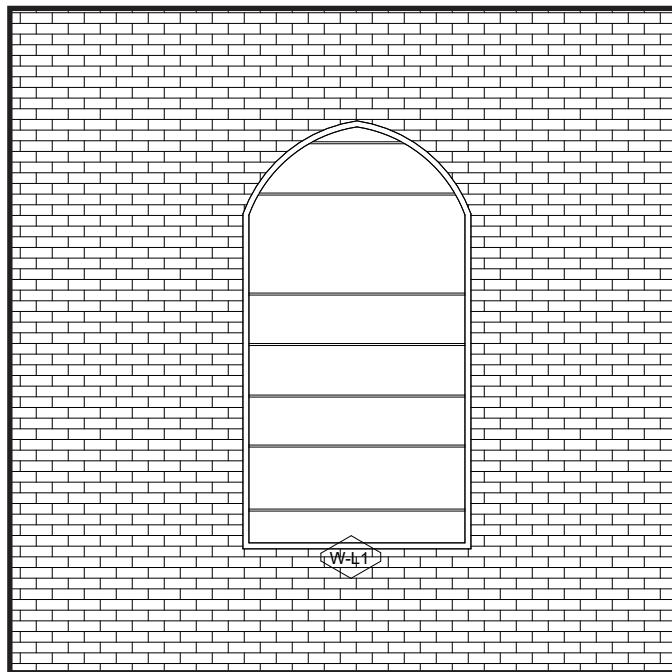
WEST ELEVATION (SECONDARY FAÇADE)

# Window Type W-L

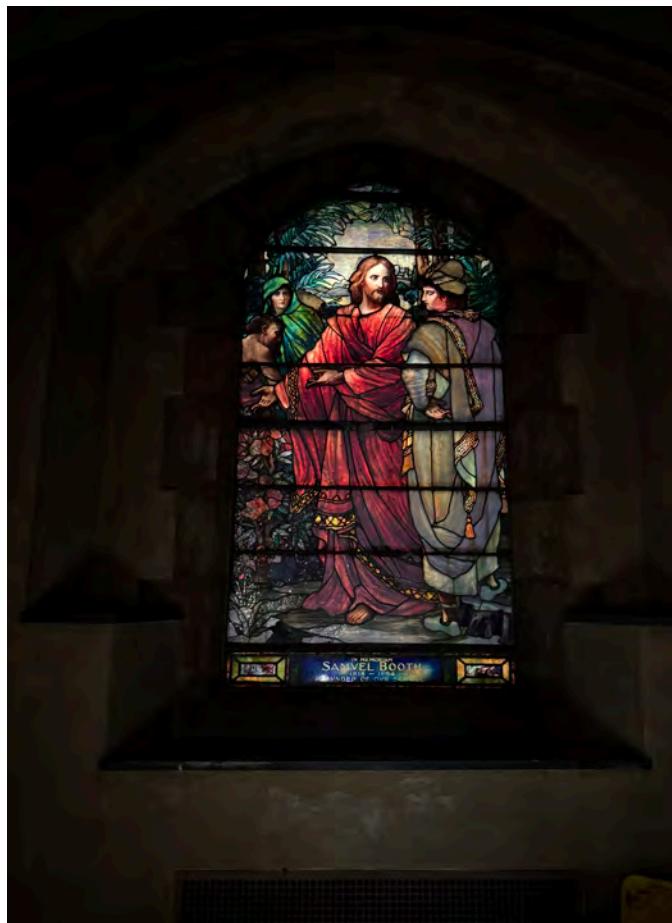
INTERIOR VIEW

### **W-L1: Tiffany Window**

- Depiction of Jesus dressed in a scarlet robe, symbolic of sacrifice and authority.
- Dedicated to Samuel Booth, the founder of the Church School
- Condition is fair

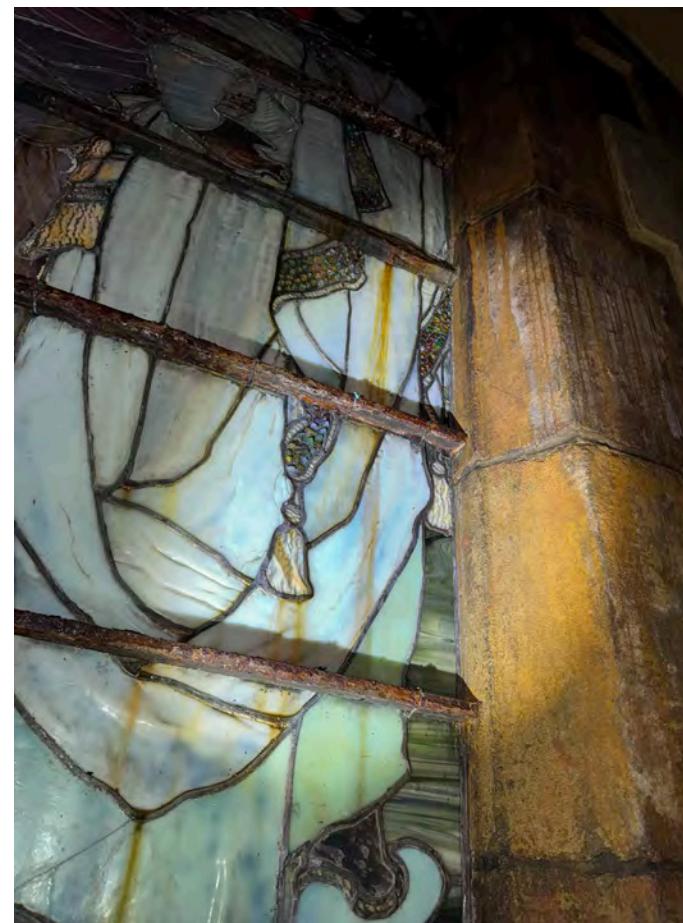
Rusting Mullions

- Minor rusting on steel framing and mullions
- Panels containing religious iconography

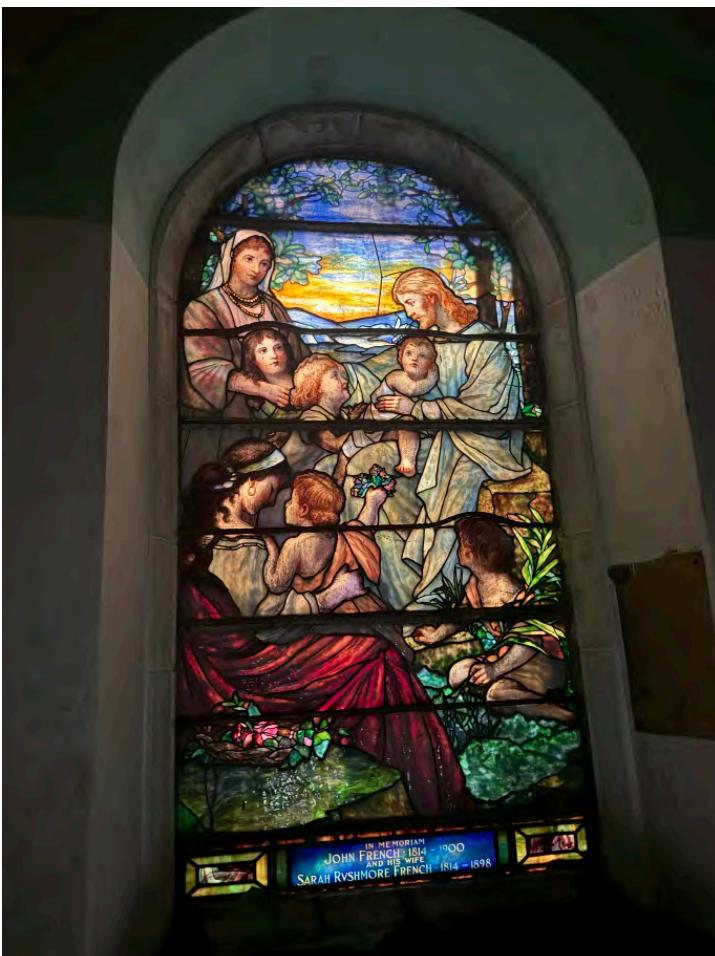
INTERIOR VIEW

**W-N1:** Tiffany Window

- Depiction of Jesus blessing children.
- Dedicated to John French and his wife Sarah Rushmore French
- Condition is fair

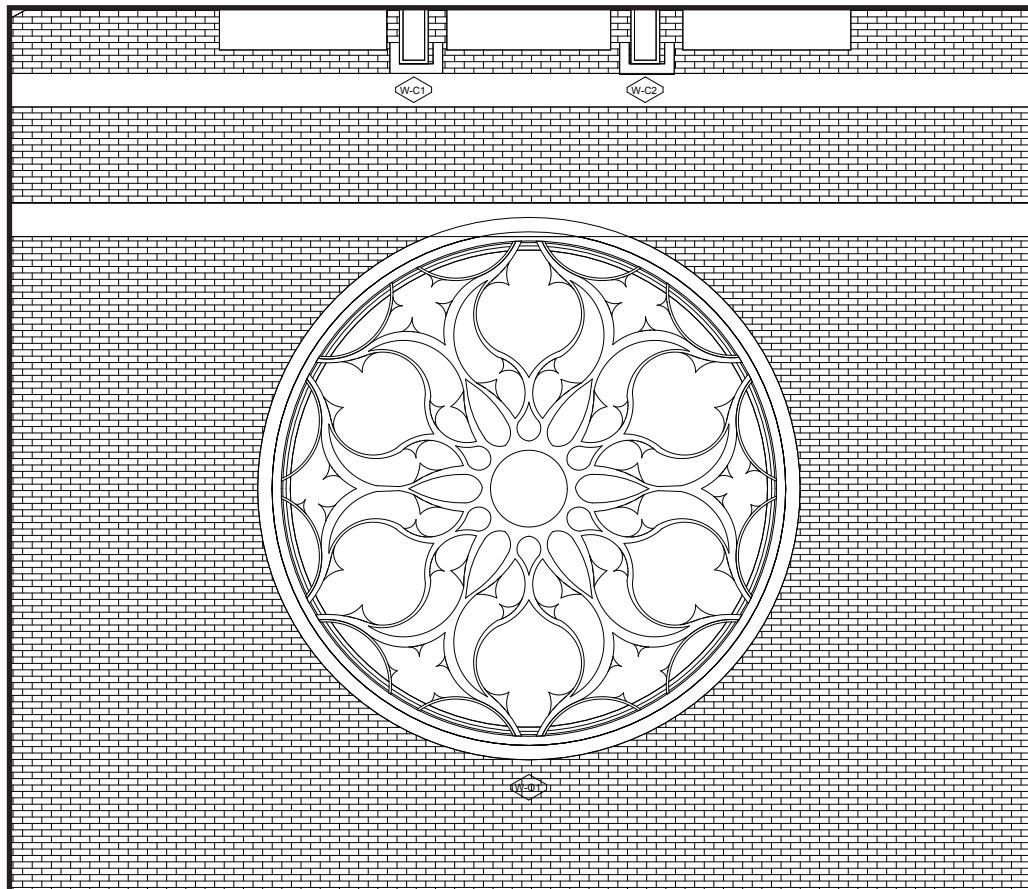
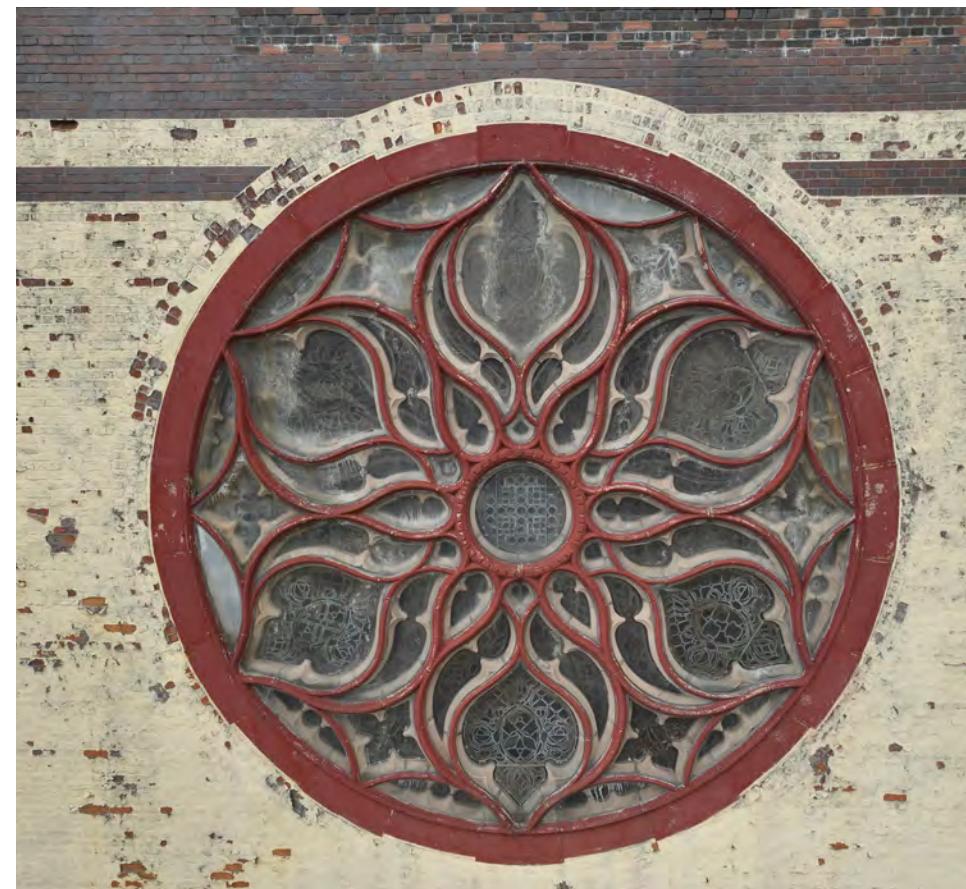
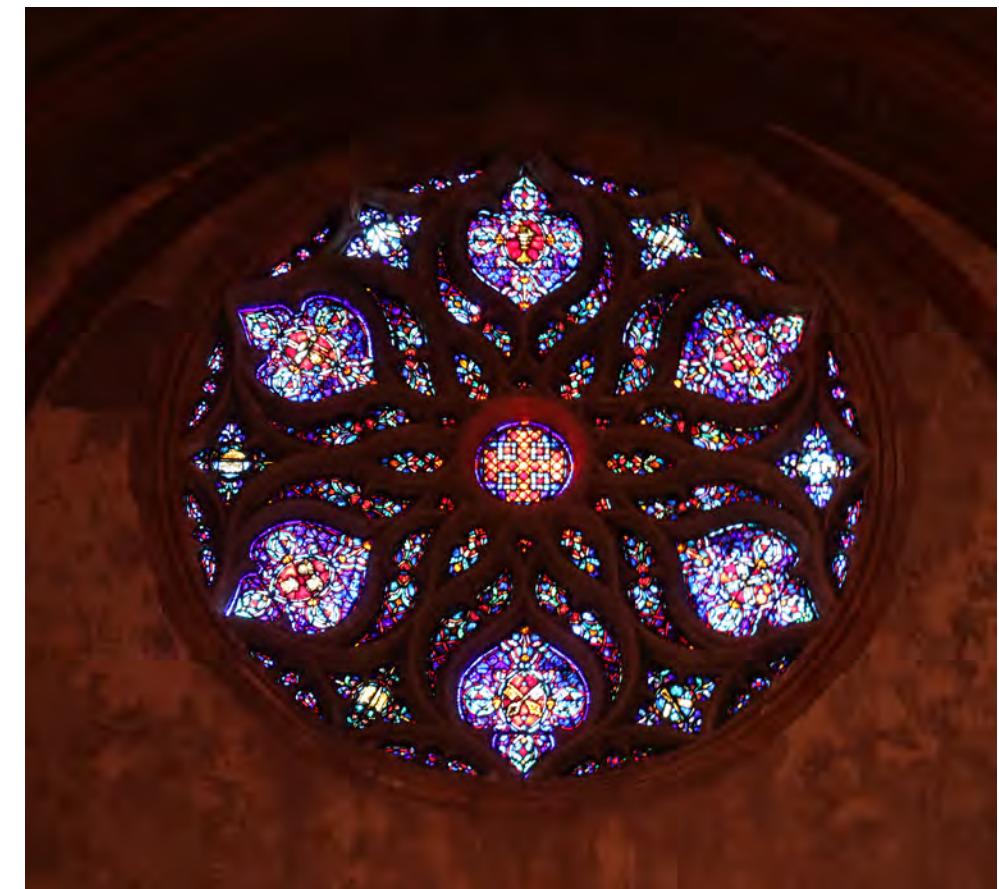
NORTH ELEVATION (SECONDARY FAÇADE)

- Steel frame with lead caming and decorative stained glass
- Rose Window style including dagger, mouchette, and cusp tracery elements
- Window inset in cast-stone opening with cast stone tracery
- Symbol of Jerusalem Cross with imagery of the Twelve Disciples in the petals.

- Minor rusting on steel framing and mullions
- Stained glass in good condition
- Panel O.1 displays religious iconography

The Rose Window has historic value that dates back to church completion in 1931 and to the Brooklyn Academy of Music Historic District designation in 1978. The stained glass is in good condition and can be reused for the building's restoration and adaptation.

Window shall be salvaged, restored and reused at the interior of the new residential lobby removing it from the lot line of the building to a location where it can be visible to residents of the new building. Tracery shall be salvaged and restored as a part of the window relocation. The window shall not be reinstalled at the same location on the exterior due to the proposed demolition of the north façade and proposed new construction.

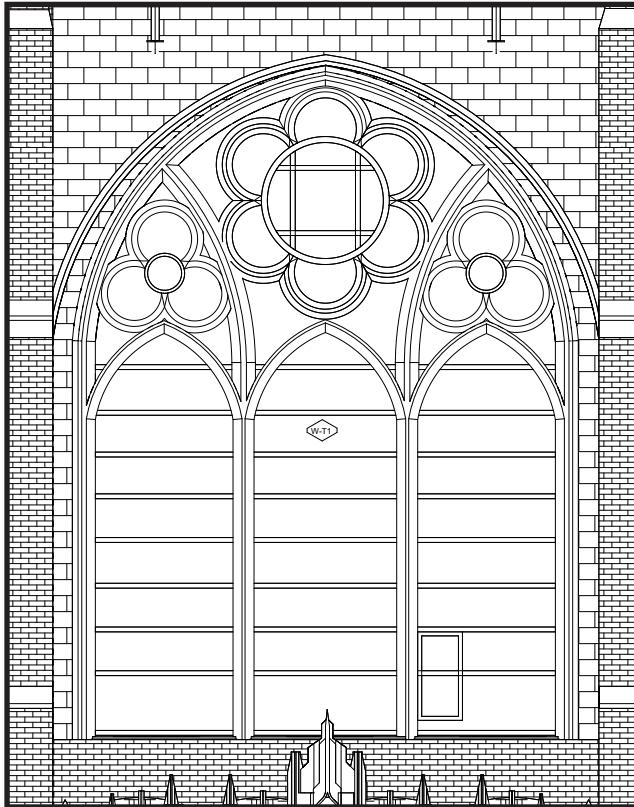
SOUTH ELEVATION (PRIMARY FAÇADE)

- Steel frame with lead caming and decorative stained glass
- Geometric tracery with a series of pointed windows and non-original single casement window
- Window inset in cast-stone opening with cast stone tracery

- Window was gifted by Eugene W. Spaulding
- Exterior is covered in non-original protective glazing
- Small operable window was added later in building's history to provide roof access
- Stained glass is in good condition
- Minor rusting of steel window frame
- Separation of cast-stone surround creates breaks in insulation continuity
- Glazing panels T.1, T.2, T.3 and T.5 display religious iconography including the Three Kings and the Nativity scene

# Window Type W-T

Window shall be salvaged, restored, modified and reinstalled in the existing location for use in the new building amenity space. Panels T.1, T.2, and T.3 shall be removed and donated/returned to the church. The design proposes to replace these panels with salvaged stained glass from the secular panels on the West facade of the church, pending review from stained glass artisan. Tracery shall be salvaged to create casts for new tracery to retain the historic context of the neighborhood and pay tribute to the history of the building in its new construction.

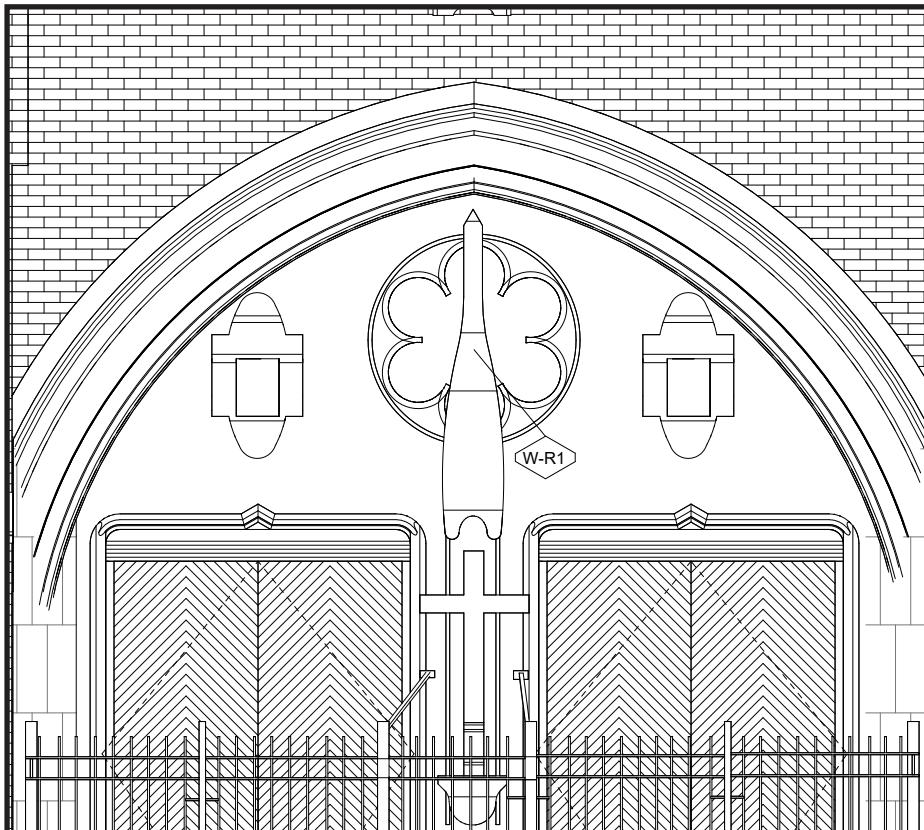
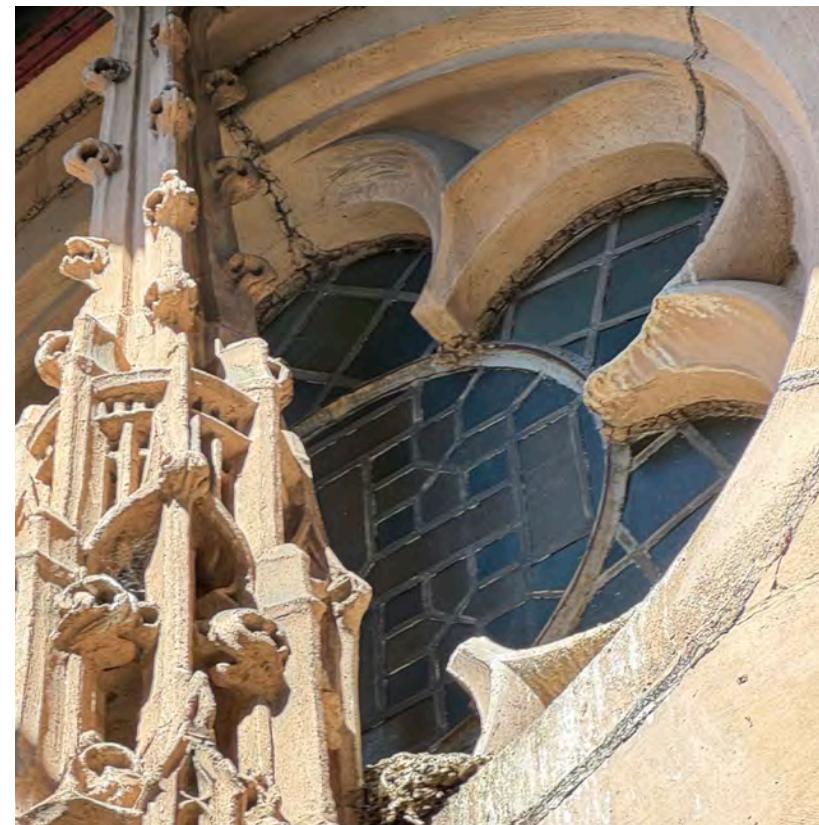
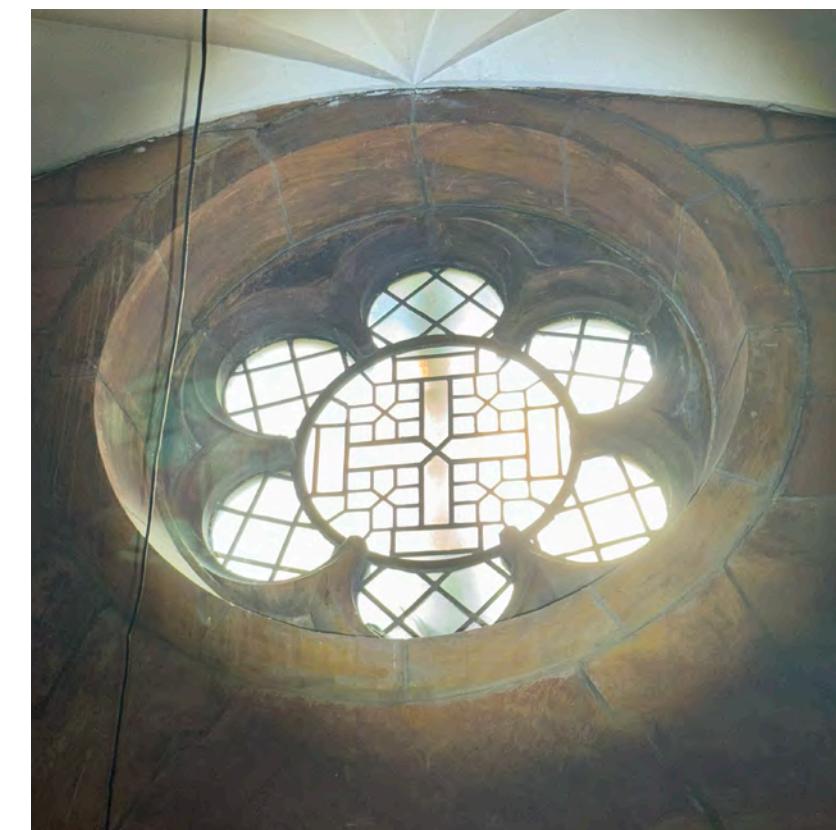
SOUTH ELEVATION (PRIMARY FAÇADE)

- Steel frame with lead came and decorative stained glass
- Geometric tracery reflects window style W-T above
- Window inset in cast-stone opening

- Stained glass is in good condition without cracks or damage
- Pane R.1 displays religious iconography

Historic value of the window dates back to the church completion in 1931 and to the Brooklyn Academy of Music Historic District designation in 1978. The stained glass is in good condition and can be reused for the building's restoration and adaptation.

Window shall be salvaged, restored and reinstalled in the existing location for the future use of the building. Tracery shall be salvaged to create casts for new tracery to retain the historic context of the neighborhood and pay tribute to the history of the building in its new construction.

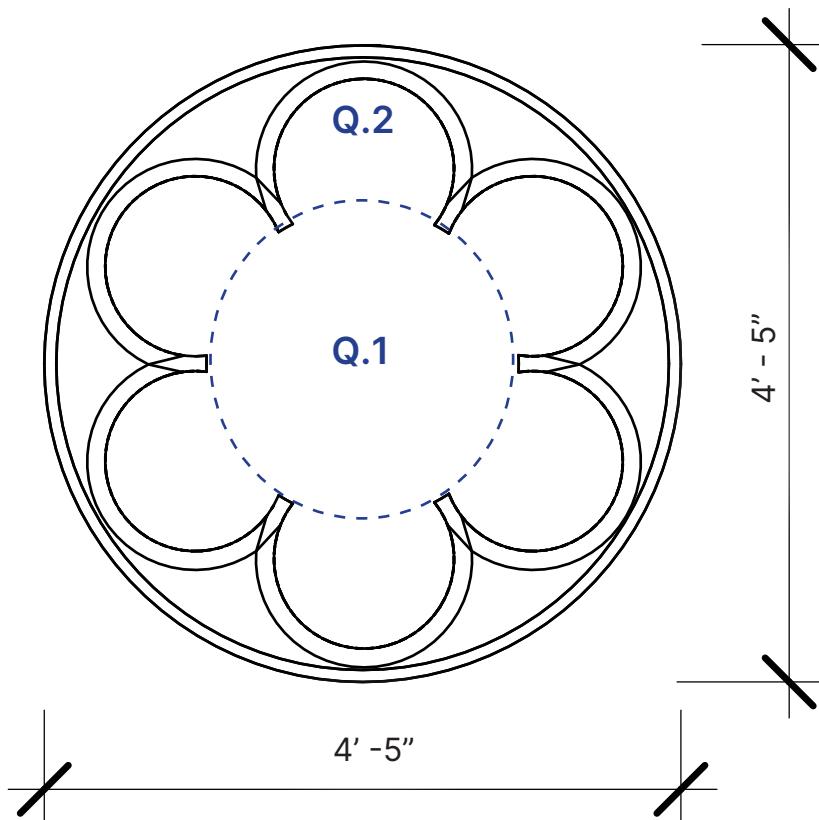
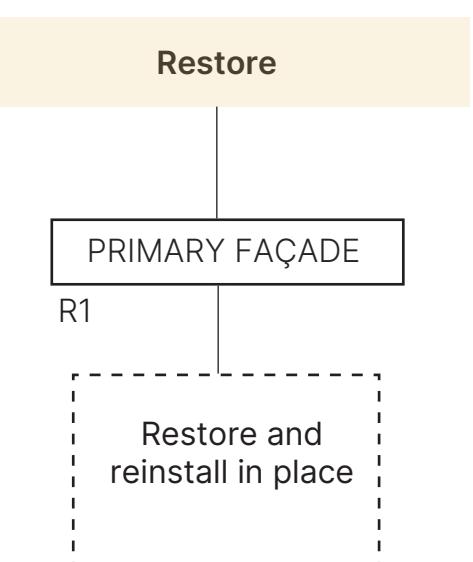
EAST ELEVATION (PRIMARY FAÇADE)

- Steel frame with lead caming and decorative stained glass
- Geometric tracery
- Window inset in cast-stone opening

- Stained glass is in good condition without cracks or damage
- Pane Q.1 displays religious iconography

Window shall be salvaged, restored and reinstalled in the existing location for the future use of the building. Tracery shall be salvaged to create casts for new tracery to retain the historic context of the neighborhood and pay tribute to the history of the building in its new construction.

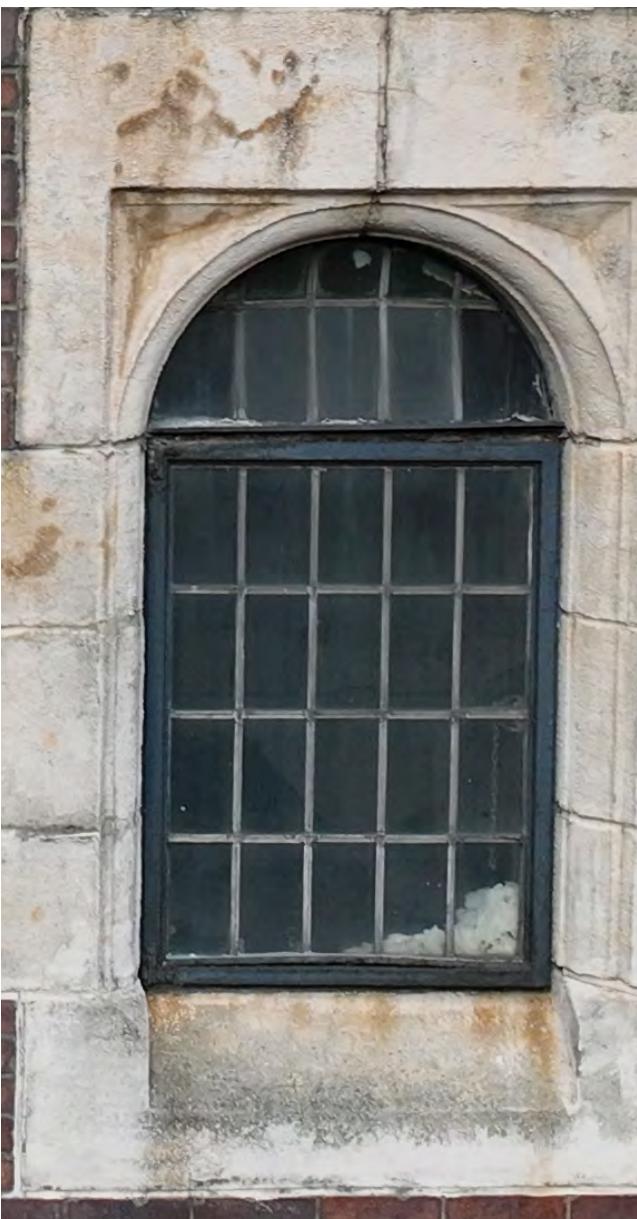
BOWING

- Generally in poor condition
- Bowing at top and bottom panes
- Rusting along window sills
- No longer operable
- Broken panes

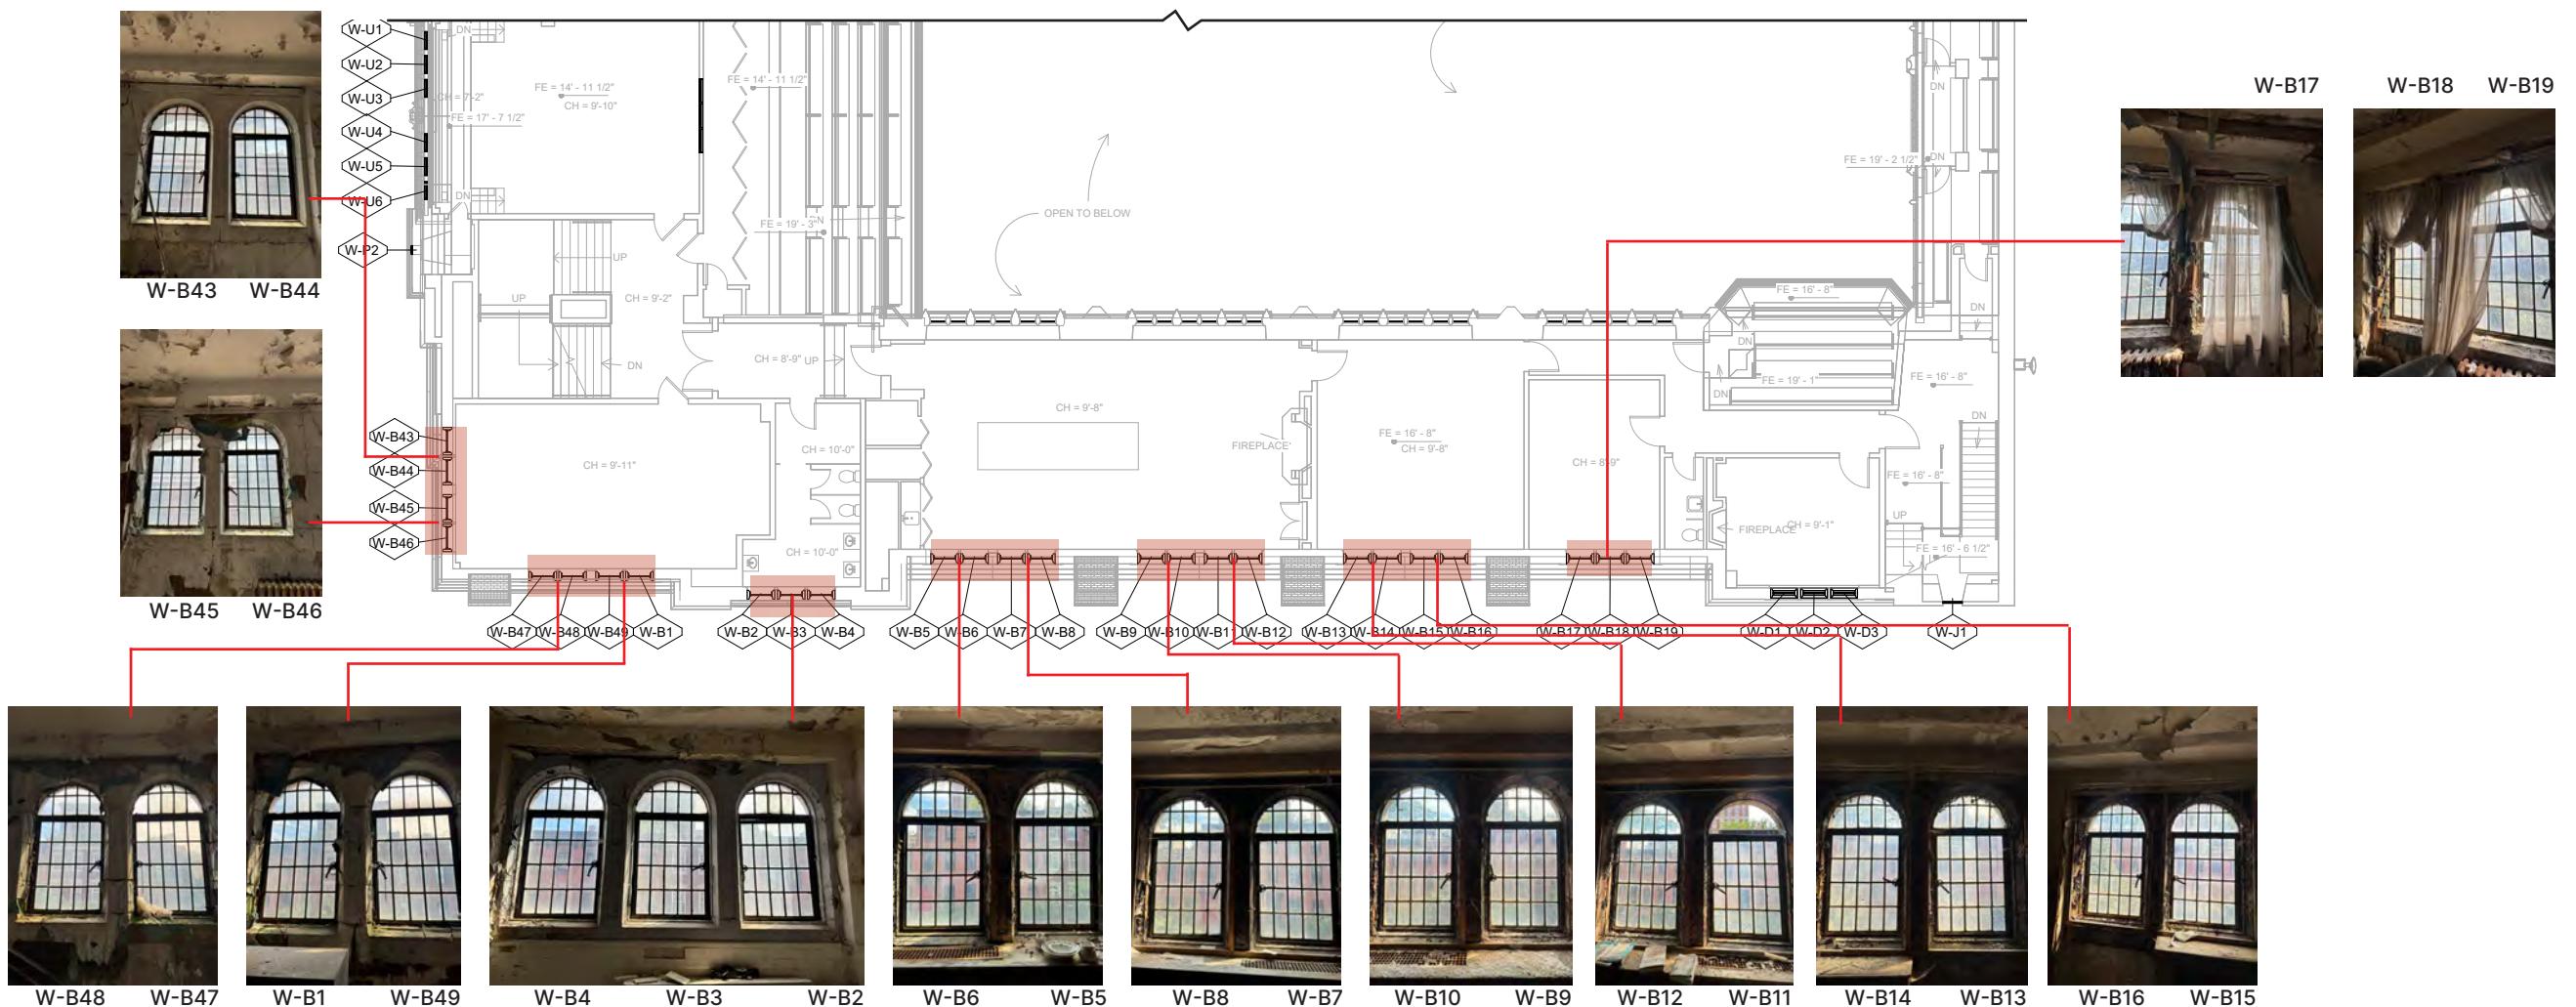
# South / East Interiors: Type W-B

Windows shall be removed and replaced based on proposed design. Windows on the south and east primary façades shall be replaced in-kind with steel, operable windows to retain the historic context of the neighborhood. Windows on the west secondary façade shall not be replaced because of the proposal to demolish this area of the building to accommodate new development.

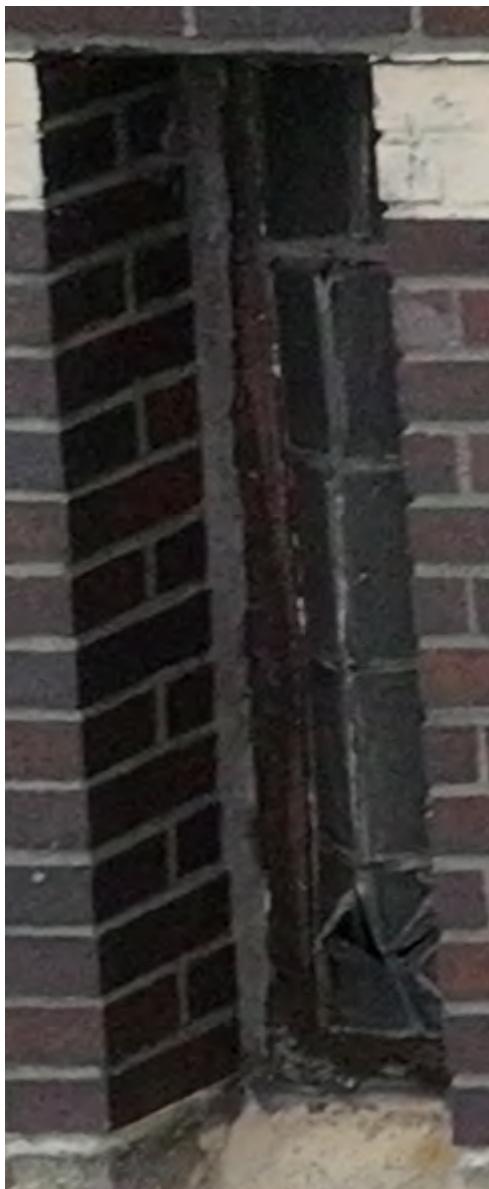
W-C1

- Generally in poor condition
- Bowing throughout
- Rusting along window sills
- Broken panes

Windows on the north secondary façade shall be removed based on proposed design. Windows shall not be replaced because of the proposal to demolish this area of the building to accommodate new development.

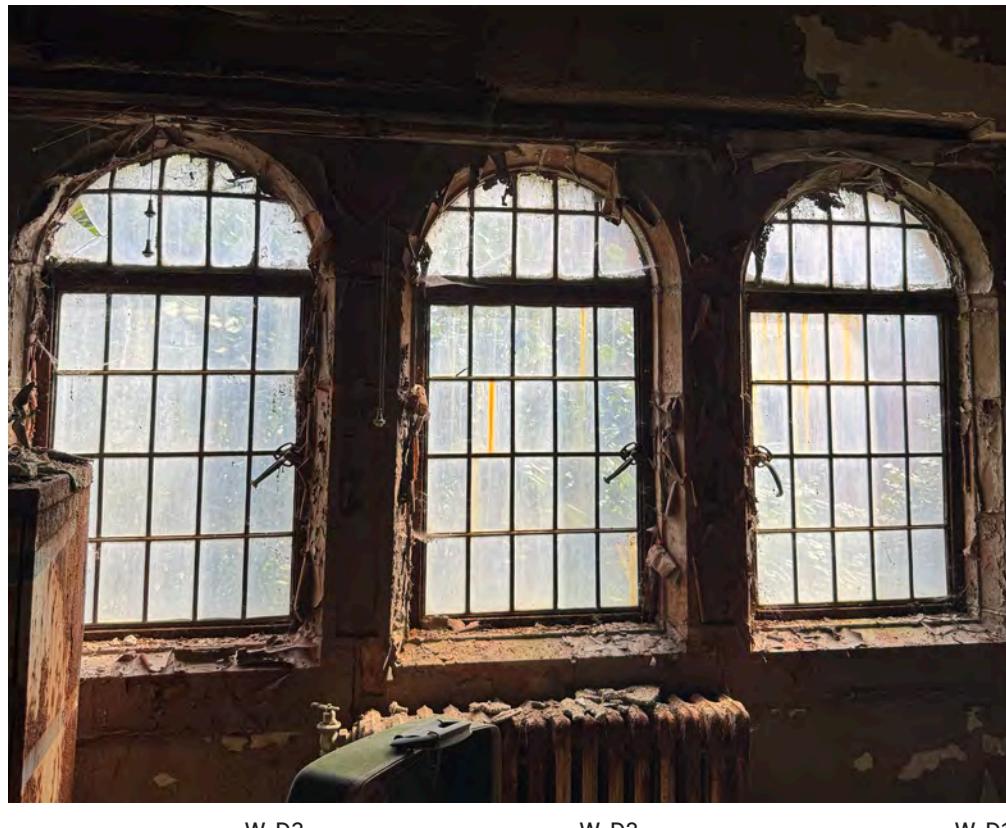
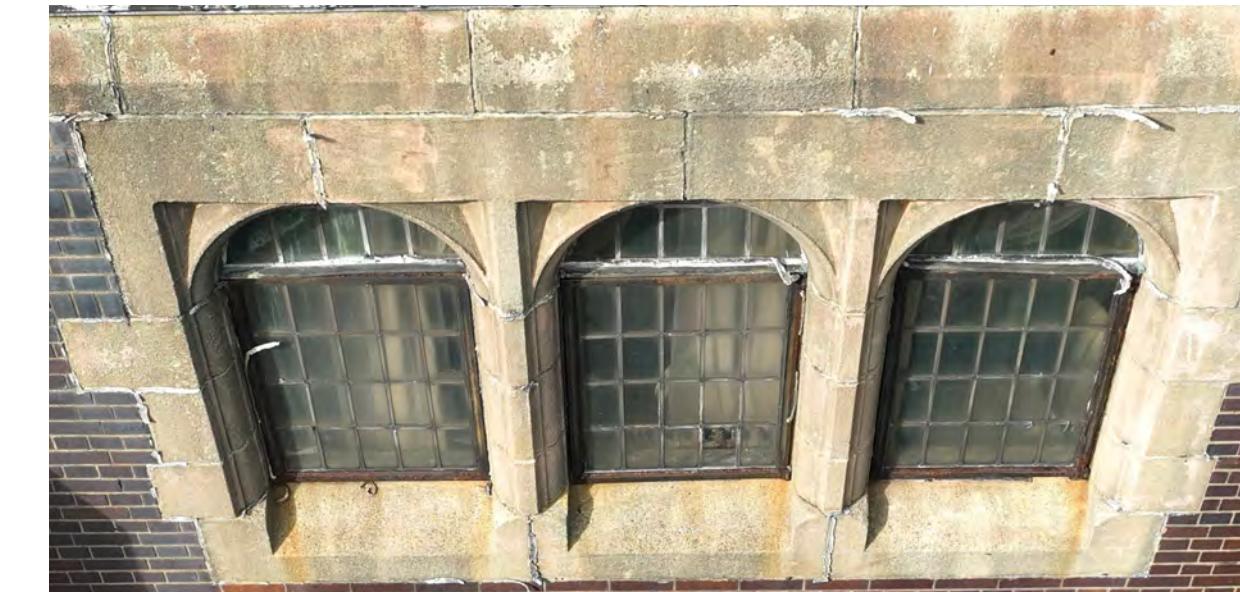
# Window Type W-D

- Major deterioration on interior
- No longer operable
- Rusting along window sills
- Frames detaching on exterior

Windows on the east primary façade shall be removed and replaced in-kind with steel, operable windows meeting all light and air standards based on proposed design and retaining the historic context of the neighborhood.
