**Preservation Department – Item 1, LPC-26-03280**

**138-154 St. Felix Street, aka 11-21 Hanson Place –  
Brooklyn Academy of Music Historic District  
Borough of Brooklyn**

# **144 ST. FELIX STREET**

## **ADAPTIVE-REUSE & ENLARGEMENT**

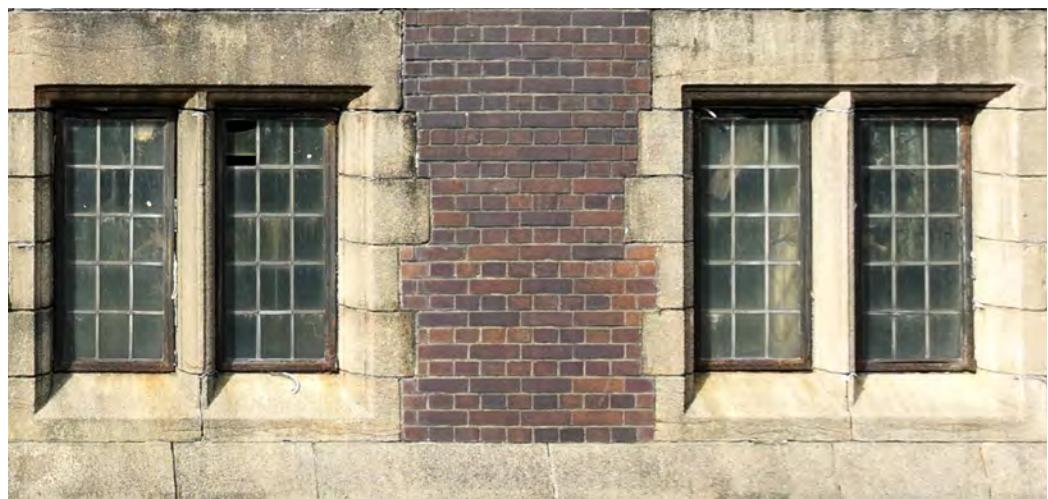
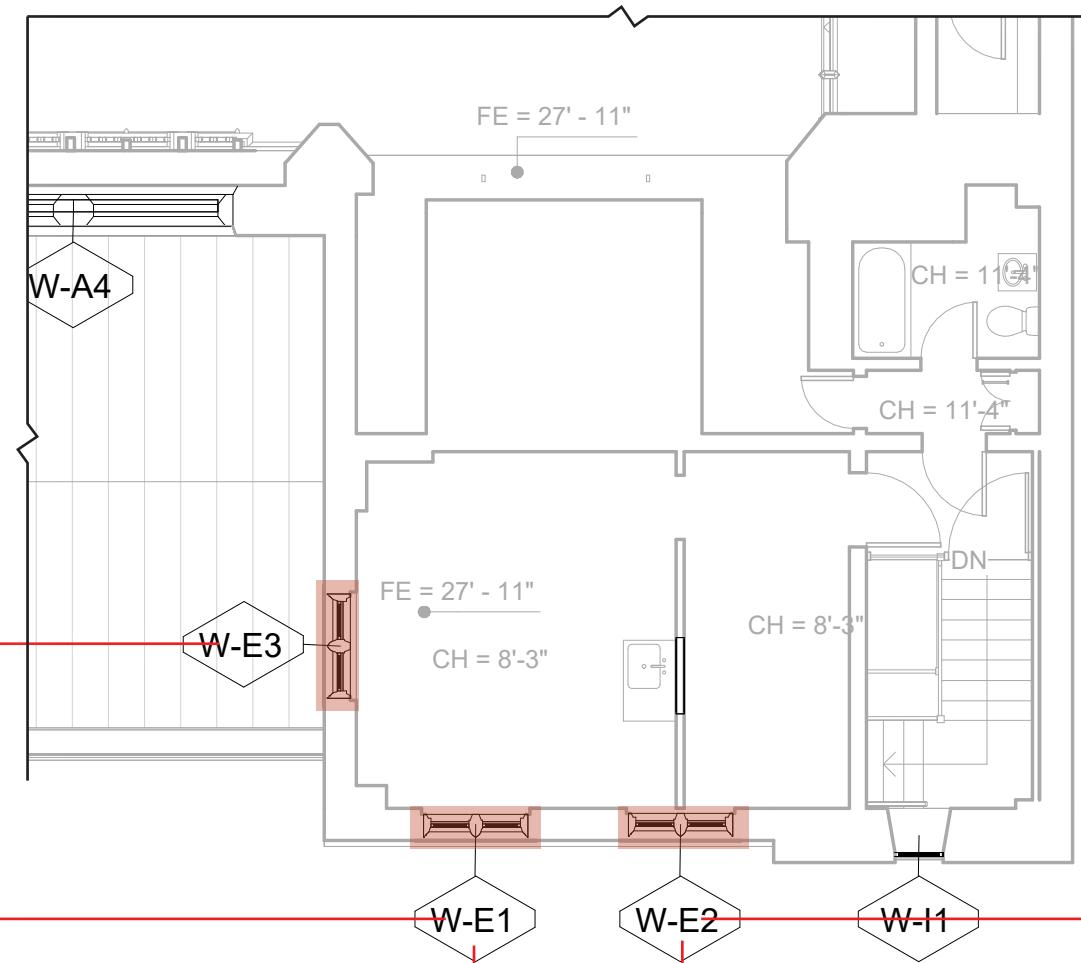
Window Type W-E

- Major deterioration on interior
- No longer operable
- Rusting along window sills
- Frames are detaching on exterior
- Broken panes

Windows shall be removed and replaced based on proposed design. Windows on the south and east façades shall be replaced in-kind with steel, operable windows meeting all light and air standards, retaining the historic context of the neighborhood.

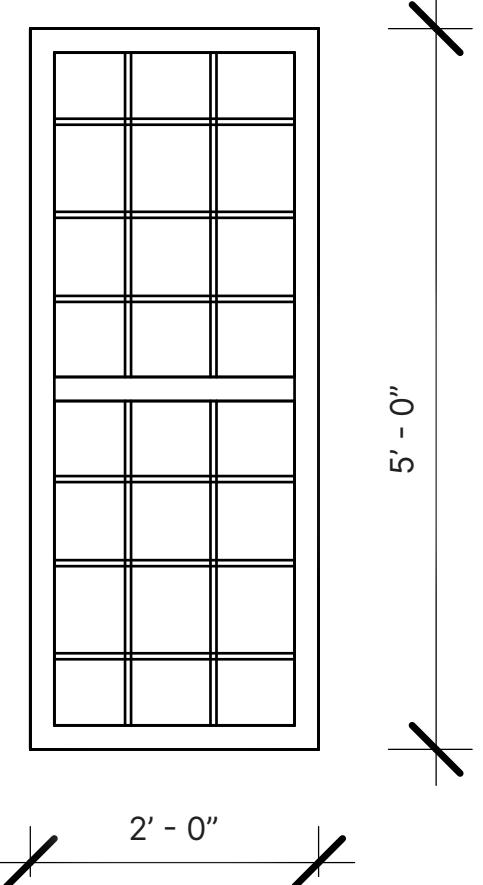
- Major deterioration on interior
- No longer operable
- Rusting along window sills
- Frames are detaching on exterior
- Broken and warping panes

Major damage appears to be typical, windows are broken and susceptible to the elements.

Windows shall be removed and replaced based on proposed design. Windows on the east façade shall be replaced in-kind with steel, operable windows to retain the historic context of the neighborhood.

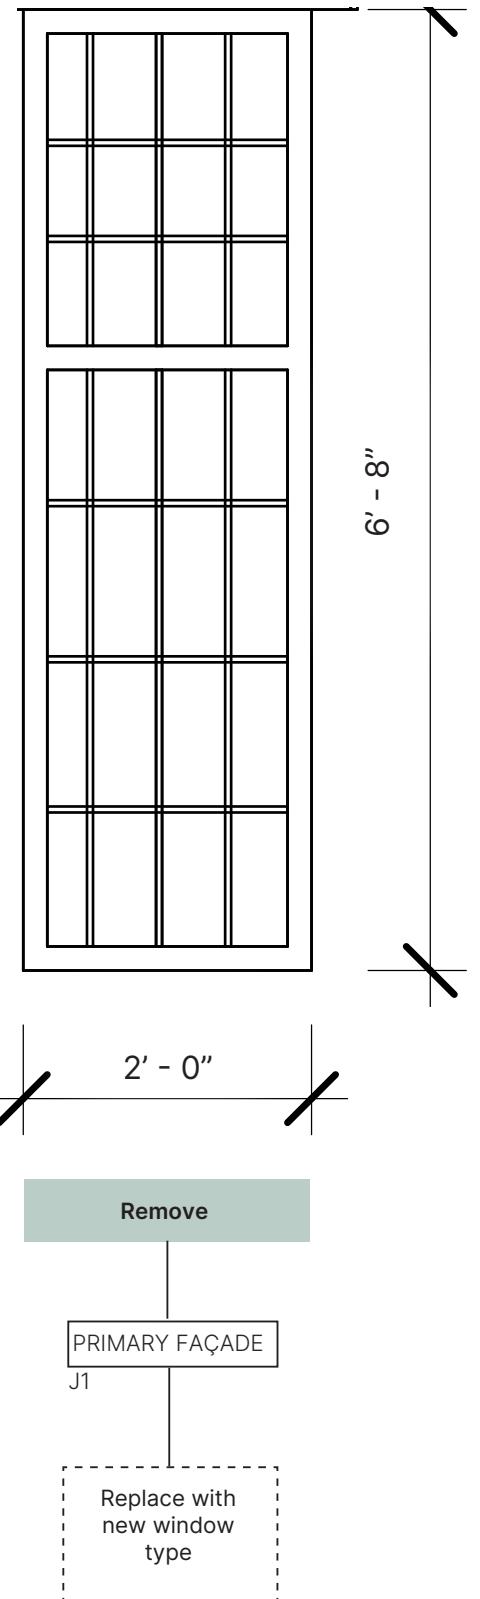
EAST ELEVATION (PRIMARY FAÇADE)

Windows shall be removed and replaced based on proposed design. This window on the east façade shall be replaced with a steel, operable window that is similar to the existing window, but shifted up half of a story to align with windows on the third floor and the revised floor plate.

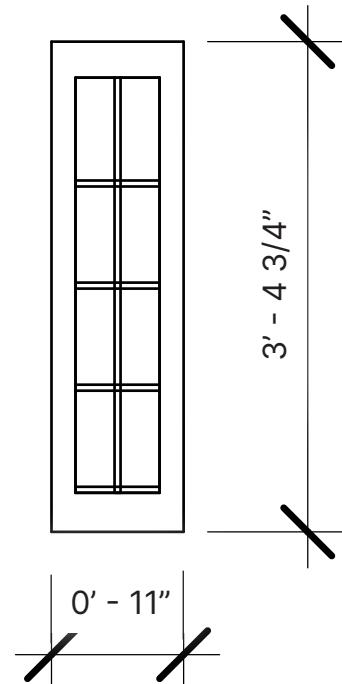
- Broken and warped panes
- One window entirely missing
- Rusted window sills
- Operability impaired

Major damage appears to be typical, windows are broken and susceptible to the elements.

Windows shall be removed and replaced based on proposed design. Windows on the east façade shall be replaced in-kind with steel, fixed windows to retain the historic context of the neighborhood.

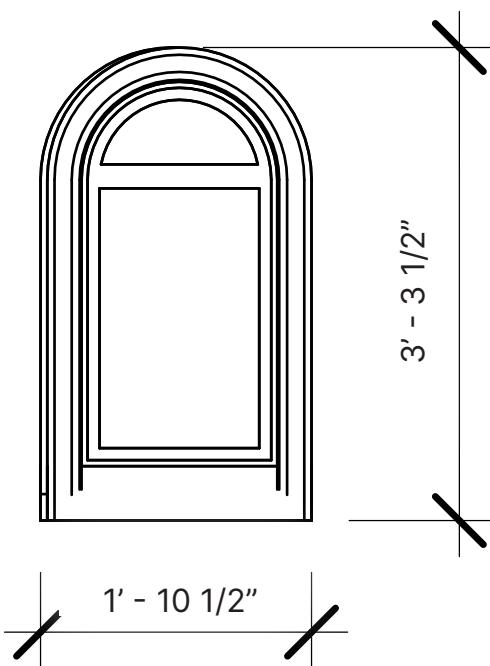
- Major deterioration on interior
- No longer operable
- Rusting along window sills
- Frames detaching on exterior
- Broken and bowing panes

Major damage appears to be typical, windows are broken and susceptible to the elements.

Windows shall be removed and replaced based on proposed design. Windows on the east primary façade shall be replaced in-kind with steel, operable windows to retain the historic context of the neighborhood. Windows on the west secondary façade shall not be replaced because of the proposal to demolish this area of the building to accommodate new development.

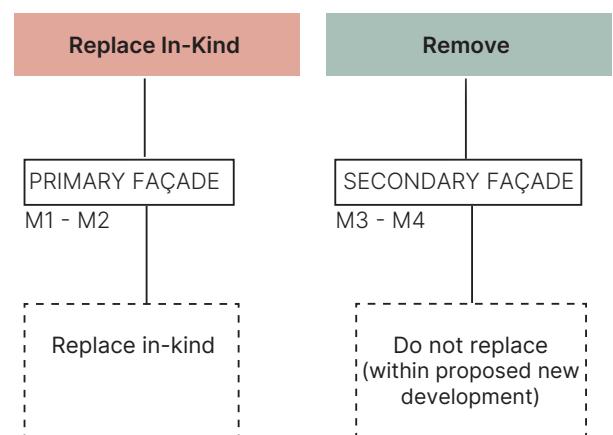
EAST ELEVATION (PRIMARY FAÇADE)

# Window Type W-M

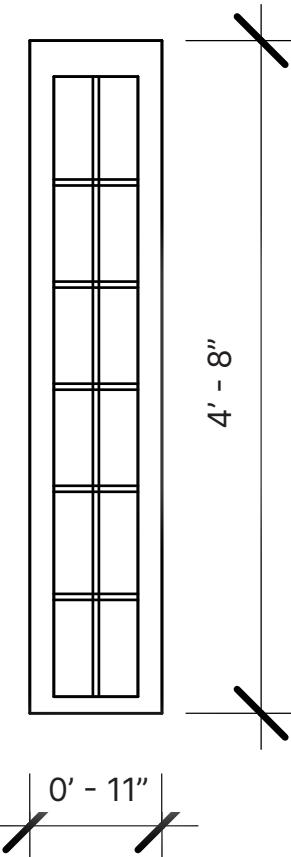
- Major deterioration on interior
- Rusting along window sills
- Frames detaching on exterior
- Boarded up on interior to prevent additional water damage
- Broken and warping panes

Major damage appears to be typical, windows are broken and susceptible to the elements.

Windows shall be removed and replaced based on proposed design. Windows on the south façade shall be replaced in-kind with steel, fixed windows to retain the historic context of the neighborhood.

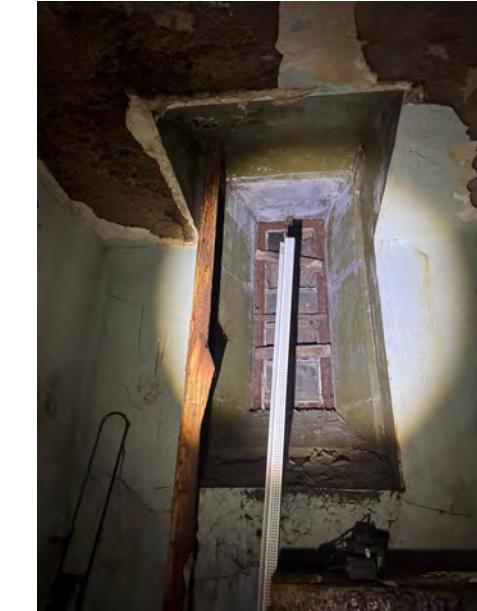
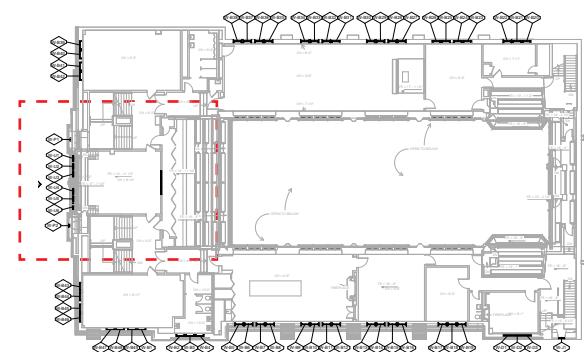
- Quantity: 10
- Operable
- Visibility from street: Yes
- Date: 1931 (Original)
- Condition: Poor/Fair

- Panels removed to install air conditioning units
- Rusting along window sills
- Warping and broken panes

Major damage appears to be typical, windows are blocked by mechanical equipment, and are no longer functioning as originally intended.

Windows shall be removed and replaced based on proposed design. Window openings shall accommodate new decorative aluminum ventilation screens for the storefronts similar to what was replaced in certain locations of the building.

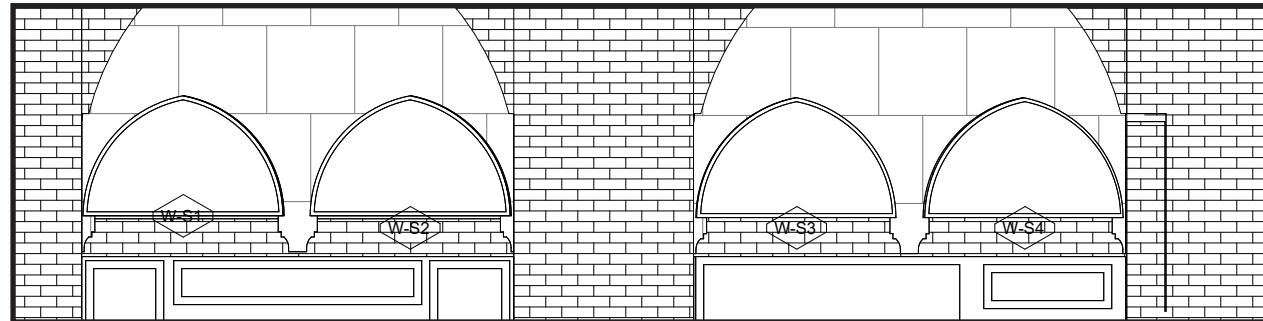
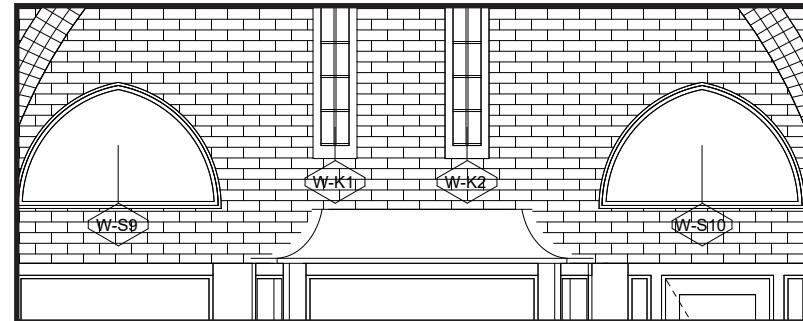
## SOUTH ELEVATION (PRIMARY FAÇADE)

# Window Type W-S

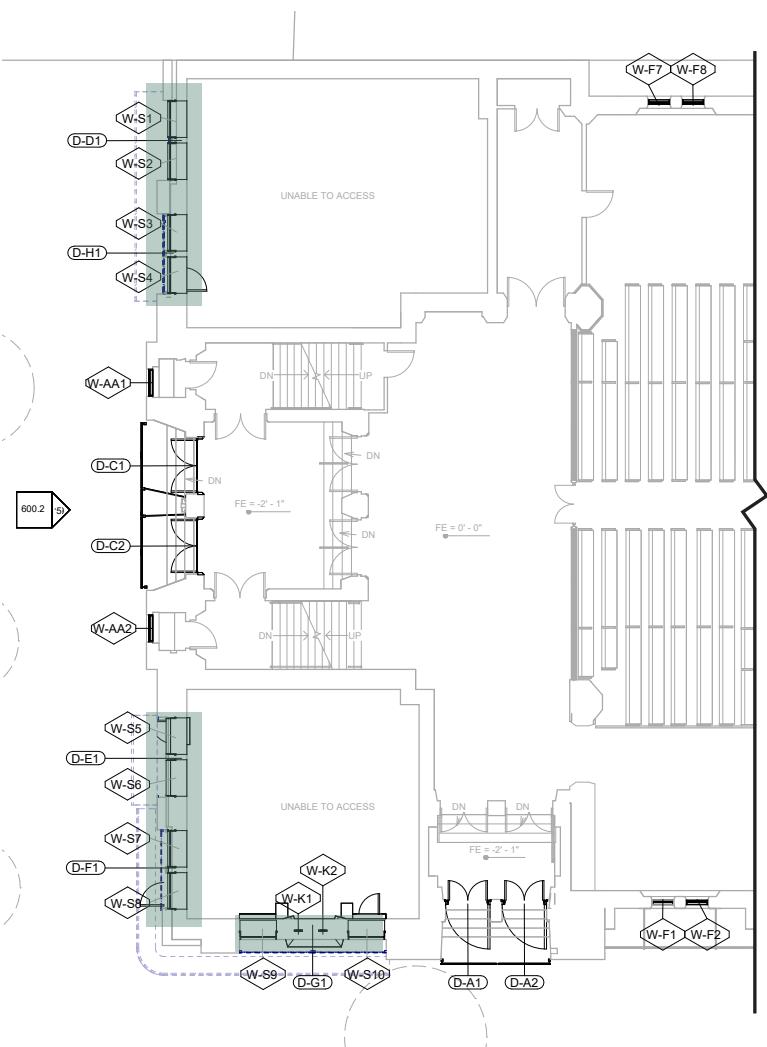
## FIRST FLOOR PLAN

\*\*Additional windows covered by scaffolding

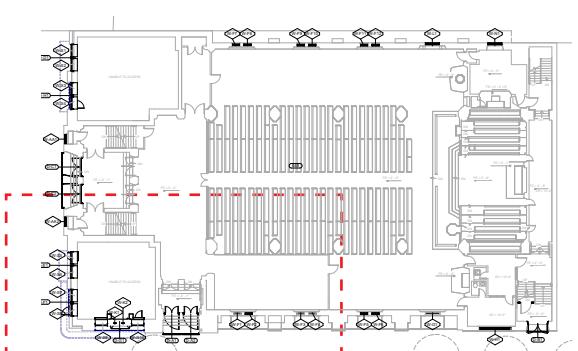
- Quantity: 6
- Operable
- Visibility from street: Yes
- Date: 1931 (Original)
- Condition: Poor

- Broken and bowing panes
- Rusting along window sill
- No longer operable

Major damage appears to be typical, windows are broken and susceptible to the elements.

Windows shall be removed and replaced based on new design. Windows on the south façade shall be replaced in-kind with steel, operable windows, meeting all light and air requirements, to retain the historic context of the neighborhood.

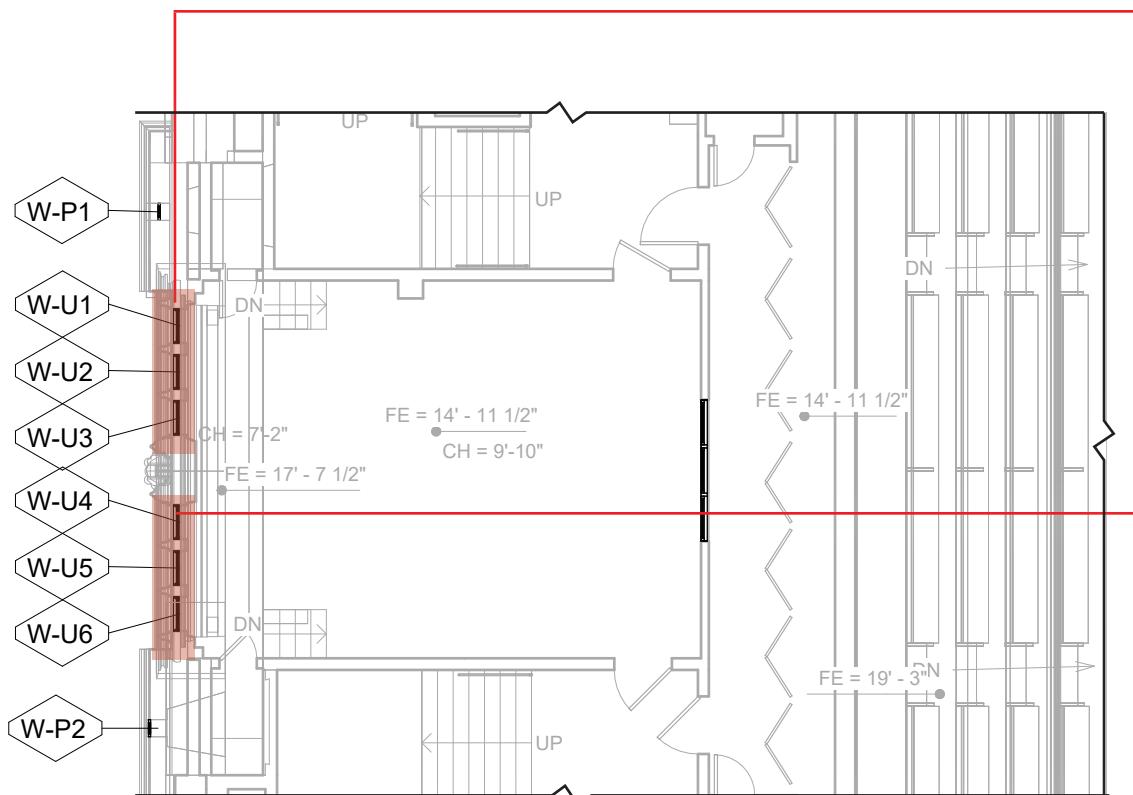
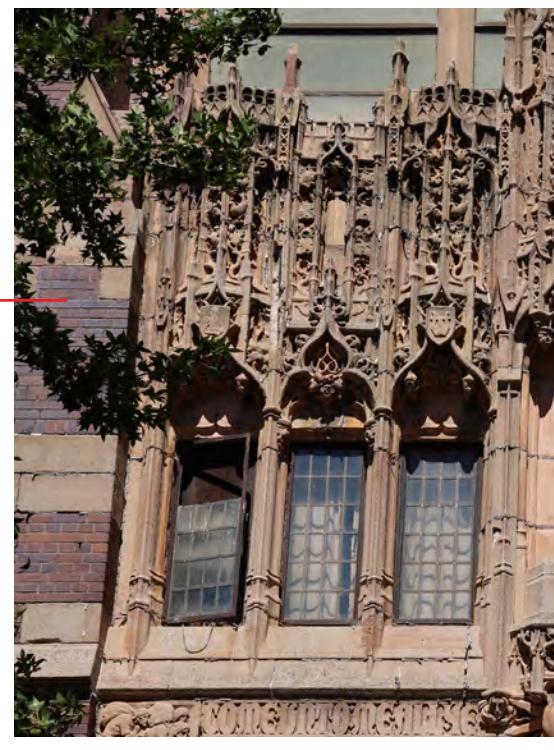
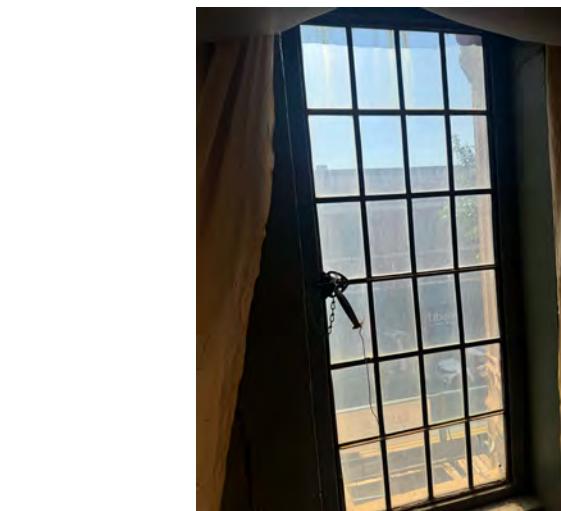
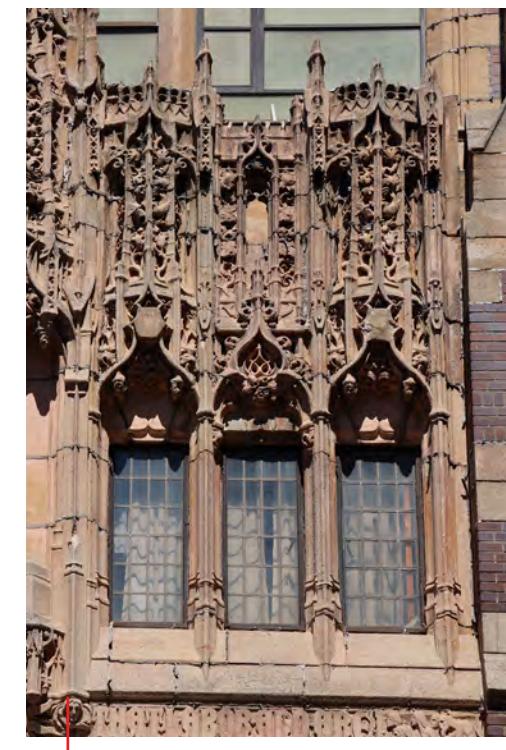
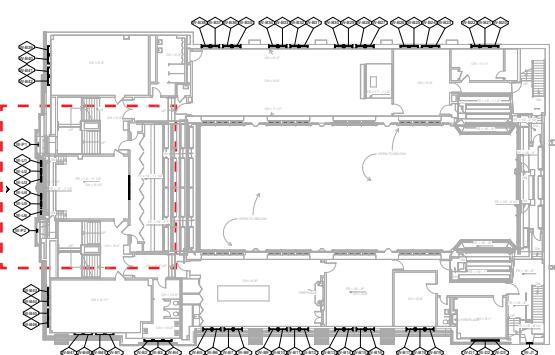
- Quantity: 33
- Operable
- Visibility from street: No
- Date: 1931 (Original)
- Condition: Poor

- Standard windows built in lightwells
- Broken and warped panes
- Rusted window sills
- Operability impaired
- Mold growth and water damage observed in select locations at lower levels
- Panes removed for air conditioner installation
- Non-original interior grille added for security

Major damage appears to be typical, windows are broken and susceptible to the elements.

Windows on the south and east primary façades shall be removed and replaced in-kind and meeting all light and air requirements based on proposed design. Thorough repairs shall be made to remove mold and other damage caused by water. Windows on the west secondary façade shall not be replaced because of the proposal to demolish this area of the building to accommodate new development.

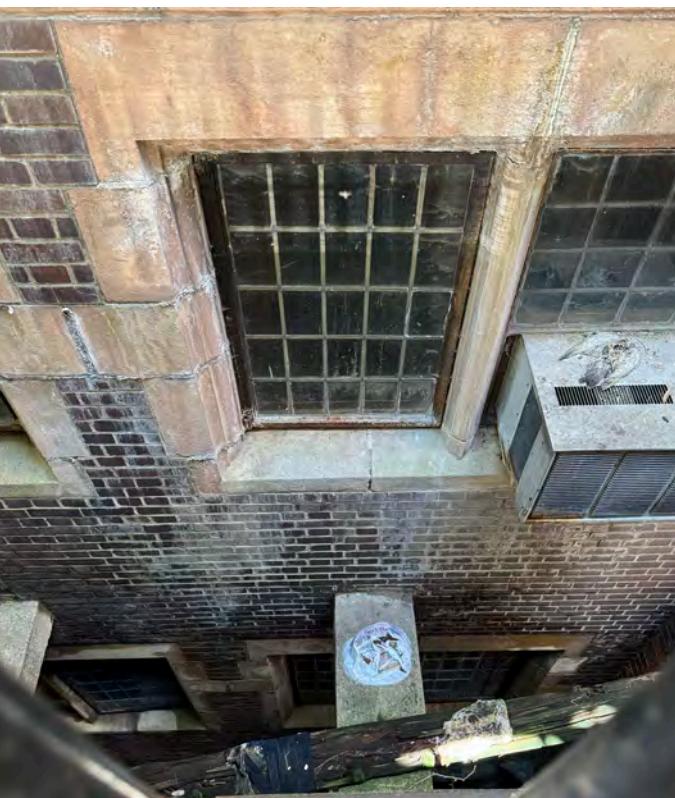
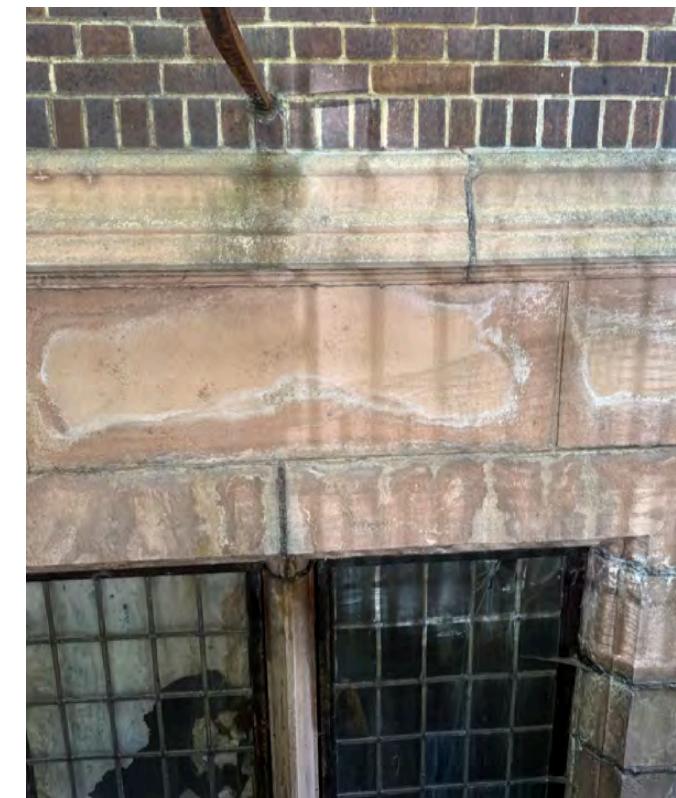
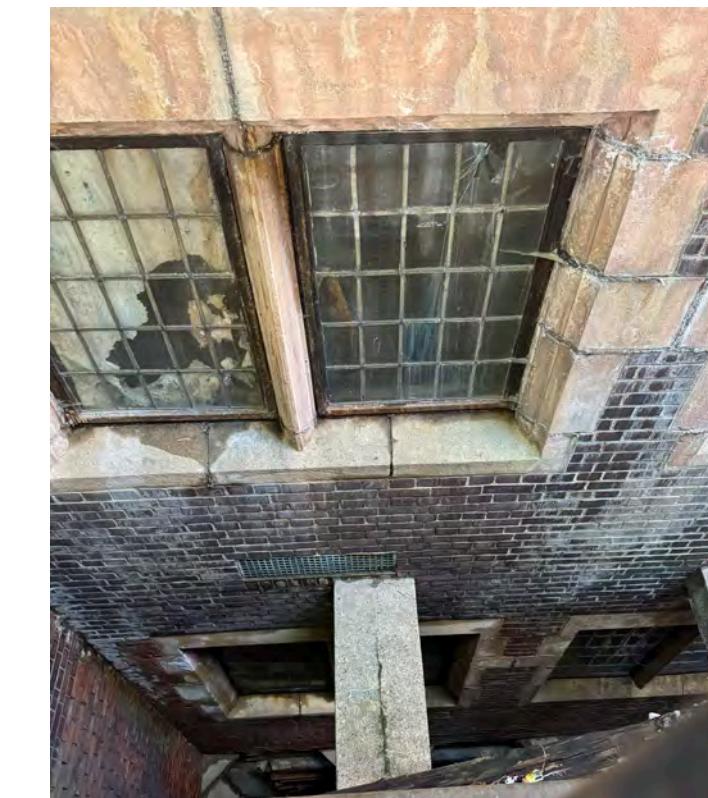
EXTERIOR

# Window Type W-V

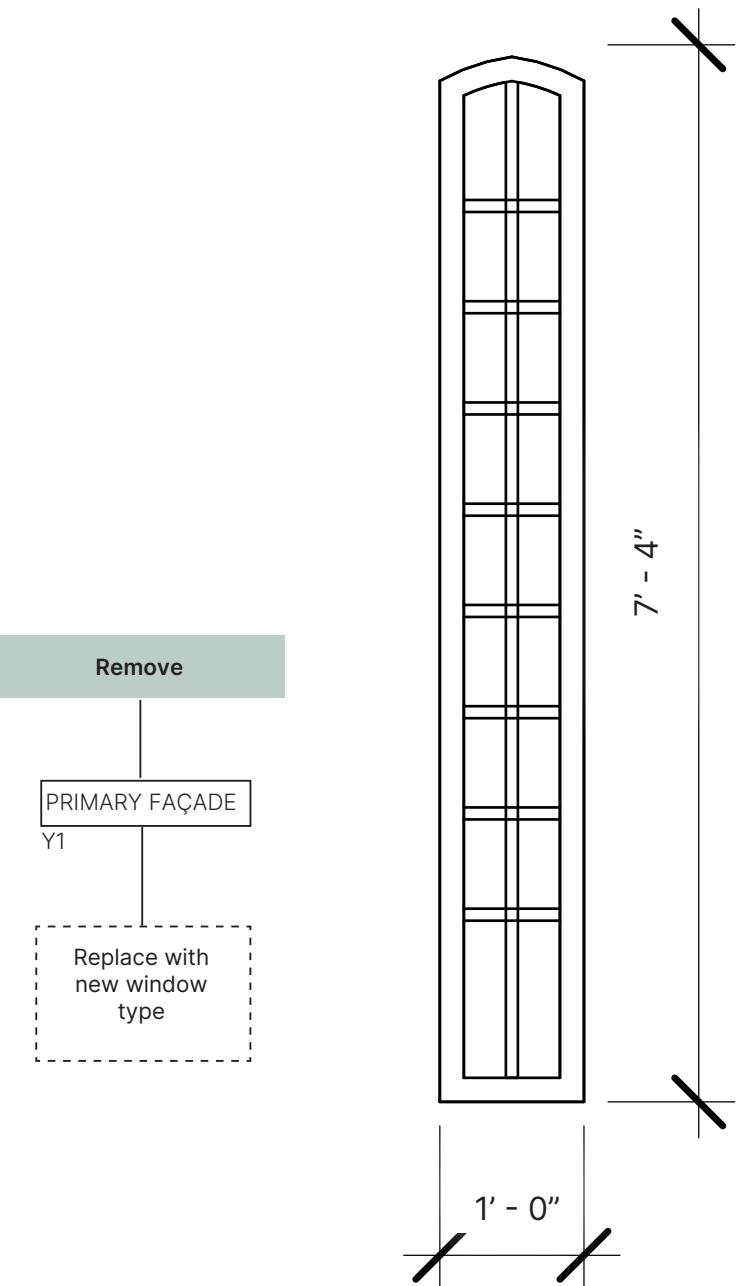
EAST ELEVATION (PRIMARY FAÇADE)

- Quantity: 1
- Fixed
- Visibility from street: Yes
- Date: 1931 (Original)
- Condition: Fair

- Rusting along window sills
- Bowing frame on exterior

Window shall be removed and replaced based on proposed design. Window on the east façade shall be replaced, meeting all light and air requirements, with a new clear operable steel window with tracery to match the adjacent existing windows retaining the historic context of the neighborhood.

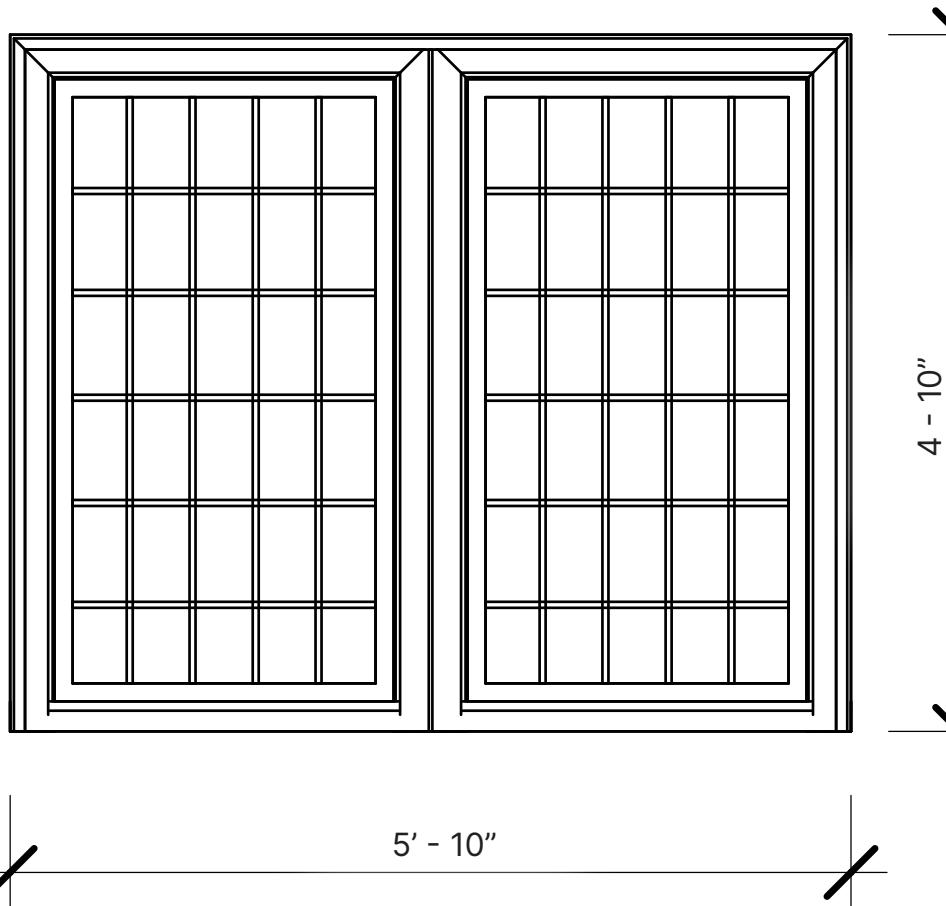
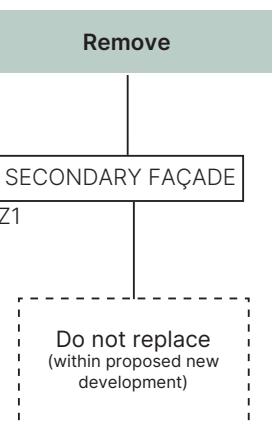
WEST ELEVATION (SECONDARY FAÇADE)

- Quantity: 1
- Operable
- Visibility from street: No
- Date: 1931 (Original)
- Condition: Unknown

- Window built in lightwells
- Broken and warped panes
- Rusted window sills
- Operability impaired
- Mold growth and water damage observed in select locations at lower levels
- Panes removed for air conditioner installation

Window shall be removed based on proposed design. Thorough repairs shall be made to remove mold and other damage caused by water in the existing openings. Windows on the west secondary façade shall not be replaced because of the proposal to demolish this area of the building to accomodate new development.

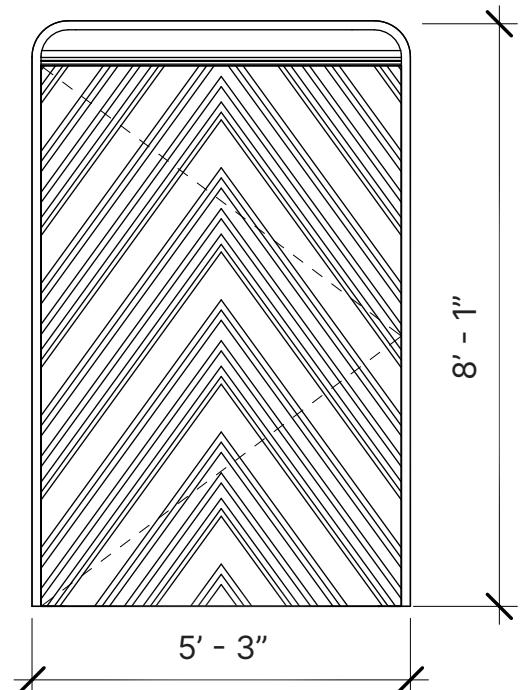
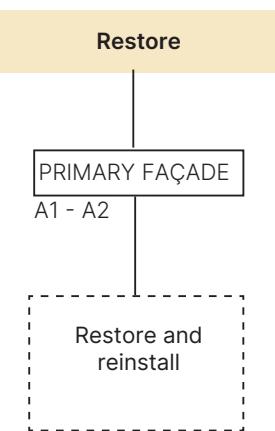
Door Type: D-A

- Quantity: 2
- Visibility from street: Yes
- Date: 1931 (Original)
- Condition: Fair

- Warped door does not close as required
- Paint is chipped

Doors shall be salvaged and restored. Doors on the east primary façade shall be reinstalled and used for egress purposes only to retain the historic context of the neighborhood.

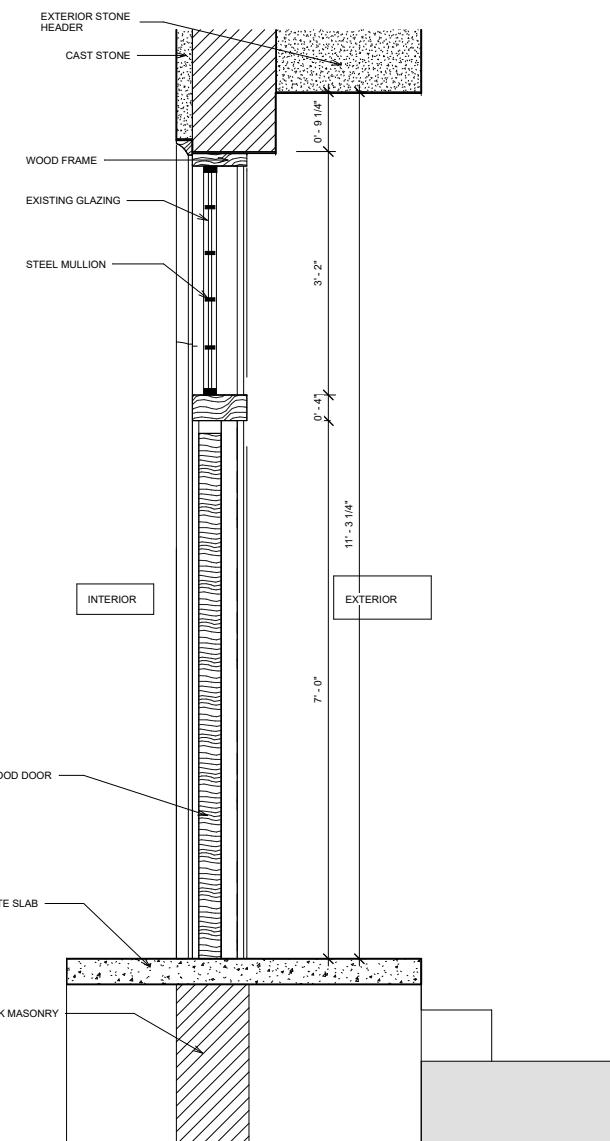
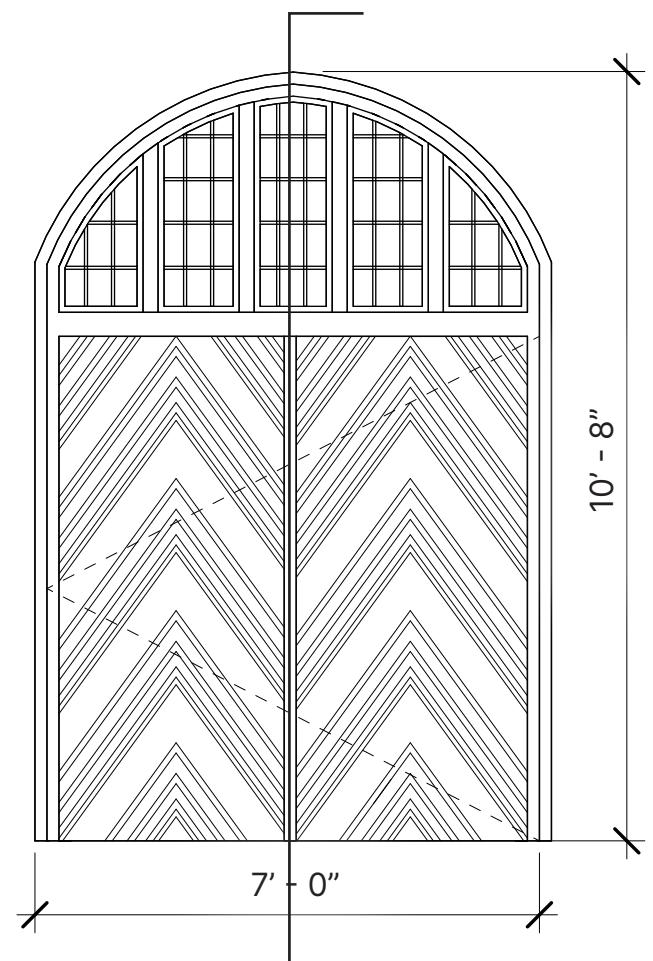
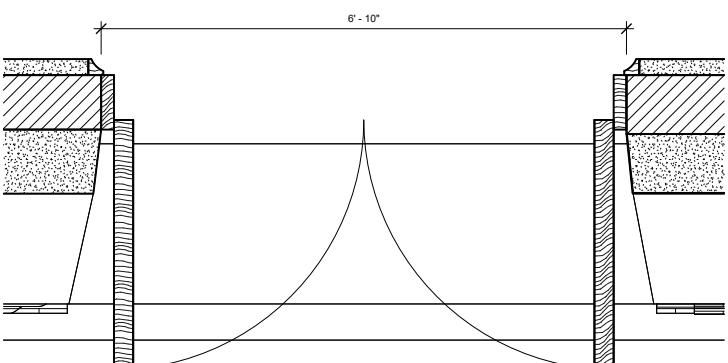
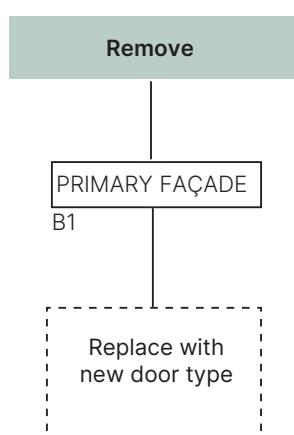
Door Type: D-B

- Quantity: 1
- Visibility from street: Yes
- Date: 1931 (Original)
- Condition: Poor

Doors shall be removed and replaced based on proposed design. Door on the east primary façade shall be replaced with a new storefront to accommodate new proposed entry to residential development.

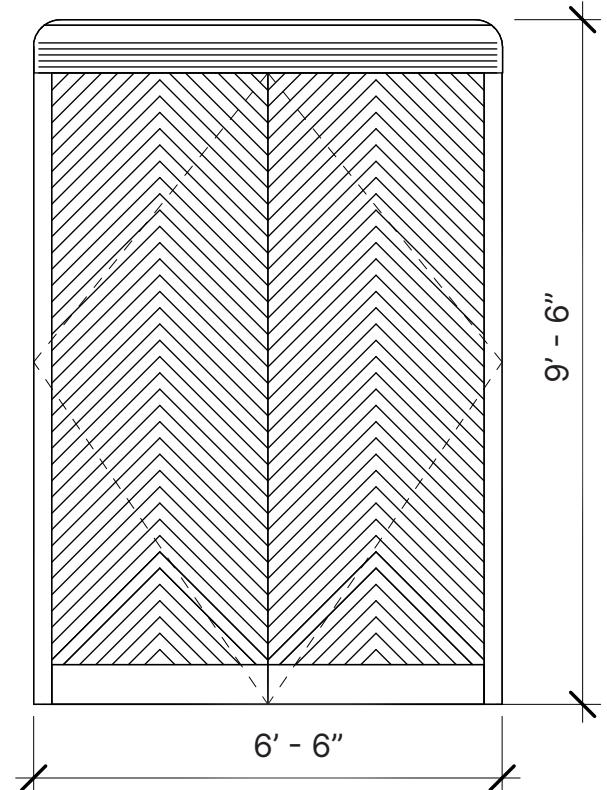
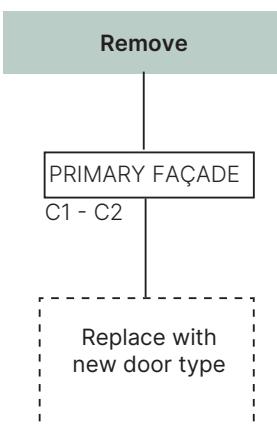
Door Type: D-C

- Quantity: 2
- Visibility from street: Yes
- Date: 1931 (Original)
- Condition: Poor

- Warping causes door to no longer shut properly
- Chipping paint
- Doors boarded up from the interior

Doors shall be removed and replaced based on proposed design. Doors on the south primary façade shall be replaced with new storefront to accommodate proposed new community main entrance.

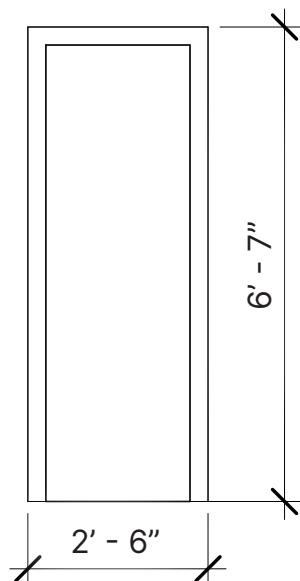
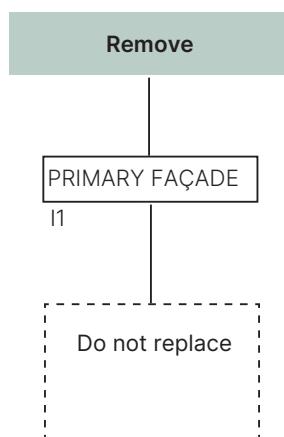
Door Type: D-I

- Quantity: 1
- Visibility from street: No
- Date: Unknown (Non-original)
- Condition: Poor

- Original steel door has been removed and makeshift wood board remains in place
- Operability is impaired
- Opening is exposed to the exterior

Door shall be removed based on proposed design. Door on the east primary façade shall not be replaced because of the proposal to demolish this area of the building to accommodate new development.

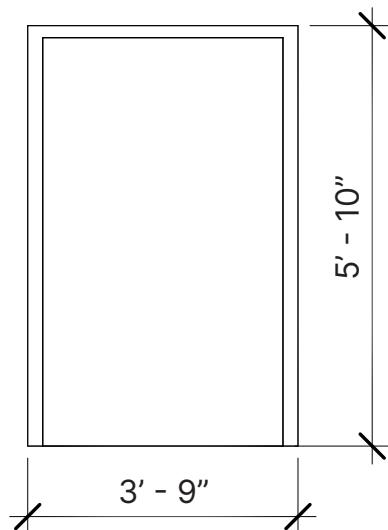
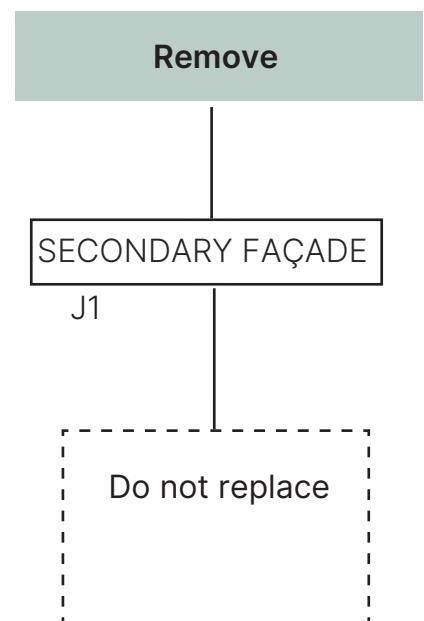
Door Type: D-J

Major damage appears to be typical, doors are broken and susceptible to the elements.

Door shall be removed based on proposed design. Door on the west secondary façade shall not be replaced because of the proposal to demolish this area of the building to accomodate new development.

WEST ELEVATION (SECONDARY FAÇADE)

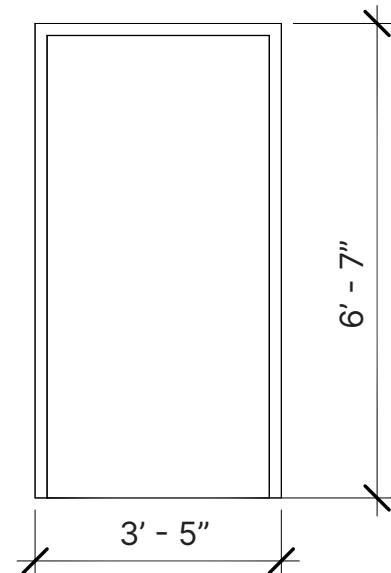
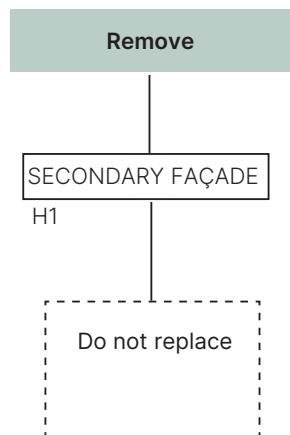
Door Type: D-K

- Warped door does not close as required
- Paint is chipped
- Door is stuck adjar

Major damage appears to be typical, doors are broken and susceptible to the elements.

Door shall be removed based on proposed design. Door shall not be replaced because of the proposal to demolish this area of the building to accomodate new development.

SOUTH ELEVATION (PRIMARY FAÇADE)

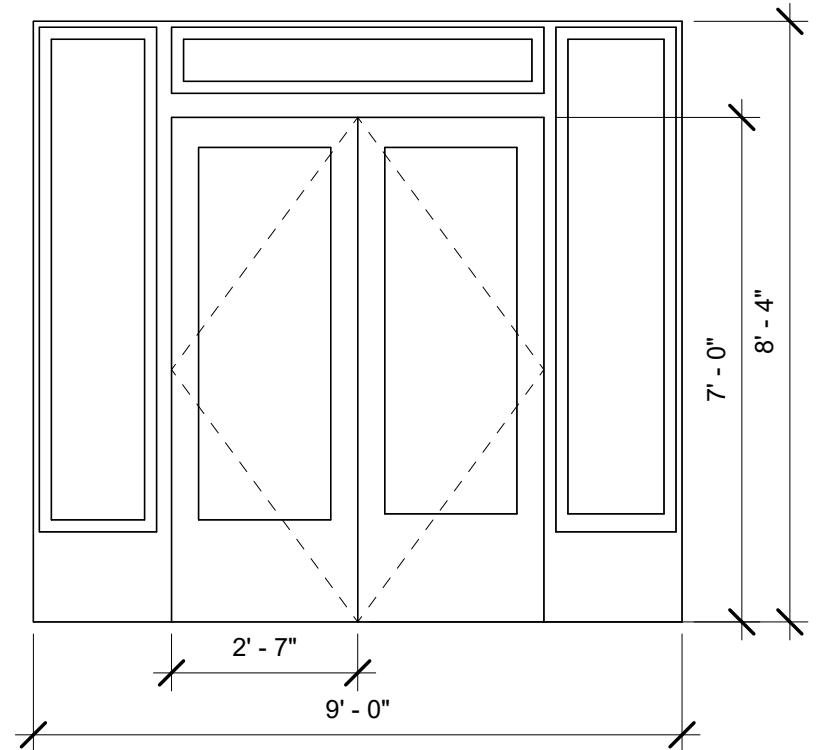
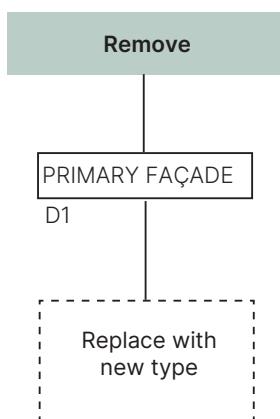
SOUTH ELEVATION (PRIMARY FAÇADE)

- Installed in front of original storefronts
- Fine condition

- Framing system is rusted
- Glazing is damaged

Security grille is generally in good condition but shall not be required for proposed storefronts at ground level in future design.

Security grilles and existing storefronts shall be removed. Existing security grilles shall not be replaced to accommodate new proposed storefronts. New storefront material shall be similar to existing and include double doors.

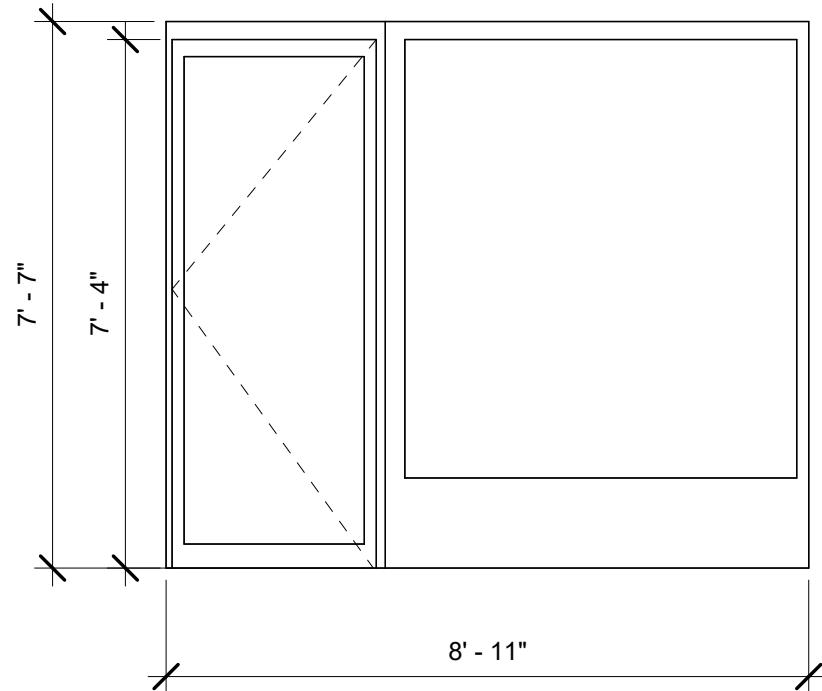
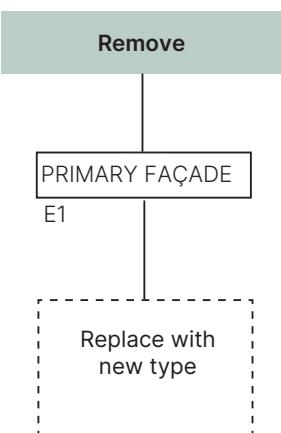
SOUTH ELEVATION (PRIMARY FAÇADE)

- Installed in front of original storefronts
- Fine condition

- Framing system is rusted
- Glazing is damaged

Security grille is generally in good condition but shall not be required for proposed storefronts at ground level in future design.

Security grilles and existing storefronts shall be removed. Existing security grilles shall not be replaced to accommodate new proposed storefronts. New storefront material shall be similar to existing and include double doors.

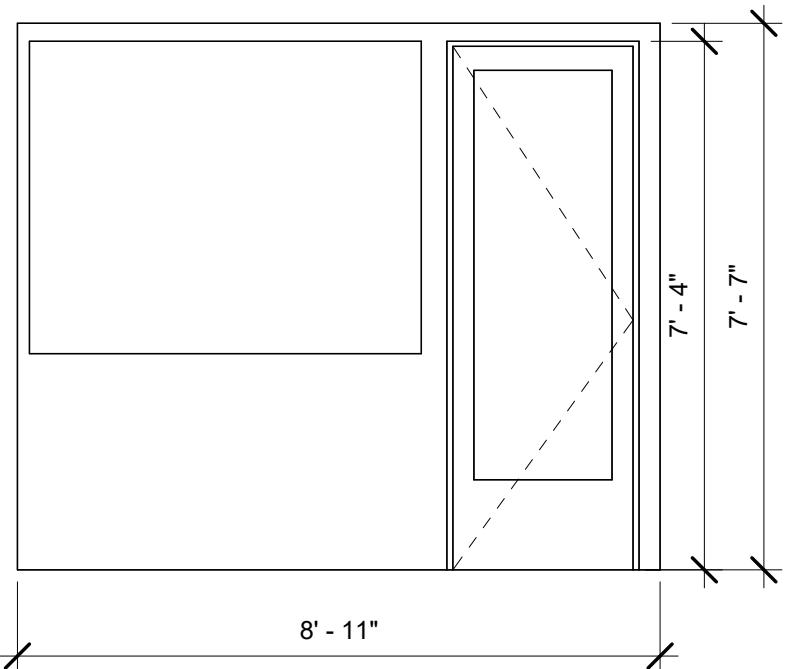
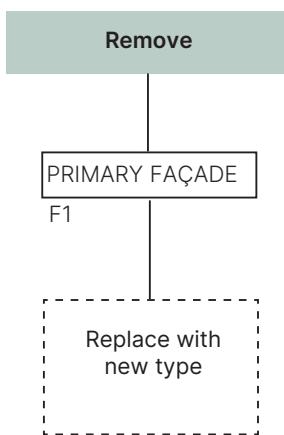
SOUTH ELEVATION (PRIMARY FAÇADE)

- Installed in front of original storefronts
- Fine condition

- Framing system is rusted
- Glazing is damaged

Security grille is generally in good condition but shall not be required for proposed storefronts at ground level in future design.

Security grilles and existing storefronts shall be removed. Existing security grilles shall not be replaced to accommodate new proposed storefronts. New storefront material shall be similar to existing and include double doors.

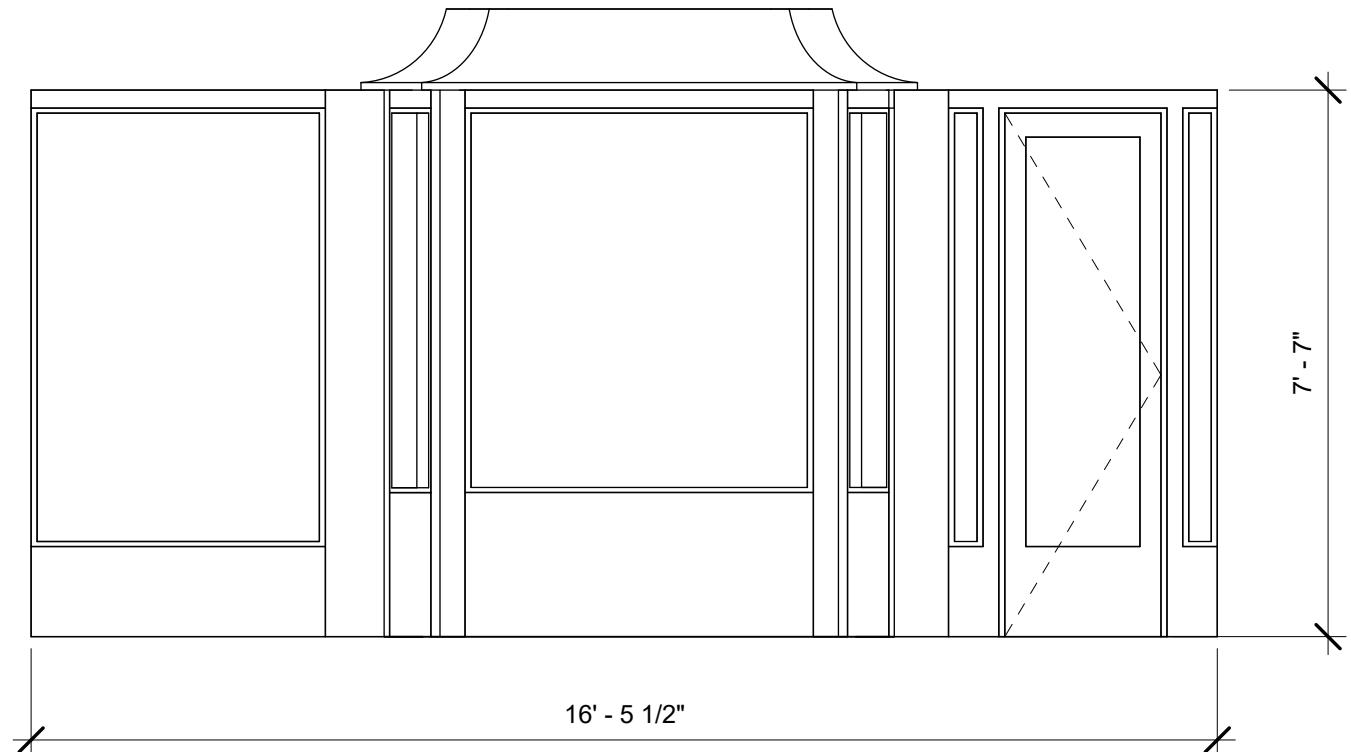
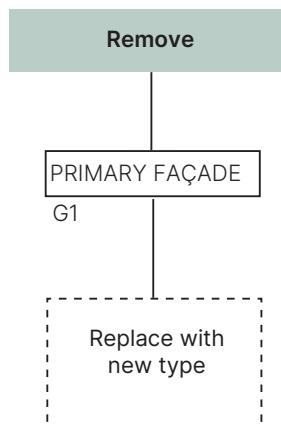
Door Type: D-G

- Installed in front of original storefronts
- Fine condition

- Framing system is rusted
- Glazing is damaged

Security grille is generally in good condition but shall not be required for proposed storefronts at ground level in future design.

Security grilles and existing storefronts shall be removed. Existing security grilles shall not be replaced to accommodate new proposed storefronts. New storefront material shall be similar to existing and include double doors.

EAST ELEVATION (PRIMARY FAÇADE)
