**Preservation Department – Item 1, LPC-26-03280**

**138-154 St. Felix Street, aka 11-21 Hanson Place –  
Brooklyn Academy of Music Historic District  
Borough of Brooklyn**

# **144 ST. FELIX STREET**

## **ADAPTIVE-REUSE & ENLARGEMENT**

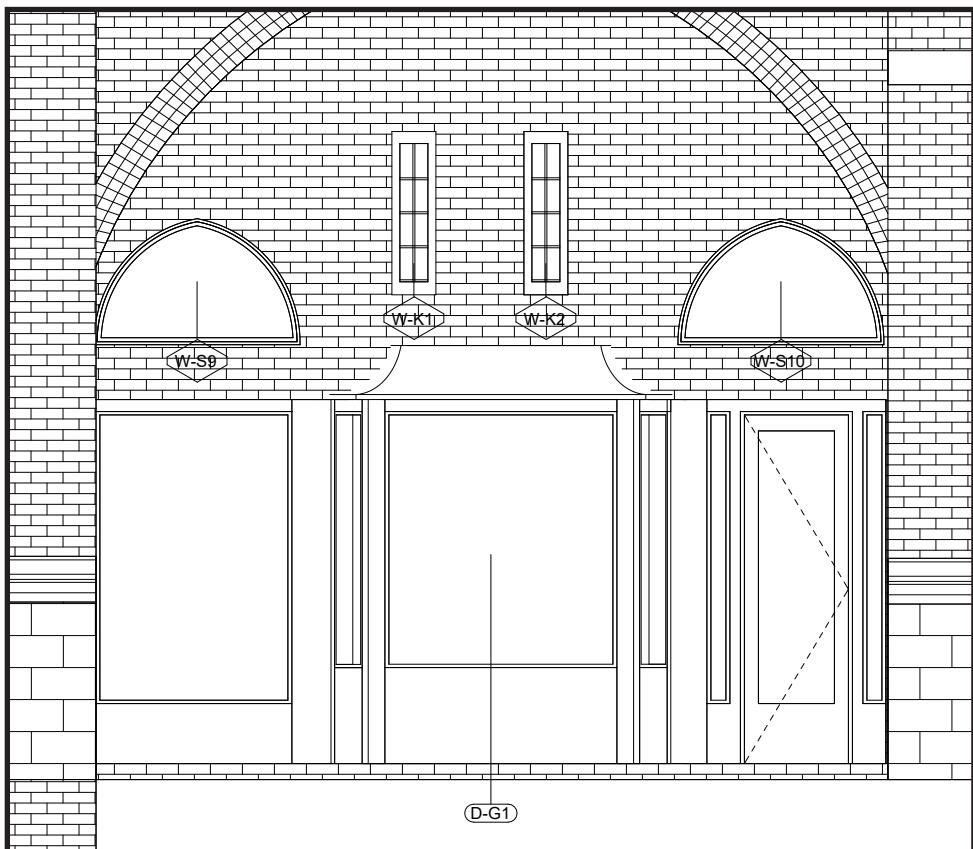
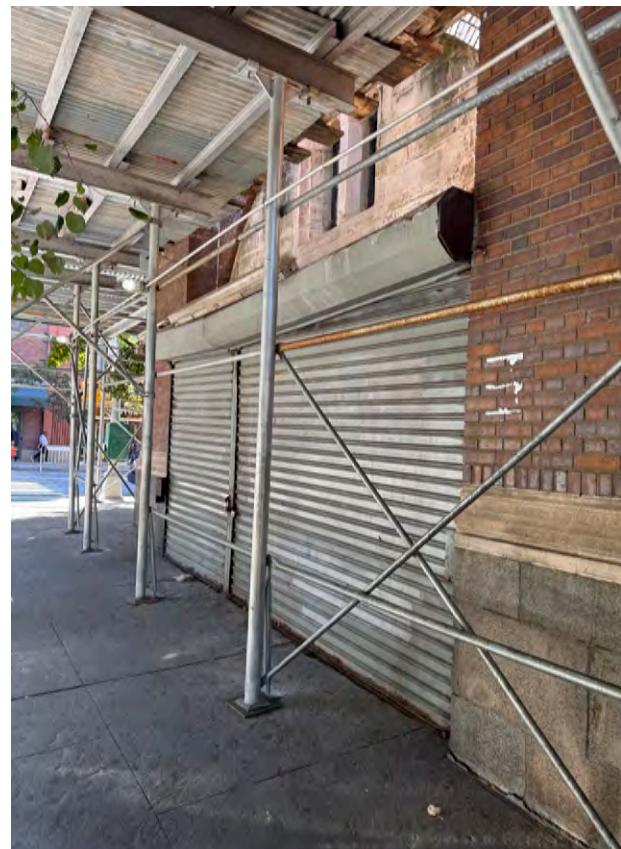
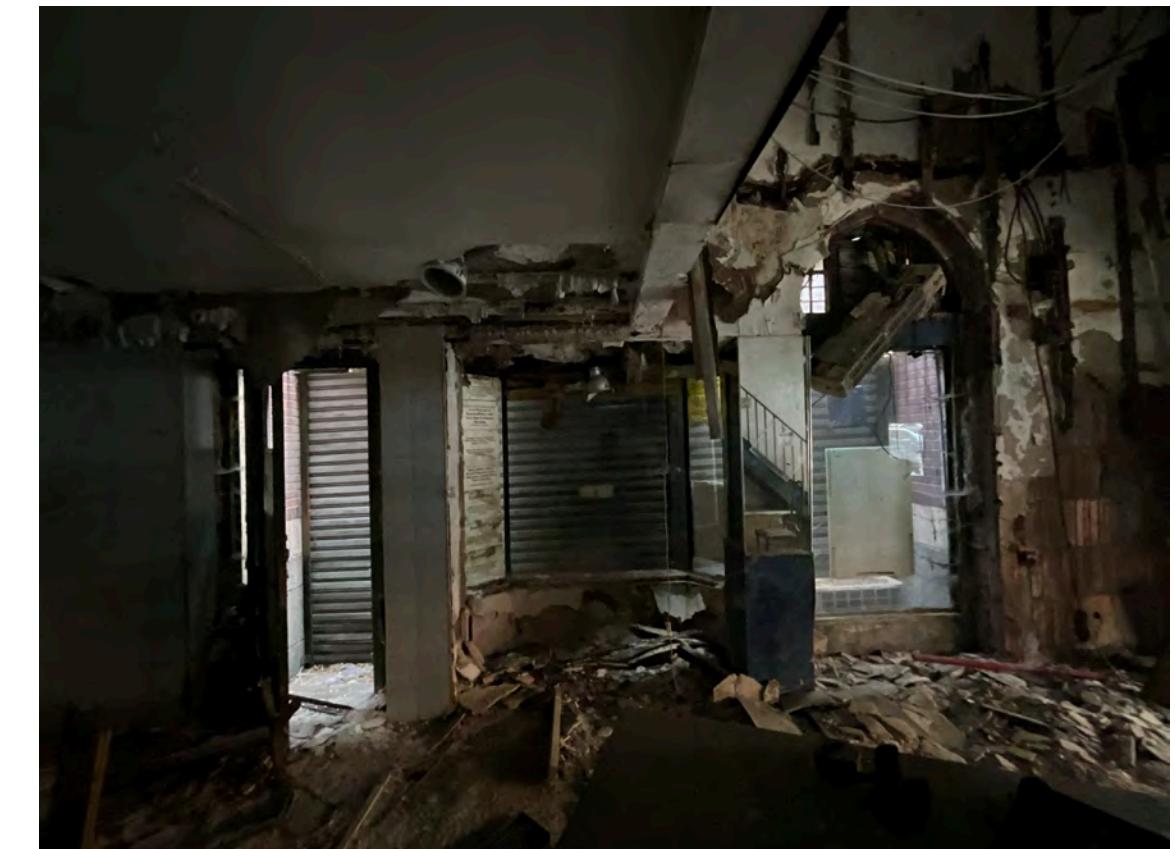
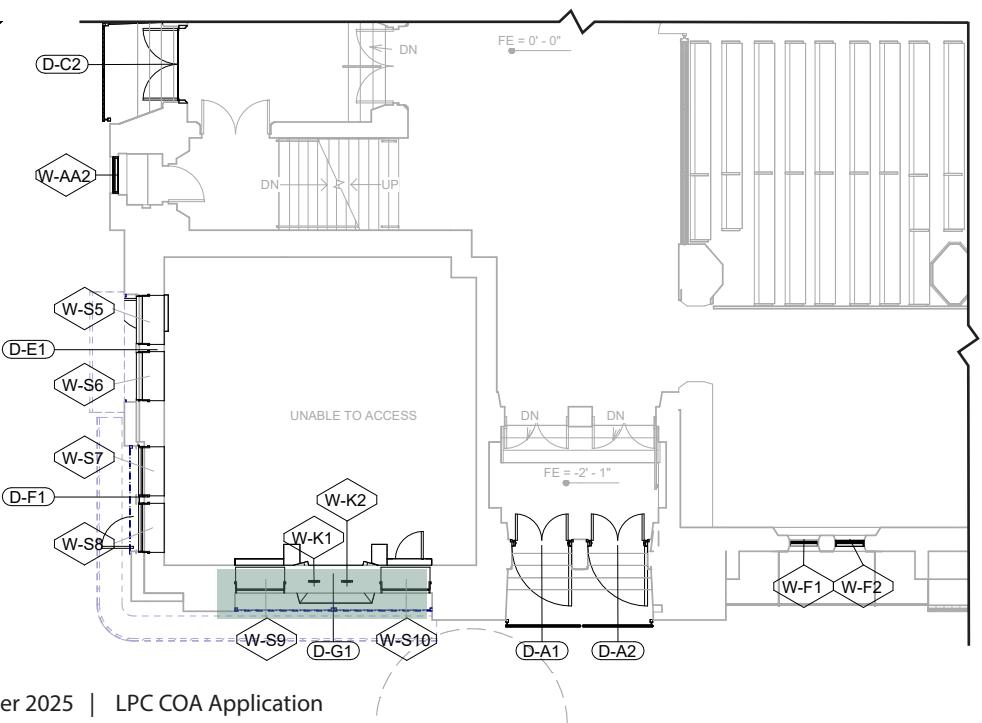
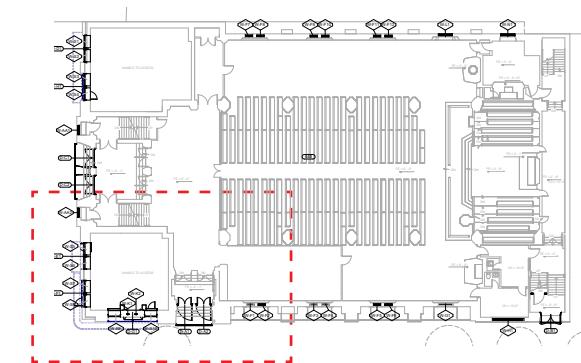
Door Type: D-G

EAST ELEVATION (PRIMARY FAÇADE)

FIRST FLOOR PLAN

- Quantity: 1
- Visibility from street: Yes
- Date: 1931 (Original)
- Condition: Fair

- Installed in front of original storefronts
- Fine condition

- Framing system is rusted
- Glazing is damaged

Security grille is generally in good condition but shall not be required for proposed storefronts at ground level in future design.

Security grilles and existing storefronts shall be removed. Existing security grilles shall not be replaced to accommodate new proposed storefronts. New storefront material shall be similar to existing and include double doors.

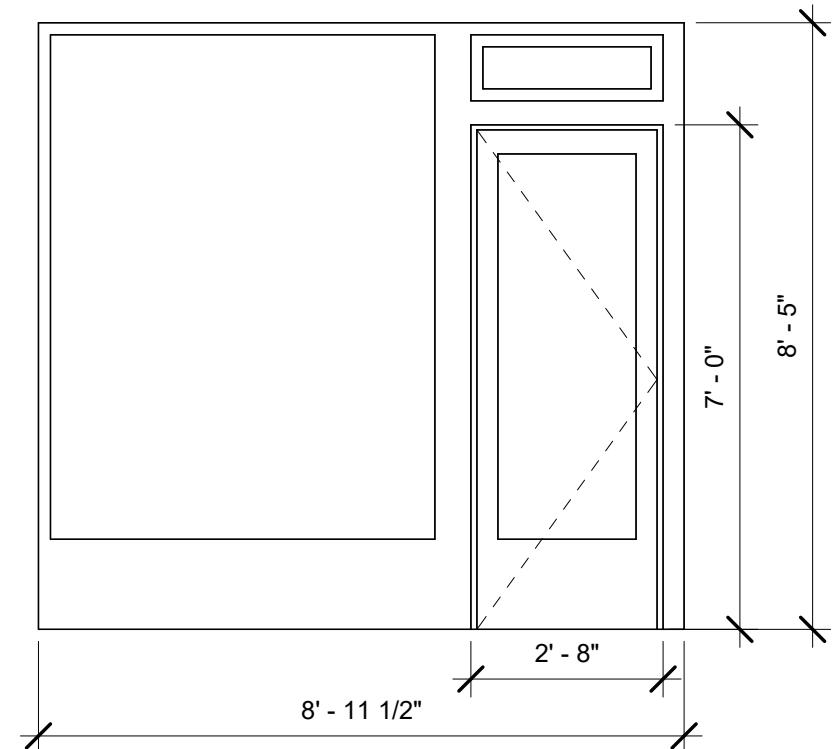
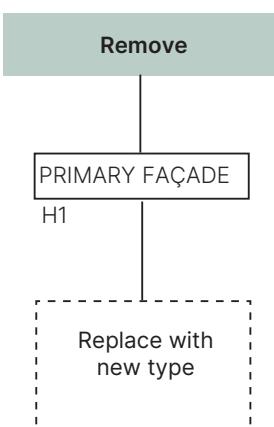
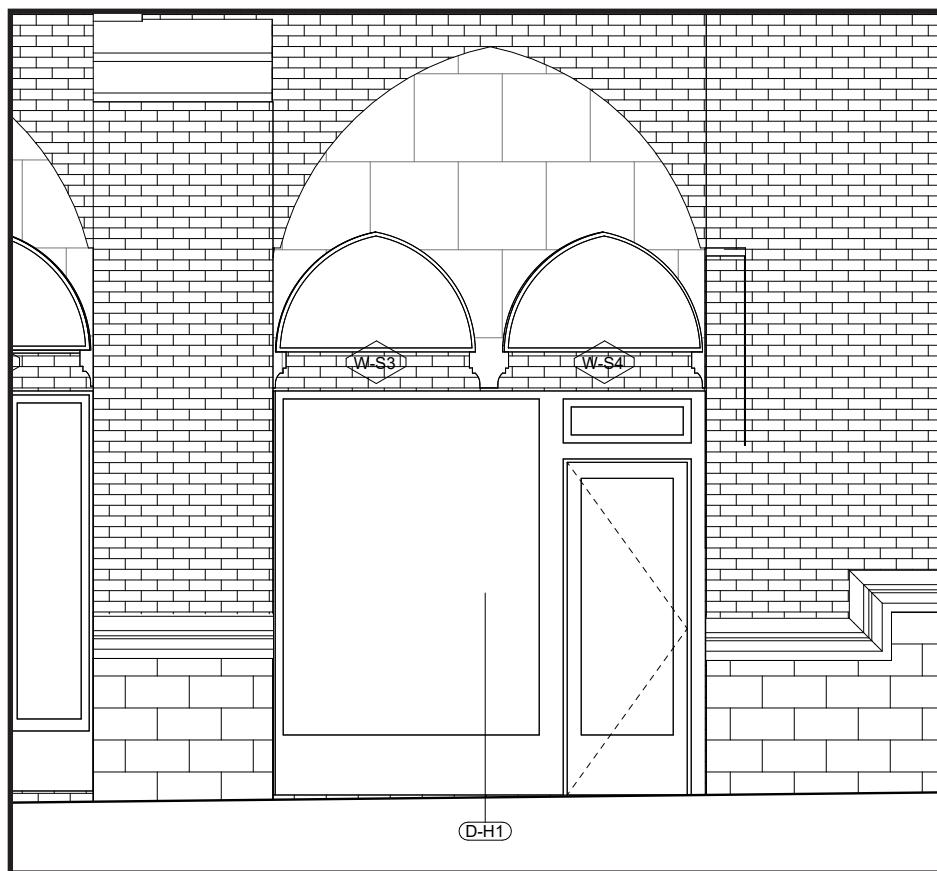
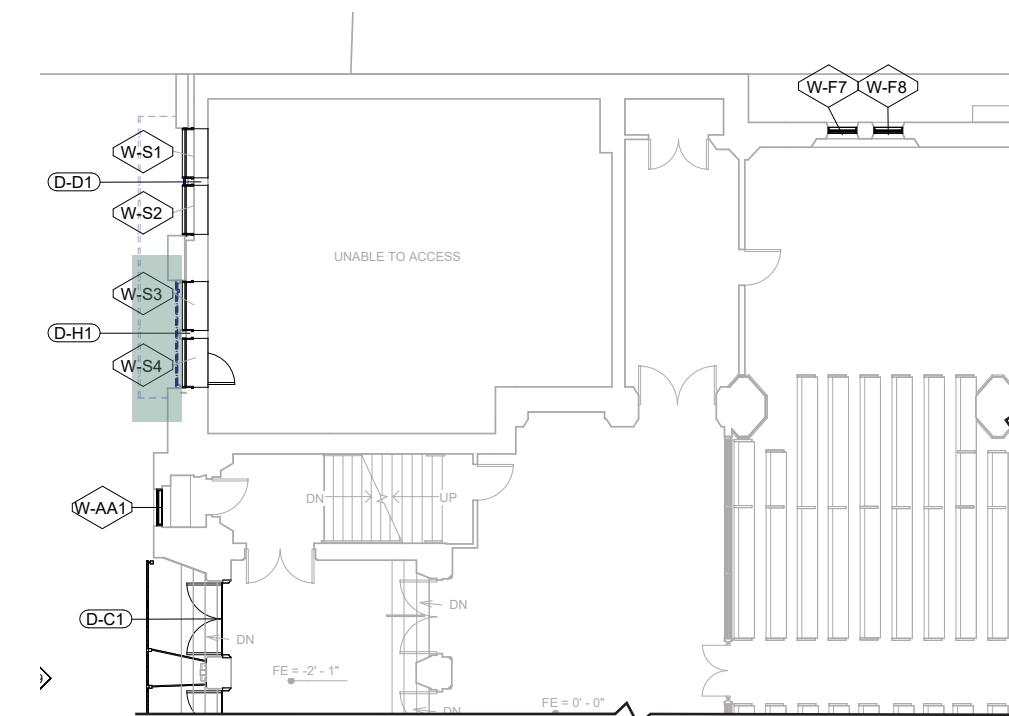
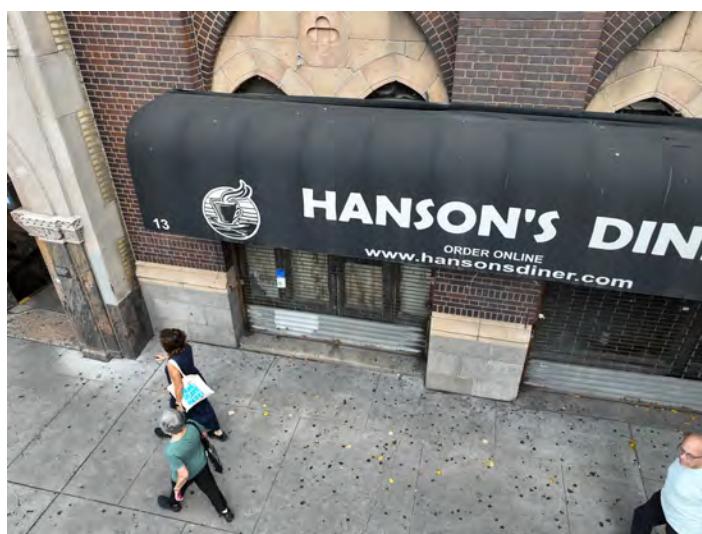
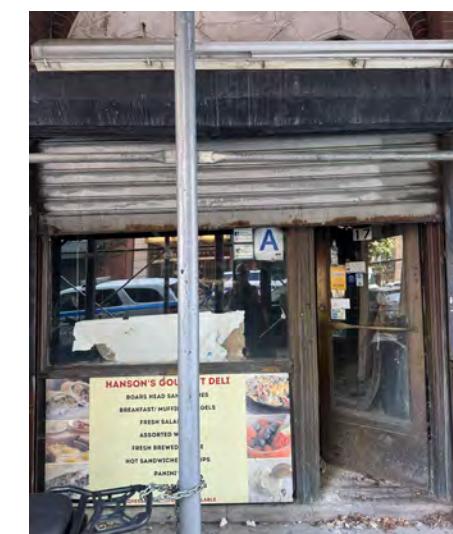
D-H1

SOUTH ELEVATION (PRIMARY FAÇADE)

FIRST FLOOR PLAN
