**Preservation Department – Item 5, LPC-26-03891**

**26-30 West 67th Street – Upper West Side/Central Park West  
Historic District – Borough of Manhattan**

# 30 West 67<sup>th</sup> Street

Landmarks Preservation Commission  
January 13, 2026

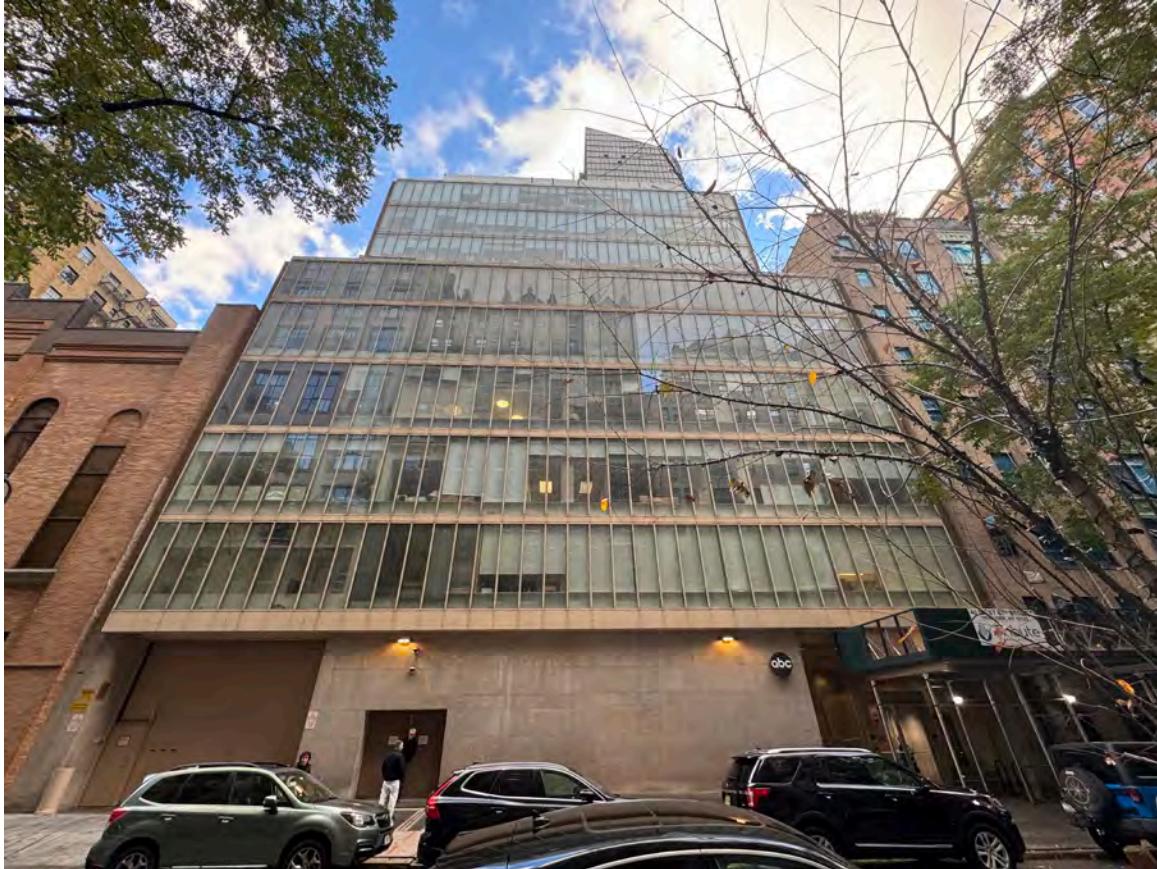
30 West 67<sup>th</sup> Street - Existing Condition

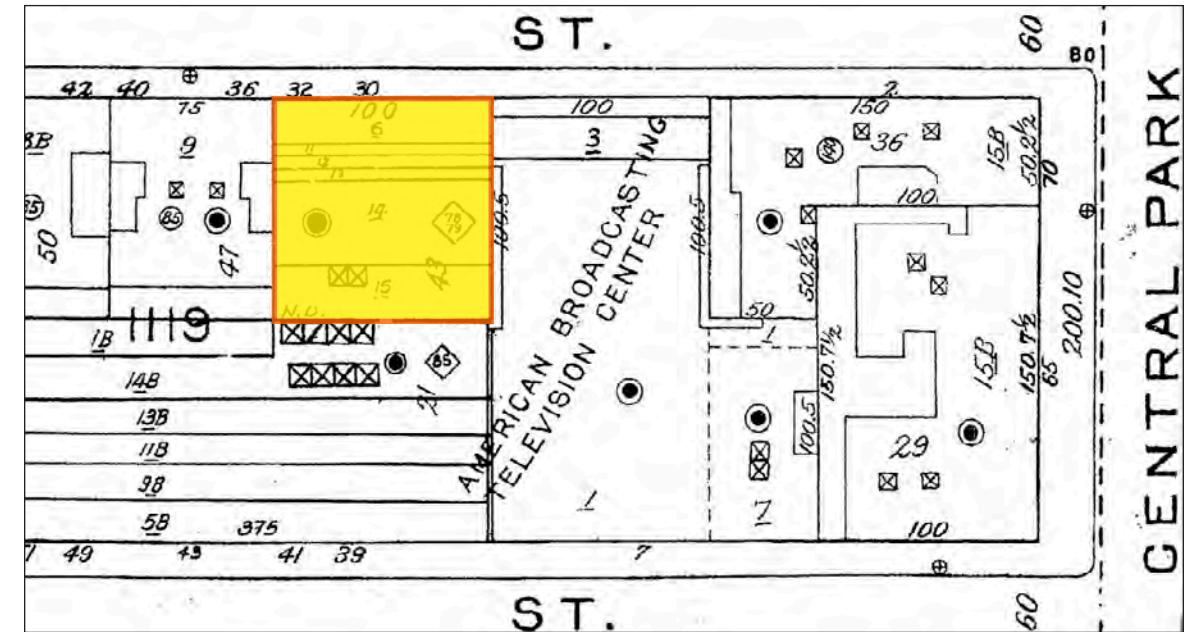
30 West 67<sup>th</sup> Street, located on West 67<sup>th</sup> Street between Central park West and Columbus Avenue

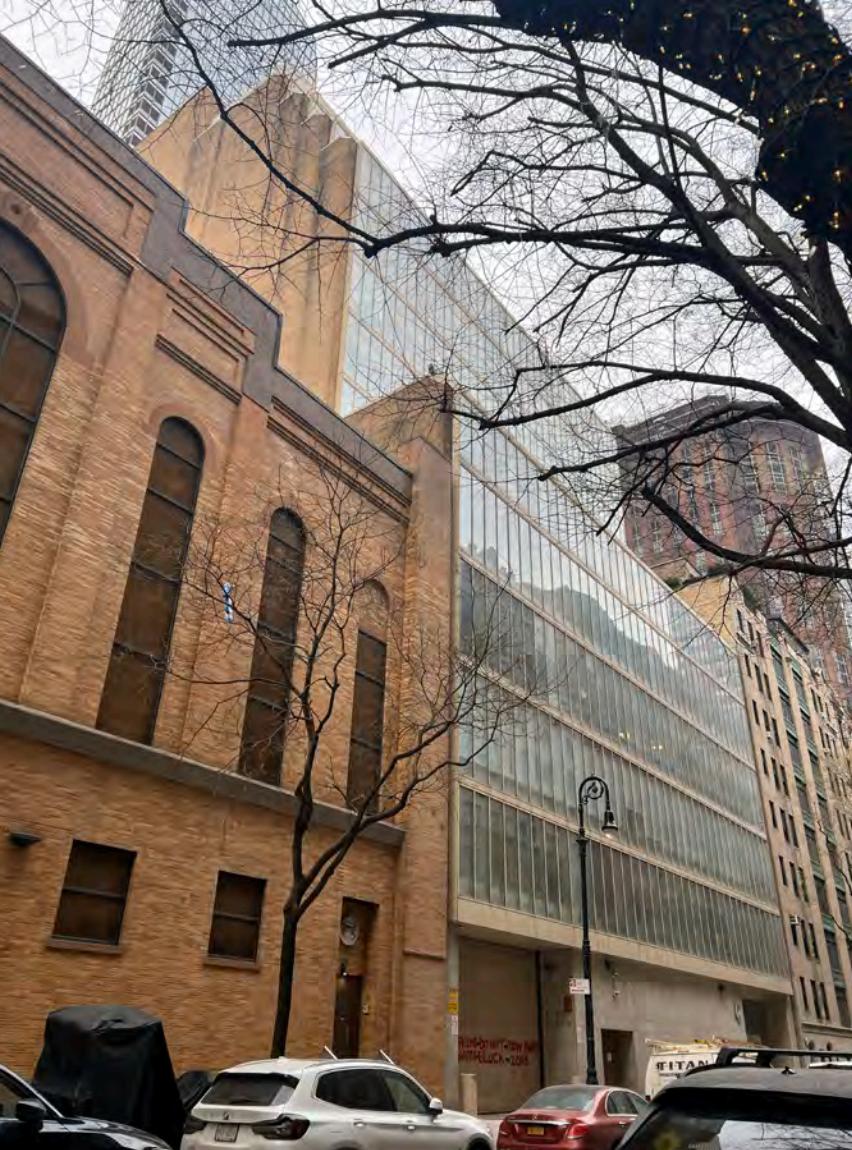
View of Building looking Southwest

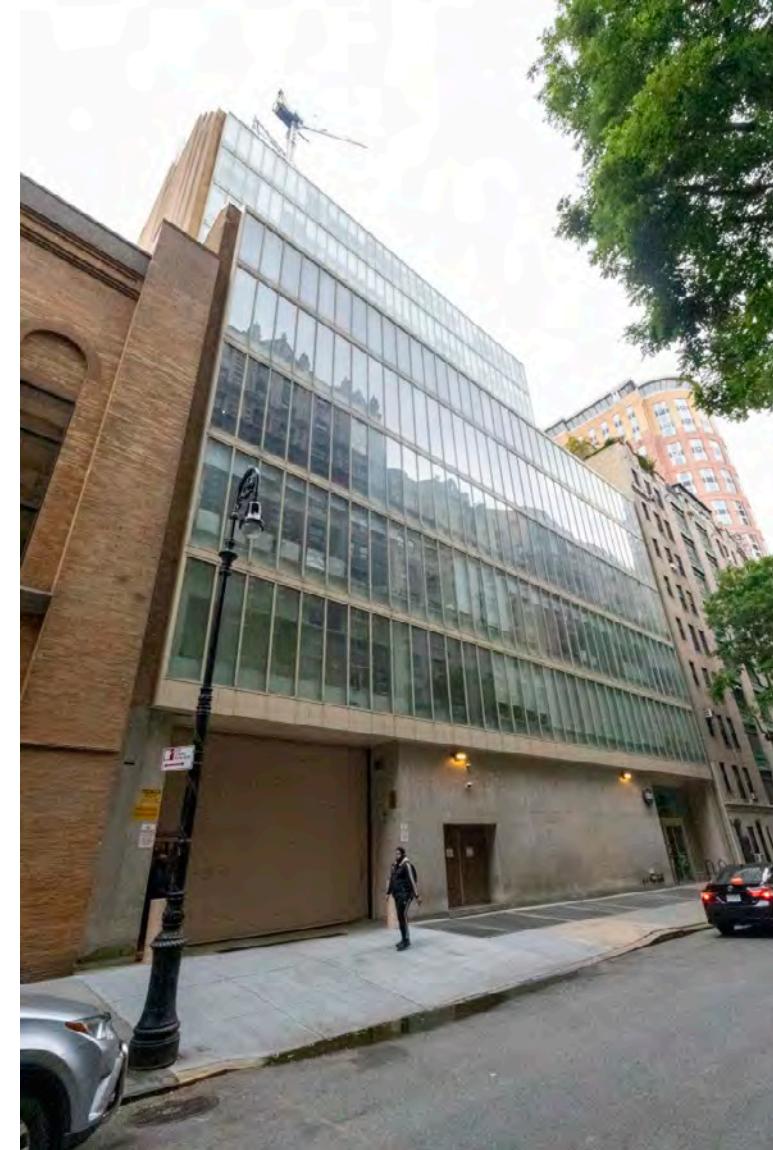
View of Building looking Southwest

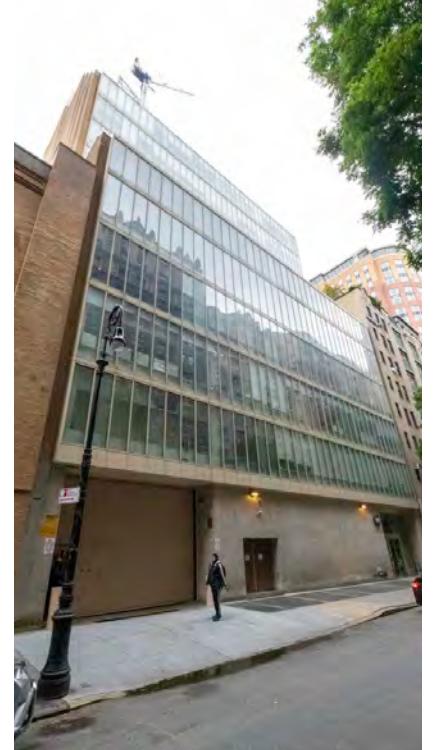
30 West 67<sup>th</sup> Street  
KPF, 1979  
Style: Modern

*Of the six purpose-built “office buildings” in the district, 30 West 67th Street is an outlier in terms of its age, style, massing and height.*

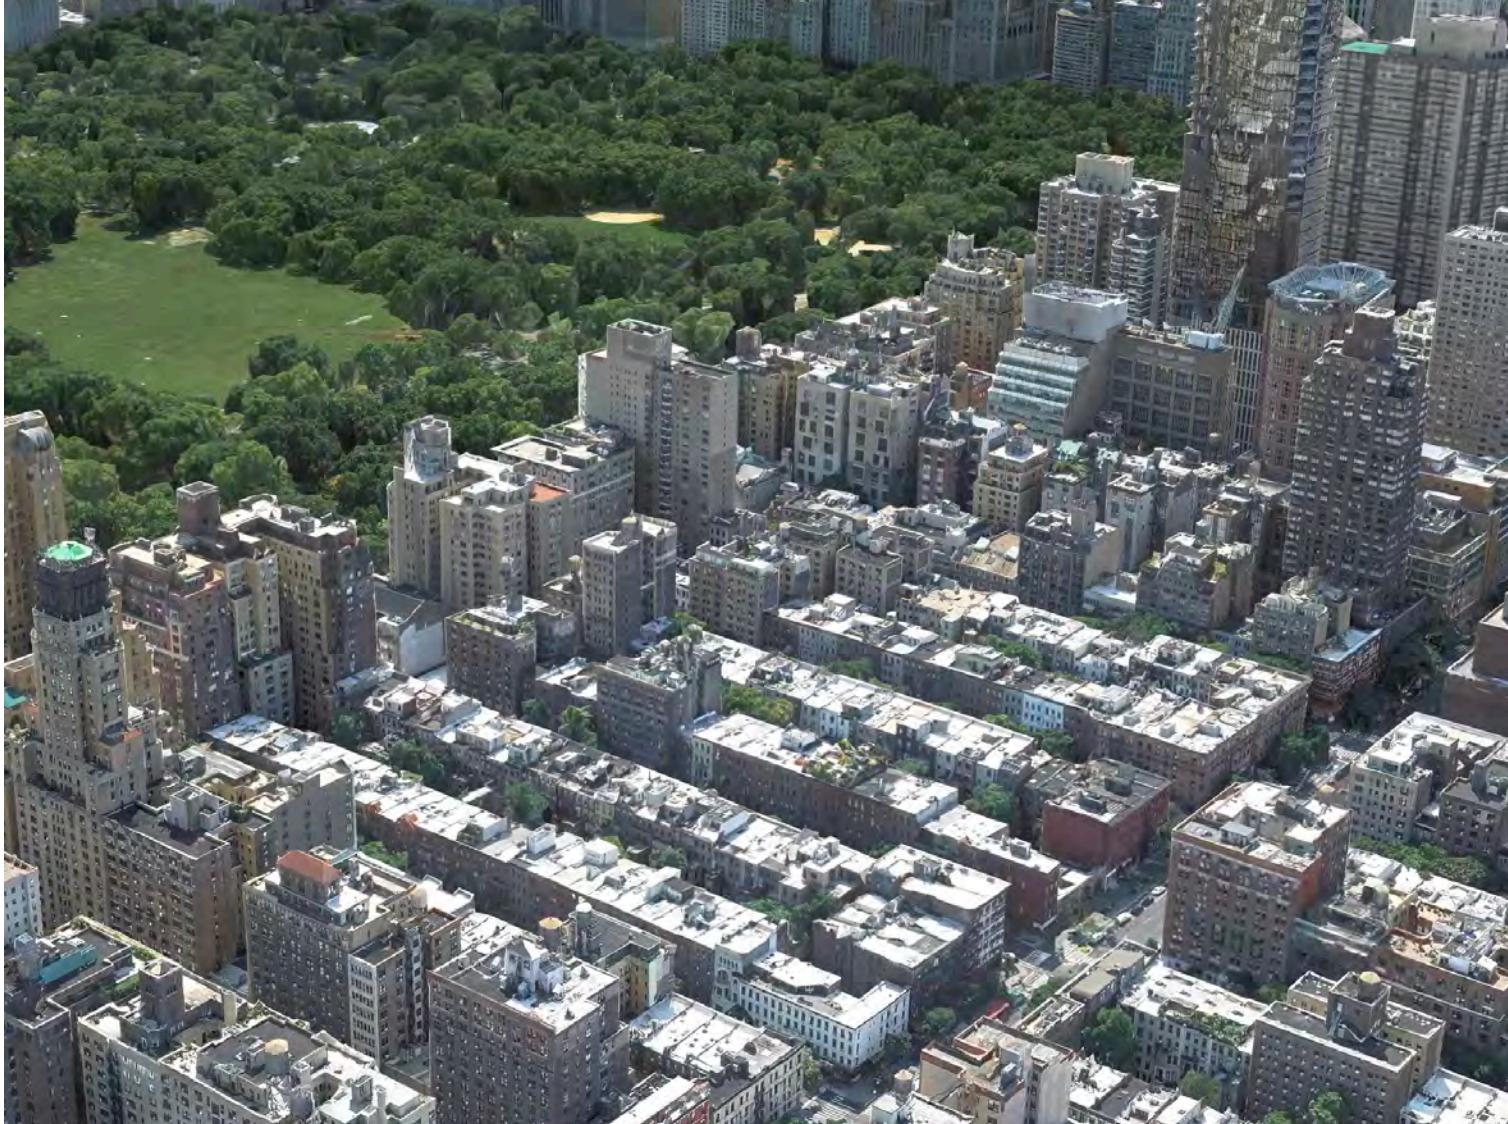
Aerial View

*The building contrasts significantly with the urban and architectural development of the historic district.*

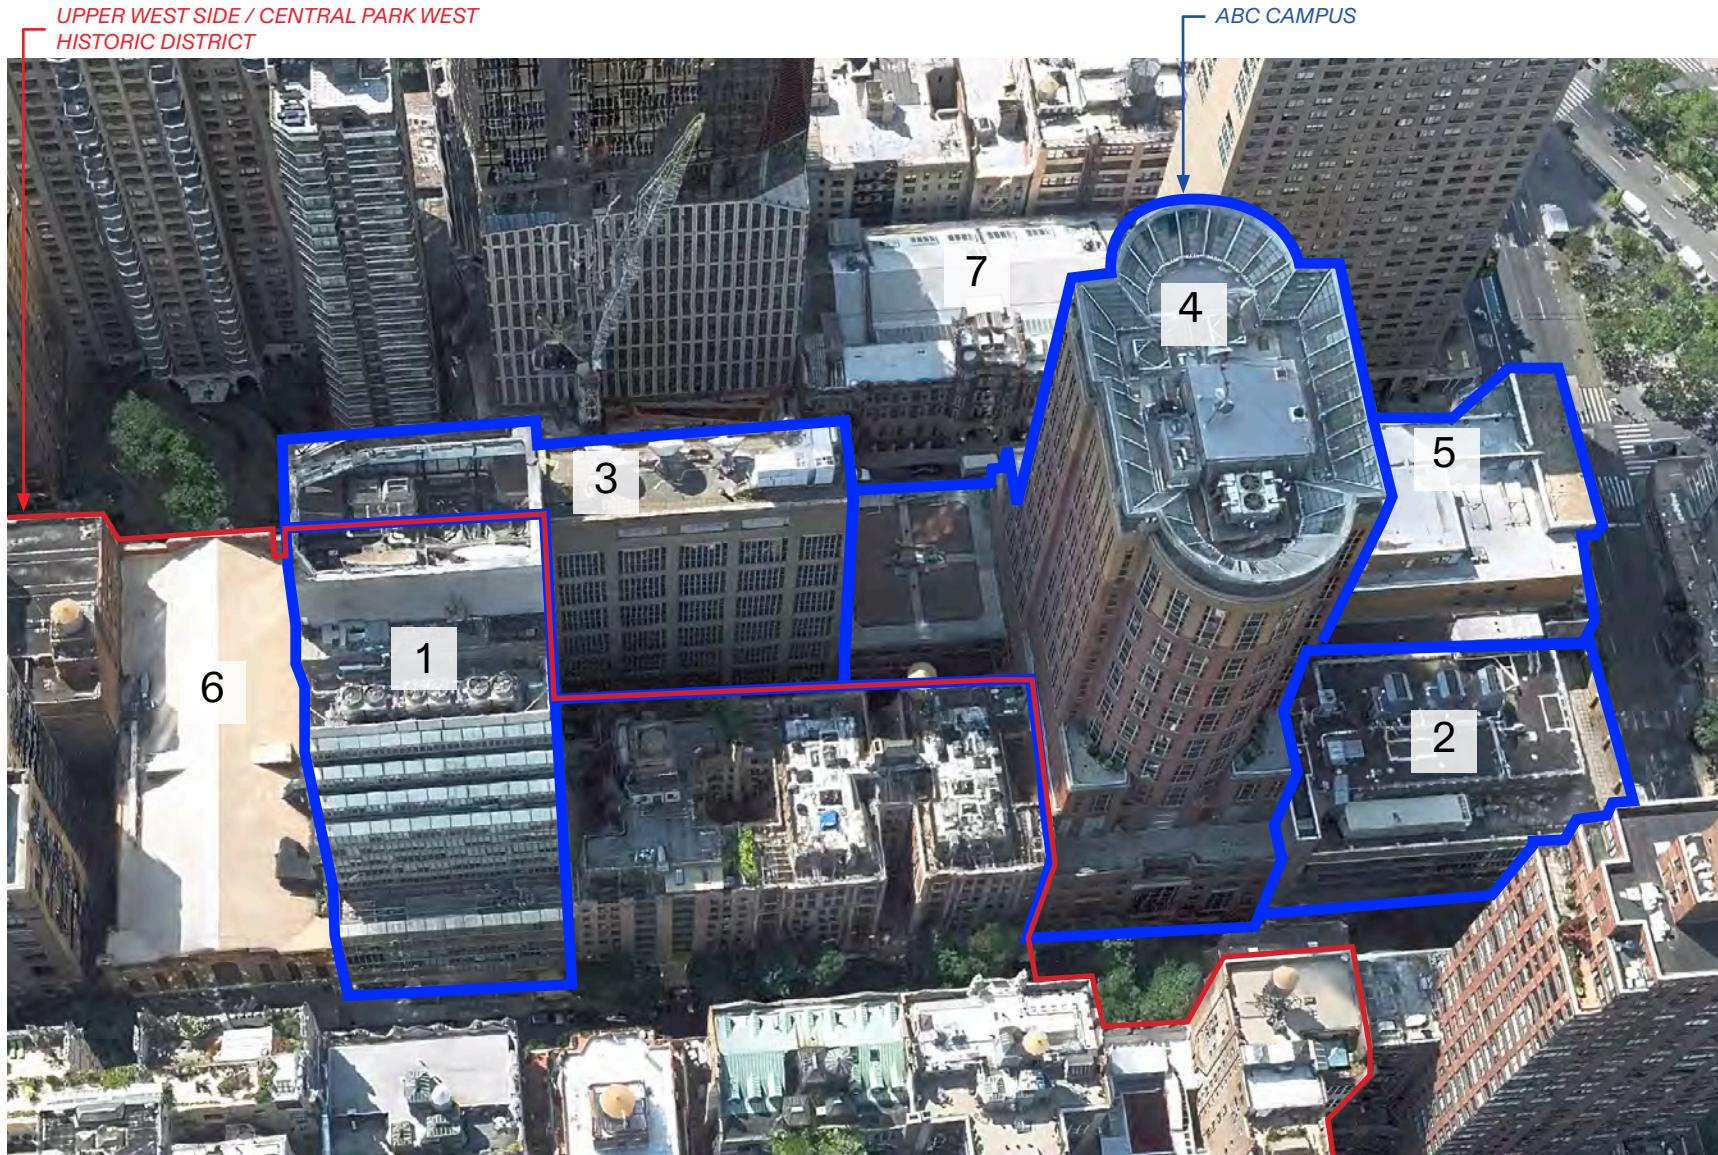
*The building is one component of a larger corporate campus, which includes five purpose-built office buildings.*

- 1 - 30 WEST 67TH STREET (1979)
- 2 - 7 LINCOLN SQUARE (1979)
- 3 - ABC PHASE II BUILDING - 47 WEST 66<sup>TH</sup> ST (1985)
- 4 - CAPITAL CITIES/ABC HQ - 77 WEST 66<sup>TH</sup> ST (1988)
- 5 - 147 COLUMBUS AVENUE (1991)

- 6 - DURLAND RIDING ACADEMY - 24 WEST 67<sup>TH</sup> ST (1901)
- 7 - FIRST BATTERY ARMORY - 56 WEST 66<sup>TH</sup> ST (1903)

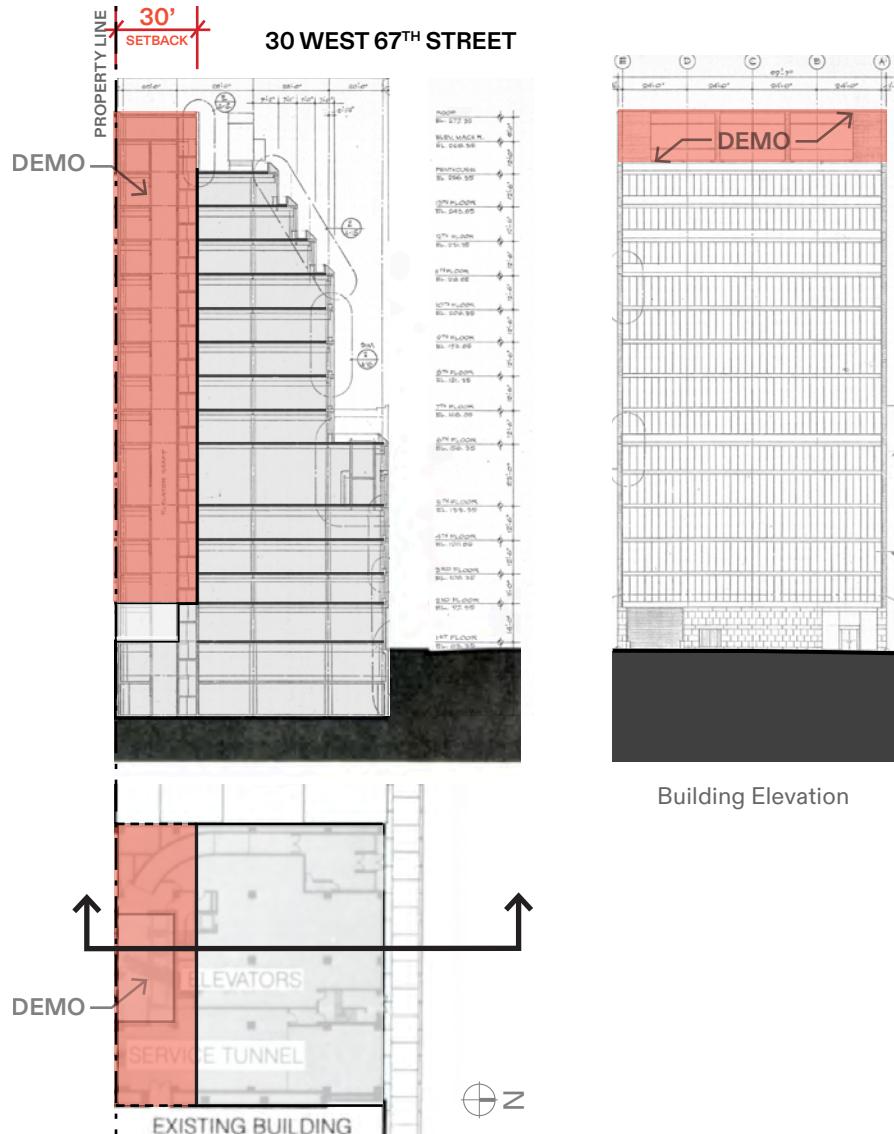
# #1

## REQUIRED MODIFICATIONS

1. DEMOLISH 30 FEET OF SOUTHERN PORTION OF BUILDING FOR REAR YARD SETBACK.

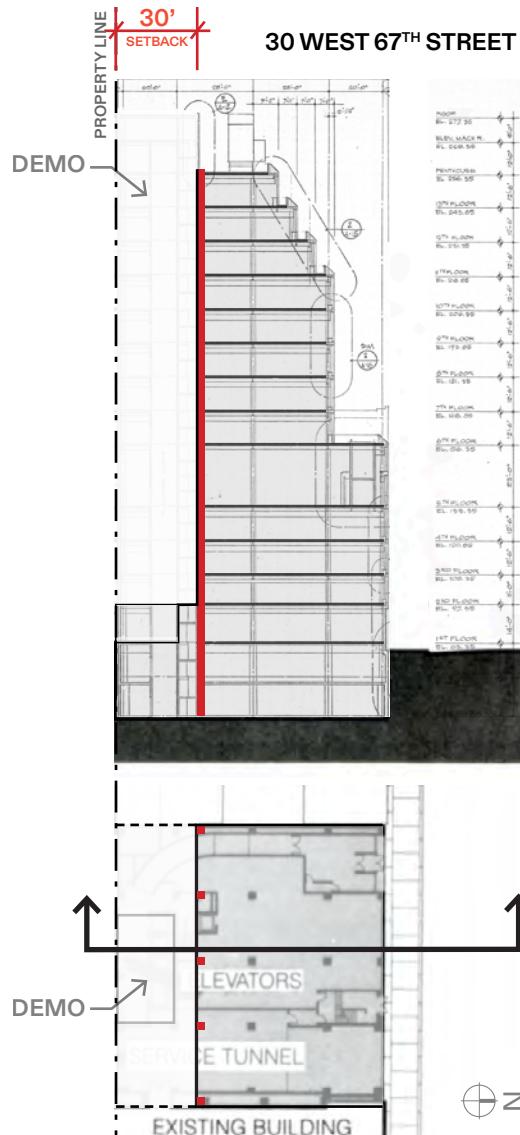
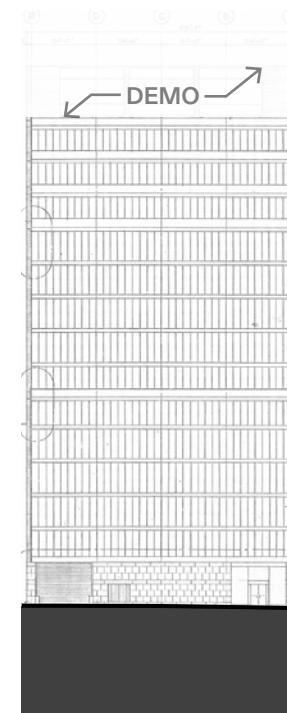
# #2

Building Section & Plan  
(Progressive Architecture, Jan 1988)

## REQUIRED MODIFICATIONS

1. DEMOLISH 30 FEET OF SOUTHERN PORTION OF BUILDING FOR REAR YARD SETBACK.
2. NEW STRUCTURAL COLUMNS AND NEW SOUTH FAÇADE.

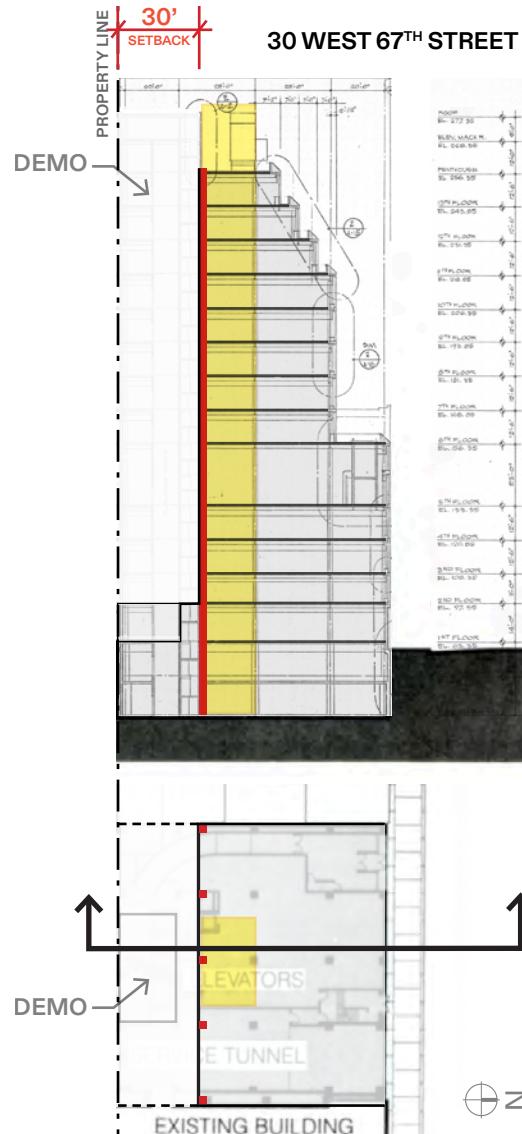
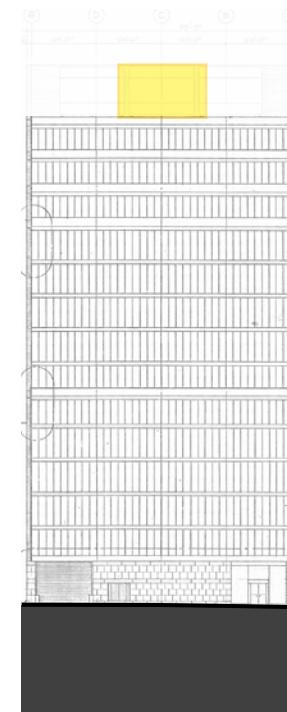
# #3

Building Section & Plan  
(Progressive Architecture, Jan 1988)

Building Elevation

## REQUIRED MODIFICATIONS

1. DEMOLISH 30 FEET OF SOUTHERN PORTION OF BUILDING FOR REAR YARD SETBACK.
2. NEW STRUCTURAL COLUMNS AND NEW SOUTH FAÇADE.
3. NEW CORE (VISIBLE AT BULKHEAD).
  - AFTER EXISTING CORE IS DEMOLISHED, INSTALL TEMPORARY LIFE SAFETY STAIR AND STANDPIPE, UNTIL NEW CORE IS BUILT.

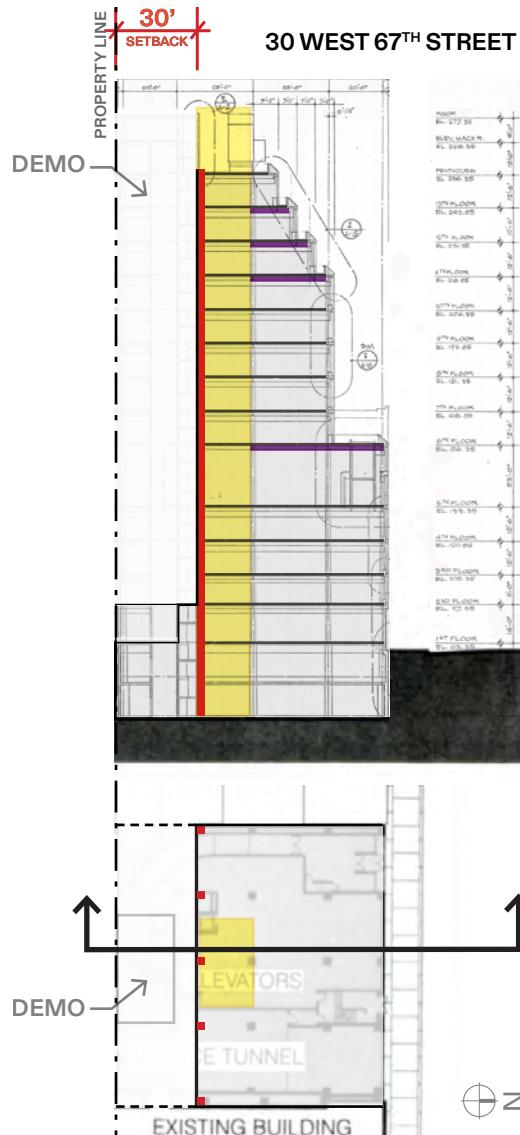
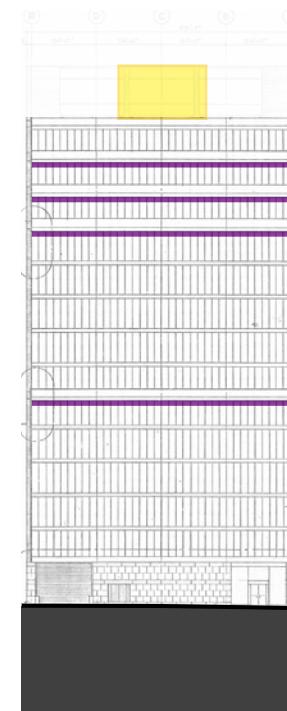
#4

## REQUIRED MODIFICATIONS

1. DEMOLISH 30 FEET OF SOUTHERN PORTION OF BUILDING FOR REAR YARD SETBACK.
2. NEW STRUCTURAL COLUMNS AND NEW SOUTH FAÇADE.
3. NEW CORE (VISIBLE AT BULKHEAD).
  - AFTER EXISTING CORE IS DEMOLISHED, INSTALL TEMPORARY LIFE SAFETY STAIR AND STANDPIPE, UNTIL NEW CORE IS BUILT.
4. PLUMBING TRANSFERS AT EACH MASSING SETBACK.

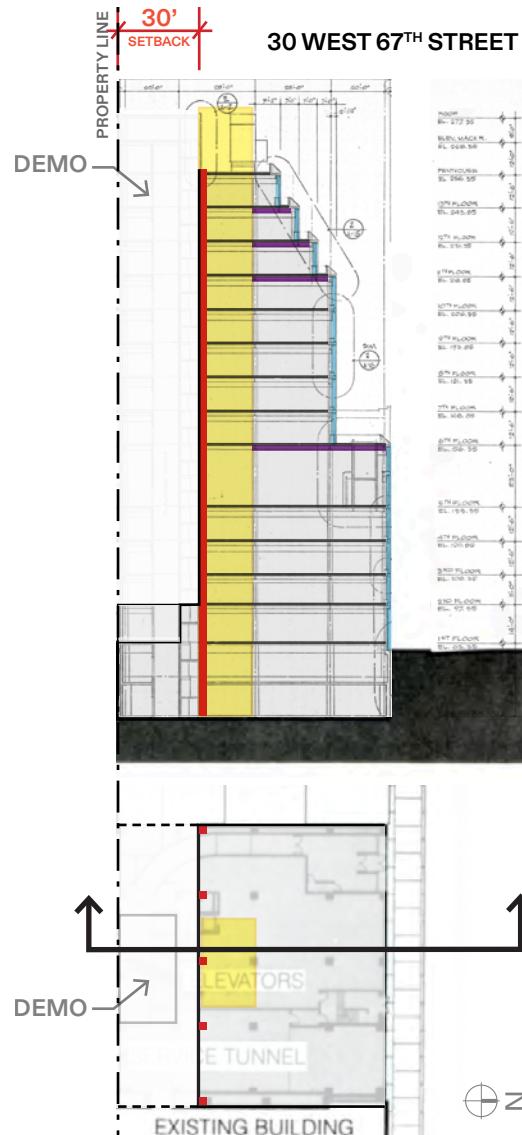
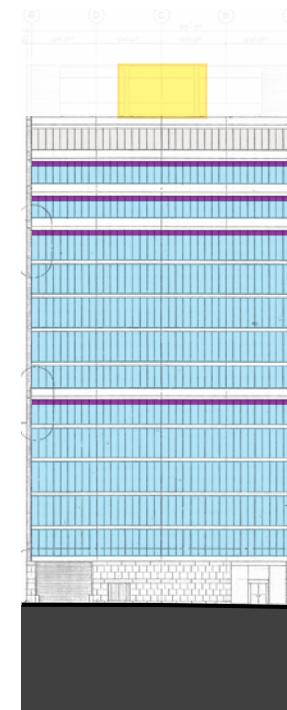
#5

Building Section & Plan  
(Progressive Architecture, Jan 1988)

## REQUIRED MODIFICATIONS

1. DEMOLISH 30 FEET OF SOUTHERN PORTION OF BUILDING FOR REAR YARD SETBACK.
2. NEW STRUCTURAL COLUMNS AND NEW SOUTH FAÇADE.
3. NEW CORE (VISIBLE AT BULKHEAD).
  - AFTER EXISTING CORE IS DEMOLISHED, INSTALL TEMPORARY LIFE SAFETY STAIR AND STANDPIPE, UNTIL NEW CORE IS BUILT.
4. PLUMBING TRANSFERS AT EACH MASSING SETBACK.
5. REPLACE NORTH FAÇADE TO PROVIDE OPERABLE WINDOWS AND BIRD-SAFE GLAZING.

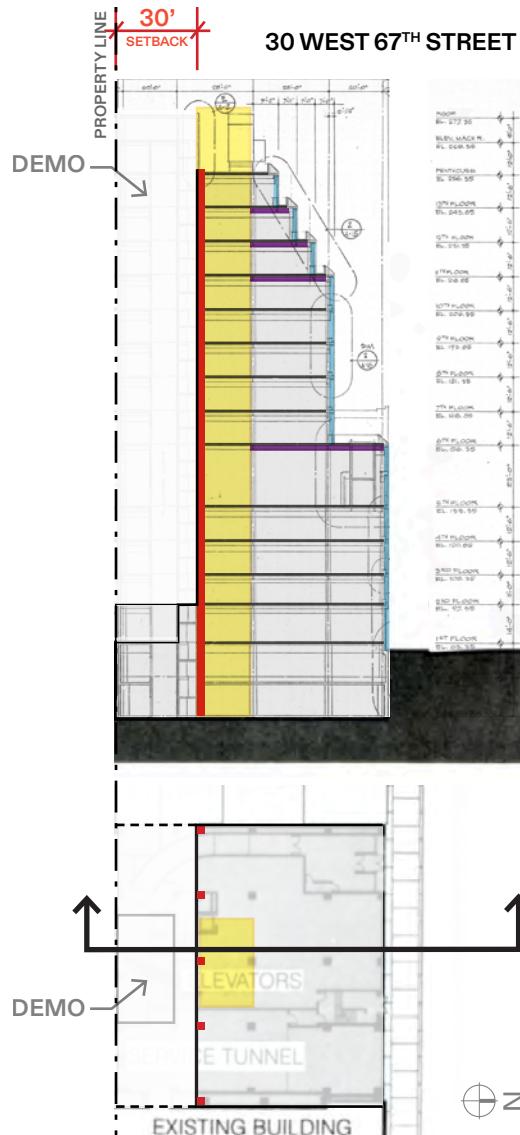
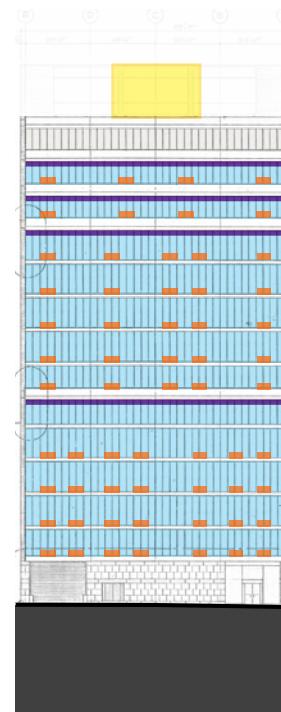
#6

Building Section & Plan  
(Progressive Architecture, Jan 1988)

## REQUIRED MODIFICATIONS

1. DEMOLISH 30 FEET OF SOUTHERN PORTION OF BUILDING FOR REAR YARD SETBACK.
2. NEW STRUCTURAL COLUMNS AND NEW SOUTH FAÇADE.
3. NEW CORE (VISIBLE AT BULKHEAD).
  - AFTER EXISTING CORE IS DEMOLISHED, INSTALL TEMPORARY LIFE SAFETY STAIR AND STANDPIPE, UNTIL NEW CORE IS BUILT.
4. PLUMBING TRANSFERS AT EACH MASSING SETBACK.
5. REPLACE NORTH FAÇADE TO PROVIDE OPERABLE WINDOWS AND BIRD-SAFE GLAZING.
6. ADD PTHP UNITS ON FAÇADE.

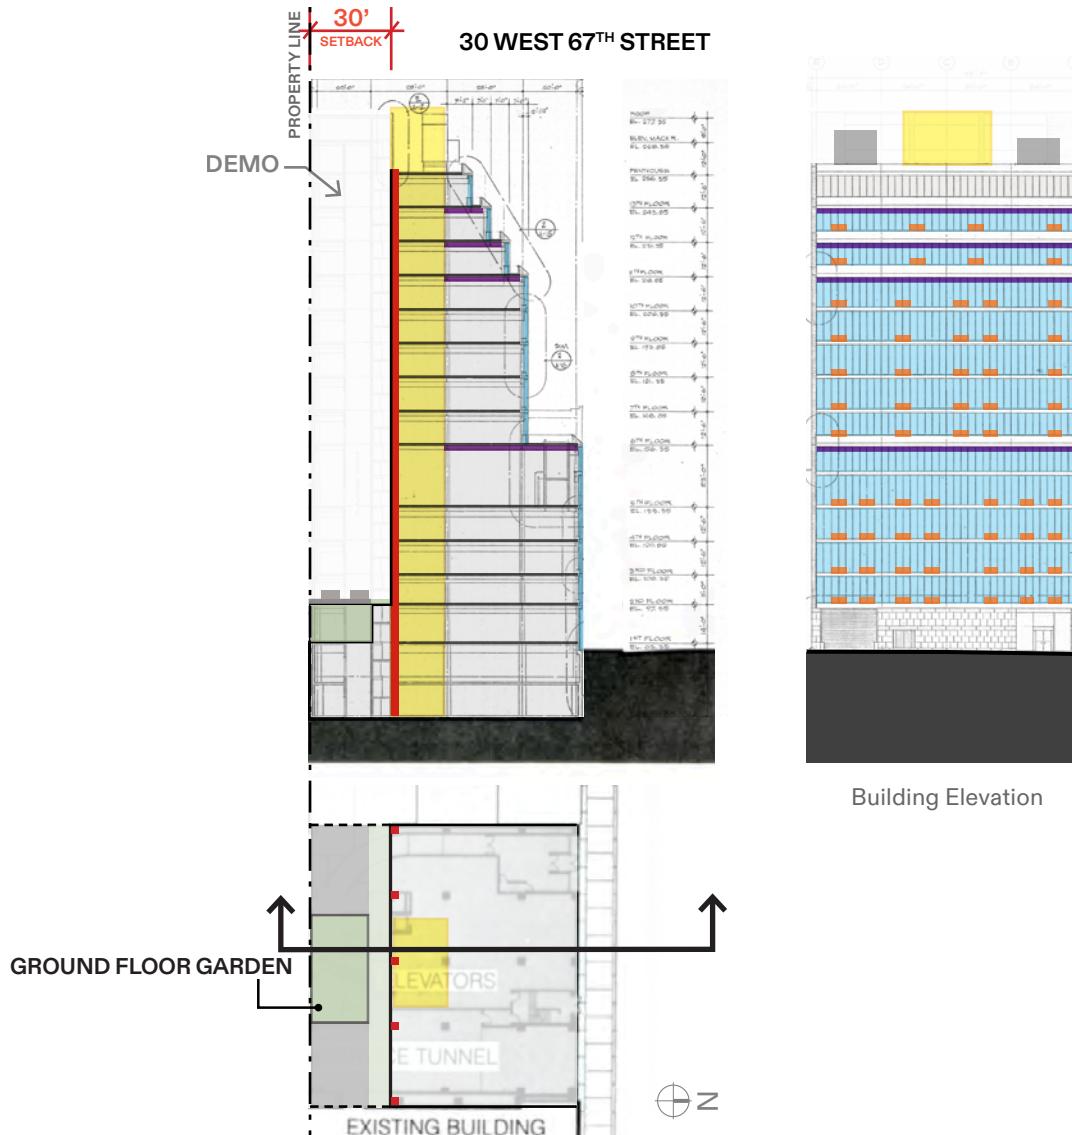
#7

## REQUIRED MODIFICATIONS

1. DEMOLISH 30 FEET OF SOUTHERN PORTION OF BUILDING FOR REAR YARD SETBACK.
2. NEW STRUCTURAL COLUMNS AND NEW SOUTH FAÇADE.
3. NEW CORE (VISIBLE AT BULKHEAD).
  - *AFTER EXISTING CORE IS DEMOLISHED, INSTALL TEMPORARY LIFE SAFETY STAIR AND STANDPIPE, UNTIL NEW CORE IS BUILT.*
4. PLUMBING TRANSFERS AT EACH MASSING SETBACK.
5. REPLACE NORTH FAÇADE TO PROVIDE OPERABLE WINDOWS AND BIRD-SAFE GLAZING.
6. ADD PTHP UNITS ON FAÇADE.
7. SHARED OUTDOOR AMENITIES ONLY AT GROUND FLOOR (DUE TO SECOND FLOOR AND ROOFTOP MEP)

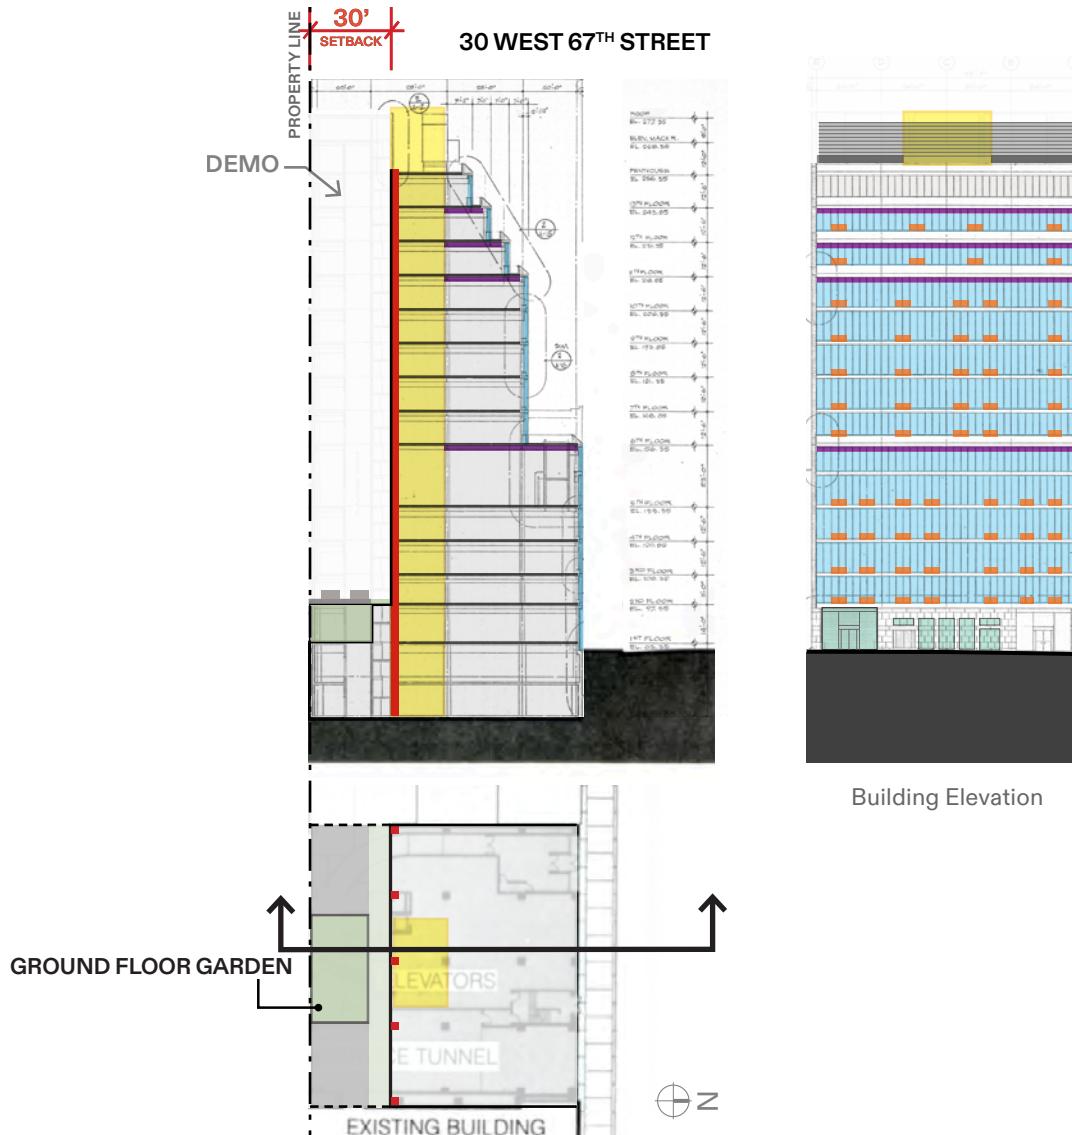
## REQUIRED MODIFICATIONS

1. DEMOLISH 30 FEET OF SOUTHERN PORTION OF BUILDING FOR REAR YARD SETBACK.
2. NEW STRUCTURAL COLUMNS AND NEW SOUTH FAÇADE.
3. NEW CORE (VISIBLE AT BULKHEAD).
  - *AFTER EXISTING CORE IS DEMOLISHED, INSTALL TEMPORARY LIFE SAFETY STAIR AND STANDPIPE, UNTIL NEW CORE IS BUILT.*
4. PLUMBING TRANSFERS AT EACH MASSING SETBACK.
5. REPLACE NORTH FAÇADE TO PROVIDE OPERABLE WINDOWS AND BIRD-SAFE GLAZING.
6. ADD PTHP UNITS ON FAÇADE.
7. SHARED OUTDOOR AMENITIES ONLY AT GROUND FLOOR (DUE TO SECOND FLOOR AND ROOFTOP MEP)
8. CONVERT GROUND FLOOR FAÇADE TO RESIDENTIAL.

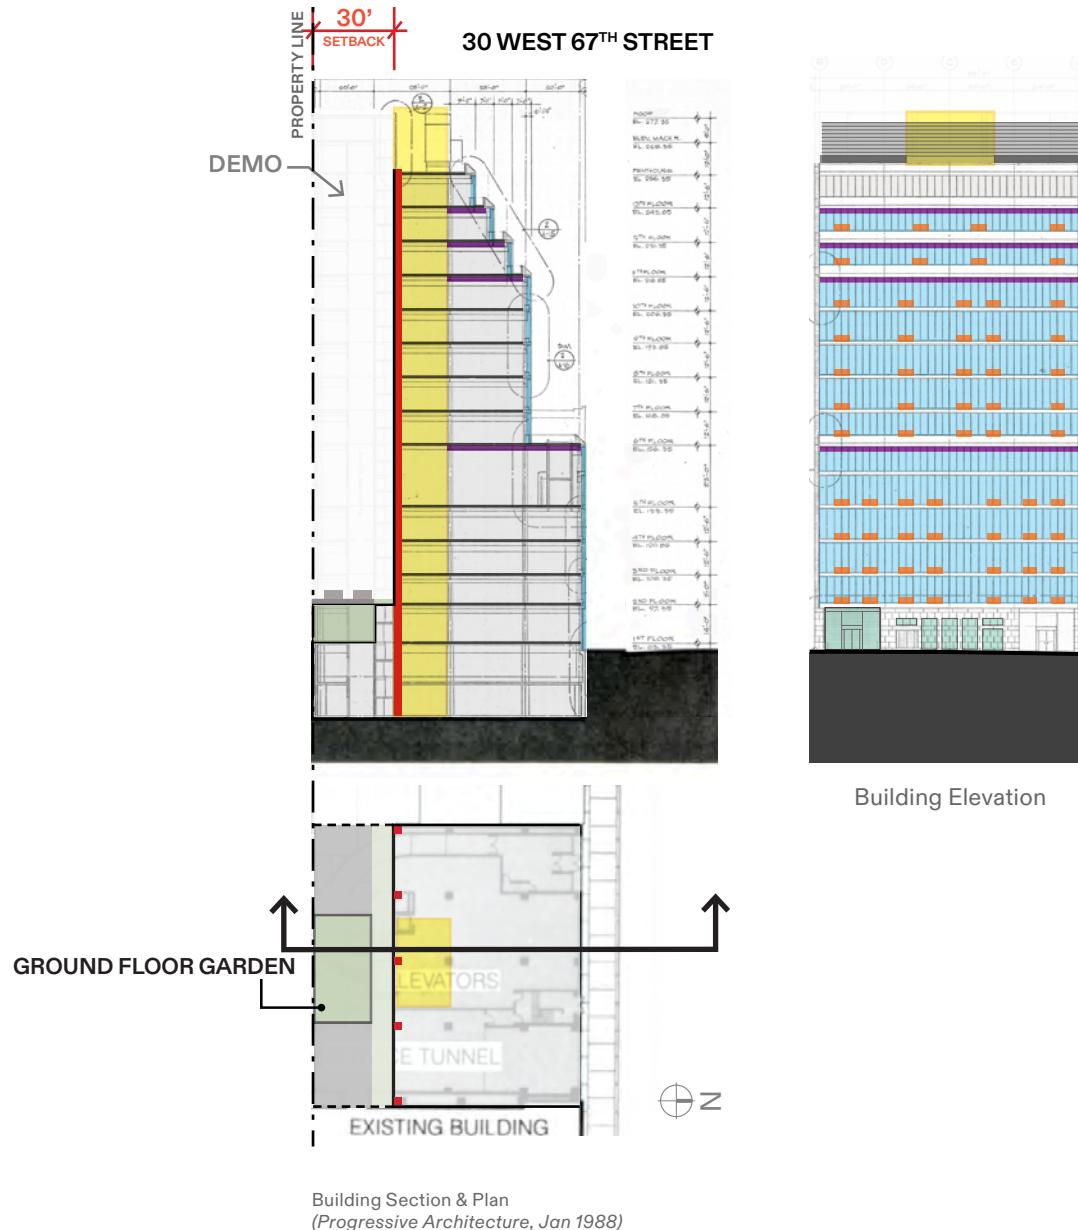
# Structural Challenges

## REQUIRED MODIFICATIONS

1. DEMOLISH 30 FEET OF SOUTHERN PORTION OF BUILDING FOR REAR YARD SETBACK.
2. NEW STRUCTURAL COLUMNS AND NEW SOUTH FAÇADE.
3. NEW CORE (VISIBLE AT BULKHEAD).
  - AFTER EXISTING CORE IS DEMOLISHED, INSTALL TEMPORARY LIFE SAFETY STAIR AND STANDPIPE, UNTIL NEW CORE IS BUILT.
4. PLUMBING TRANSFERS AT EACH MASSING SETBACK.
5. REPLACE NORTH FAÇADE TO PROVIDE OPERABLE WINDOWS AND BIRD-SAFE GLAZING.
6. ADD PTHP UNITS ON FAÇADE.
7. SHARED OUTDOOR AMENITIES ONLY AT GROUND FLOOR (DUE TO SECOND FLOOR AND ROOFTOP MEP)
8. CONVERT GROUND FLOOR FAÇADE TO RESIDENTIAL.

## ADDITIONAL STRUCTURAL CHALLENGES

1. TEMPORARY REPLACEMENT OF BUILDING'S LATERAL SYSTEM NECESSARY DURING CONSTRUCTION DUE TO REMOVAL OF SOUTH FAÇADE AND EXISTING CORE.
2. EXISTING FOUNDATION MAT SLAB WILL NOT BE ABLE TO SUPPORT LOCATION OF NEW PERMANENT CORE.
  - EXISTING STEEL REINFORCING IS CONCENTRATED AT CURRENT COLUMNS AND CORE LOCATION.
  - EXTENSIVE REINFORCING AND PARTIAL MAT REPLACEMENT WILL BE NECESSARY.
  - NEW ELEVATOR PITS REQUIRE EXTENDING BEYOND CURRENT FOUNDATION MAT (WILL REQUIRE DEWATERING DURING CONSTRUCTION AND RESTORING WATER-PROOFING MAT).

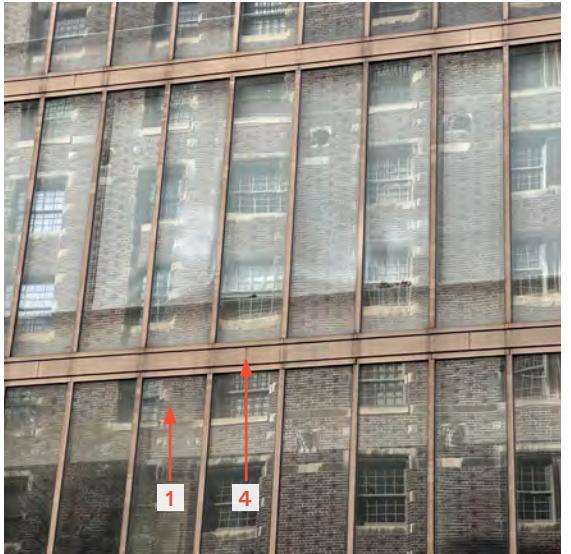
Existing window wall facade

1. The existing facade is a window wall system. This system is known to have relatively poor thermal performance and water resistance at the slab edge. Narrow slab edge covers were observed. Based on the position of the slab edge and slab edge cover, the insulation behind these covers appears limited.

1. The existing facade is a window wall system. This system is known to have relatively poor thermal performance and water resistance at the slab edge. Narrow slab edge covers were observed. Based on the position of the slab edge and slab edge cover, the insulation behind these covers appears limited.

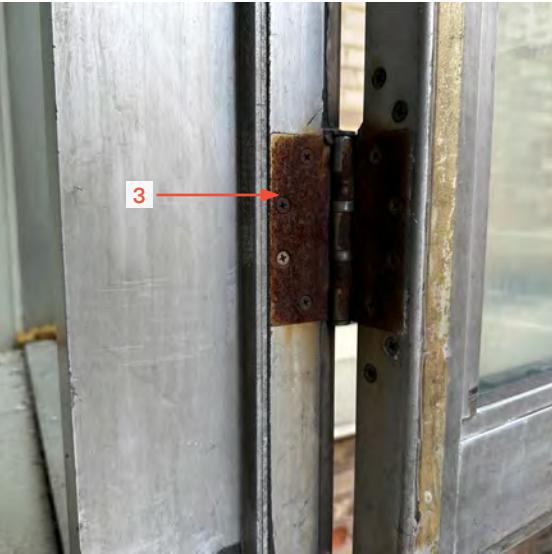
Non-thermally broken aluminum window

3. The IGUs are capture-glazed into non-thermally broken anodized aluminum mullions. On all floors observed, mullion surface temperatures were consistently around 40°F despite the interior space being heated, indicating thermal bridging to the exterior.

Non-thermally broken aluminum window

3. The IGUs are capture-glazed into non-thermally broken anodized aluminum mullions. On all floors observed, mullion surface temperatures were consistently around 40°F despite the interior space being heated, indicating thermal bridging to the exterior.

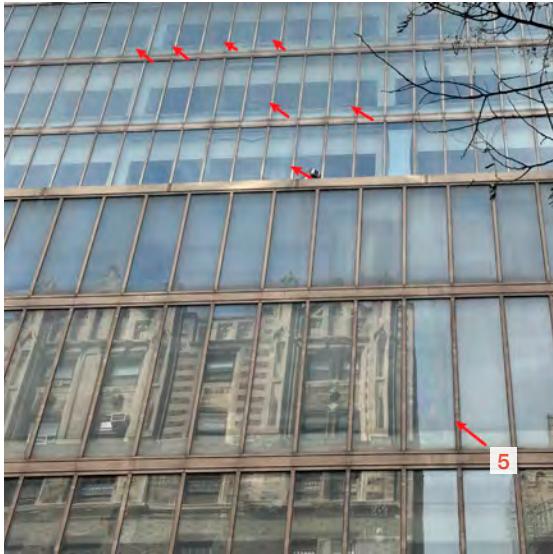
IGU failure

2. Based on field measurements taken with a laser glass thickness gauge, the existing vision glass appears to be double-pane insulating glass units (IGUs) without low-e coatings. Without low-e coating, the thermal performance of the glass is limited.

4. The facade also has minimal spandrel area, which further affects its overall thermal performance.
5. Multiple IGU failures with fogged cavities were noted on the north facade below the 6th floor. At the Level 6 terraces, more than half of the IGUs have failed.

1. Multiple IGU failures with fogged cavities were noted on the north facade below the 6th floor. At the Level 6 terraces, more than half of the IGUs have failed.
2. Repeated signs of condensation were observed on mullions, transoms, and on adjacent interior finishes, indicating poor thermal performance of the system.
3. In several areas, corrosion/pitting of the anodized aluminum was noted as a likely result of prolonged condensation; unlike painted finishes, the anodized layer is not easily repairable.
4. Localized bubbling was observed on some exterior pressure caps, indicating paint degradation and a lack of maintenance.
5. Gaskets also show significant aging, with softening and powdering observed in multiple locations. In some areas, gaskets intended to retain the glass are missing altogether.

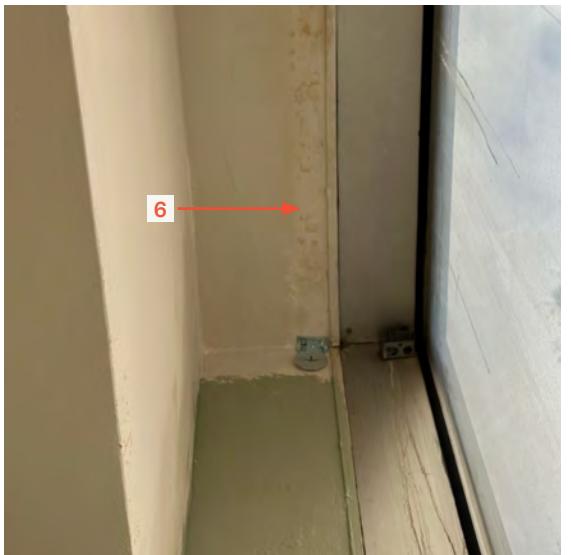
Condensation and interior finish damage

6. Repeated signs of condensation were observed on mullions, transoms, and on adjacent interior finishes, indicating poor thermal performance of the system.

7. In several areas, corrosion/pitting of the anodized aluminum was noted as a likely result of prolonged condensation; unlike painted finishes, the anodized layer is not easily repairable.

Condensation and interior finish damage

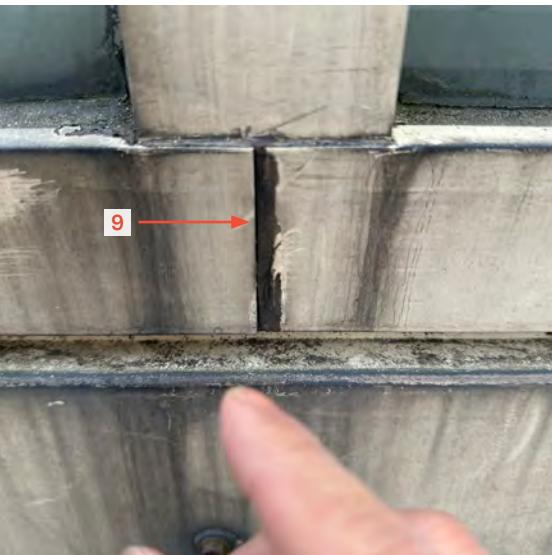
Degrading sealants and gaskets

8. Localized bubbling was observed on some exterior pressure caps, indicating paint degradation and a lack of maintenance.
9. Gaskets also show significant aging, with softening and powdering observed in multiple locations. In some areas, gaskets intended to retain the glass are missing altogether.

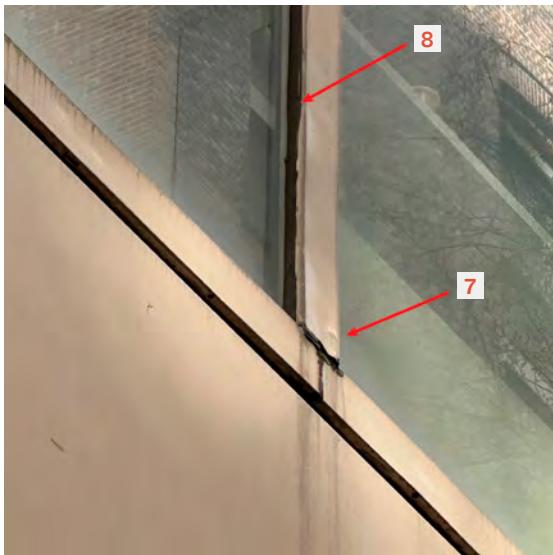
Degraded paint and sealant

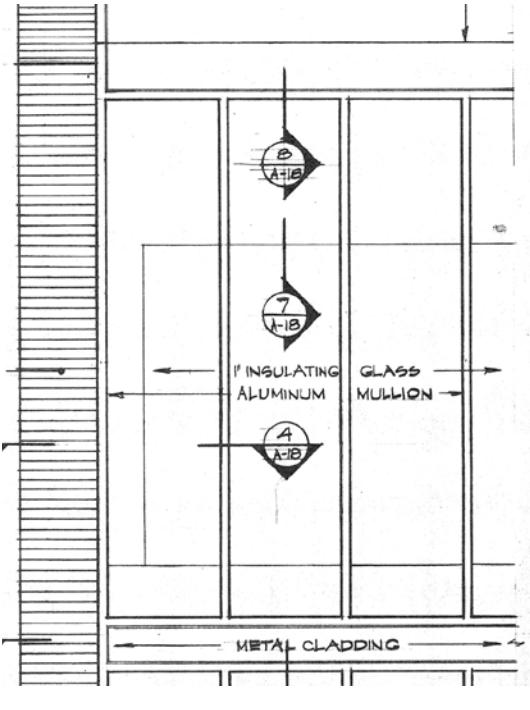
Elevation

# Adaptive Reuse Feasibility Study - Window Details

EXISTING WINDOW DETAILS

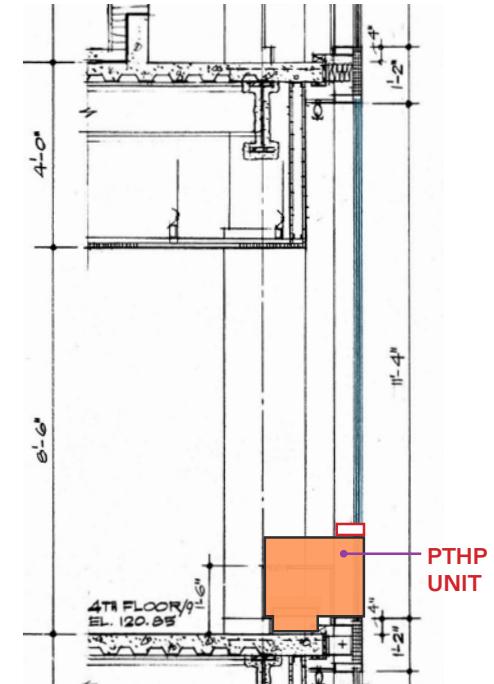
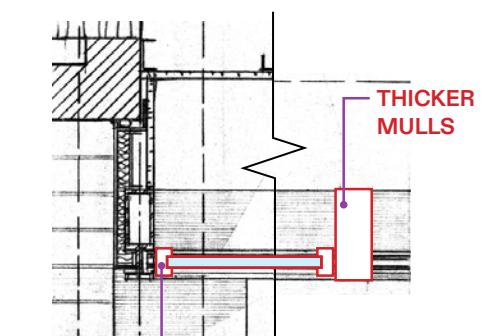
ADAPTED WINDOW DETAILS

Plan

Section

Detail

THICKER MULLS  
WIDER FRAMES FOR  
OPERABLE WINDOWS
