**Preservation Department – Item 5, LPC-26-03891**

**26-30 West 67th Street – Upper West Side/Central Park West  
Historic District – Borough of Manhattan**

# 30 West 67<sup>th</sup> Street

Landmarks Preservation Commission  
January 13, 2026

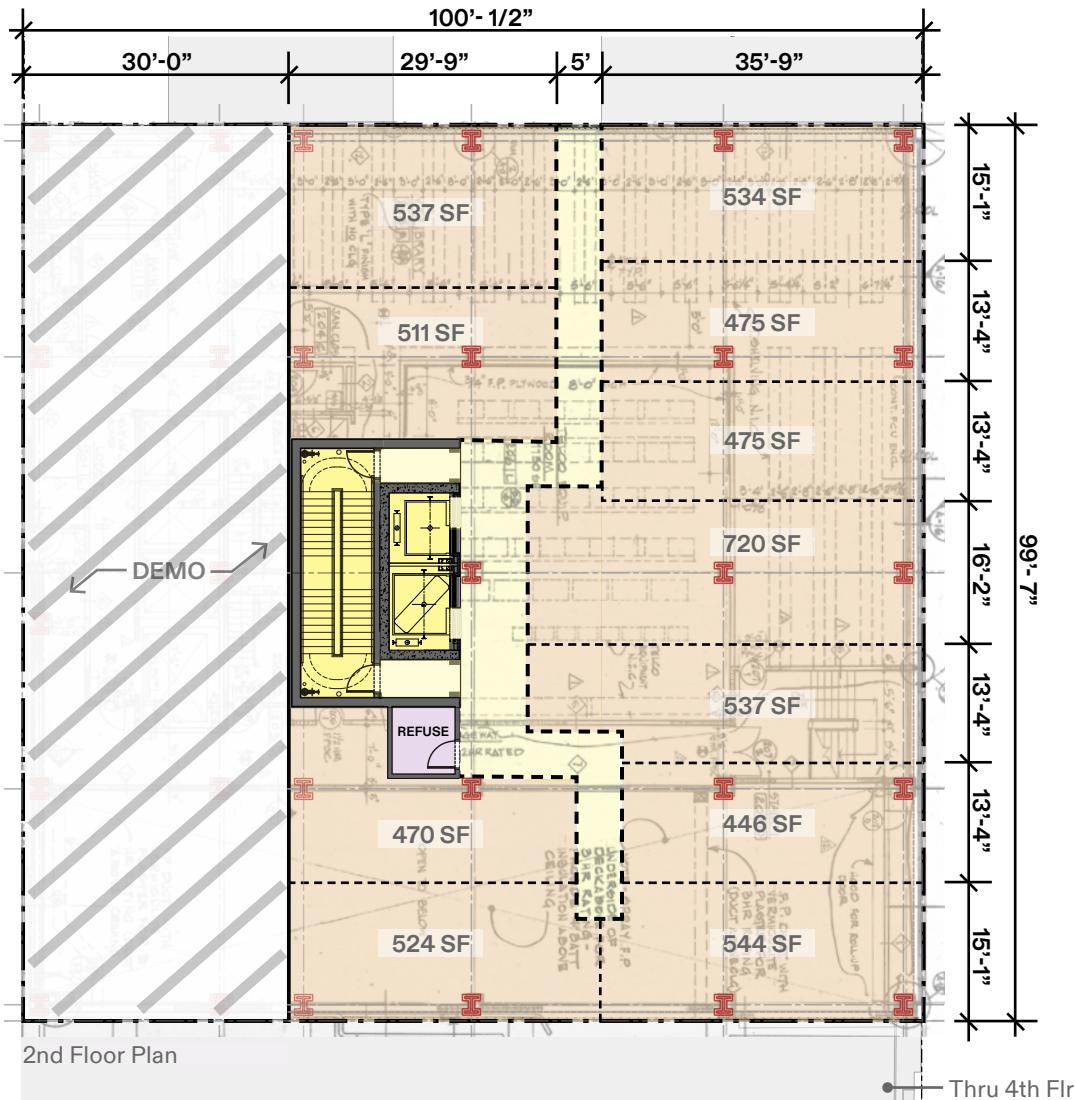
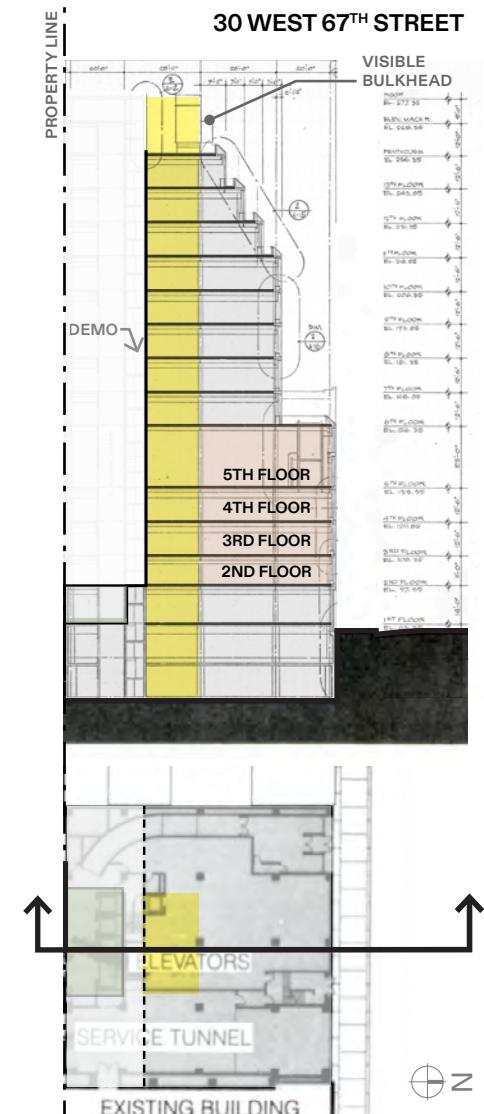
# Adaptive Reuse Feasibility Study - Typical (Levels 2-5)

## TYPICAL (LEVELS 2-5)

- GROSS AREA: 7,026 SF / FLR
- RENTABLE AREA: 5,784 SF / FLR
- EFFICIENCY: 82%
- UNITS: 11 / FLR
- TOTAL UNITS: 44

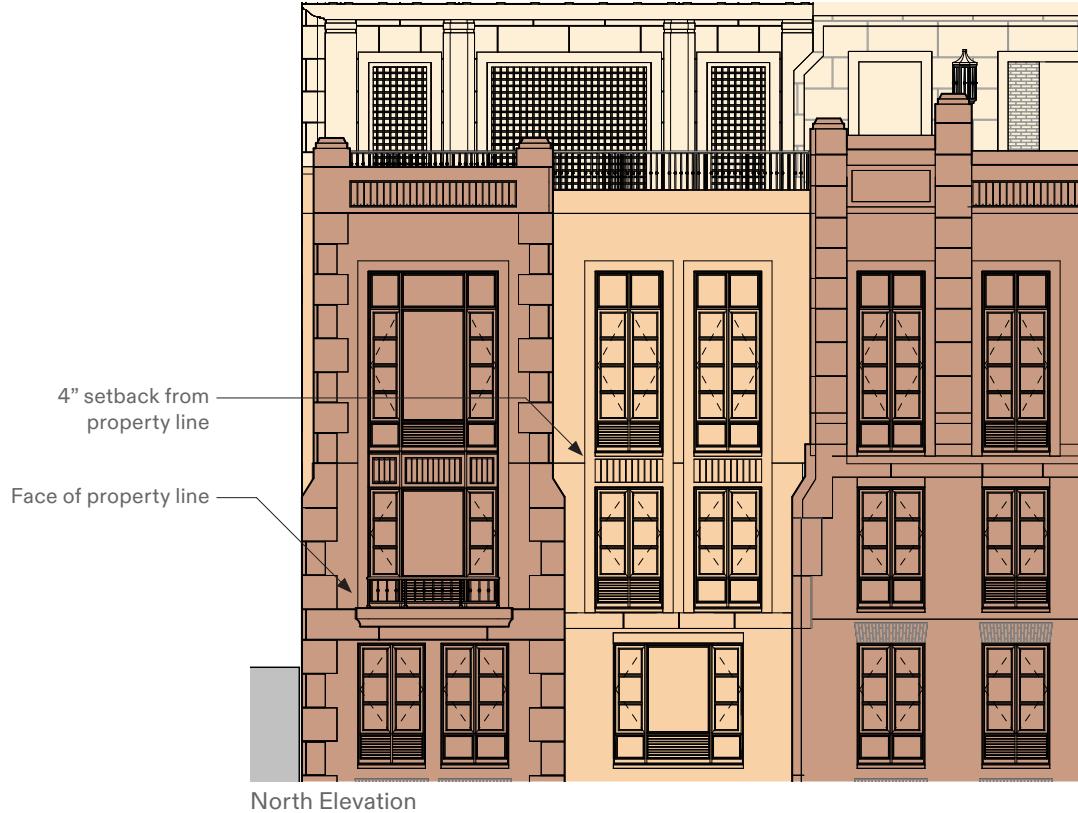
# Facade Setback

North Elevation

Level 8 Partial Plan

Level 6 Partial Plan

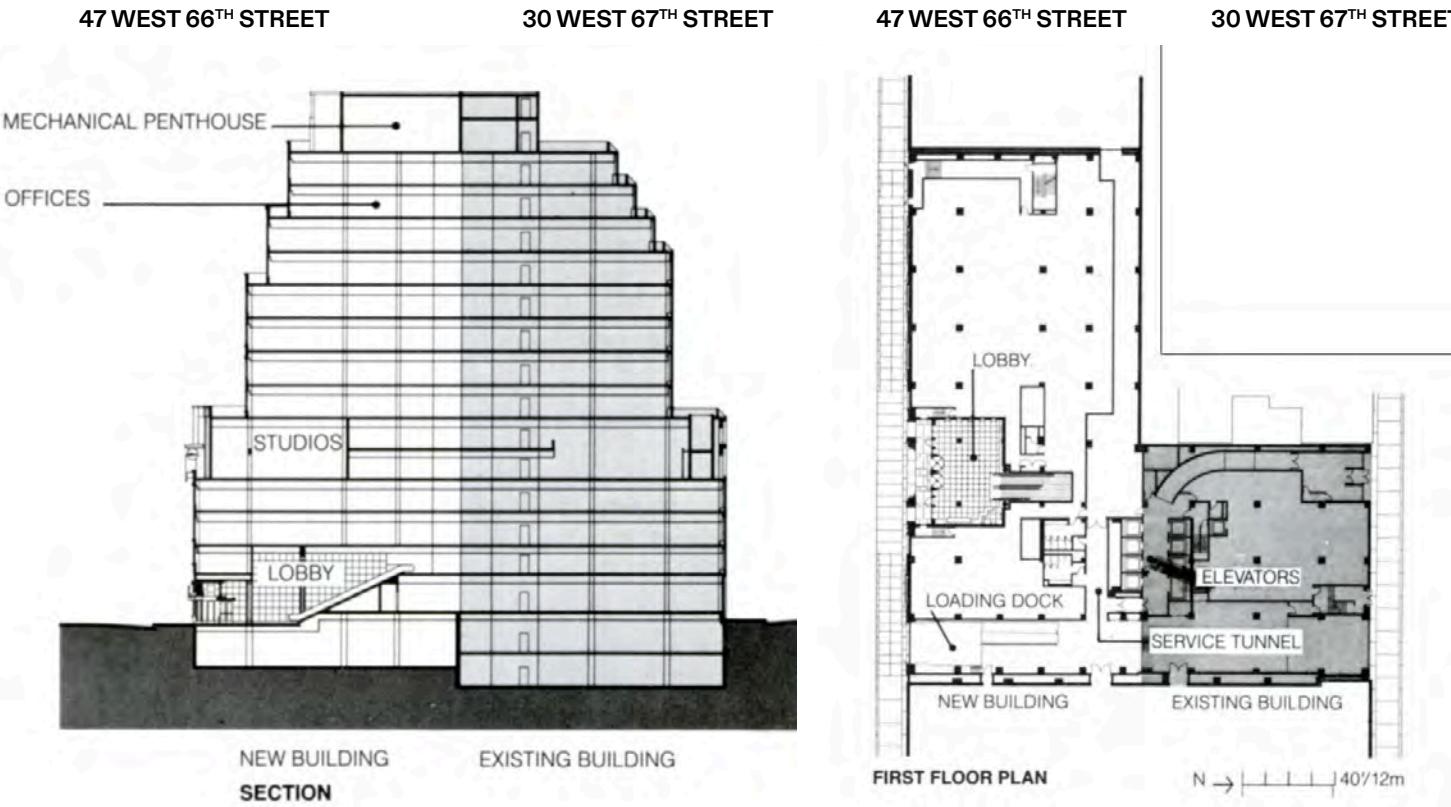
Building Section & Plan (Progressive Architecture, Jan 1988)

*The building was designed to be expanded, which it was in 1985. Functionally, it is half of one building.*

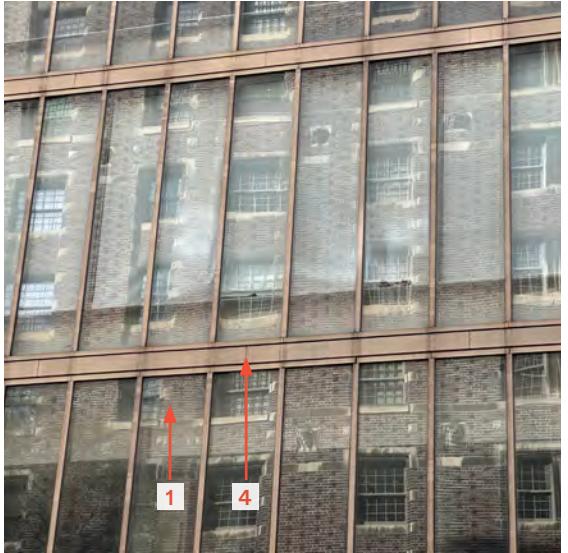
Existing window wall facade

1. The existing facade is a window wall system. This system is known to have relatively poor thermal performance and water resistance at the slab edge. Narrow slab edge covers were observed. Based on the position of the slab edge and slab edge cover, the insulation behind these covers appears limited.

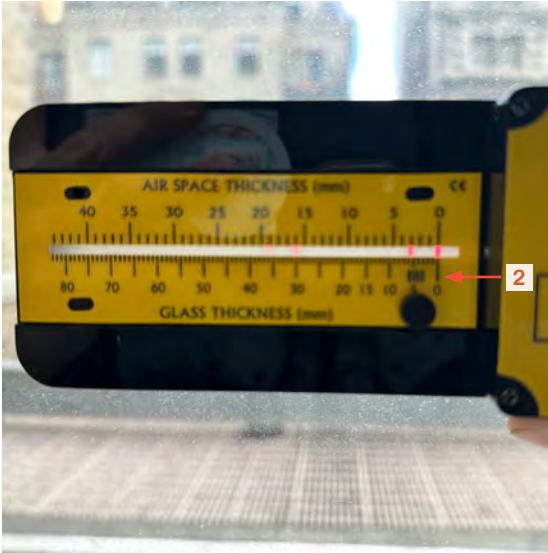
Measurement of existing IGU

1. Multiple IGU failures with fogged cavities were noted on the north facade below the 6th floor. At the Level 6 terraces, more than half of the IGUs have failed.
2. Repeated signs of condensation were observed on mullions, transoms, and on adjacent interior finishes, indicating poor thermal performance of the system.
3. In several areas, corrosion/pitting of the anodized aluminum was noted as a likely result of prolonged condensation; unlike painted finishes, the anodized layer is not easily repairable.
4. Localized bubbling was observed on some exterior pressure caps, indicating paint degradation and a lack of maintenance.
5. Gaskets also show significant aging, with softening and powdering observed in multiple locations. In some areas, gaskets intended to retain the glass are missing altogether.

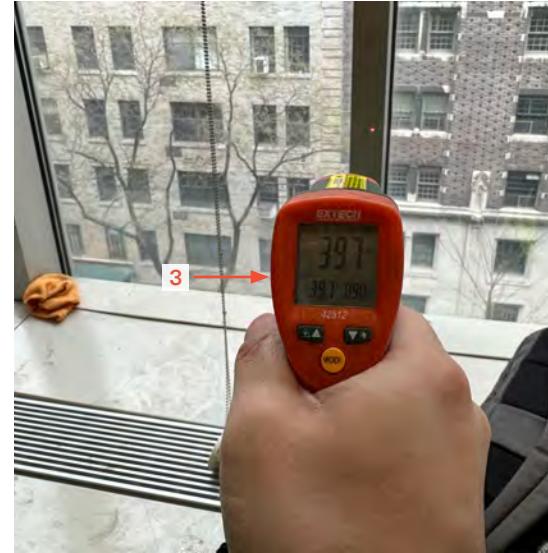
Temperature on mullion surface

3. The IGUs are capture-glazed into non-thermally broken anodized aluminum mullions. On all floors observed, mullion surface temperatures were consistently around 40°F despite the interior space being heated, indicating thermal bridging to the exterior.

3. The IGUs are capture-glazed into non-thermally broken anodized aluminum mullions. On all floors observed, mullion surface temperatures were consistently around 40°F despite the interior space being heated, indicating thermal bridging to the exterior.

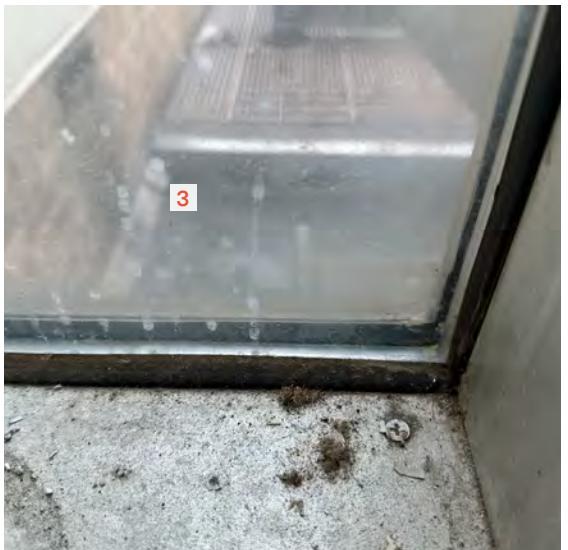
Existing IGU with foggy internal cavity

4. The facade also has minimal spandrel area, which further affects its overall thermal performance.
5. Multiple IGU failures with fogged cavities were noted on the north facade below the 6th floor. At the Level 6 terraces, more than half of the IGUs have failed.

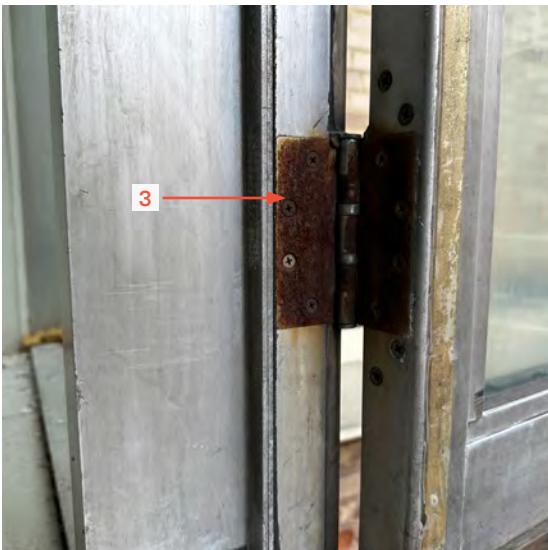
Non-thermally broken aluminum window

Non-thermally broken aluminum window

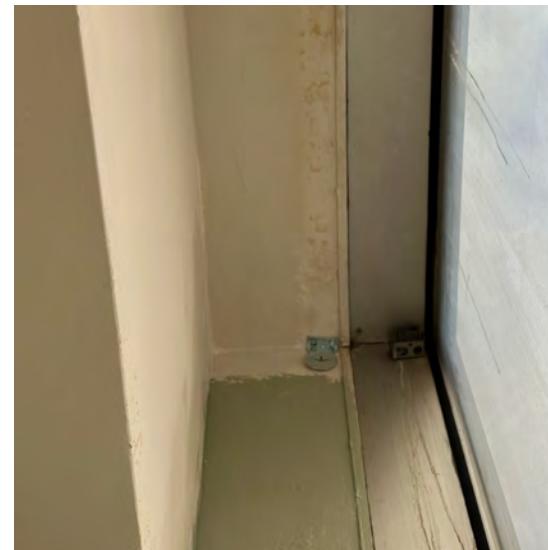
Condensation and interior finish damage

Condensation and interior finish damage

6. Repeated signs of condensation were observed on mullions, transoms, and on adjacent interior finishes, indicating poor thermal performance of the system.

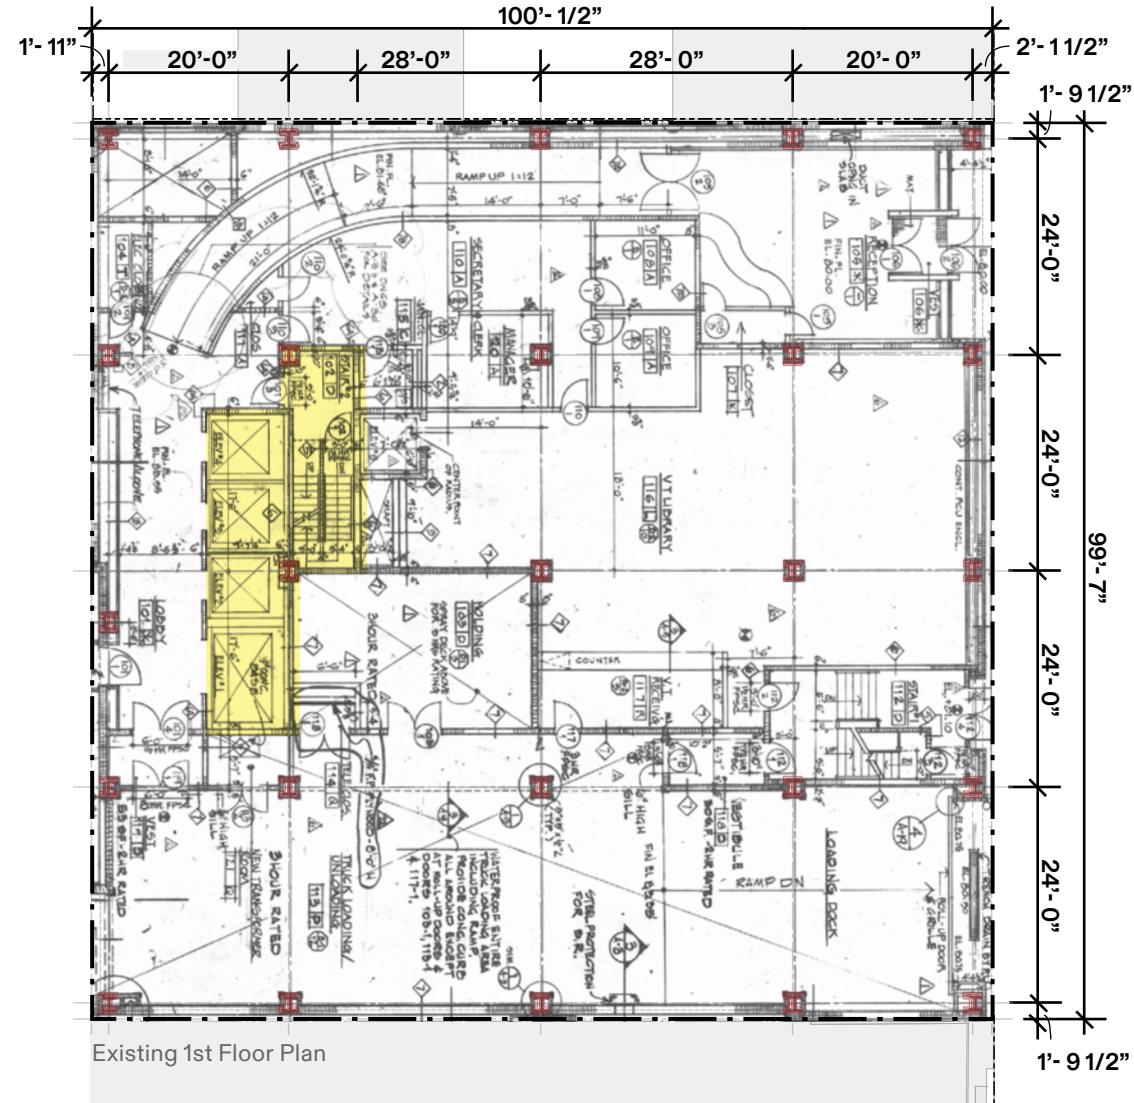
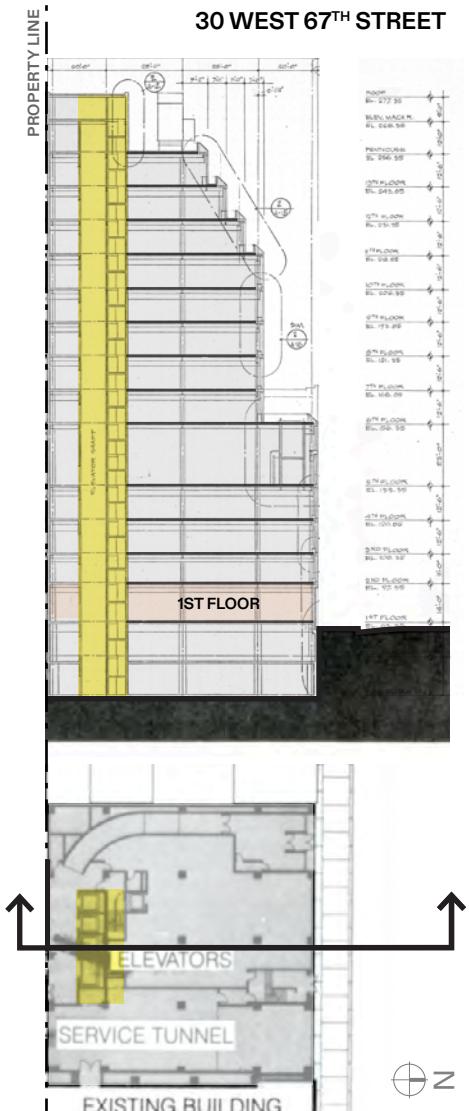
# Adaptive Reuse Feasibility Study

## EXISTING BUILDING

- KPF, 1979
- 13 FLOORS + CELLAR & MECH.
- FL-TO-FL HEIGHT:  
RANGE: 11'-0" - 23'-0"  
TYPICAL: 12'-6"

## LEVEL 1

- GROSS AREA: 9,760 SF

Building Section & Plan  
(Progressive Architecture, Jan 1988)

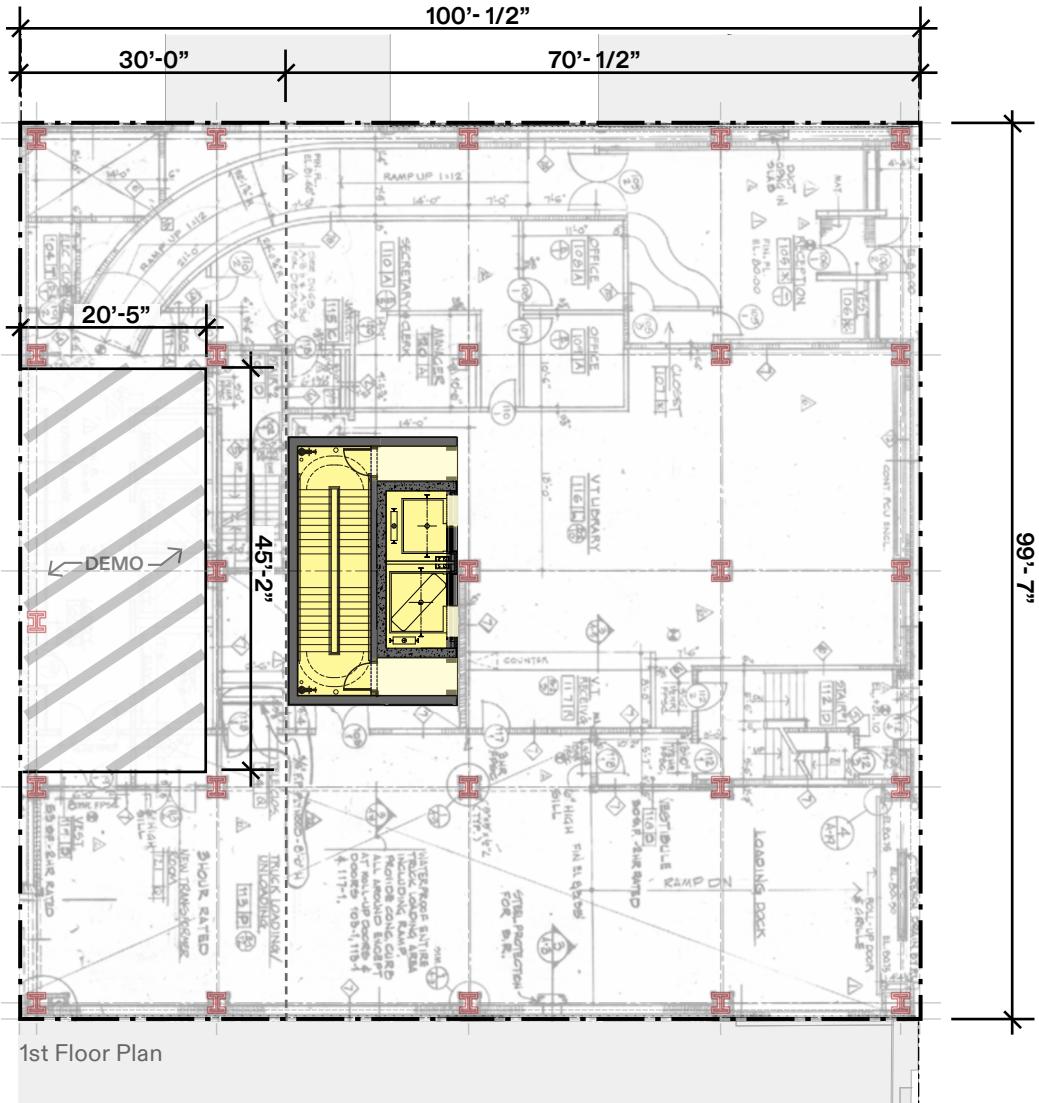
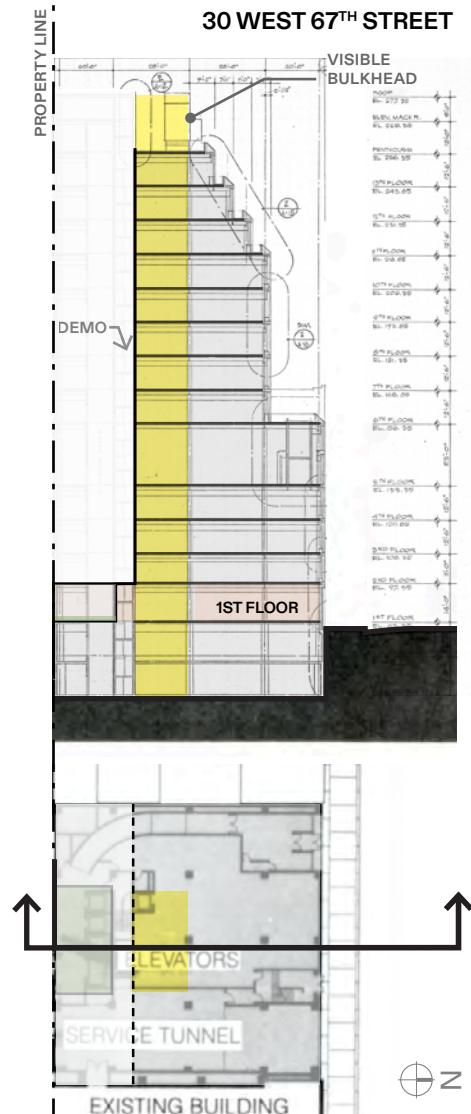
# Adaptive Reuse Feasibility Study

## LEVEL 1

- GROSS AREA: 8,838 SF

Building Section & Plan  
(Progressive Architecture, Jan 1988)

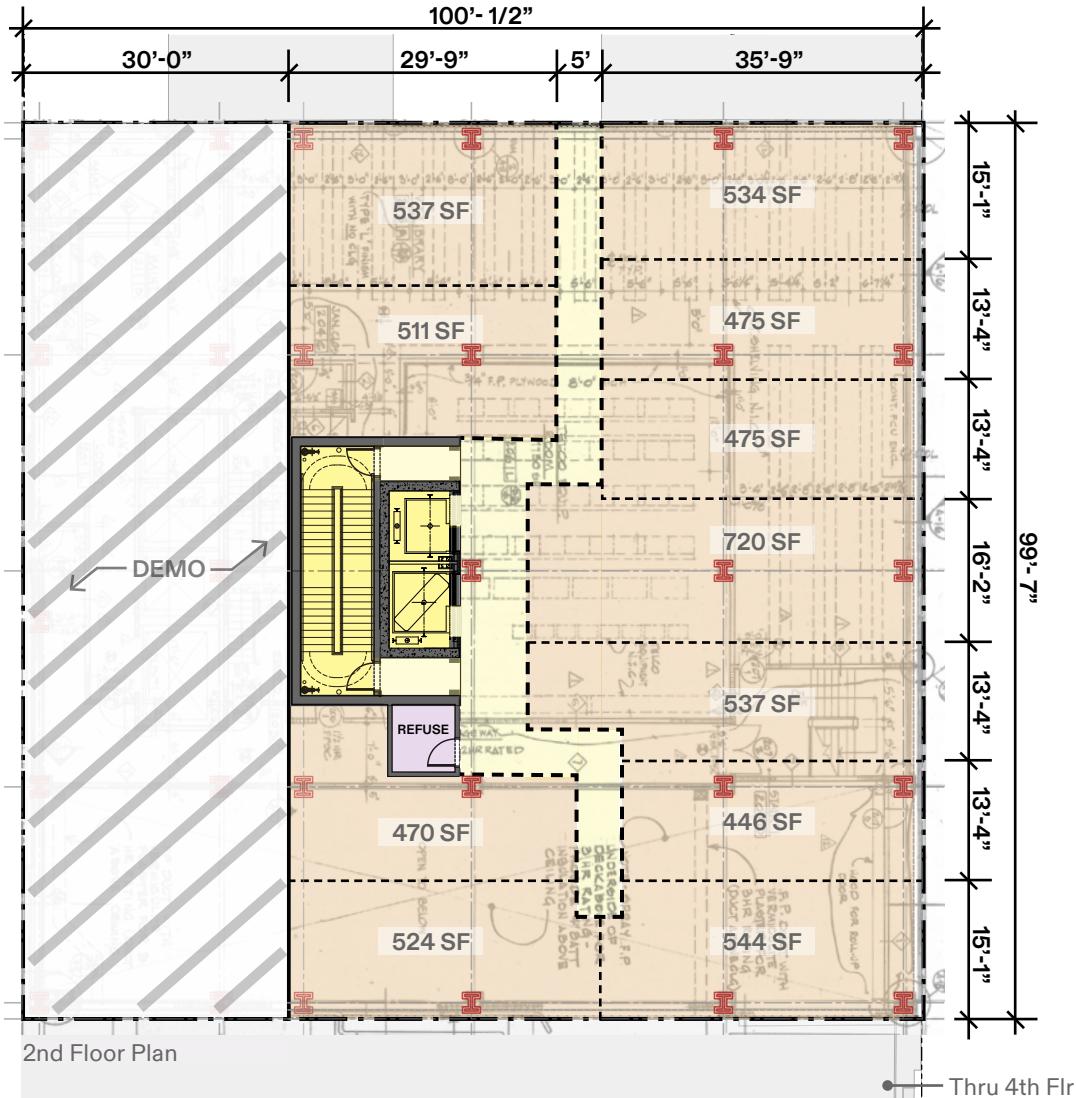
# Adaptive Reuse Feasibility Study - Typical (Levels 2-5)

## TYPICAL (LEVELS 2-5)

- GROSS AREA: 7,026 SF / FLR
- RENTABLE AREA: 5,784 SF / FLR
- EFFICIENCY: 82%
- UNITS: 11 / FLR
- TOTAL UNITS: 44

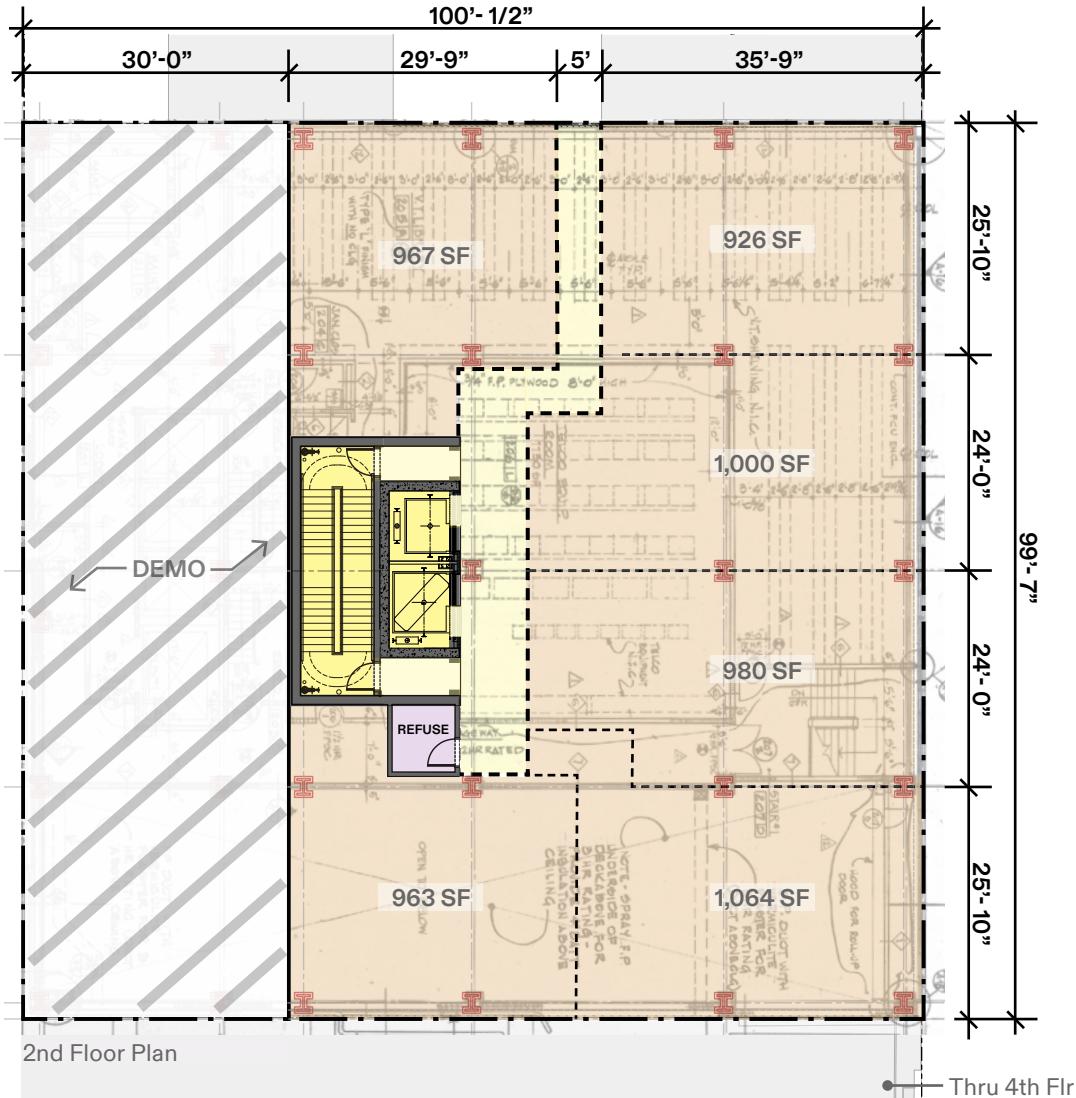
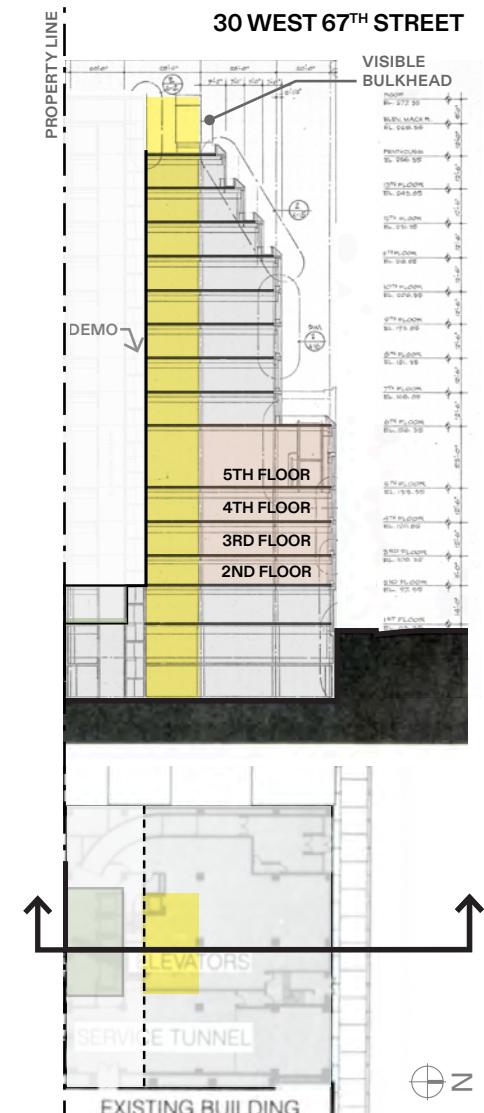
# Adaptive Reuse Feasibility Study - Typical (Levels 2-5) ALT

## TYPICAL (LEVELS 2-5)

- GROSS AREA: 7,026 SF / FLR
- RENTABLE AREA: 5,902 SF / FLR
- EFFICIENCY: 84 %
- UNITS: 6 / FLR
- TOTAL UNITS: 24

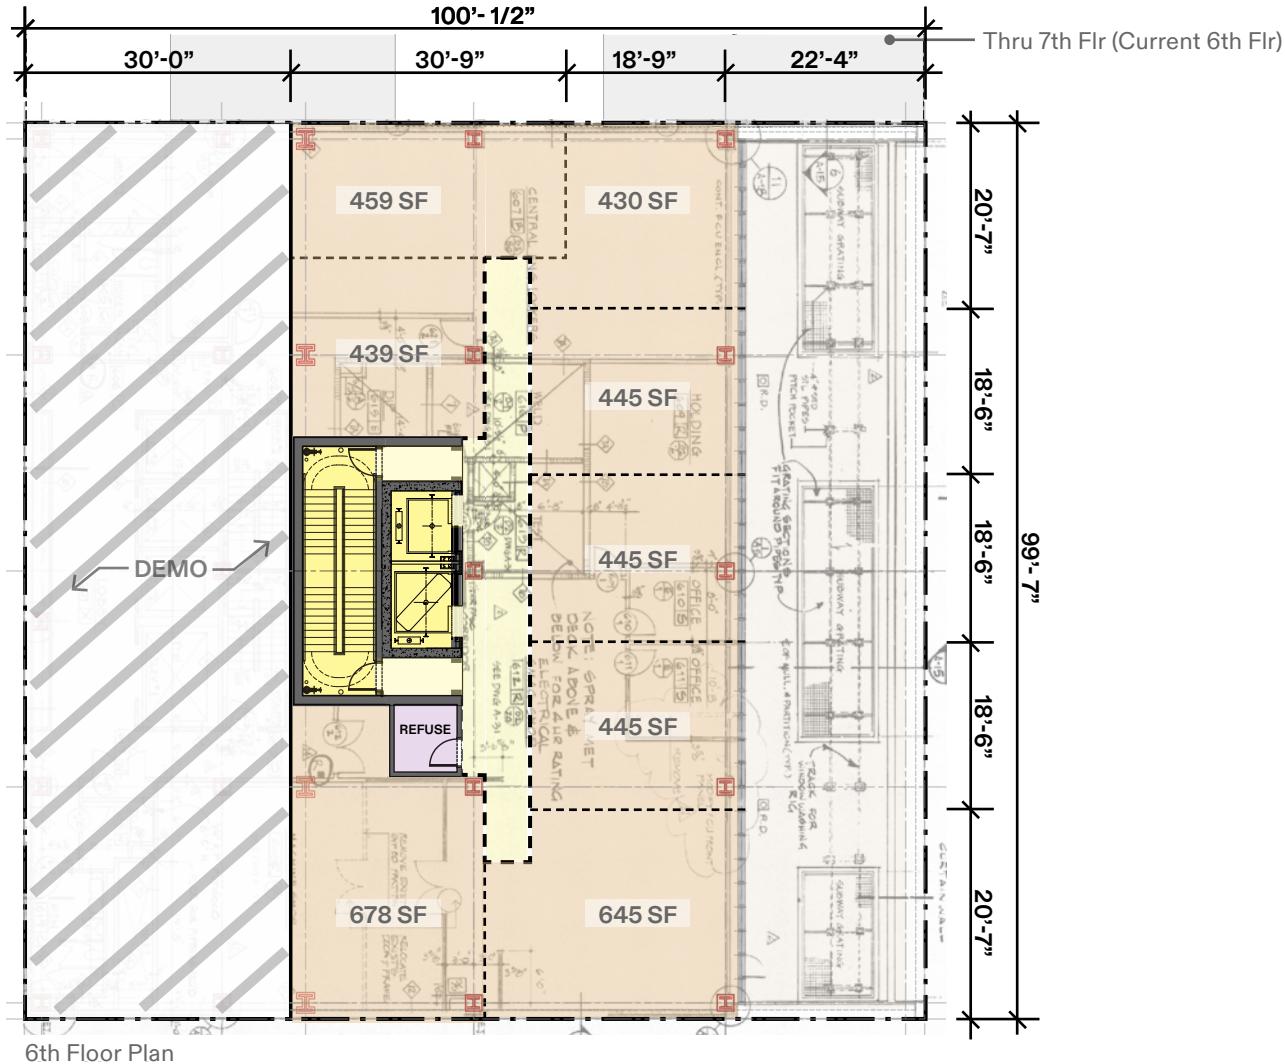
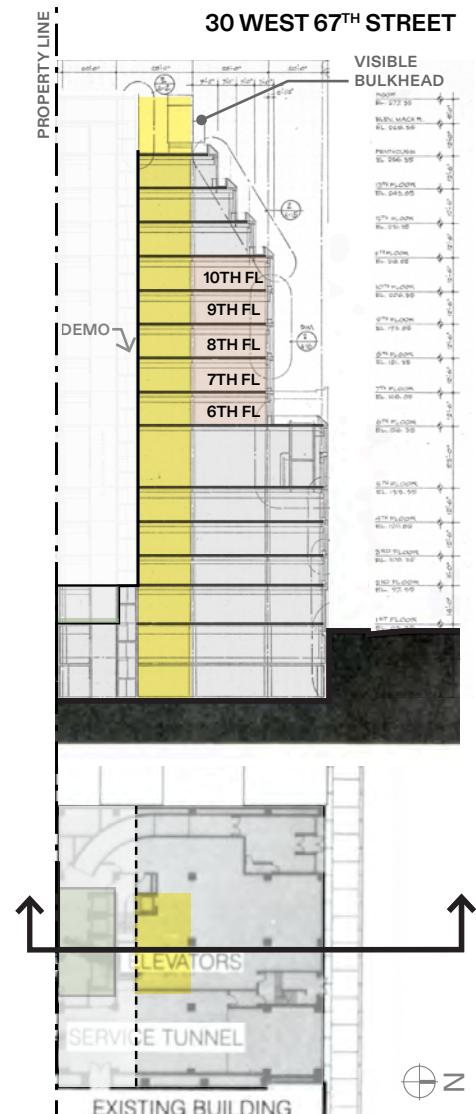
# Adaptive Reuse Feasibility Study - Levels 6-10

## TYPICAL (LEVELS 6-10)

- GROSS AREA: 5,028 SF / FLR
- RENTABLE AREA: 3,986 SF / FLR
- EFFICIENCY: 79 %
- UNITS: 8 / FLR
- TOTAL UNITS: 40

Building Section & Plan  
(Progressive Architecture, Jan 1988)

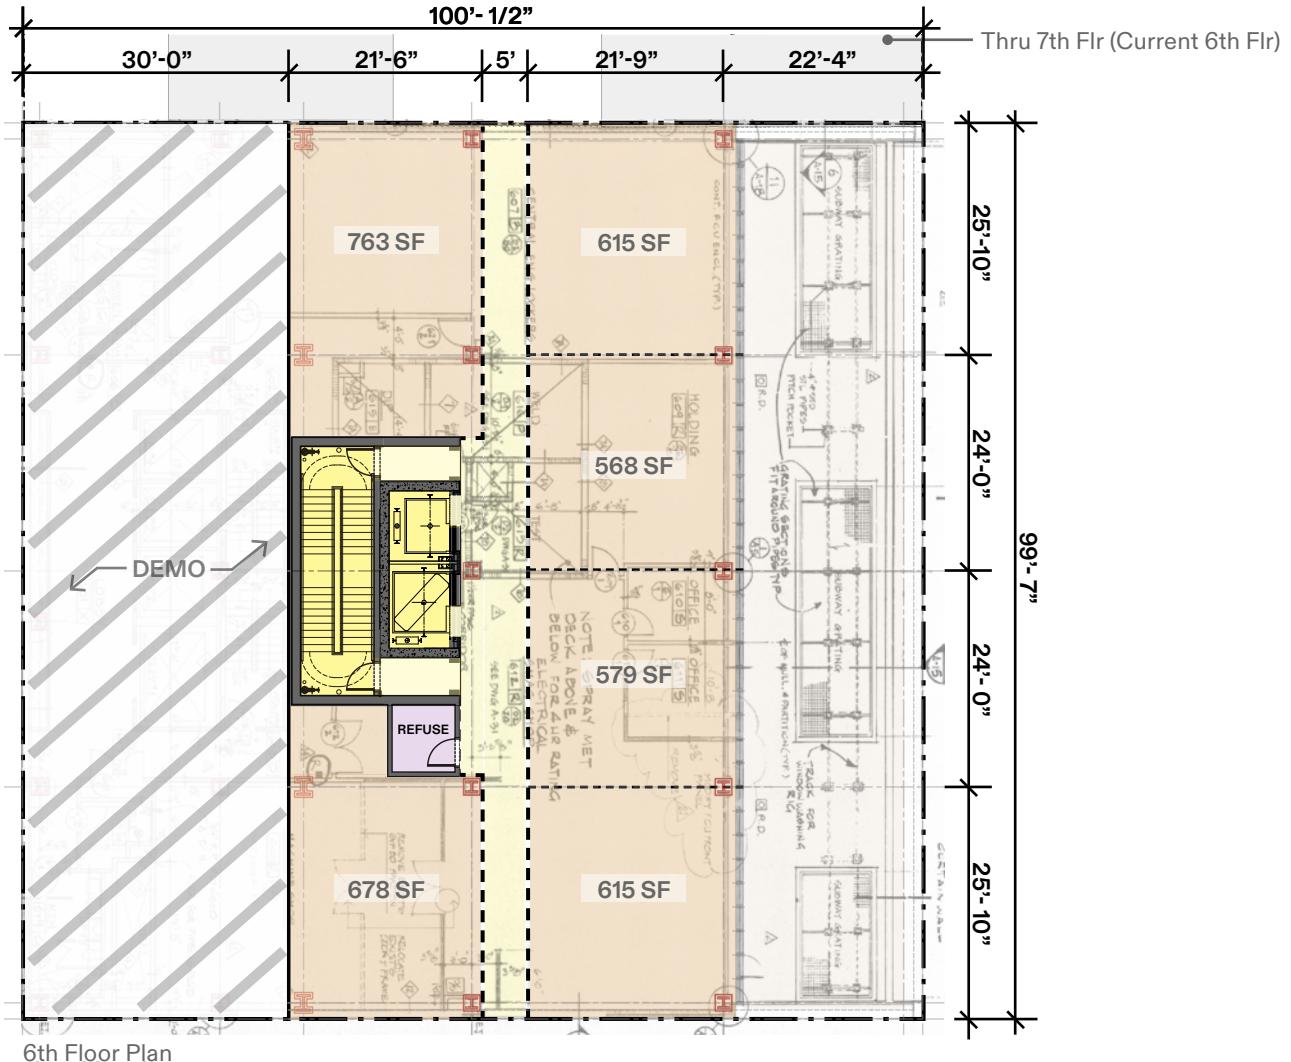
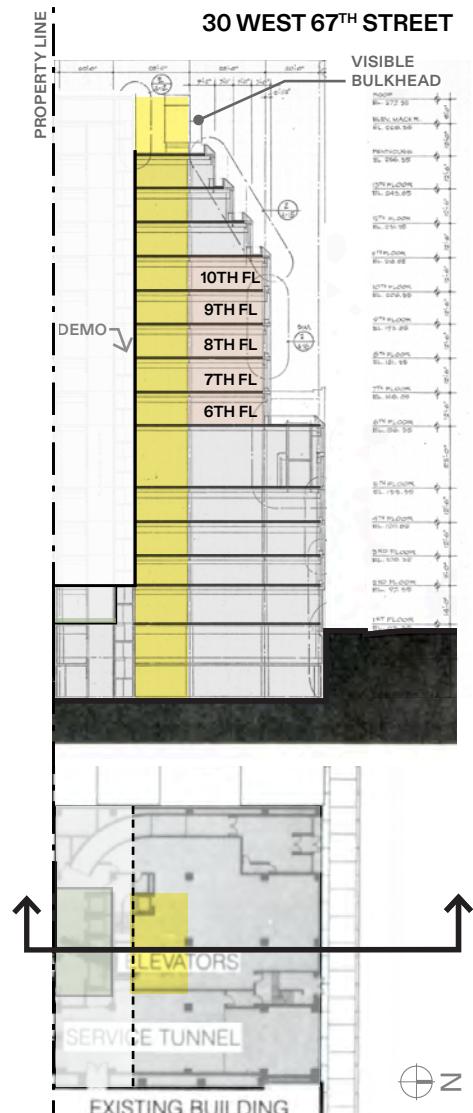
# Adaptive Reuse Feasibility Study - Levels 6-10 ALT

## TYPICAL (LEVELS 6-10)

- GROSS AREA: 5,028 SF / FLR
- RENTABLE AREA: 3,822 SF / FLR
- EFFICIENCY: 76 %
- UNITS: 6 / FLR
- TOTAL UNITS: 30

Building Section & Plan  
(Progressive Architecture, Jan 1988)

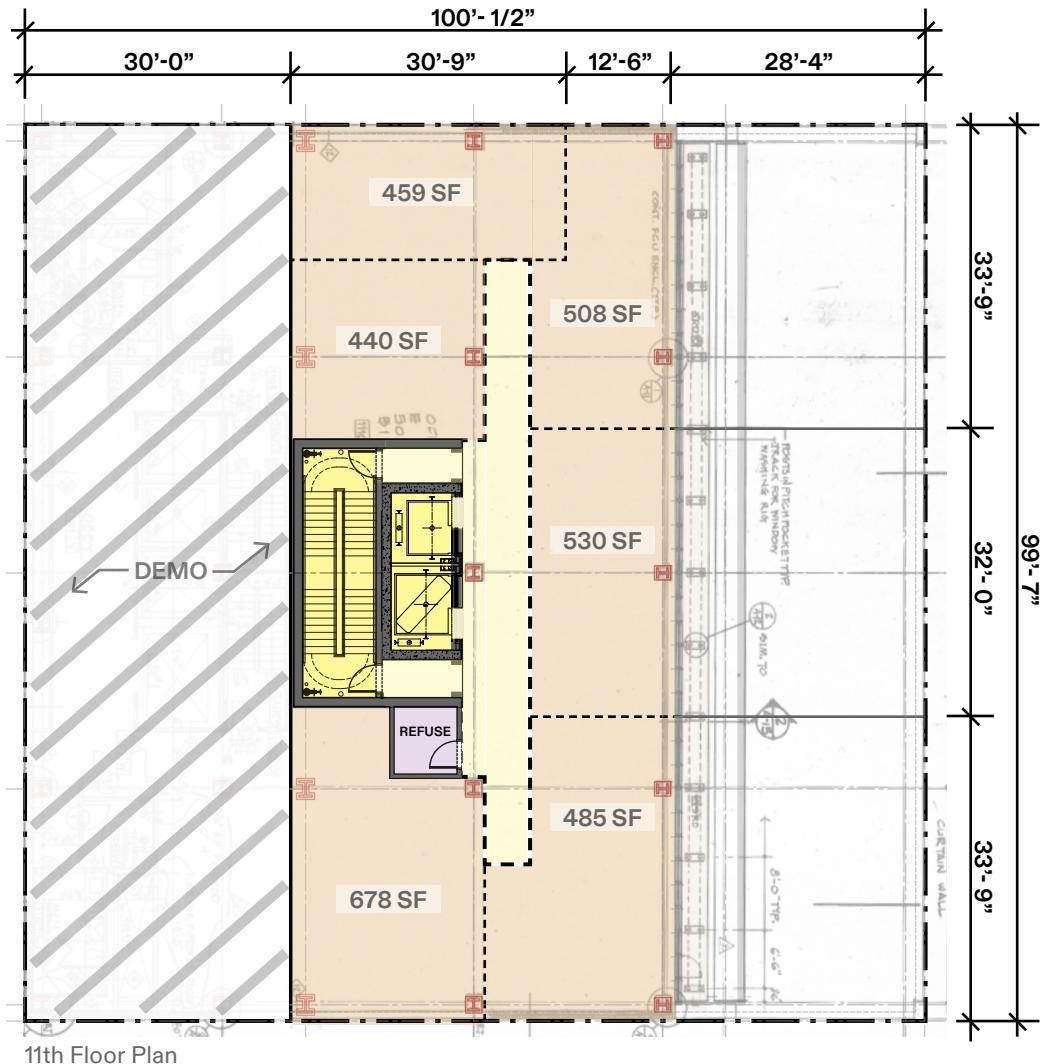
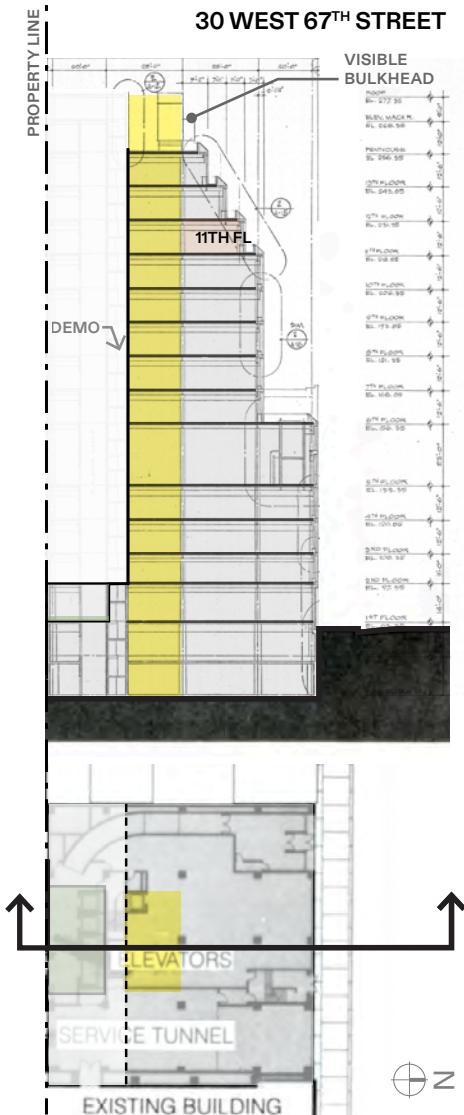
# Adaptive Reuse Feasibility Study - Level 11

LEVEL 11

- GROSS AREA: 4,331 SF
- RENTABLE AREA: 3,289 SF
- EFFICIENCY: 76 %
- TOTAL UNITS: 6

## Building Section & Plan (*Progressive Architecture*, Jan 1988)

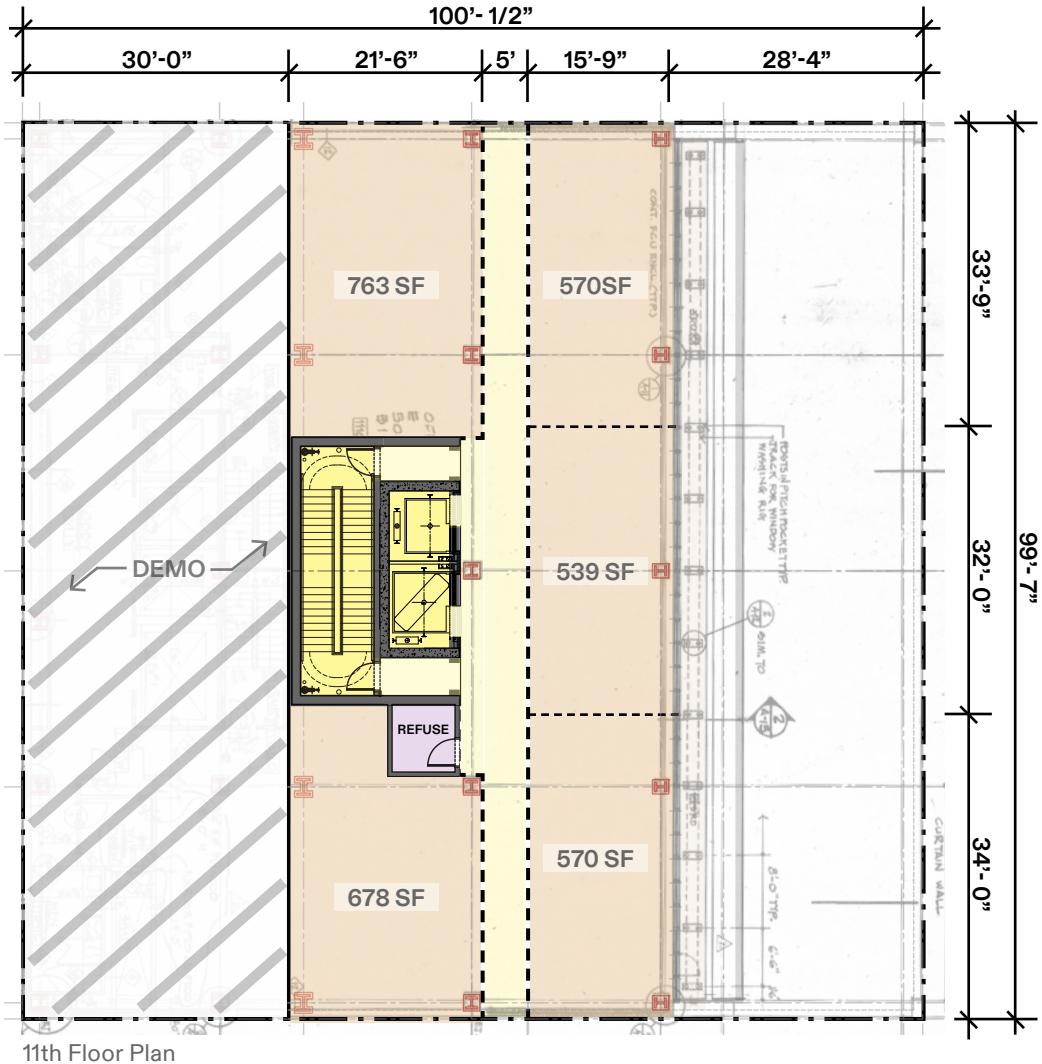
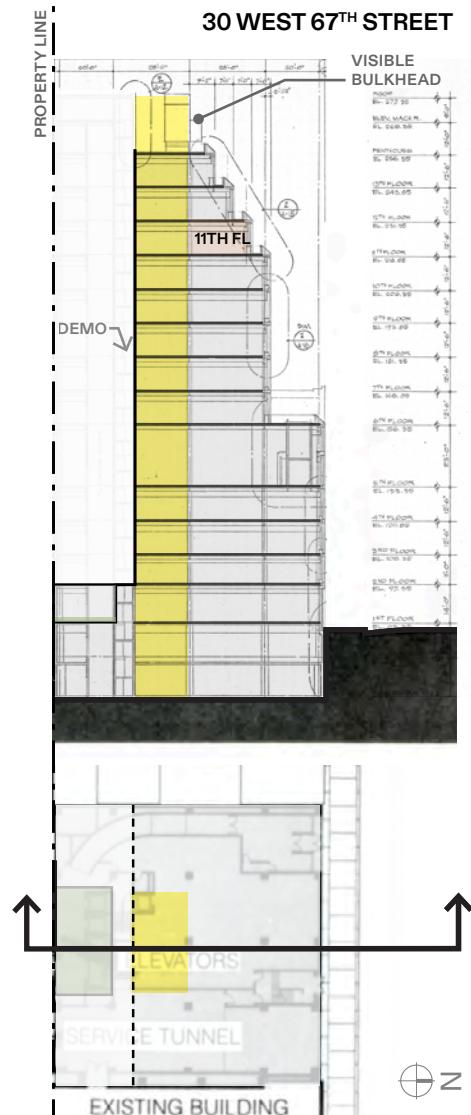
# Adaptive Reuse Feasibility Study - Level 11 ALT

## LEVEL 11

- GROSS AREA: 4,331 SF
- RENTABLE AREA: 3,125 SF
- EFFICIENCY: 72 %
- TOTAL UNITS: 5

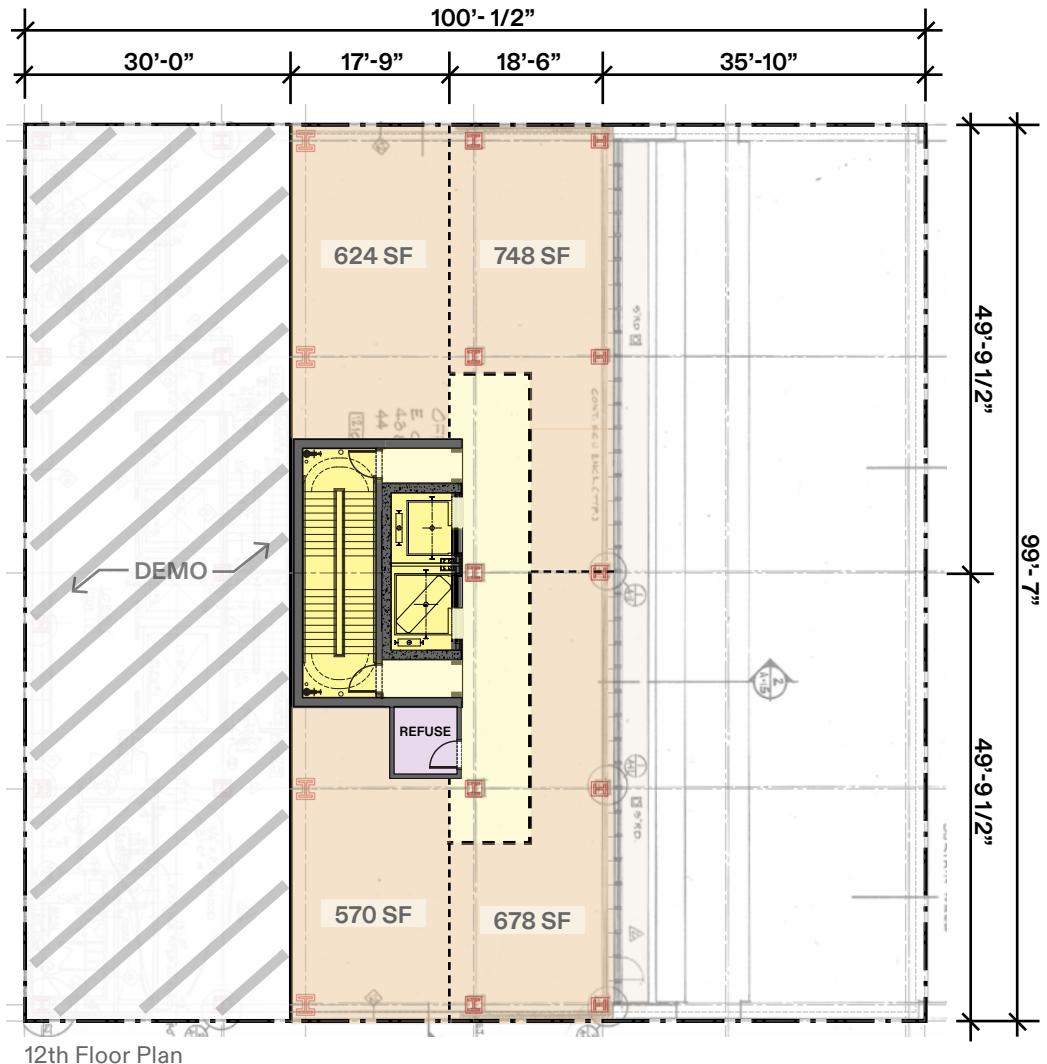
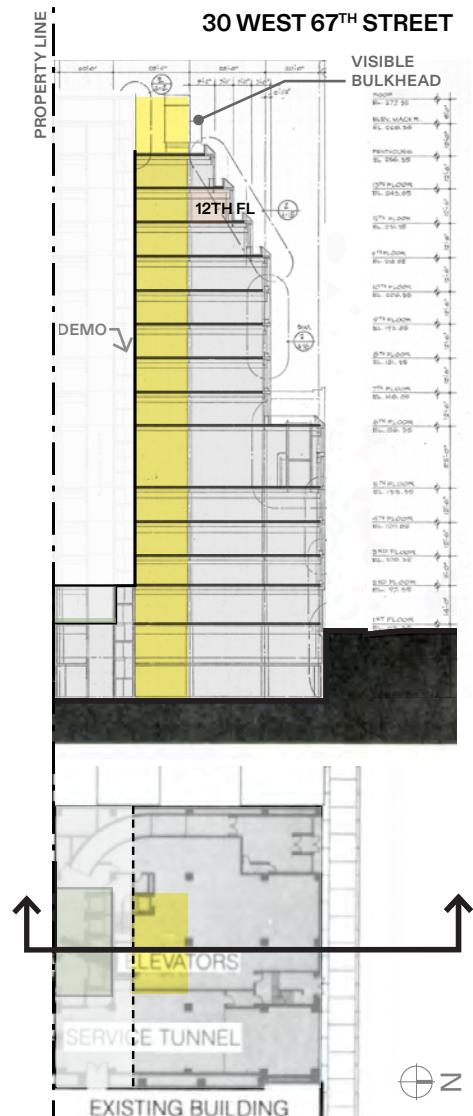
# Adaptive Reuse Feasibility Study - Level 12

## LEVEL 12

- GROSS AREA: 3,653 SF
- RENTABLE AREA: 2,618 SF
- EFFICIENCY: 72 %
- TOTAL UNITS: 4
