**Preservation Department – Item 5, LPC-26-03891**

**26-30 West 67th Street – Upper West Side/Central Park West  
Historic District – Borough of Manhattan**

# 30 West 67<sup>th</sup> Street

Landmarks Preservation Commission  
January 13, 2026

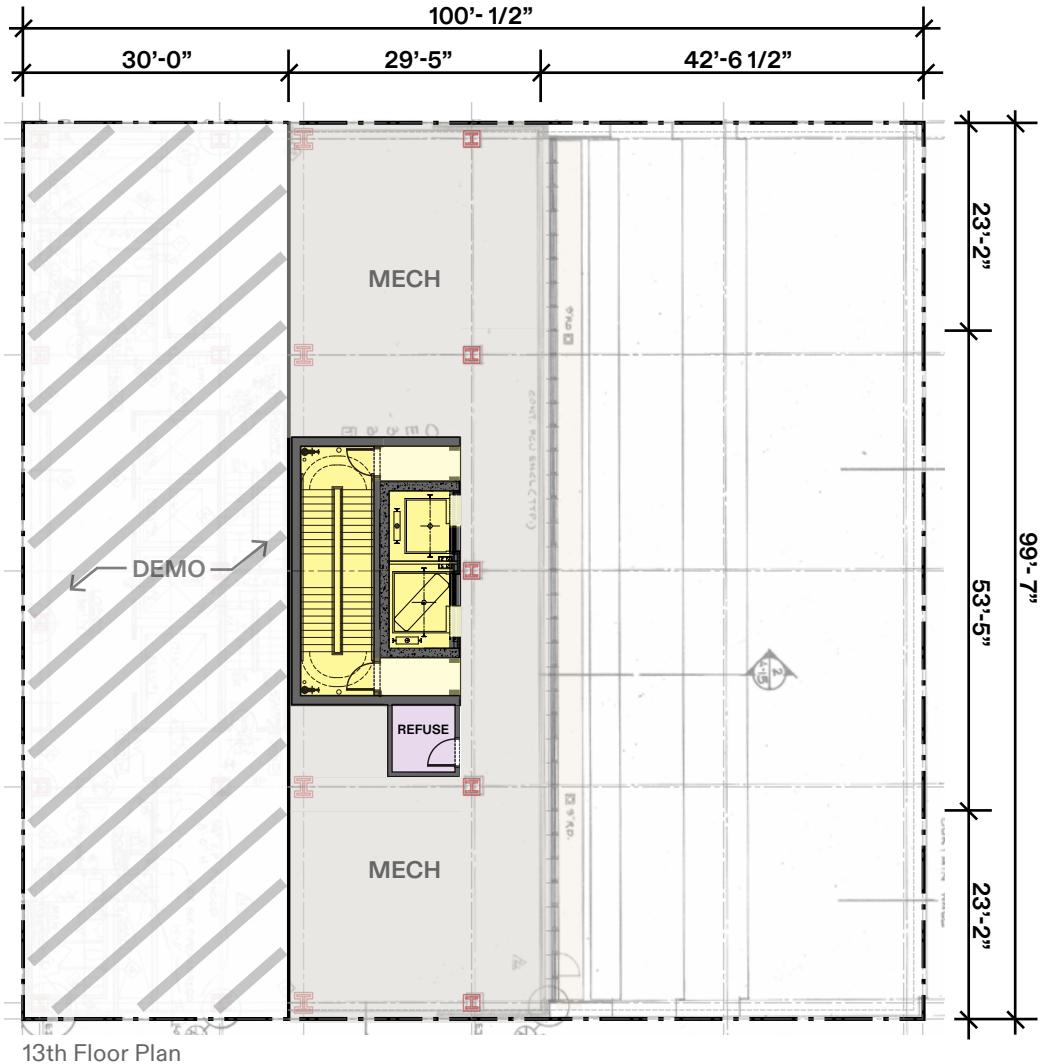
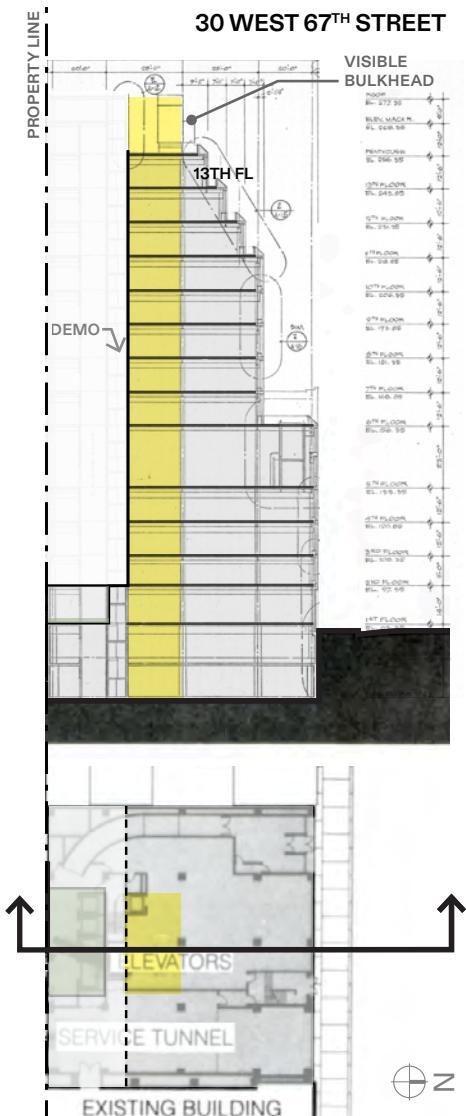
# Adaptive Reuse Feasibility Study - Level 13

## LEVEL 13

- GROSS AREA: 2,970 SF

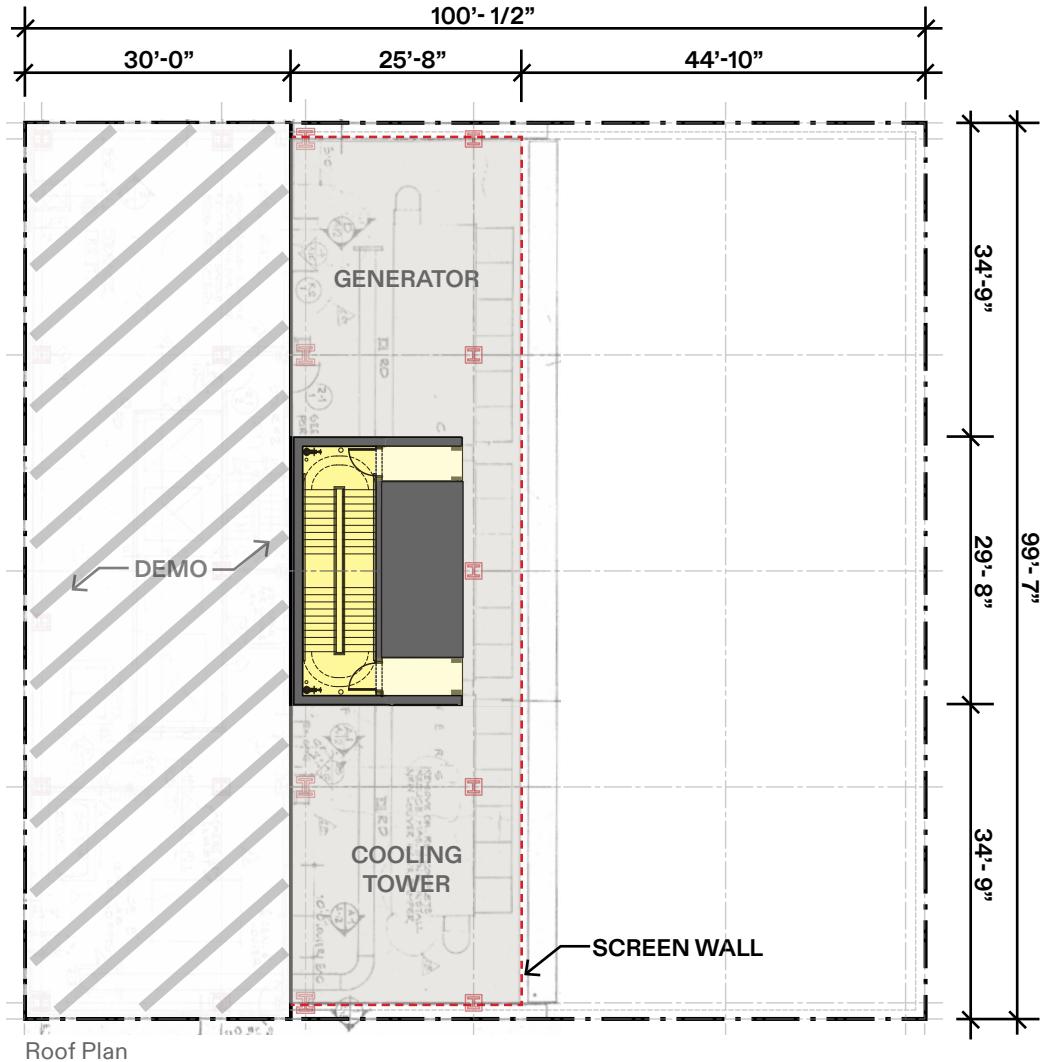
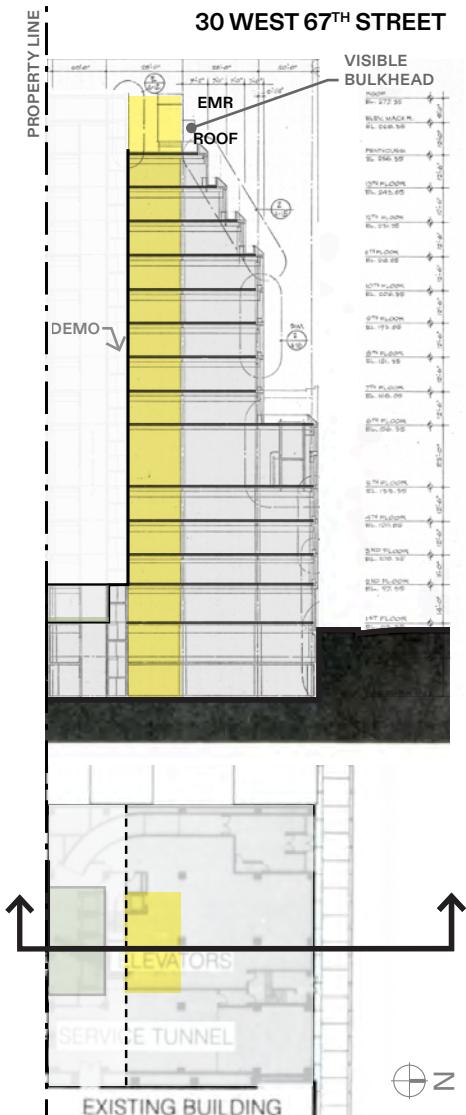
# Adaptive Reuse Feasibility Study - Roof

## ROOF

- GROSS AREA: 569 SF

Building Section & Plan  
(Progressive Architecture, Jan 1988)

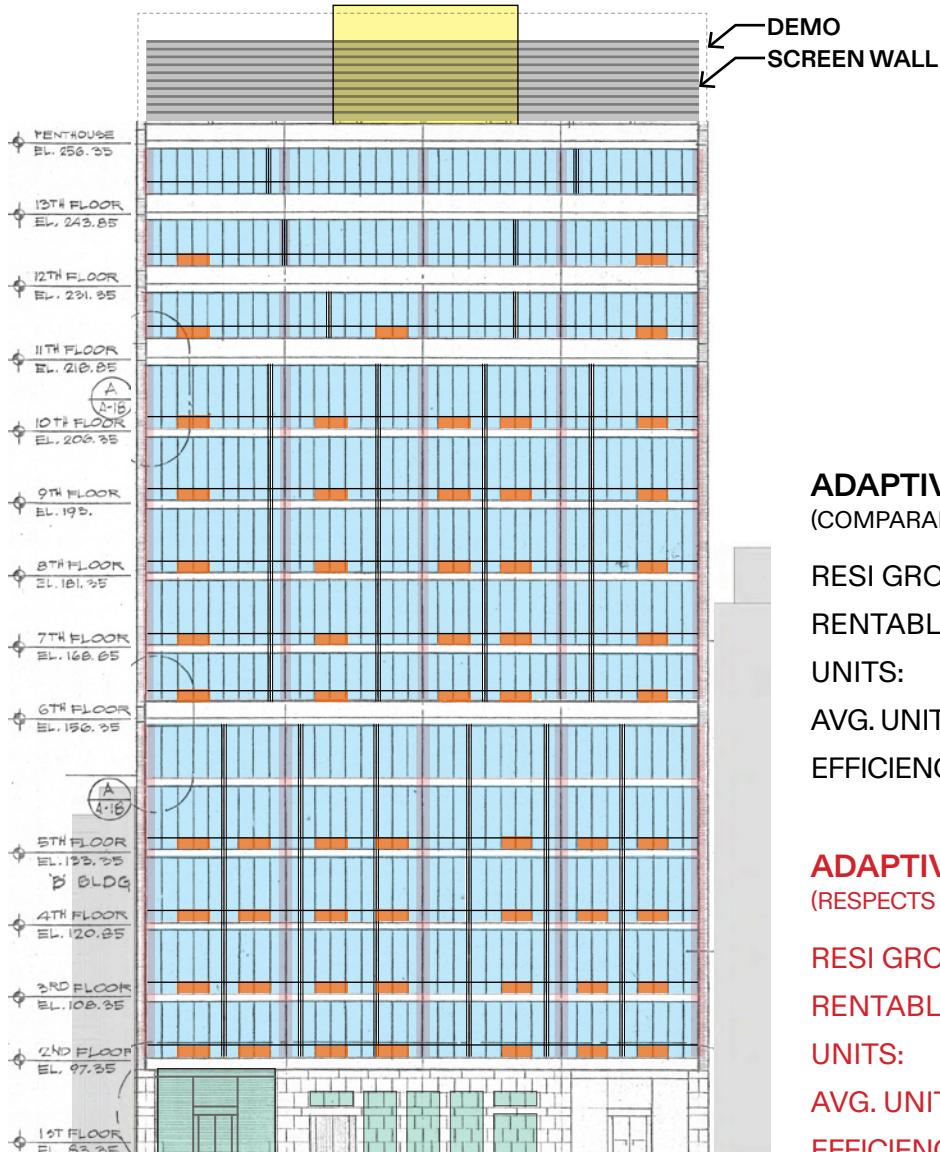
Adapted North Elevation

## ADAPTIVE REUSE (COMPARABLE UNIT SIZE)

RESI GROSS: 61,228 SF  
RENTABLE: 48,973 SF  
UNITS: 94  
AVG. UNIT: 521 SF  
EFFICIENCY: 80%

## ADAPTIVE REUSE ALT (RESPECTS EXISTING COLUMNS)

RESI GROSS: 61,228 SF  
RENTABLE: 48,461 SF  
UNITS: 63  
AVG. UNIT: 777 SF  
EFFICIENCY: 79%

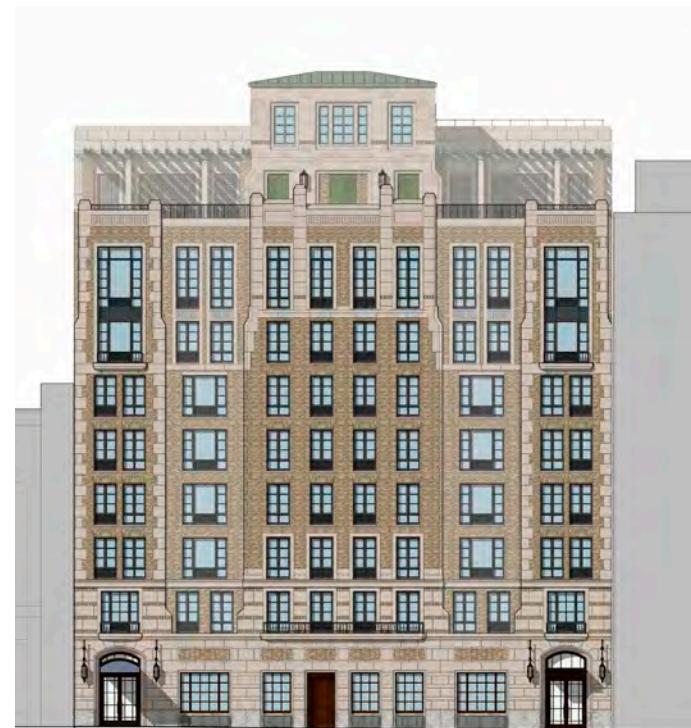
Proposed North Elevation

## NEW CONSTRUCTION (PROPOSED DESIGN)

RESI GROSS: 48,970 SF  
RENTABLE: 43,077 SF  
UNITS: 90  
AVG. UNIT: 479 SF  
EFFICIENCY: 88%

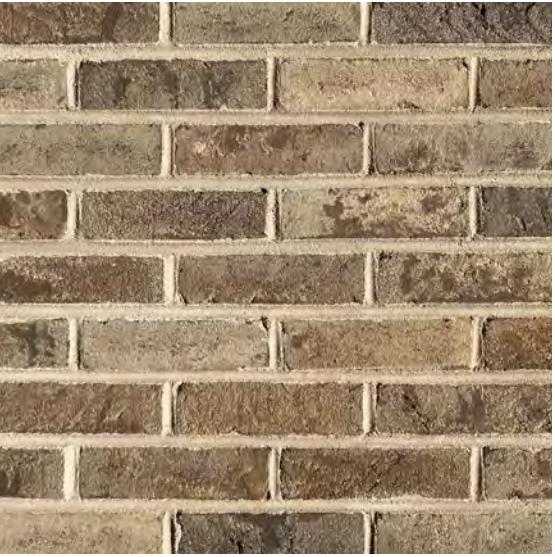
Belden - Alamo Blend Brick

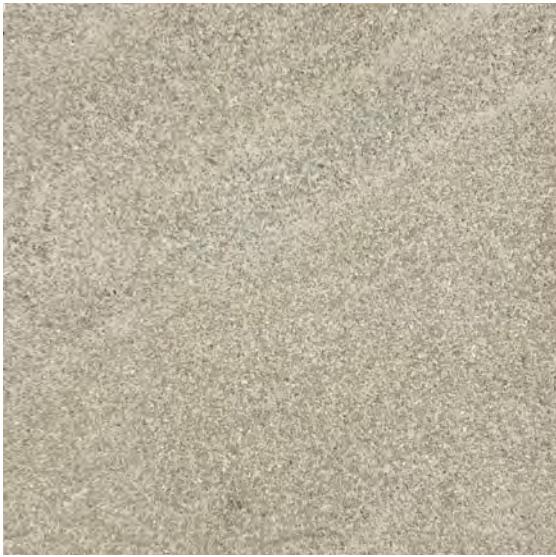
Limestone / Cast Stone (*Indiana Standard Buff or Similar*)

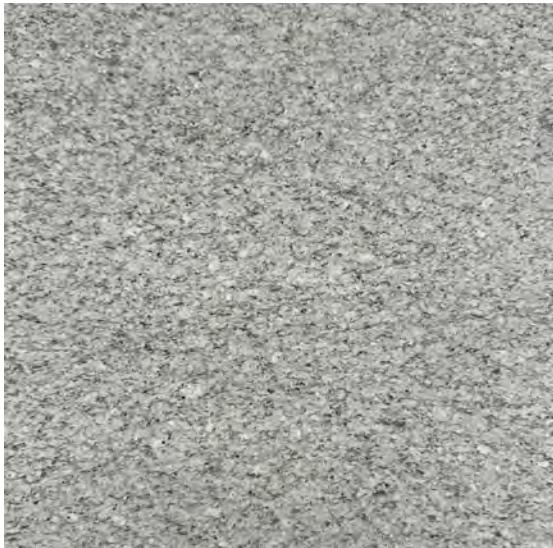
Granite Water Table (*Chelmsford or Similar*)

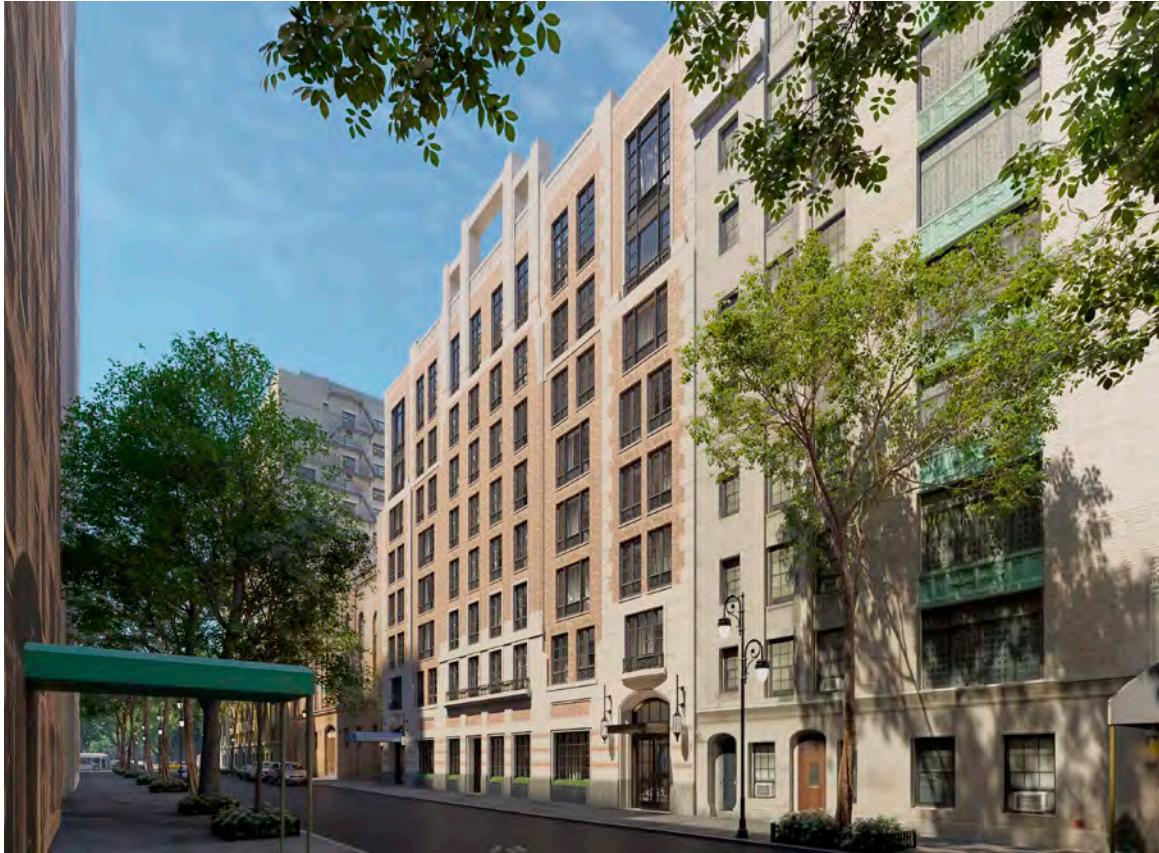
Previous

# View Looking East

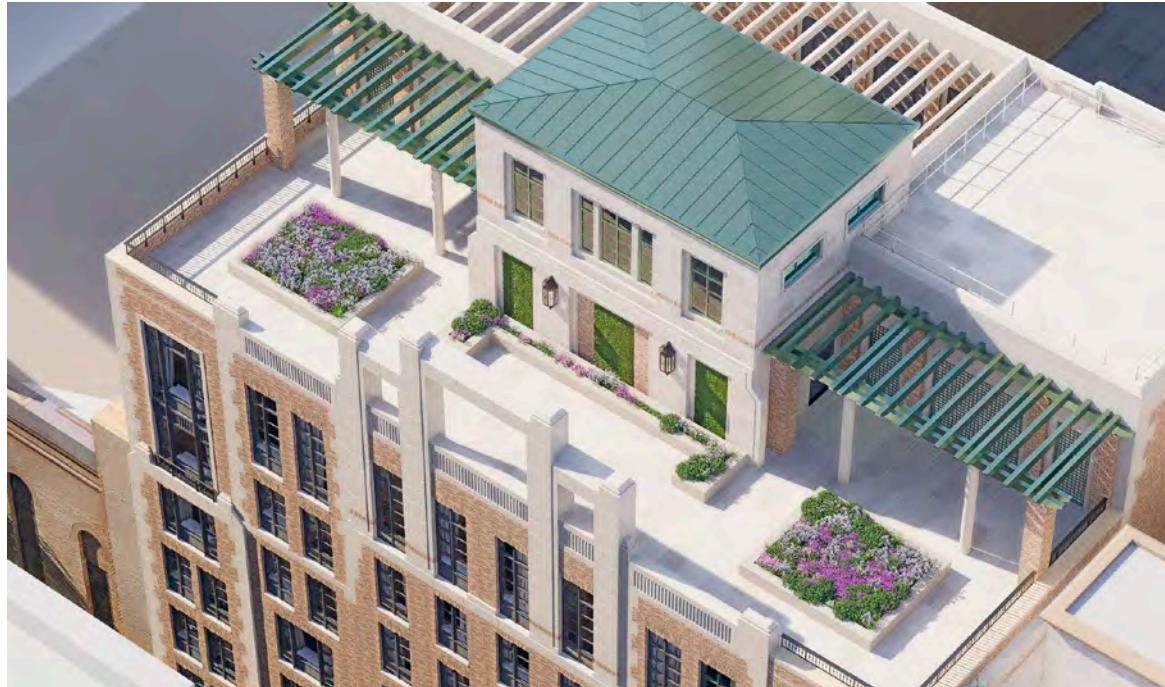
Previous

# Roof Amenity

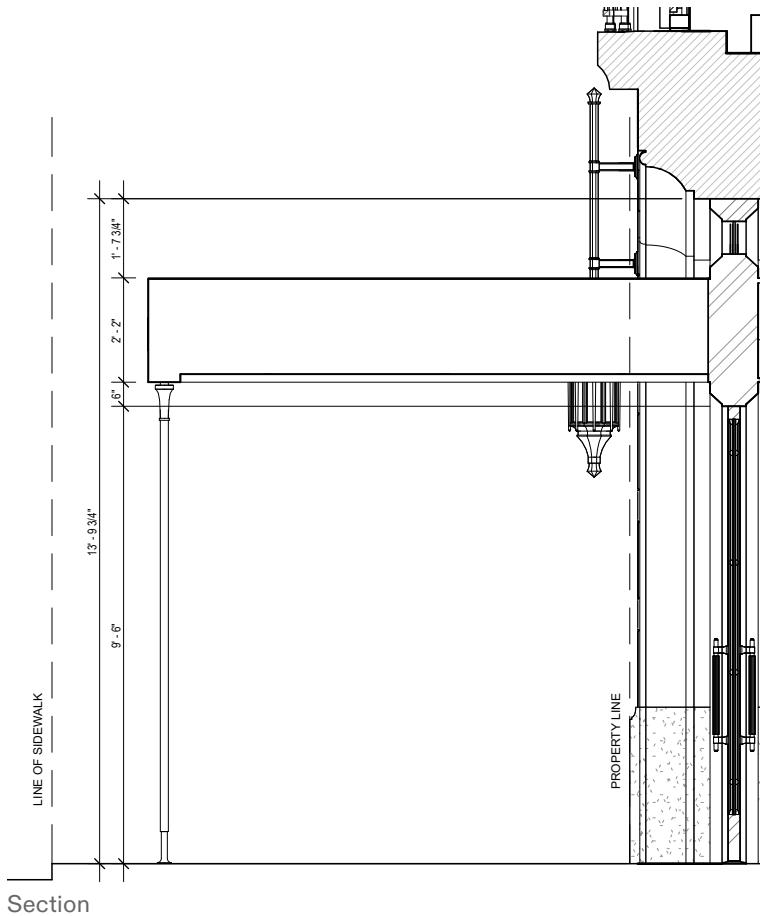
Section

# Residential Entry Door

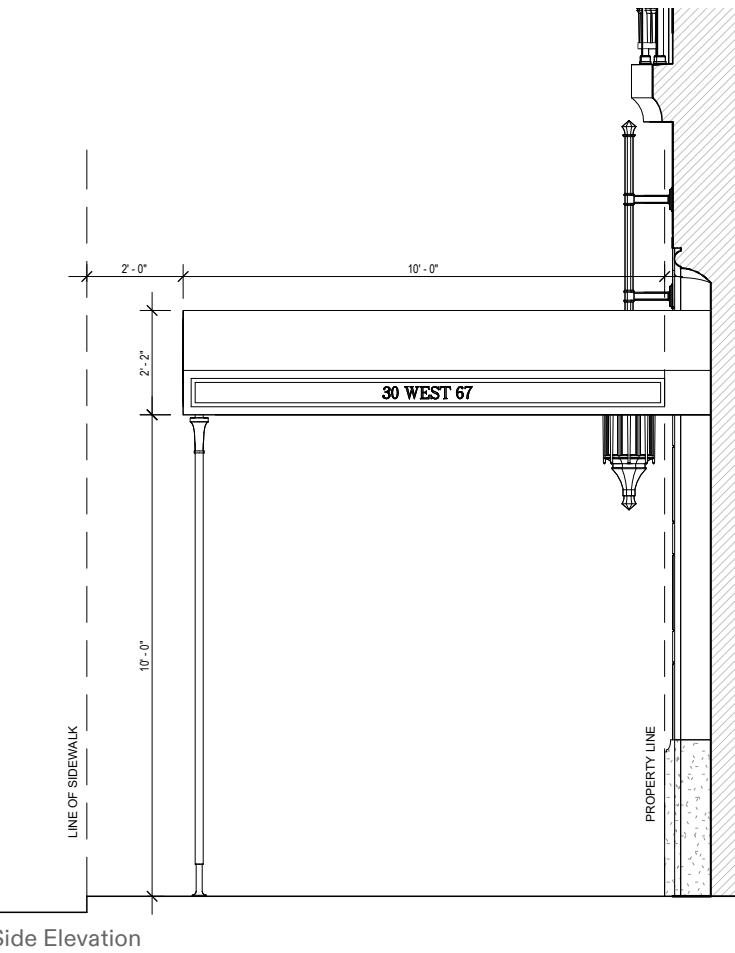
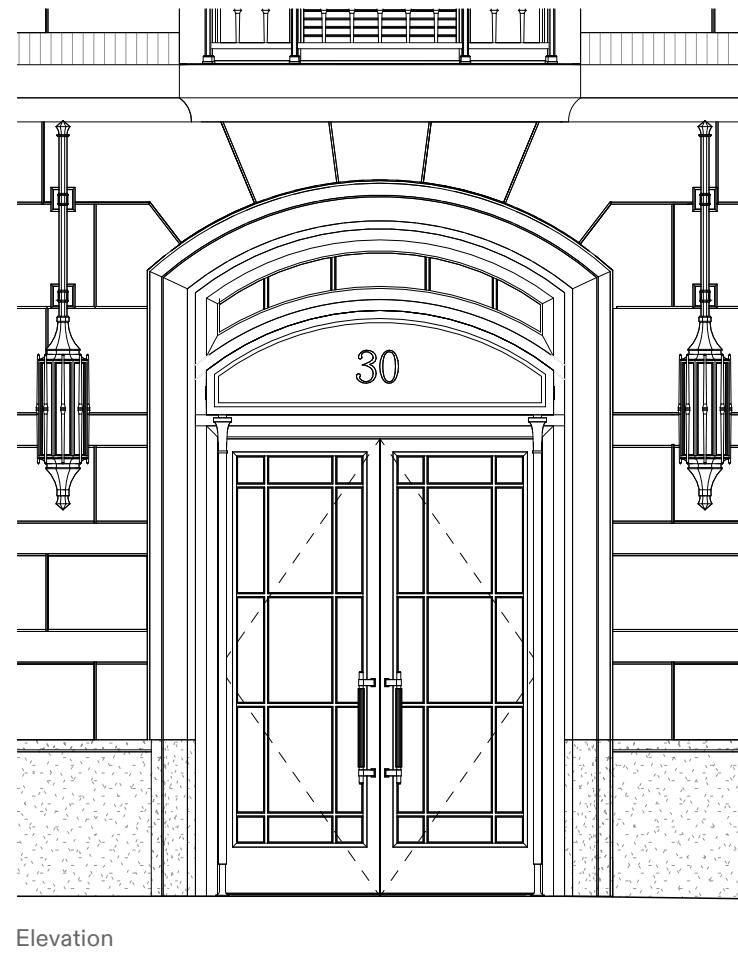
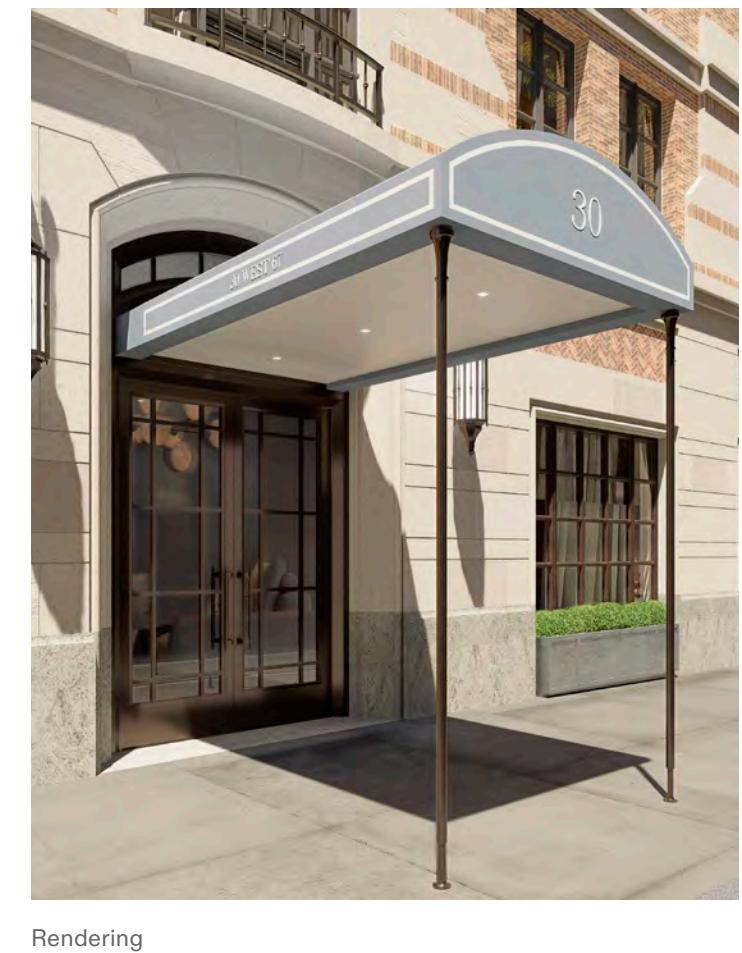
# Entry Door and Canopy

Side Elevation

Elevation

Rendering

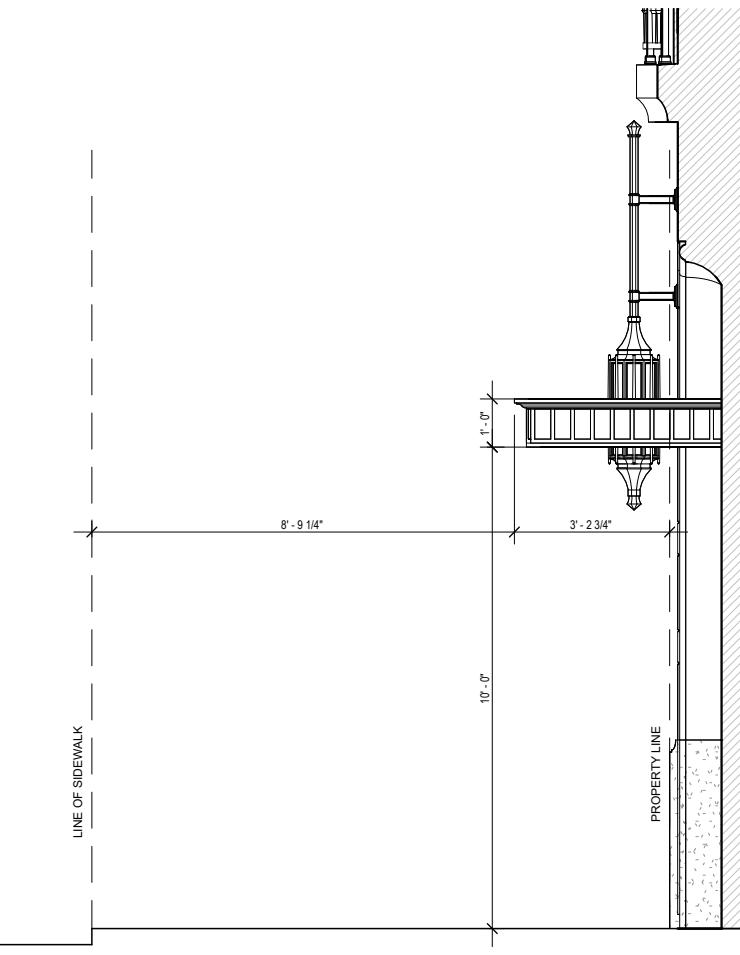
Side Elevation

# Marquee

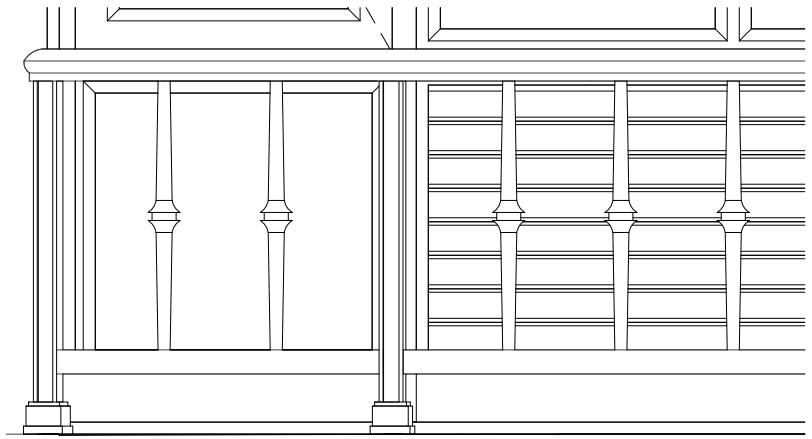
Elevation

# Railing

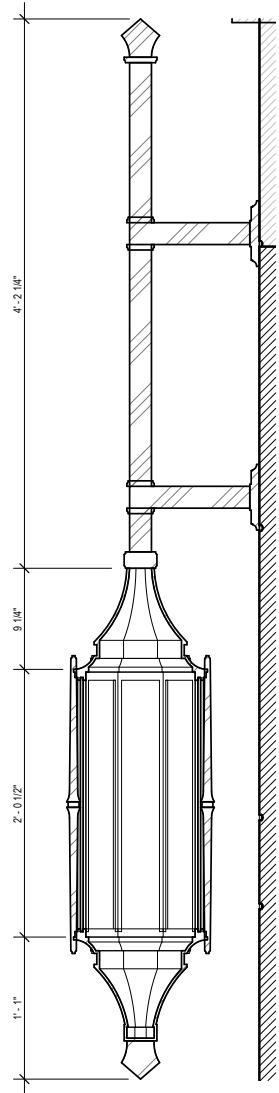
Section

# Light Fixture

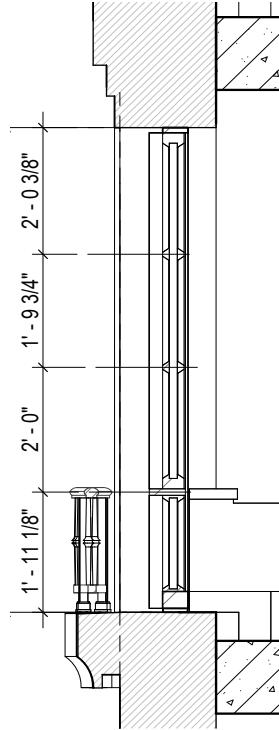
Section

# Level 2 Window

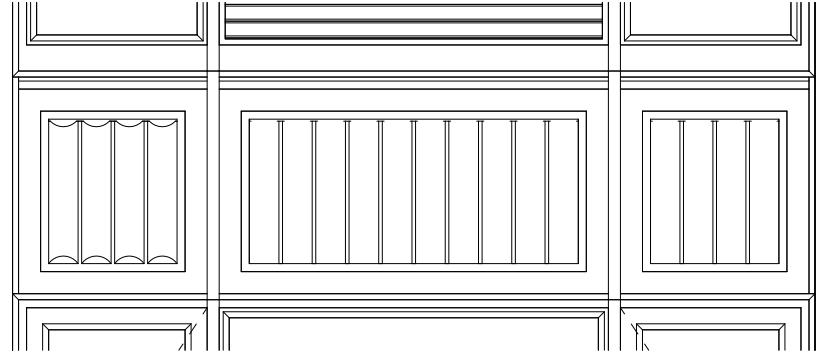
Elevation

# Metal Spandrel
