A. INTRODUCTION

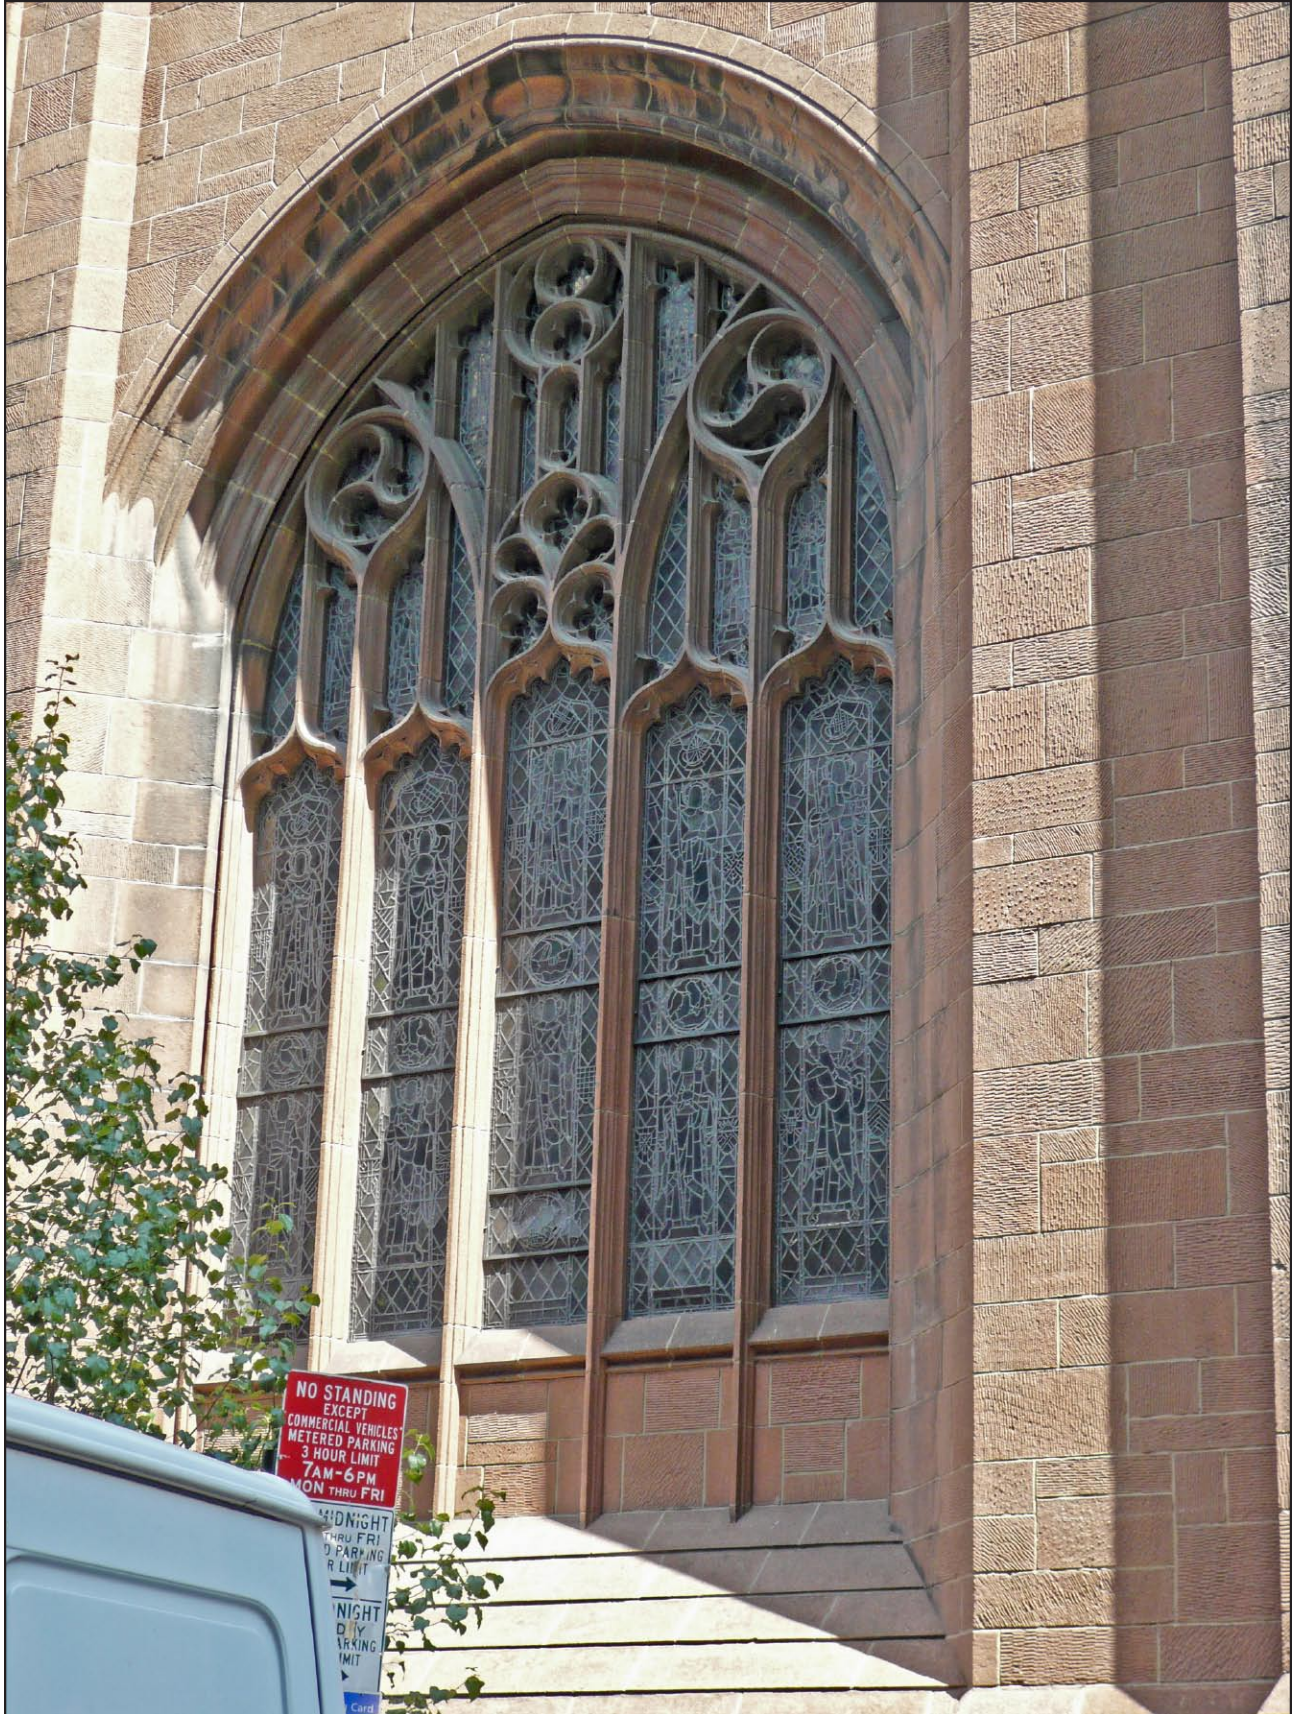
South Window Chapel of
Fifth Avenue Presbyterian Church
Figure 20-2

Interior lighting was also considered for the church sanctuary because of its unique construction with an outer stone exterior wall and an interior wall—each with windows. The inner windows are of decorative stained glass and the outer windows are clear leaded art glass with inserts of smaller colored borders. There is an air space in between of about 15 inches (except on the corners of the sanctuary walls, which are curved, creating a larger space in between the interior and exterior). This double glazing system, which functions as a sound and insulation barrier, represented an innovative solution for its time period and has significance from both an engineering and aesthetic standpoint. The system provides effective sound and temperature insulation to this day. The south-facing rear window of the church chapel also affected by shadows from the proposed project is single-glazed and does not have this cavity and, thus, interior lighting for this window is not practicable.

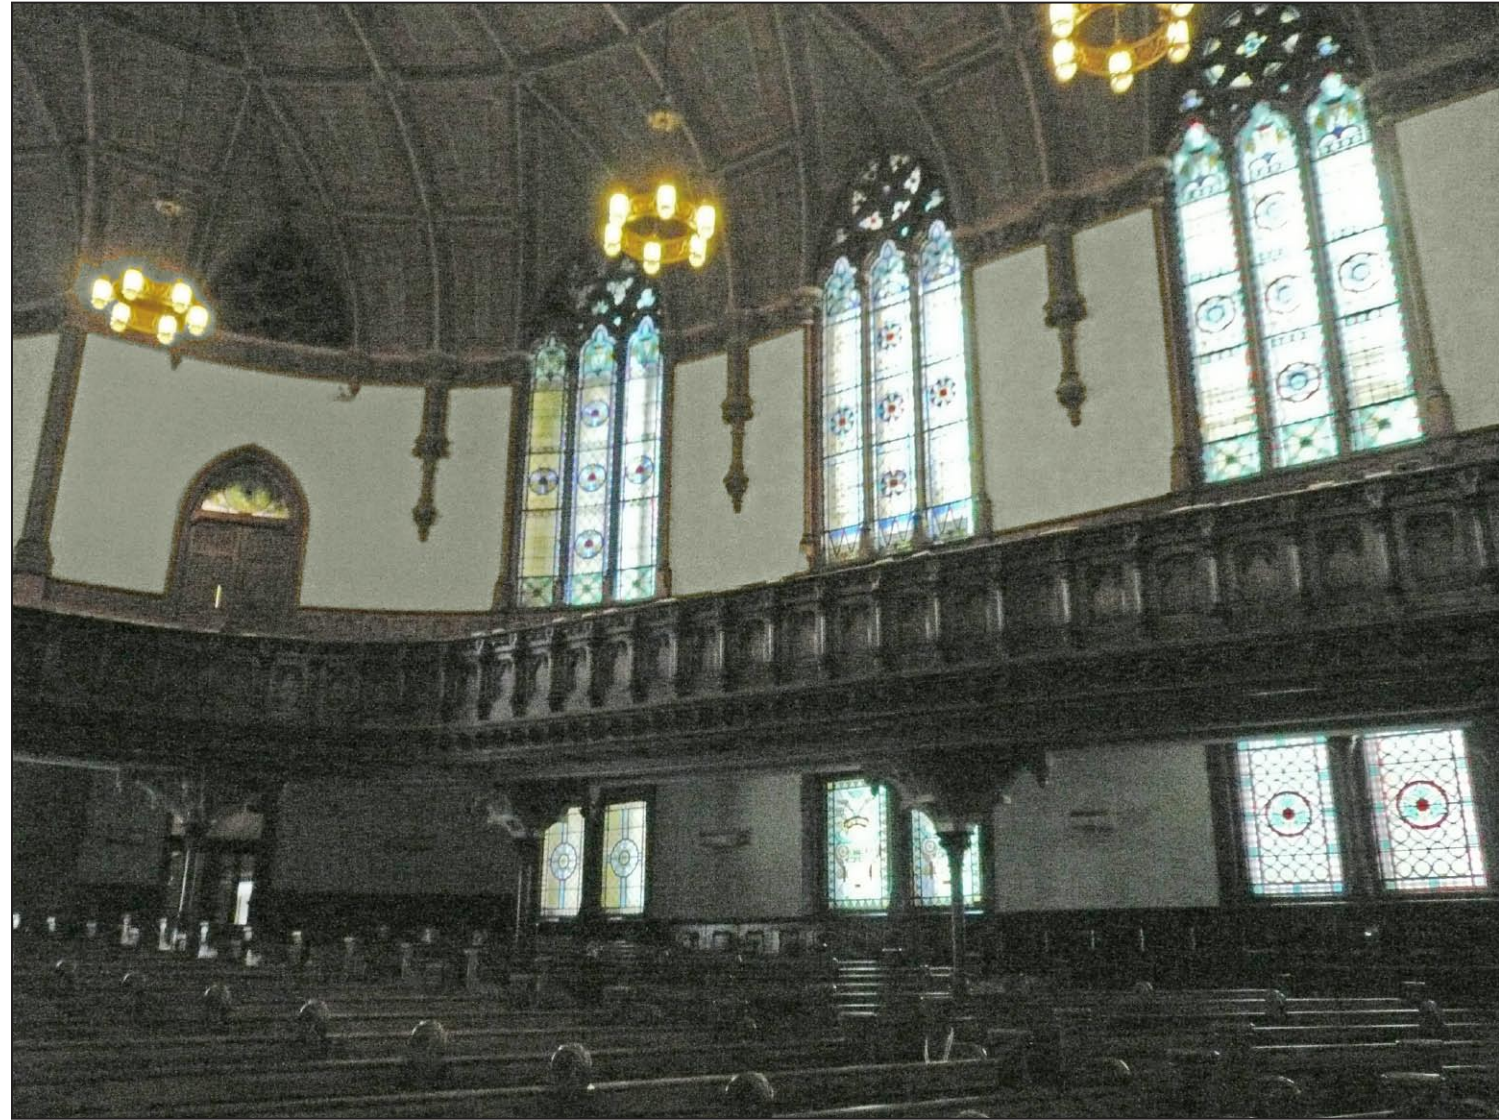
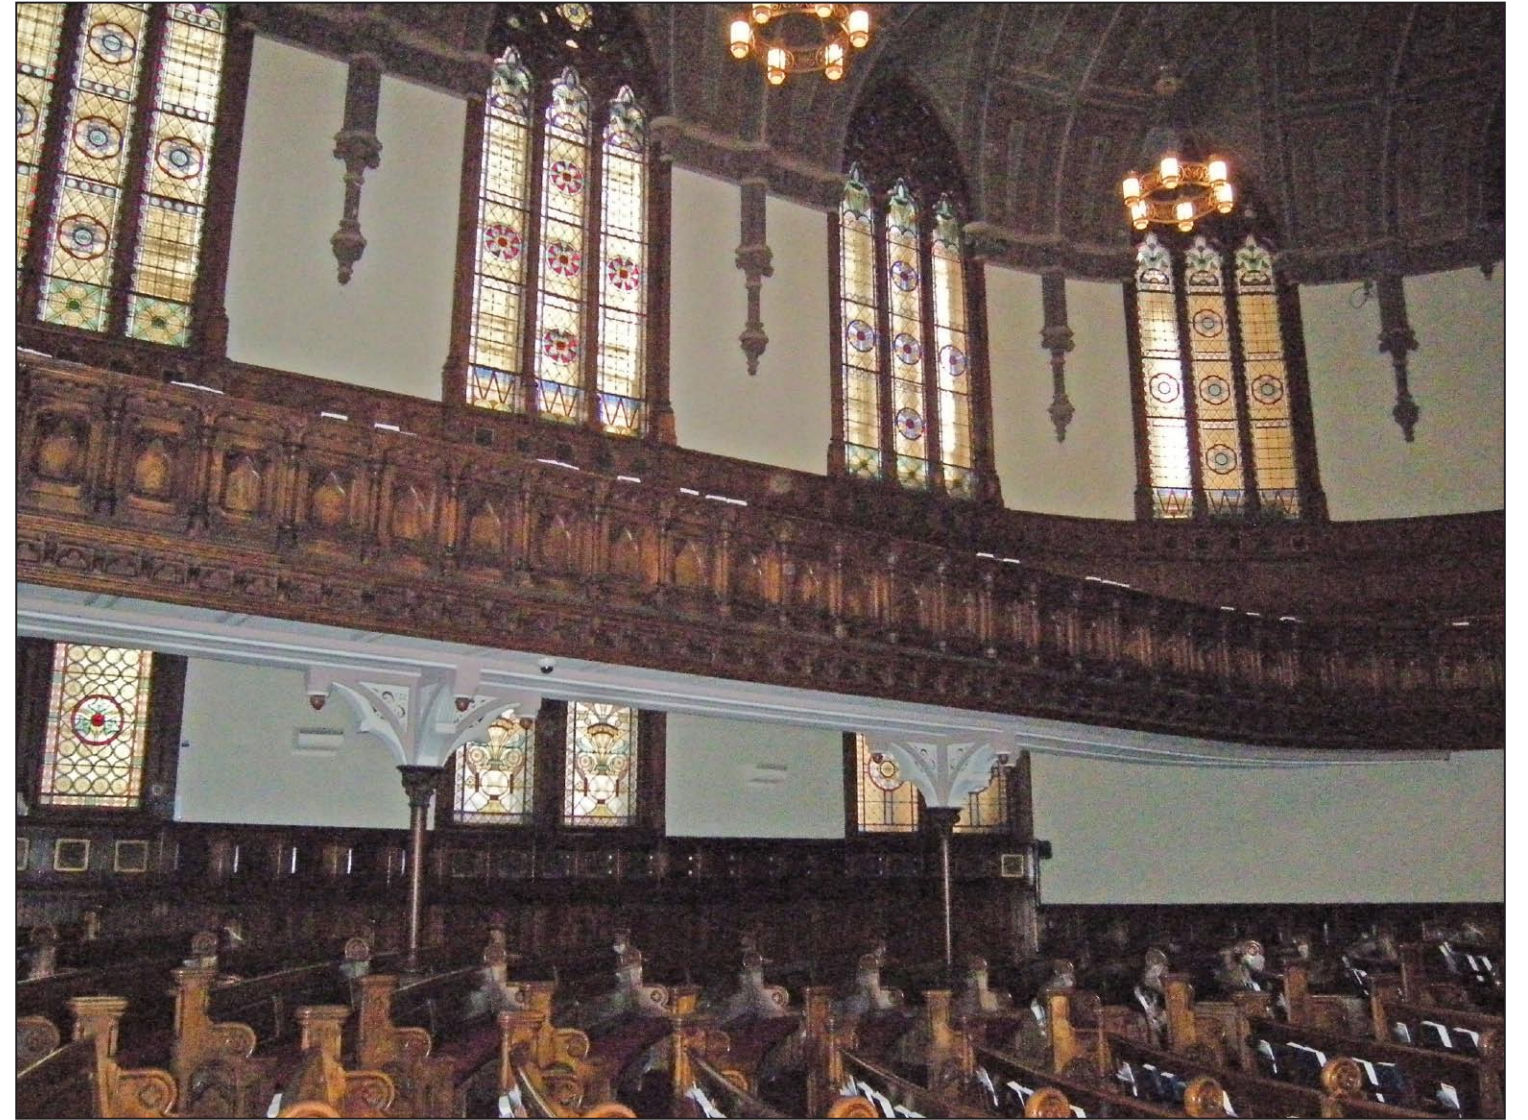
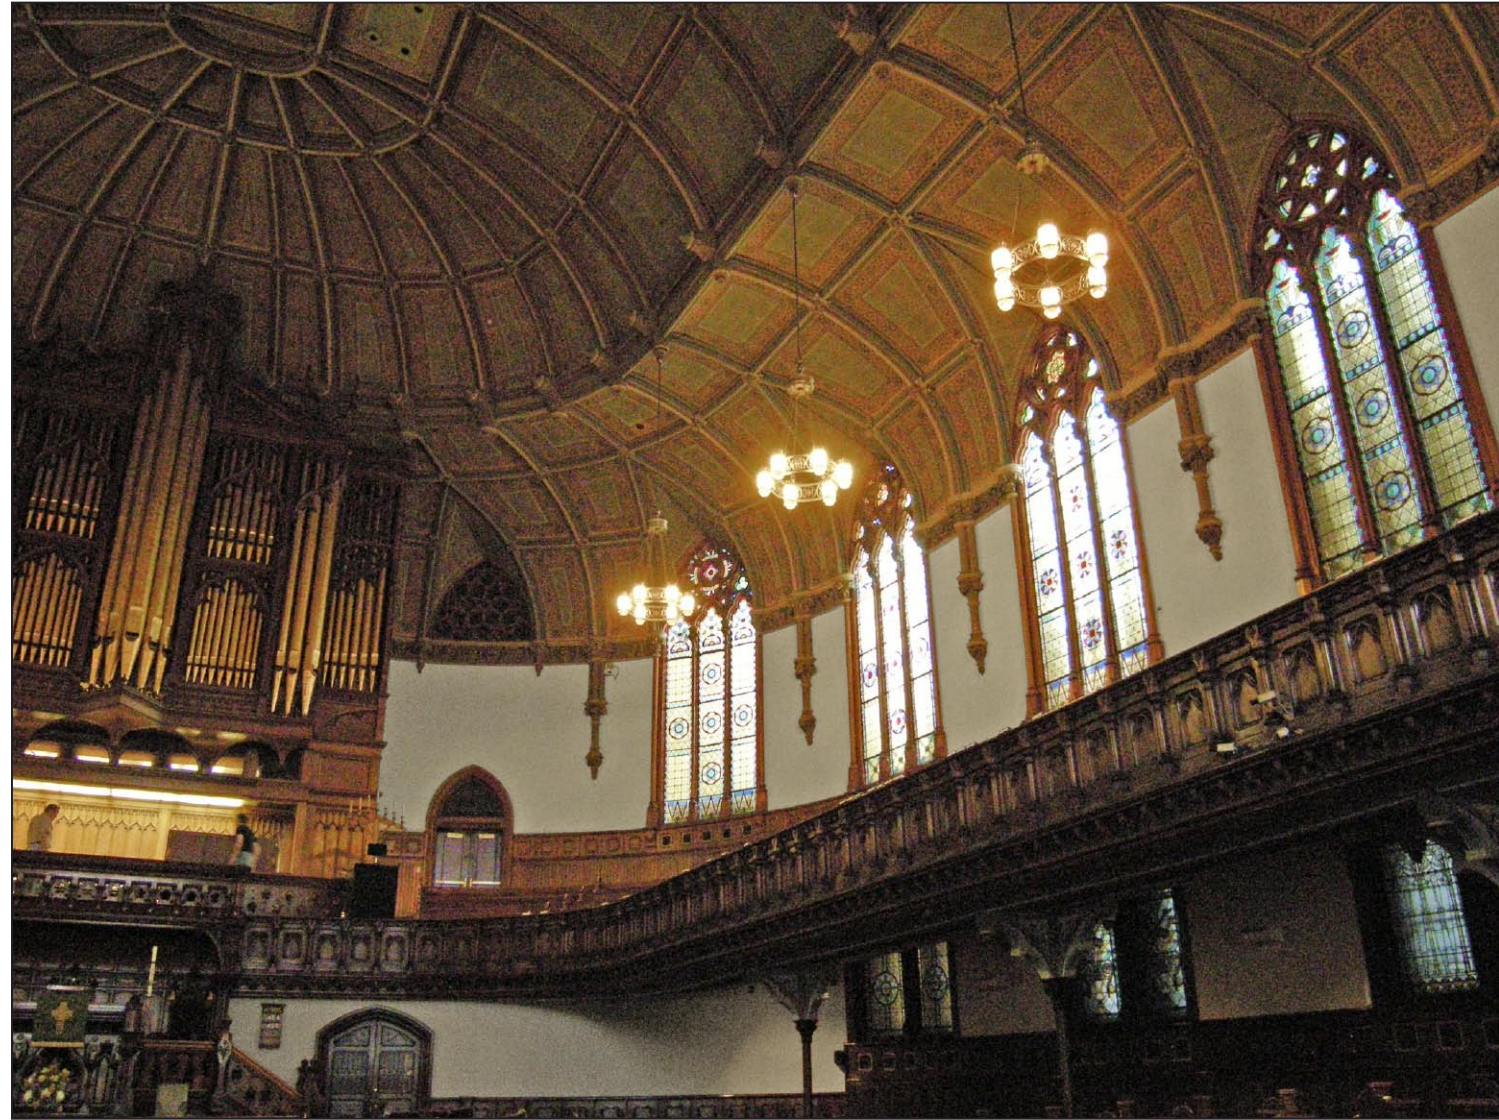
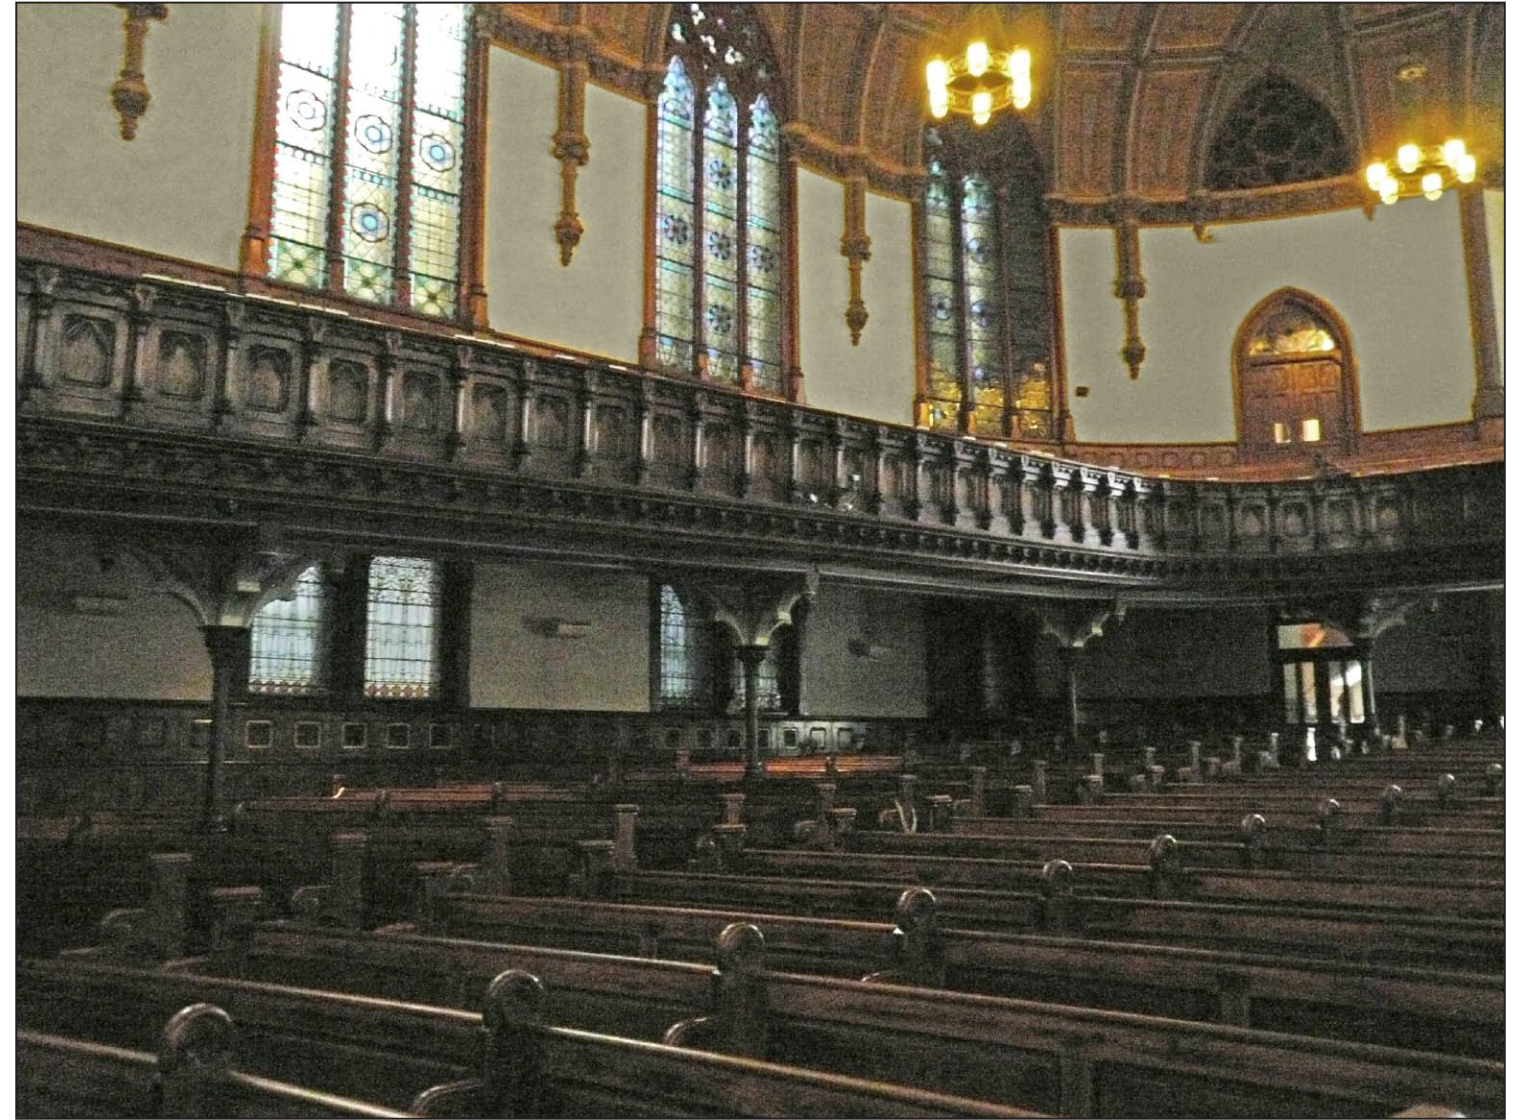
View Southeast

View Southwest

View Northwest

View Northeast

In the sanctuary there are six groupings of three windows each above the balcony on both the north and south sides of the sanctuary (see **Figures 20-3** and **20-4**). On the lower level six groupings of two windows line up below the upper windows as seen from West 55th Street; however, the westernmost pairs of windows are at least not visible on the interior of the sanctuary. In some of the upper windows, the shadow of radiators, which stand in the cavities several feet above the sills, also can be seen. To varying degrees through the day the shadow of the exterior walls can be seen on the interior windows. This is particularly visible in the southwest and southeast corner windows with the deeper recesses. On the north side the east and west corner windows are also darker, with the east being particularly dark due to the recent installation of air conditioning ducts and the building to the north being closer. In general, the windows on the sanctuary's north elevation are muted due to the proximity of the adjacent buildings, while the windows on the south elevation are significantly brighter as a result of direct sunlight along with ambient light contributed by reflected light from adjacent buildings.
