MANHATTAN

# EAST 20<sup>TH</sup> STREET/ FIRST AVENUE

## Description

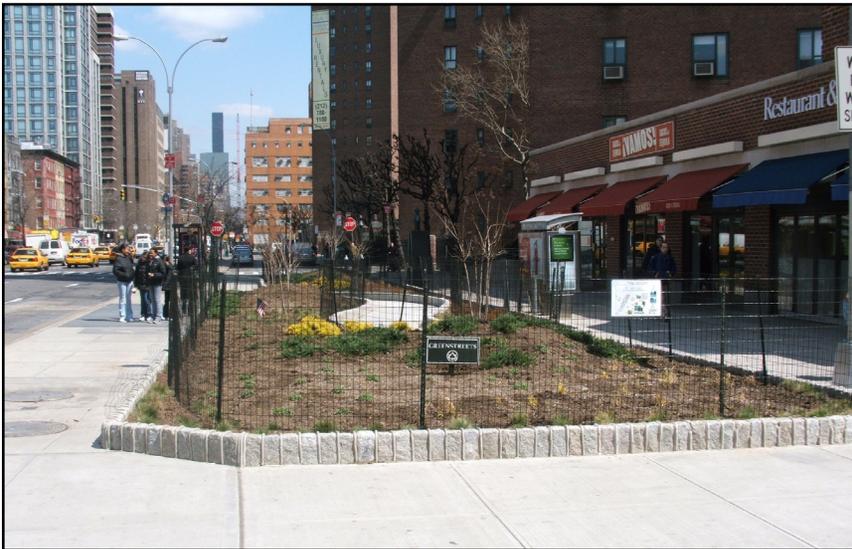
This Green Street was constructed where the service road along the eastern side First Avenue formally existed. By closing off the service area to vehicles, pedestrians have more space to walk and encounter less vehicle conflicts as they walk along First Avenue.

- The entrance to the service road on the east side of First Avenue was closed, normalizing the intersection and eliminating a portion of the service road. This reduced the distance required to cross First Avenue on the north side and allowed the Department to realign the crosswalk and shorten the crossing distance of East 20th Street on the east side. Vehicles are still able to access the service road at the existing opening in the median south of East 21st Street. As part of this closure and in conjunction with the Department of Parks and Recreation, a Greenstreet was installed between East 20th and East 21st Streets, providing an amenity to the community.

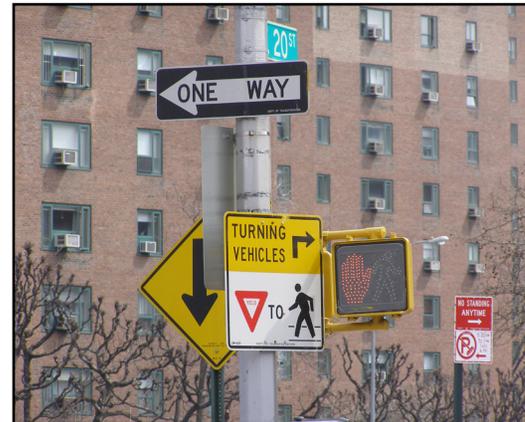
At 20th Street, this sign warns vehicles to pay attention to pedestrians crossing at this intersection.

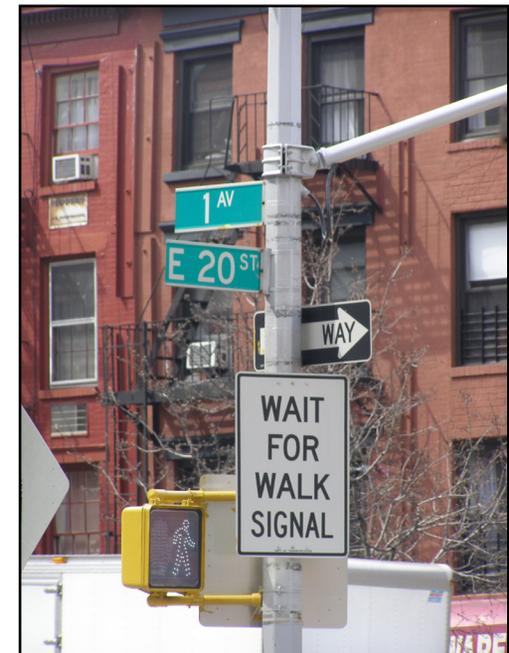
The LPI on East 20th Street gives pedestrians more time to cross the street without vehicle conflict.

- The traffic signals at East 20th Street and First Avenue were also modified to provide additional crossing time for pedestrians. The existing Leading Pedestrian Interval (LPI) across First Avenue (which allows pedestrians to begin crossing First Avenue prior to the vehicles on East 20th Street receiving a green indication) was increased to 18 seconds from 11 seconds. While the realignment of the east crosswalk resulted in the removal of the right arrow signals for northbound First Avenue, an eight second LPI was installed to supply the additional crossing time for pedestrians. Americans with Disability Act (ADA) compliant wheelchair ramps were also installed at this intersection during reconstruction.

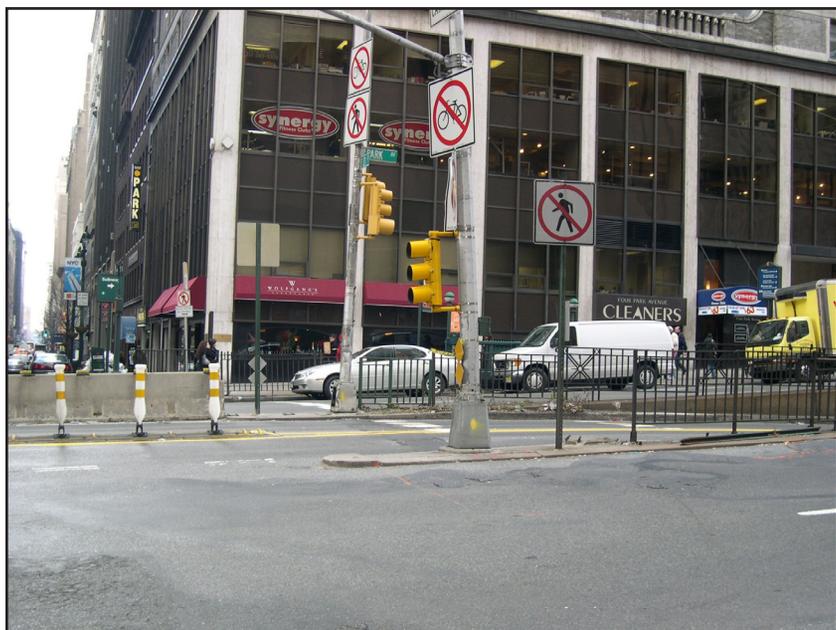
Pedestrian signage, iron pedestrian fences and other roadway improvements discourage pedestrians from crossing at this location and provide for safer vehicular movements

- A Jersey barrier separating the southbound tunnel exit from southbound Park Avenue surface traffic.
- Flexible delineators along the centerline of Park Avenue between the mouth of the tunnel and the south leg crosswalk.
- Signs prohibiting through traffic on westbound East 33<sup>rd</sup> Street and requiring all traffic to turn right to proceed northbound on Park Avenue surface road or into the tunnel (except trucks, which are prohibited in the tunnel).
- Signs to direct motorists primarily to East 31<sup>st</sup> Street to access East 33<sup>rd</sup> Street west of Park Avenue and points west.
- Signal face with right green arrow for traffic on westbound East 33<sup>rd</sup> Street approach to Park Avenue.
- Daylighting of the south curb of East 33<sup>rd</sup> Street at the approach to Park Avenue to facilitate turning movements for trucks.

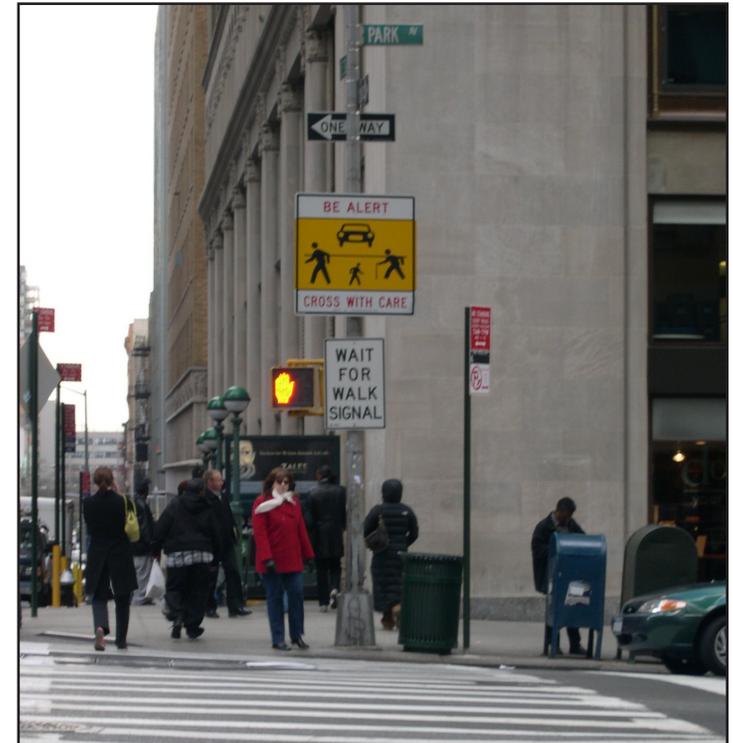
Oversized signage advised pedestrians to cross with care and wait for the walk signal

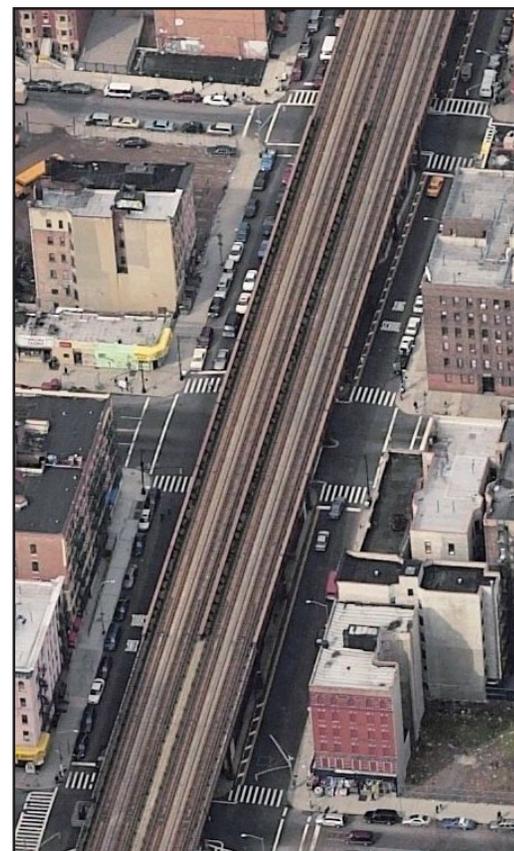
Aerial view of the Park Avenue corridor with improved markings and buffer zone

- Installed a three-foot wide thermoplastic ‘buffer’ (flush channelization) using pavement marking between East 101<sup>st</sup> and East 132<sup>nd</sup> Streets. The buffer is intended to realign the single travel lane away from the pedestrian refuge area in the center of Park Avenue’s north and south roadways. The buffer markings improve the line of sight between motorist and pedestrian as well as cause motorists to reduce speed by creating the appearance of a narrowed roadway.

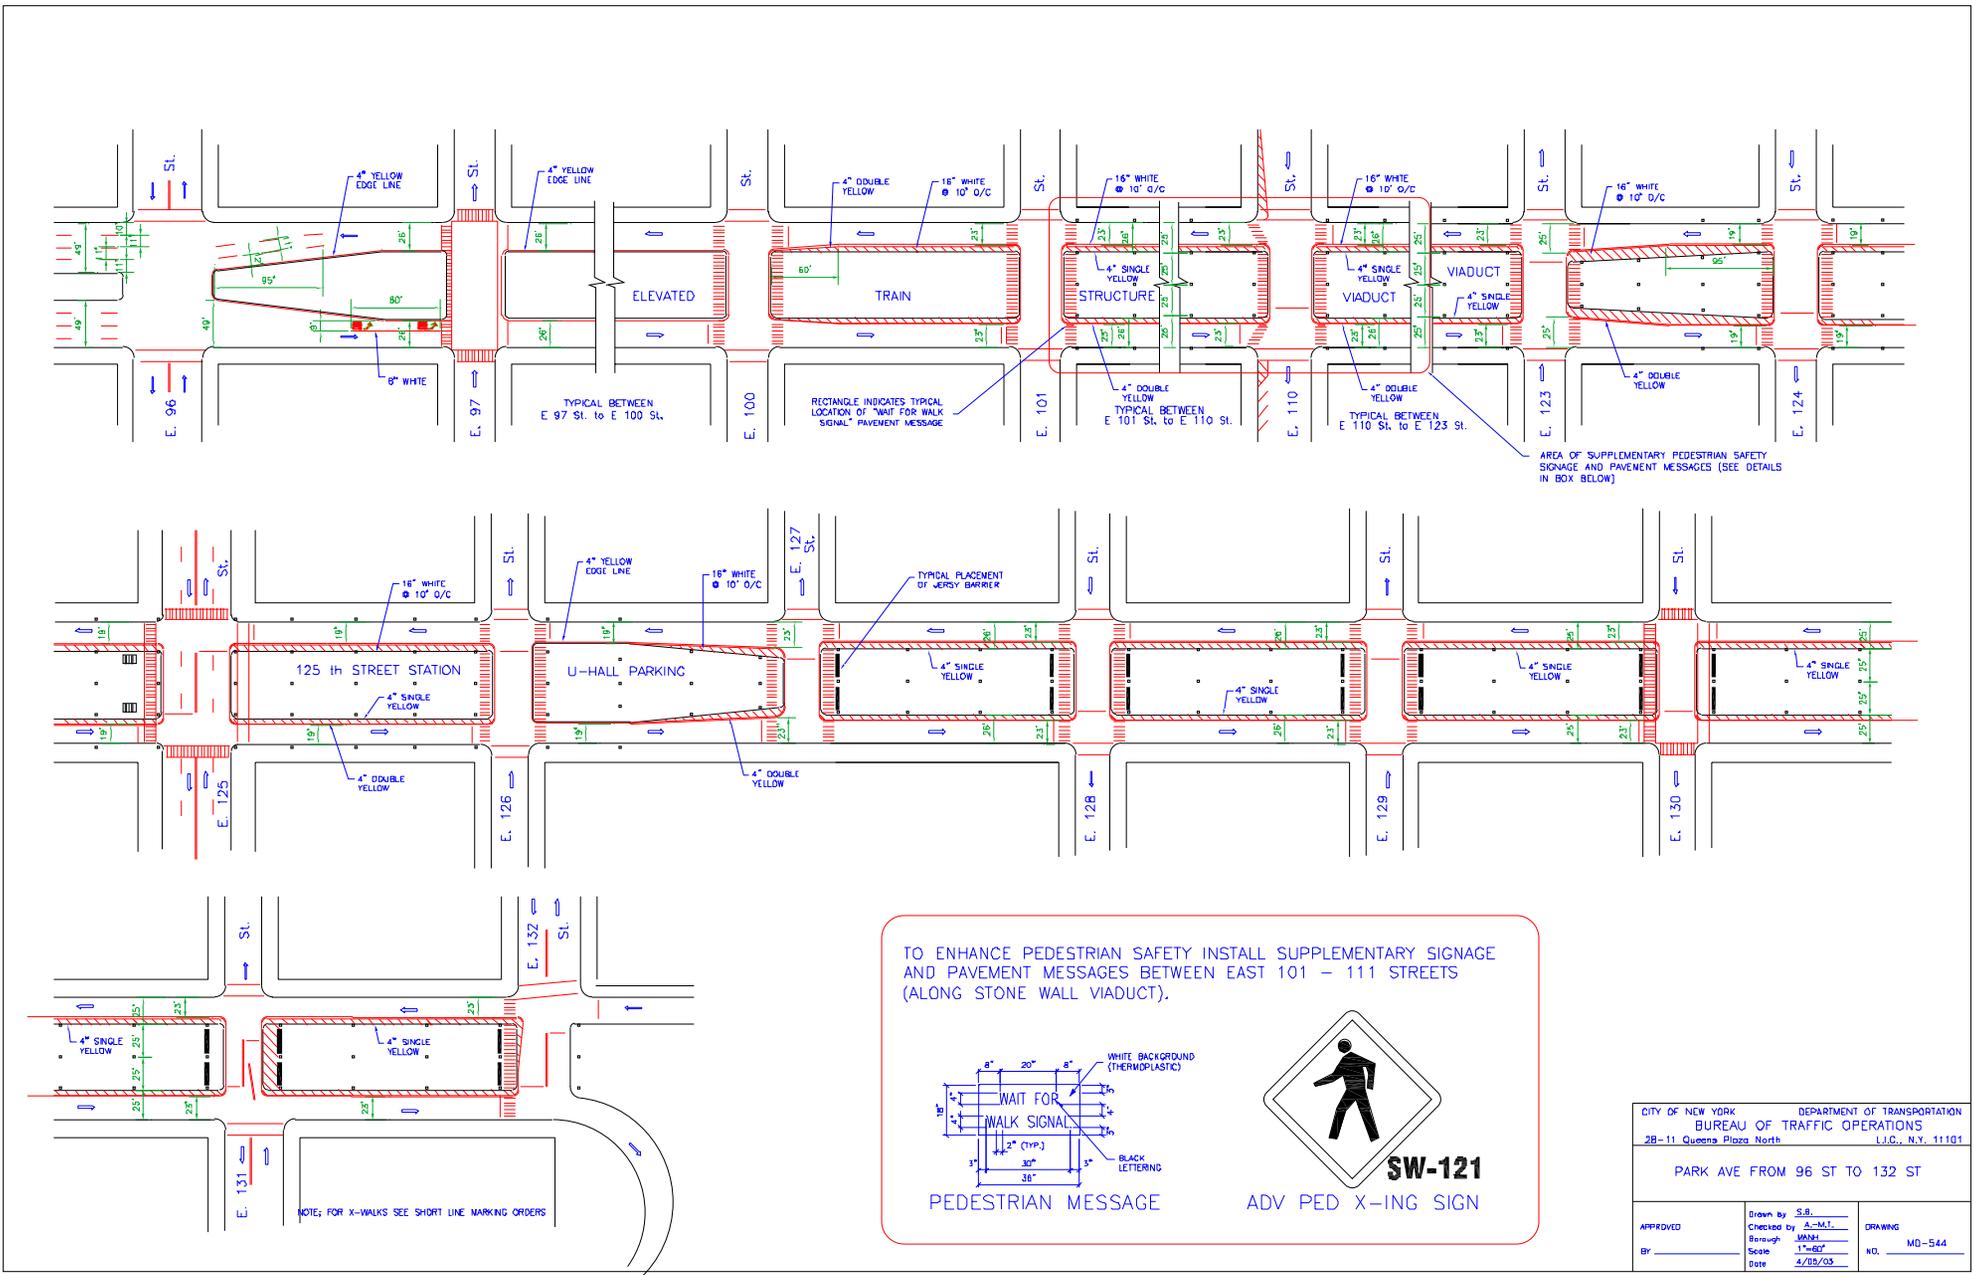
CITY OF NEW YORK		DEPARTMENT OF TRANSPORTATION
BUREAU OF TRAFFIC OPERATIONS		L.I.C., N.Y. 11101
28-11 Queens Plaza North		
PARK AVE FROM 96 ST TO 132 ST		
APPROVED	Drawn by <u>S.B.</u> Checked by <u>A.M.L.</u> Design <u>JMM</u> Scale <u>1"=60'</u> Date <u>4/18/03</u>	DRAWING NO. <u>MD-544</u>

TO ENHANCE PEDESTRIAN SAFETY INSTALL SUPPLEMENTARY SIGNAGE AND PAVEMENT MESSAGES (ALONG STONE WALL VIADUCT).

PEDESTRIAN MESSAGE

**SW-121**  
ADV PED X-ING SIGN

- Installed “Wait for Walk Signal” pavement messages to advise pedestrians to wait for a fresh walk signal between East 101<sup>st</sup> and East 111<sup>th</sup> Streets where the stone walls of the viaduct severely limit visibility for both pedestrians and motorists.

- Installed advance pedestrian crossing warning signs in the section of the stone viaduct between East 101<sup>st</sup> and East 111<sup>th</sup> Streets.

The improvements are shown on the following pages.

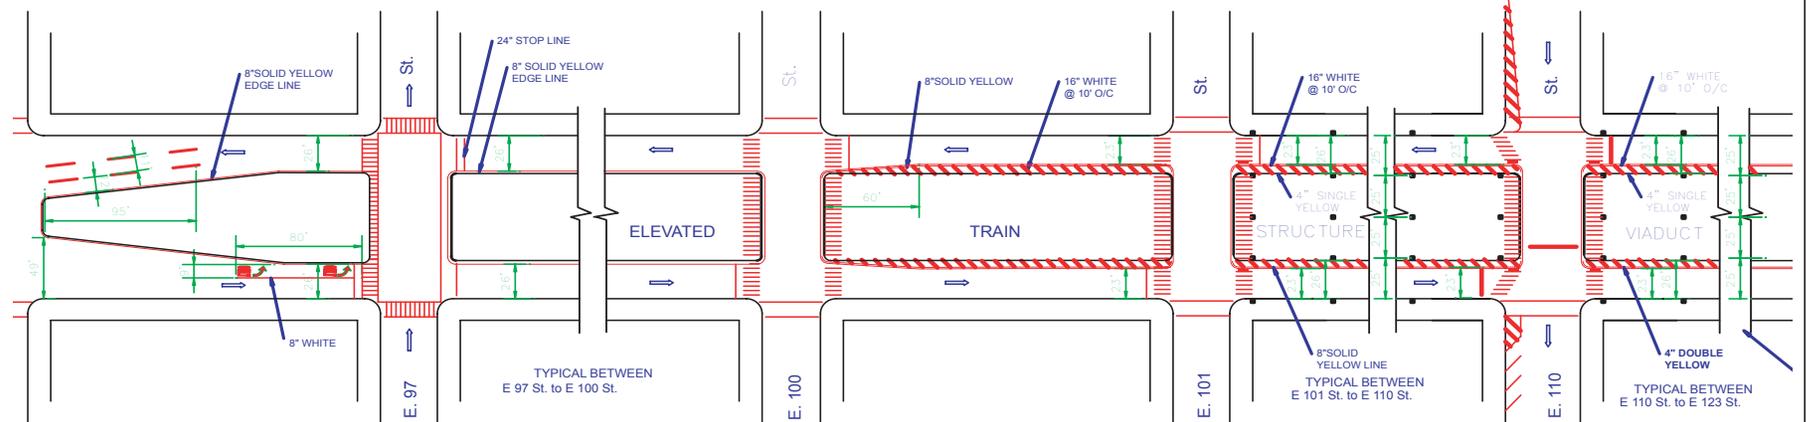
ON S/B PARK AV @ 98 STREET TAPER FROM 30 FT. IN ADVANCE OF EXTENDED E. CURB EDGE LINE AROUND THE EXPOSED CURBLINE

OFFSET X-WALKS ON PARK AVE. BETWEEN E. 101-111 STREETS SO THAT X-WALKS LEAD TO OPENING PROVIDED INSTONE WALL FOR PED. PASSAGE.

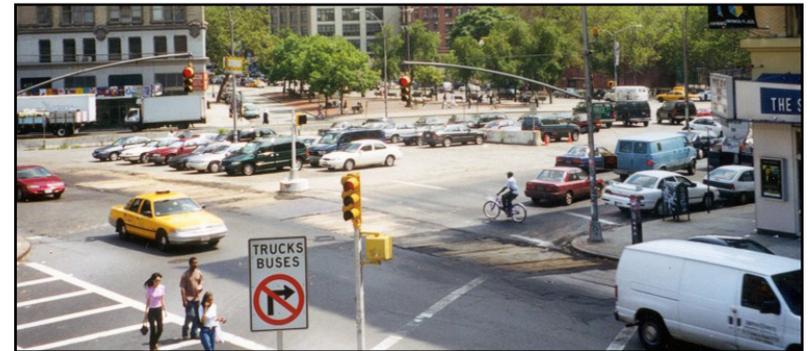
In its original configuration, the triangle was used as a temporary parking lot and did not provide adequate pedestrian space

The triangle lies due east of the Holland Tunnel Exit Rotary and experiences significant traffic exiting from the Tunnel and heading onto Canal Street and into Lower Manhattan. Currently, traffic signals and street lights within the triangle are on concrete cylinders. There is no curb or graded sidewalk separating the non-roadway portion of the area with the marked street. Parking within the triangle was largely unregulated and the area was frequently used as a storage area for disabled vehicles from the Holland Tunnel.

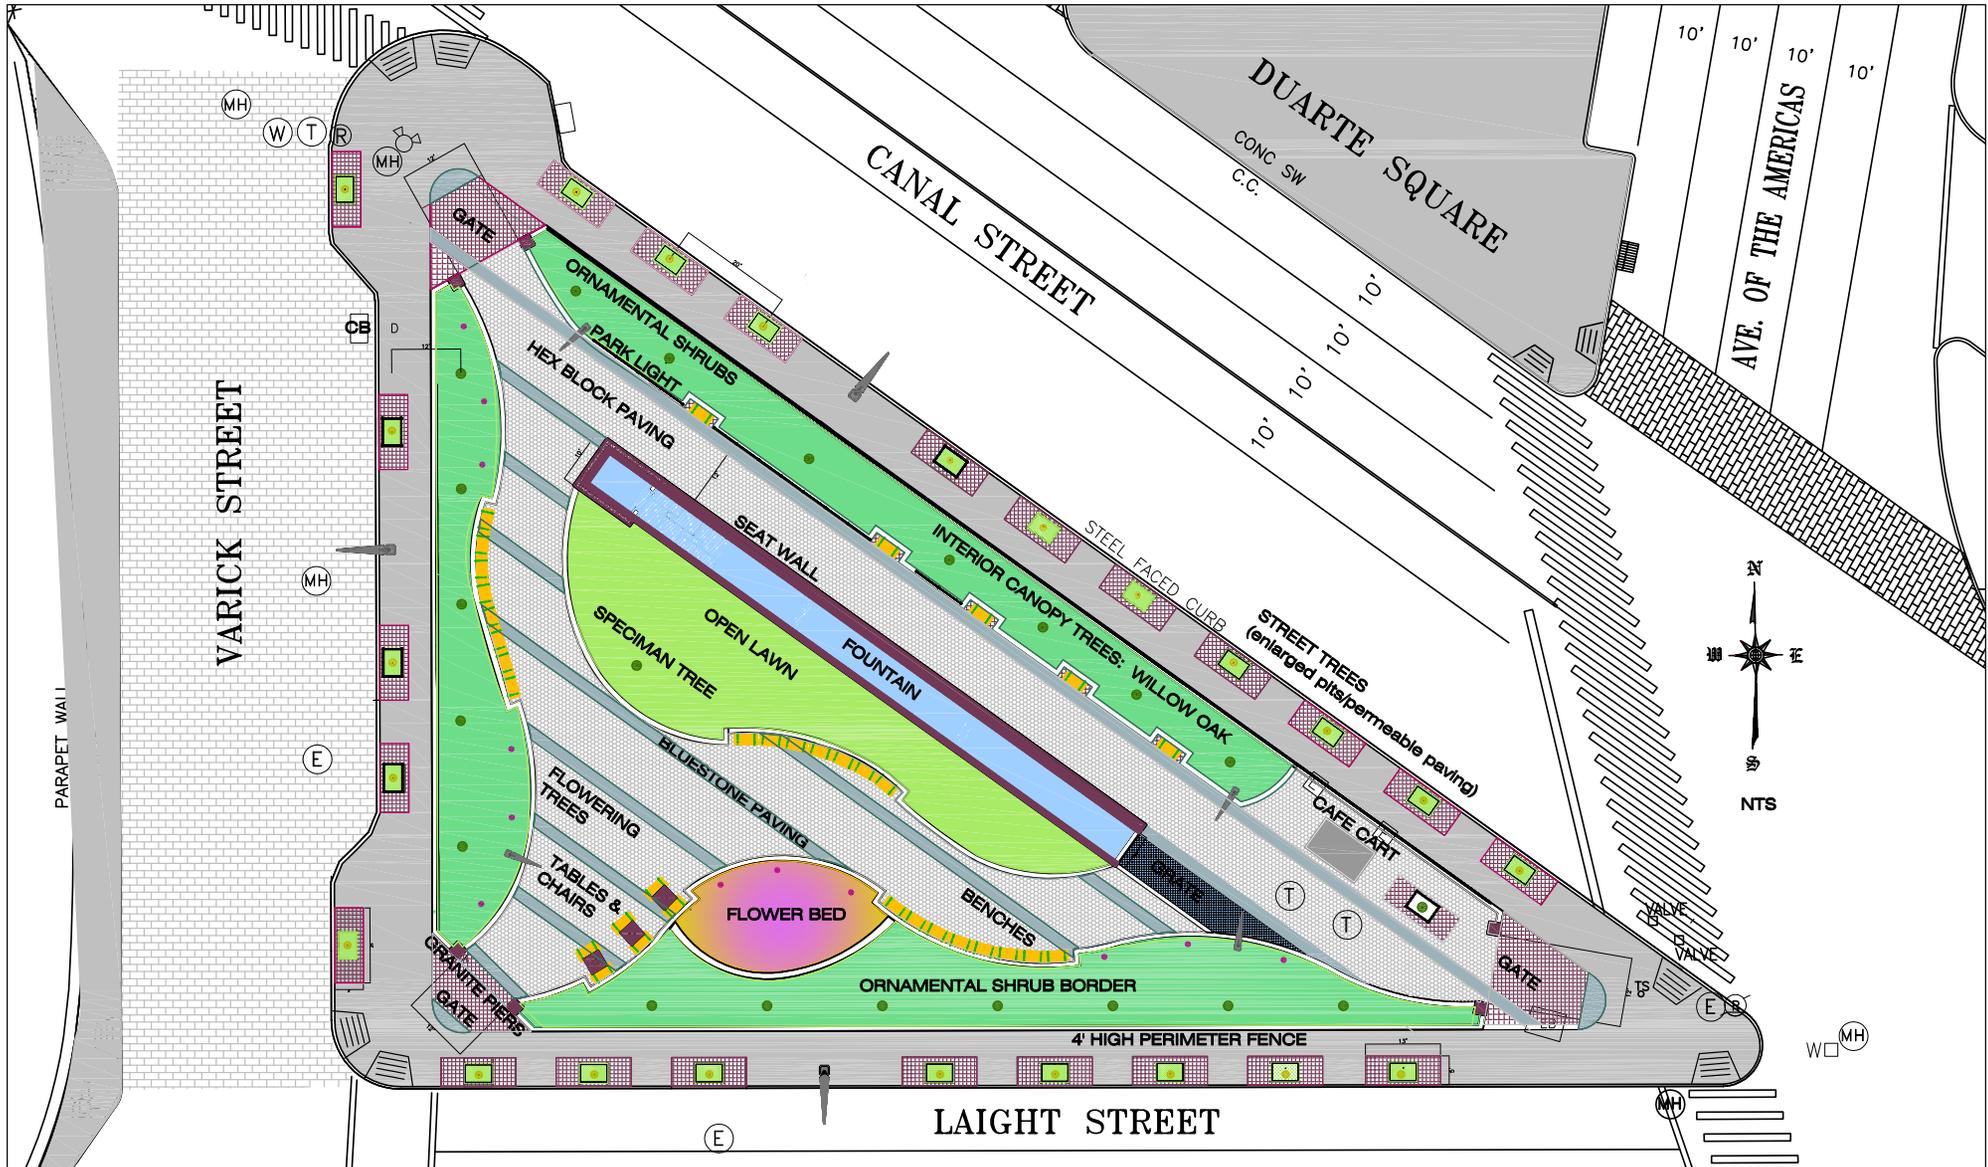
SCHEMATIC SITE PLAN

<p>City of New York Department of Design and Construction</p>	<p>NEW YORK CITY </p>	
	<p>JOB TITLE: LOWER MANHATTAN INFRASTRUCTURE PROJECT</p>	
<p><b>LiRo-Kassner, Inc.</b> 3 Aerial Way Syosset, New York</p>	<p>DRAWING TITLE: <b>CANAL STREET / VARICK STREET LAYOUT PLAN</b></p>	
	<p>DATE: JANUARY, 2004 DESIGNED BY: R.M. DRAWN BY: J.J.D.</p>	<p>DATE: 02-44-2050 CHECKED BY: R.M. PROJ. ENG: J.J.D.</p>

TRIANGLE AT  
CANAL, VARICK & LAIGHT STREETS

- March 2003
  - DOT – Manhattan Street Maintenance excavated the triangle area and prepared it for construction
- June 2003
  - Department of Design and Construction – Restoration of Varick Street roadway and replacement of the sidewalk on the western side and the curb on the eastern side
- Fall 2003
  - DOT - Installed new streetlights on Canal Street, Laight Street and Varick Street
- September 2004
  - DOT – Relocated and modified street light and signal poles and traffic and pedestrian signals to accommodate the new street alignment
- October 2004
  - Port Authority of New York and New Jersey – Construction of the sidewalk around the triangle and installation of curbs on Laight and Canal Streets
- Winter/Spring 2006
  - New York City Parks Department – Redesign Park
- Spring 2006
  - Implementation of interim plan that includes site cleanup and installation of sod lawn

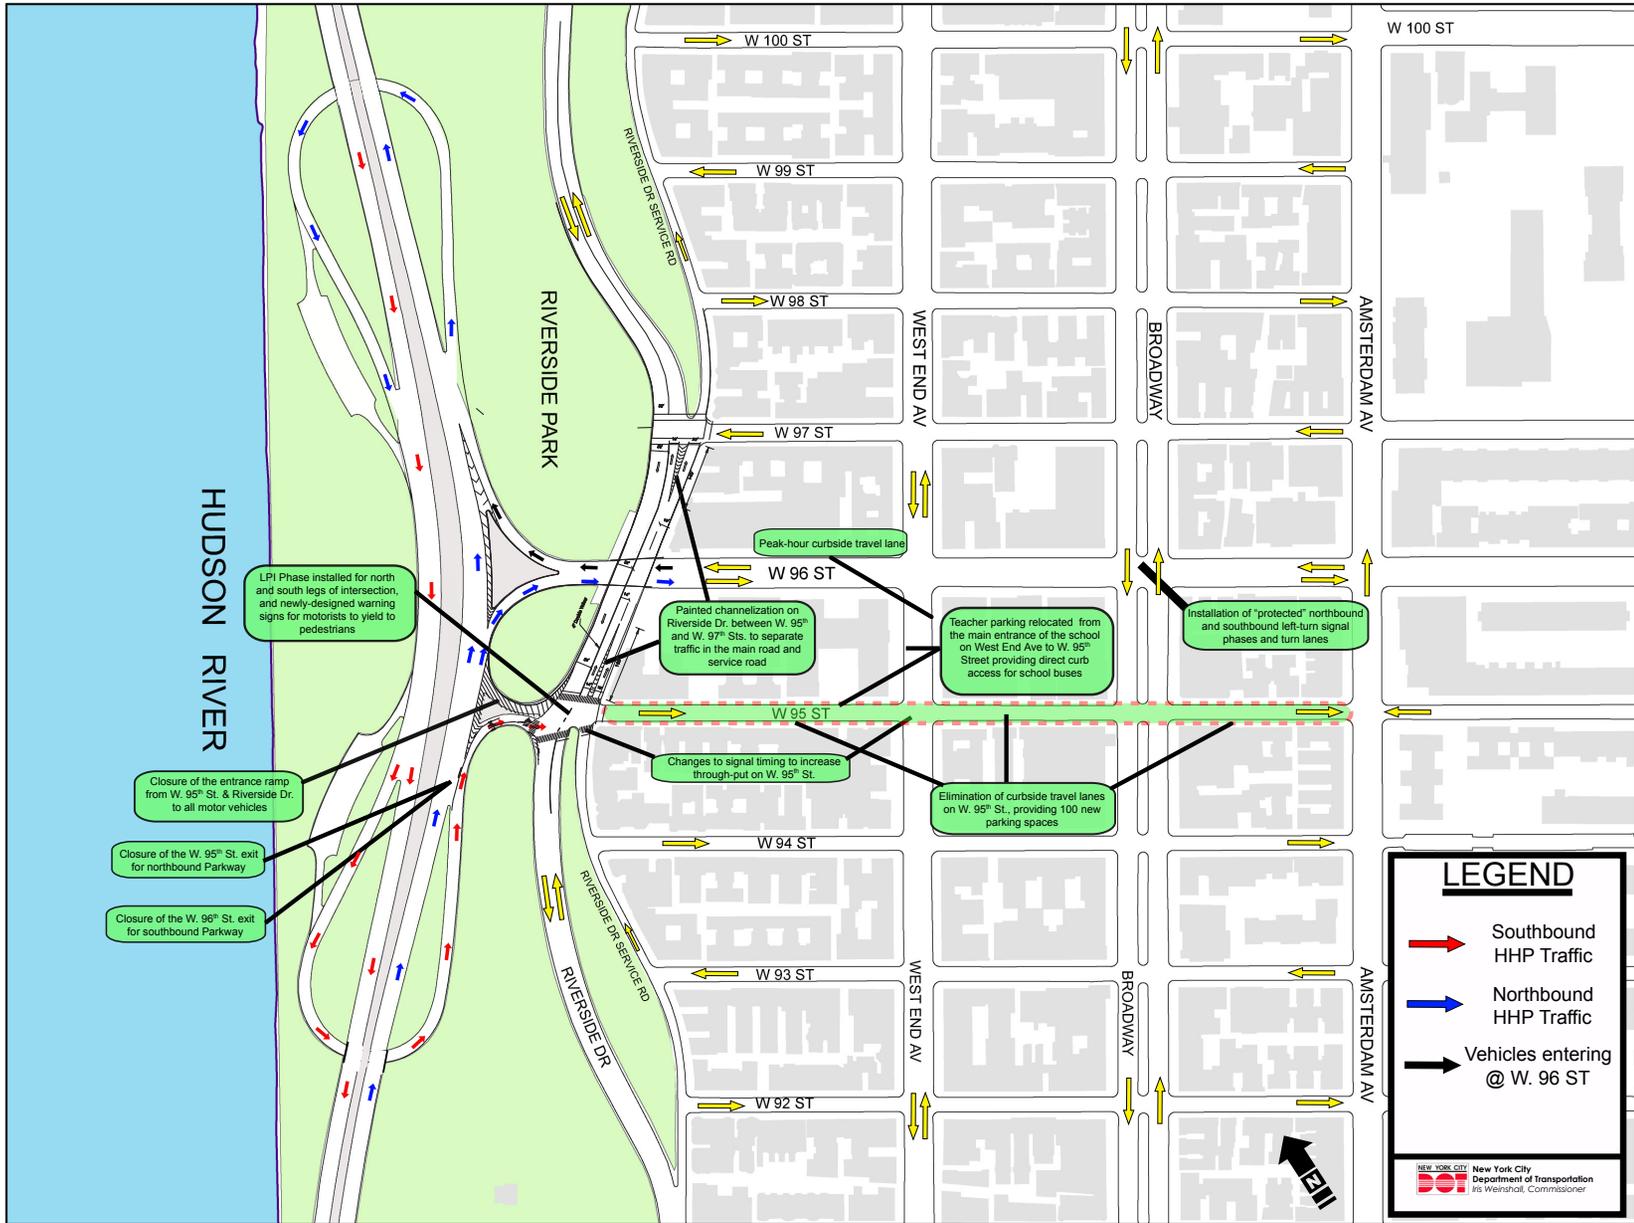
While the operation of the Henry Hudson Parkway interchange was the central component of this initiative, the safety improvements and changes in regulations on the interchange's supporting intersections provide for a substantial improvement in pedestrian and vehicular safety throughout the area. Although each component is detailed in the following pages, the illustration on the following page summarizes the overall improvements.

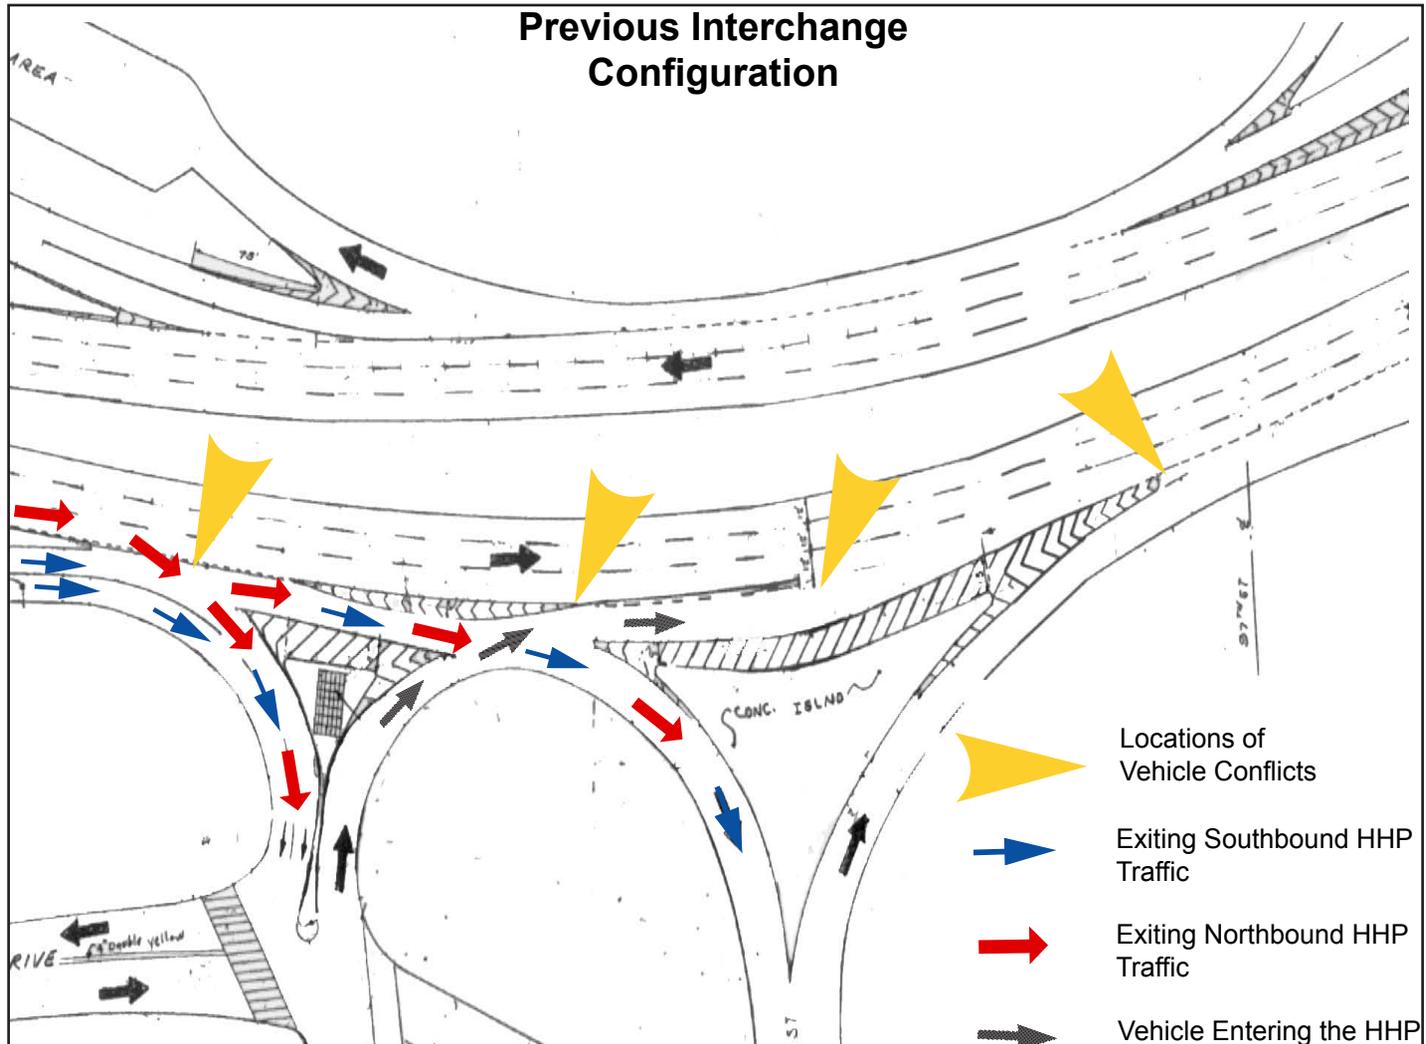
The original configuration of the interchange, as well as conflict points is illustrated graphically below:

The interchange had provided two pairs of closely spaced entrance and exit ramps, all with substandard conditions for weaving, accelerating/decelerating and queuing. This design required all vehicles exiting the Parkway from both the northbound and southbound directions to utilize a single ramp. From this ramp, they had the option to exit at either West 95<sup>th</sup> or West 96<sup>th</sup> Street. Additionally, the exit ramp also served as the entrance ramp for vehicles entering the northbound parkway from West 95<sup>th</sup> Street. The substandard weaving section created chronic vehicle conflicts resulting in frequent overtaking and rear-end crashes. Vehicle merges were made more difficult by the large speed differential in traffic entering and exiting the Parkway. Furthermore, the interchange created undesirable demands on nearby local streets that served the access and egress needs of the Parkway.

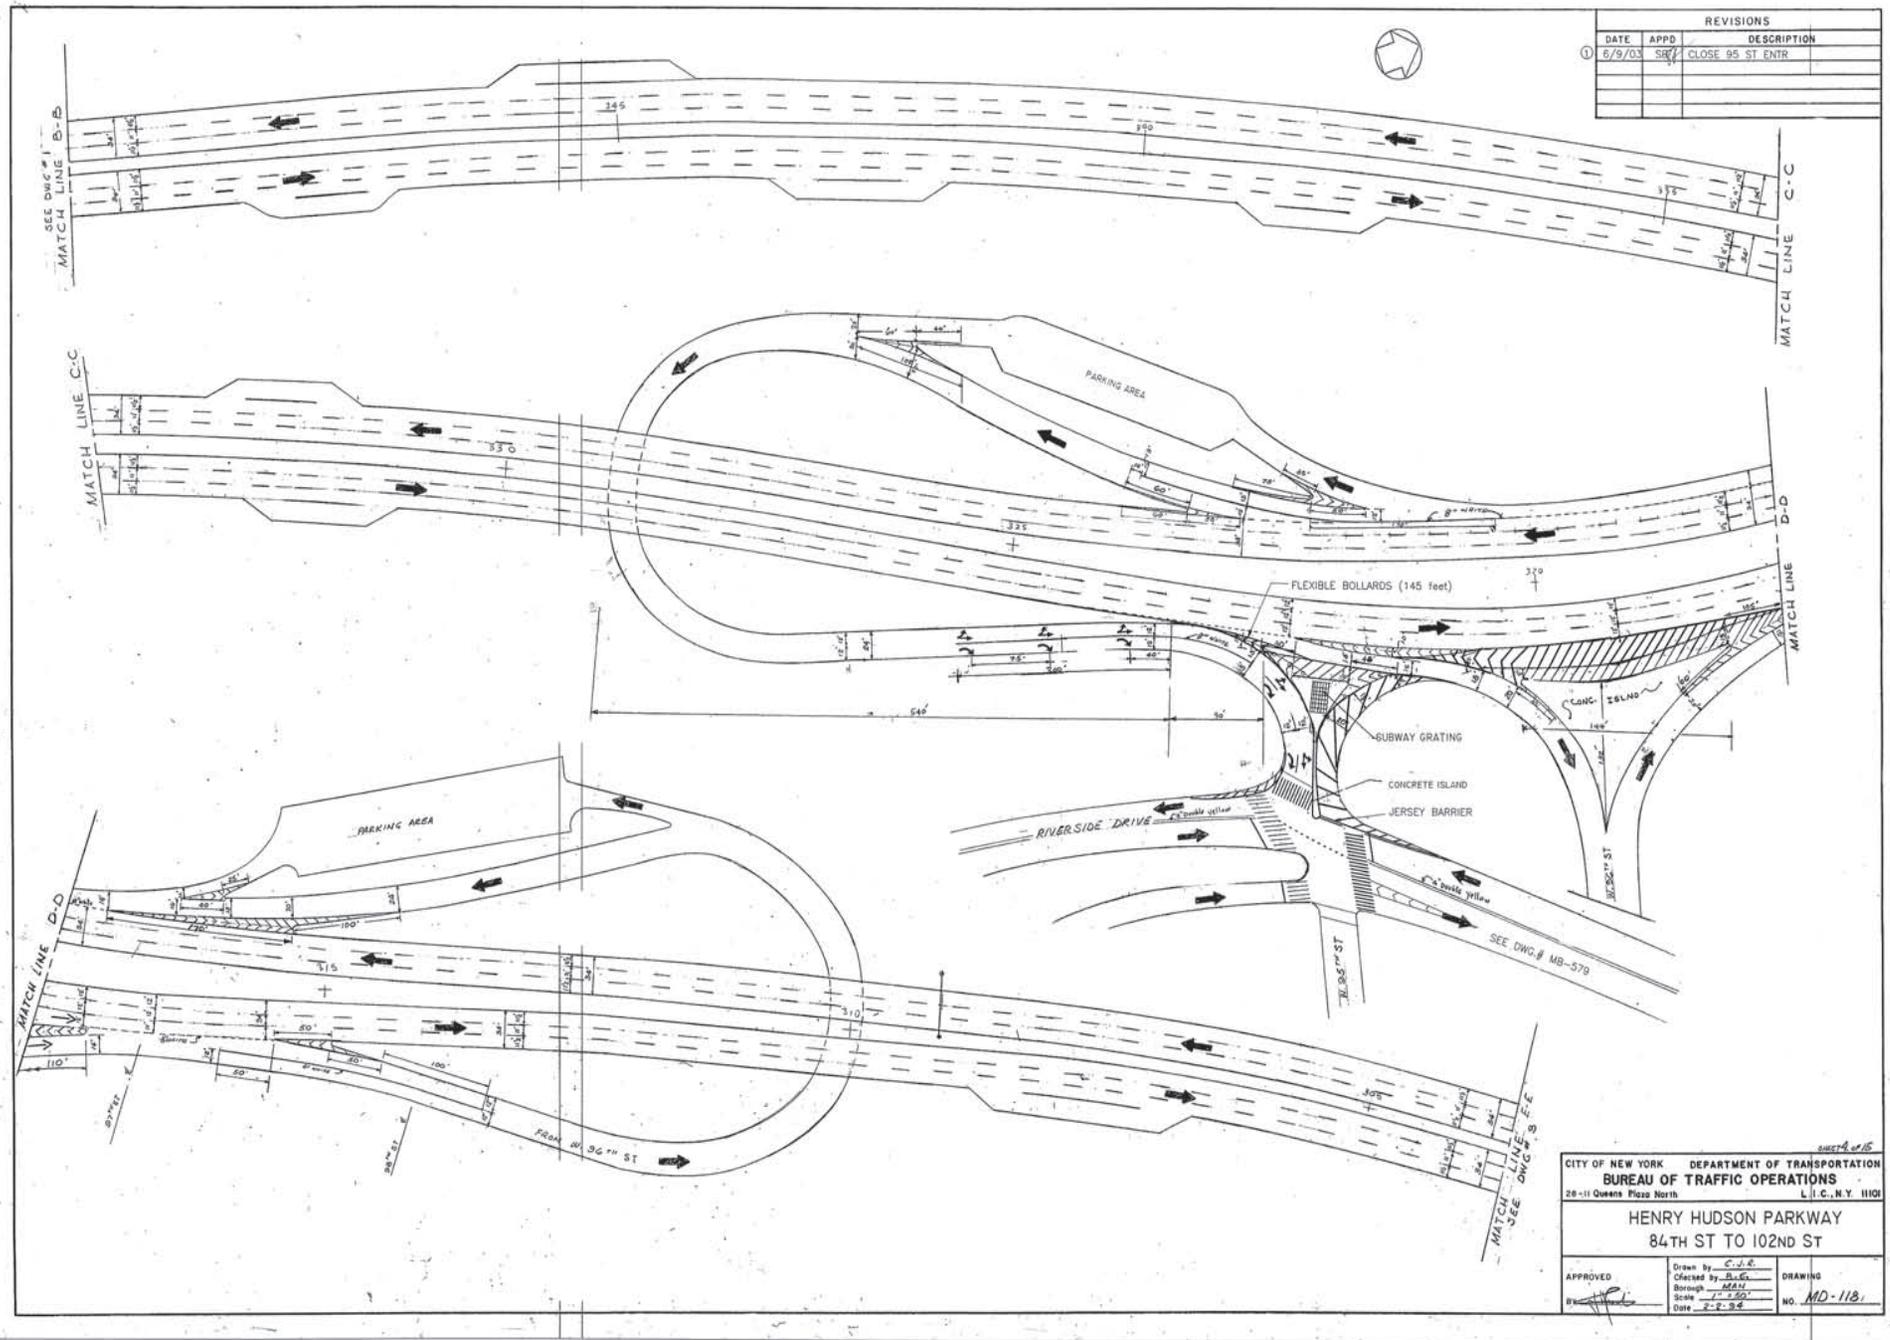
SHEET 4 OF 15

REVISIONS		
DATE	APPD	DESCRIPTION
6/9/03	SBV	CLOSE 95 ST ENTR

**HENRY HUDSON PARKWAY**  
 84TH ST TO 102ND ST

- Closing the entrance ramp from West 95<sup>th</sup> Street and Riverside Drive to all traffic
- Eliminating the West 95<sup>th</sup> Street exit for exiting northbound HHP traffic
- Eliminating the West 96<sup>th</sup> Street exit for southbound traffic

The improvements and resulting changes in traffic flow are shown on the following two pages.

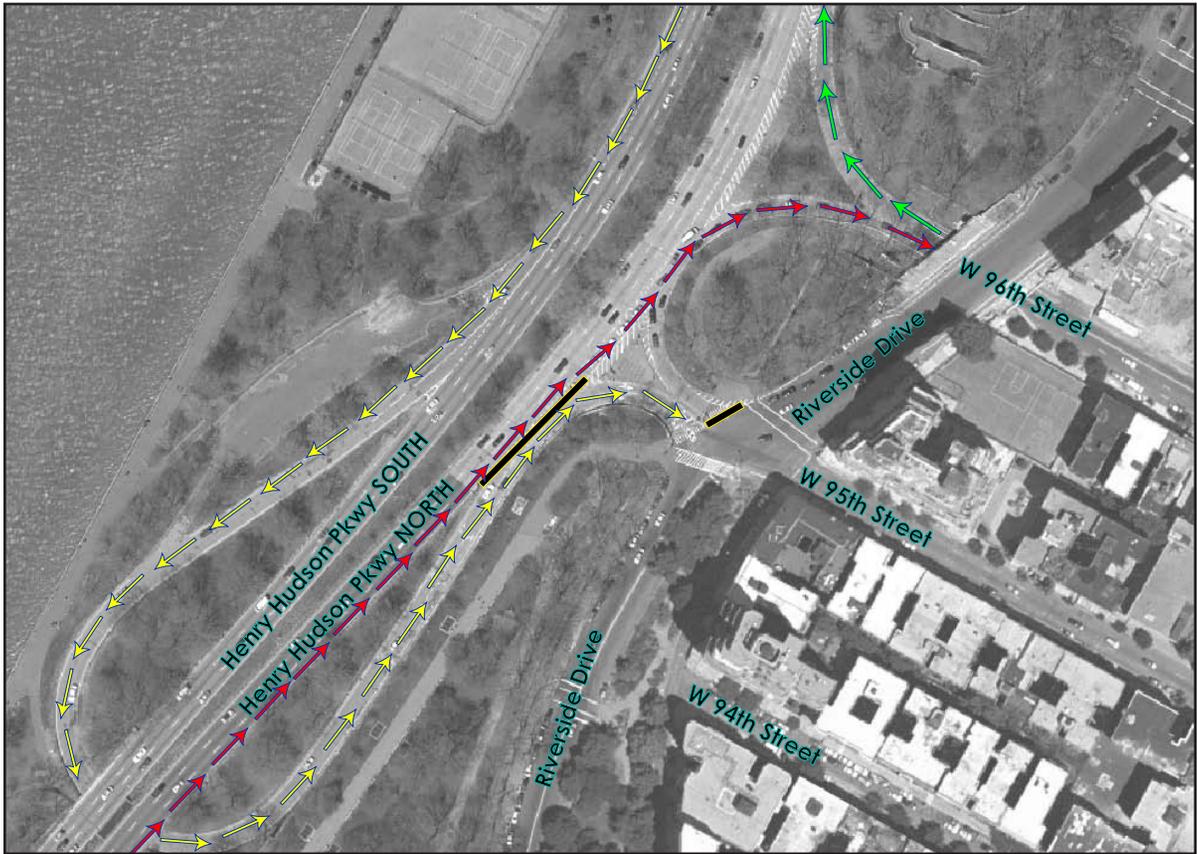
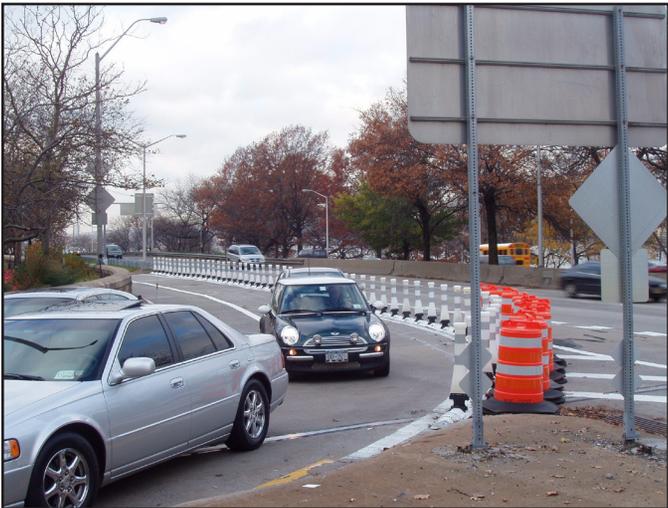
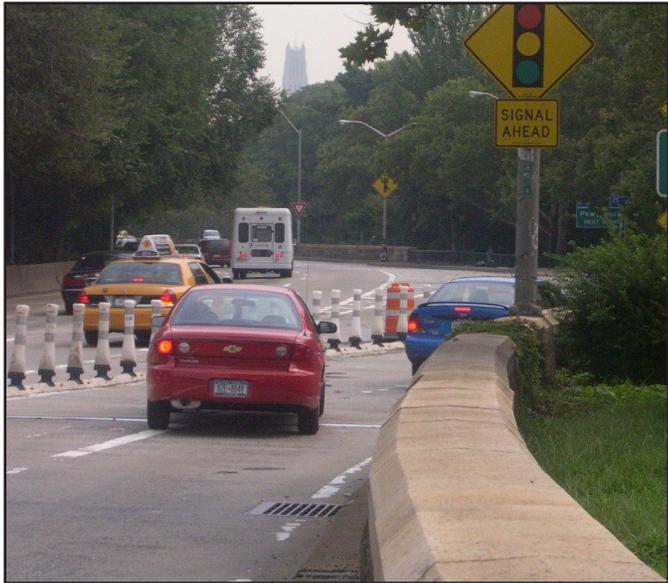
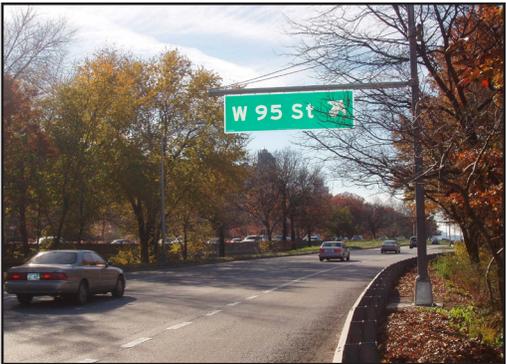
Clockwise from above: The operation of the Henry Hudson Parkway/ West 95<sup>th</sup>/96<sup>th</sup> Street Interchange under the new configuration. Flexible delineators, traffic barrels and improved markings for southbound vehicles exiting at West 95<sup>th</sup> Street. Advanced signage advises motorists of approaching signal. Oversized gantry mounted signage advises motorists of approaching exit ramp.

These treatments were implemented through the use of new markings on the roadway, advance signage, and the use of flexible bollards and delineators on all approaches and ramps. This represented a highly effective, low cost mitigation strategy that effectively improved vehicular safety at the interchange. **A**

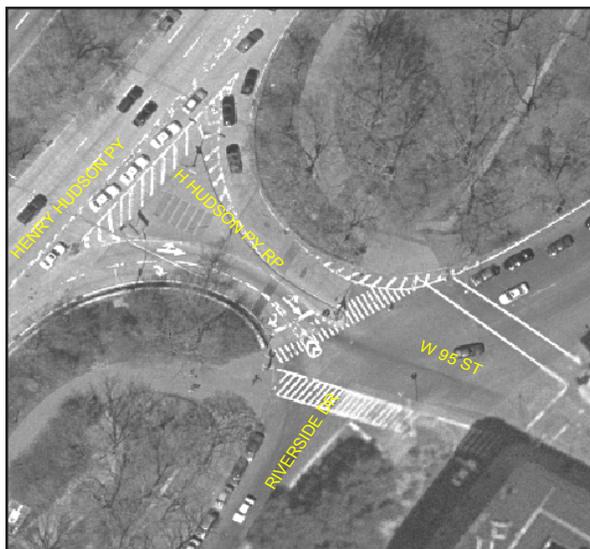
Original configuration of Intersection

The intersection of West 95<sup>th</sup> Street and Riverside Drive was a signalized four-way intersection with an entrance and exit ramp to the Henry Hudson Parkway along its western leg. Due to the curvature of the exit ramps from the northbound Henry Hudson Parkway, motorists had little time to react to pedestrians crossing the southwest side of the intersection. Motorists entering the northbound Henry Hudson Parkway, especially those turning from southbound Riverside Drive had limited visibility of pedestrians crossing on the northwest side of the intersection. Additionally, there was insufficient refuge area for pedestrians crossing between the exit and exit ramps.

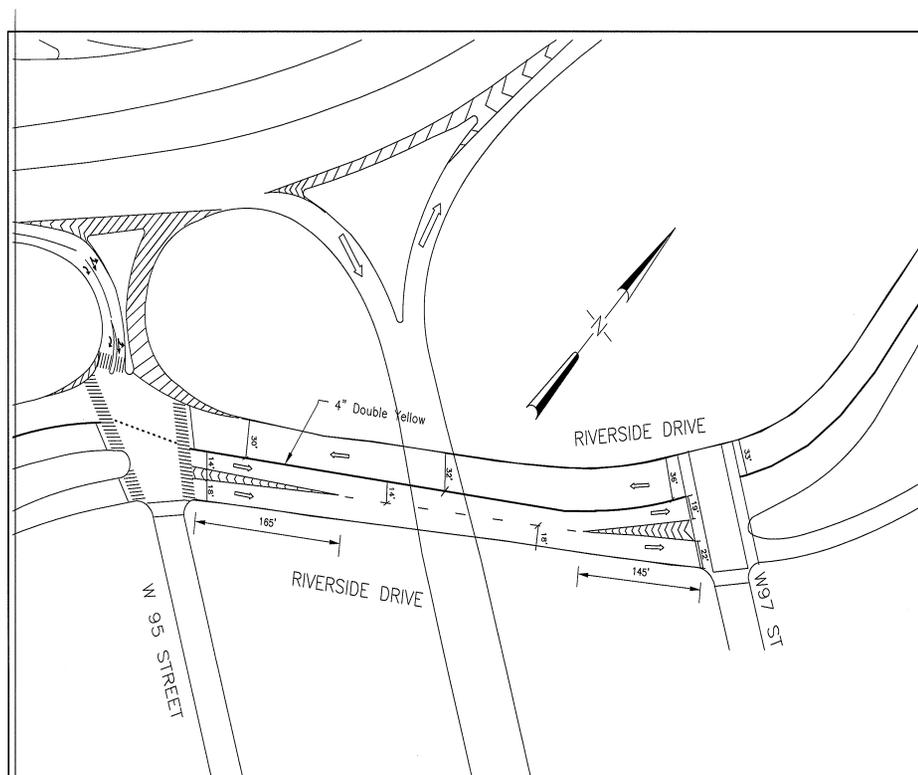
Details of new roadway markings and channelization on Riverside Drive

- As part of the overall changes in the operation of the Henry Hudson Parkway interchange, the Department closed the entrance ramp from West 95<sup>th</sup> Street and Riverside Drive to reduce conflicts on the Parkway. This closure was implemented through the use of signage and barriers.
- In an effort to better channelize traffic and organize weaving movement between the main roadway and service road of Riverside Drive, the Department installed additional roadway markings between West 95<sup>th</sup> and West 97<sup>th</sup> Streets. The improvement is illustrated below.

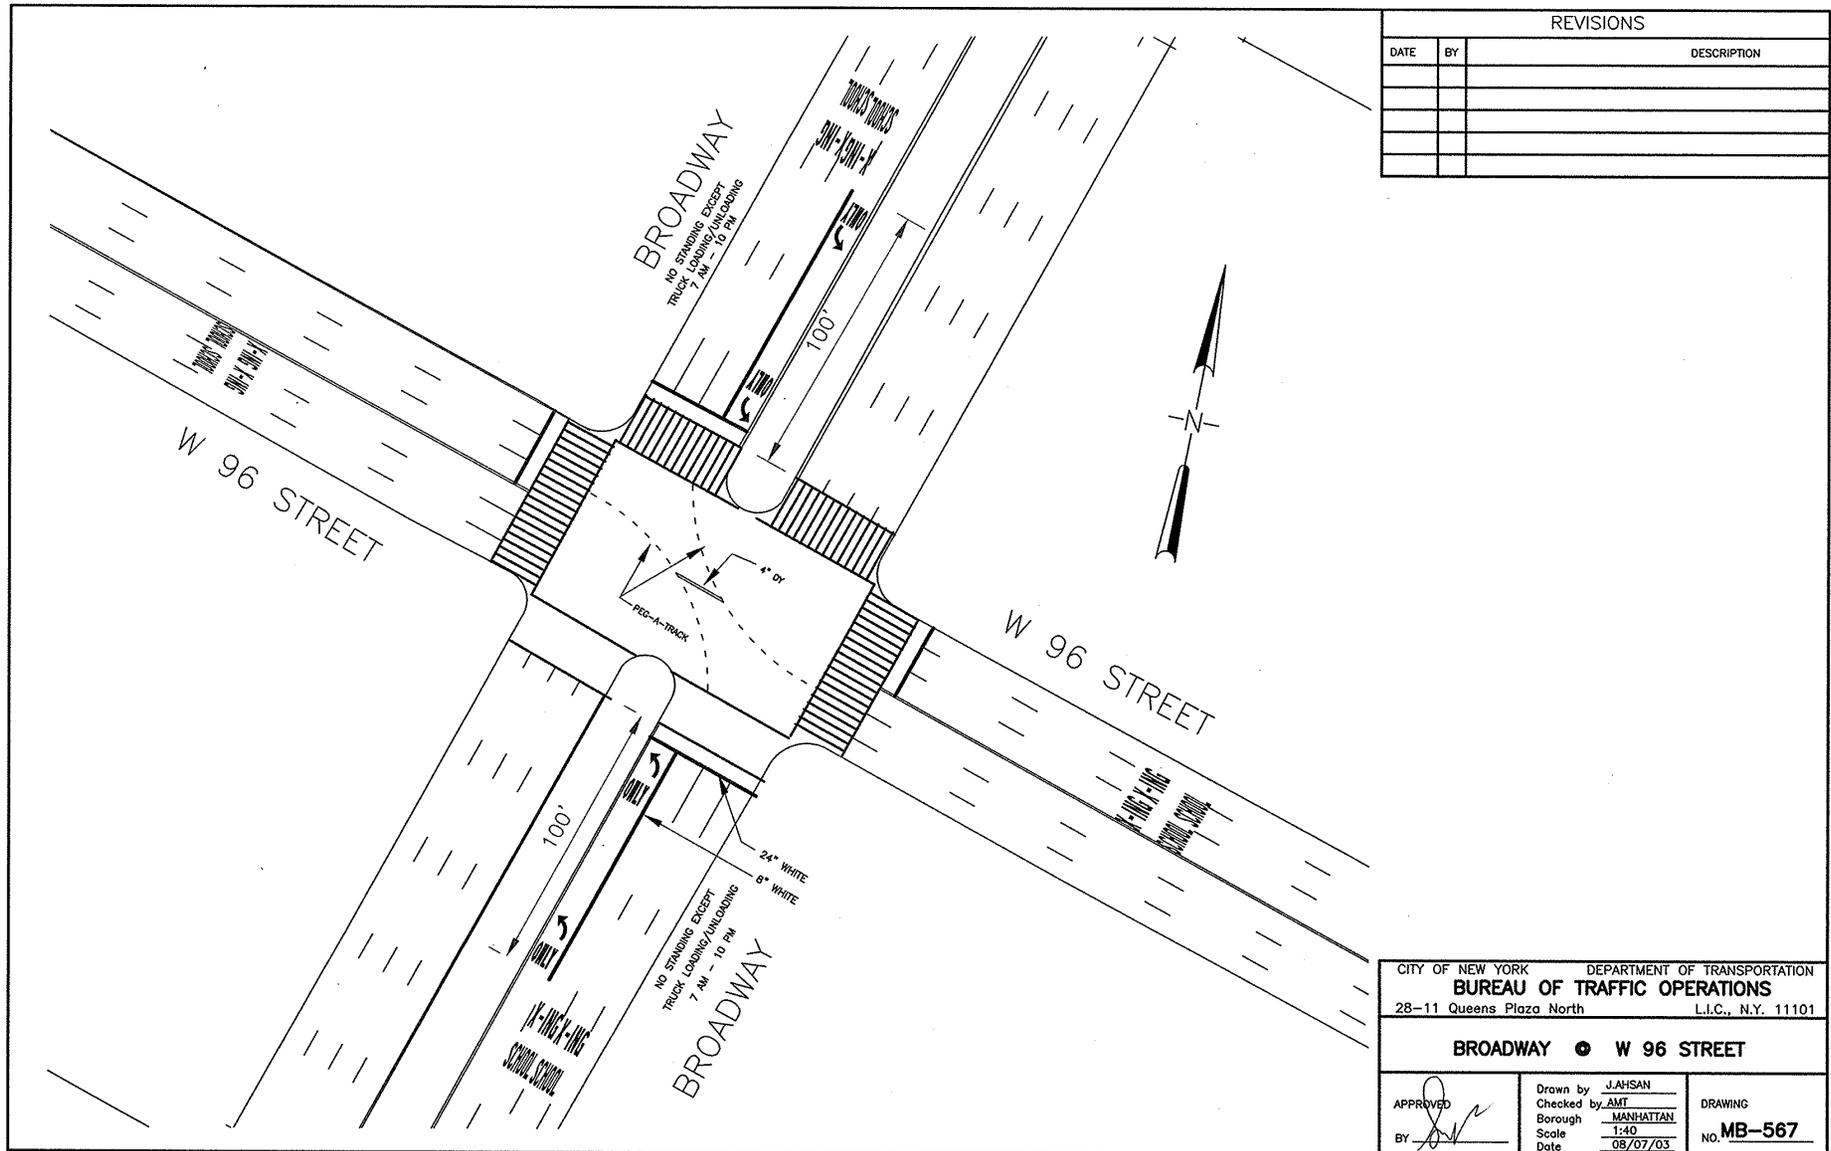
CITY OF NEW YORK		DEPARTMENT OF TRANSPORTATION	
<b>BUREAU OF TRAFFIC OPERATIONS</b>			
28-11 Queens Plaza North		L.I.C., N.Y. 11101	
<b>BROADWAY • W 96 STREET</b>			
APPROVED BY

- Installation of a left turn signal phase and left turn bays on Broadway at West 96<sup>th</sup> Street to improve the performance of the intersection and to enable left turns.
- Replacement of meters on two blockfaces with truck loading zones to prevent double parking and ensure that at least two travel lanes are available for through traffic.

The improvements are shown on the following page.
