Broadway at West 71st Street and Amsterdam Avenue

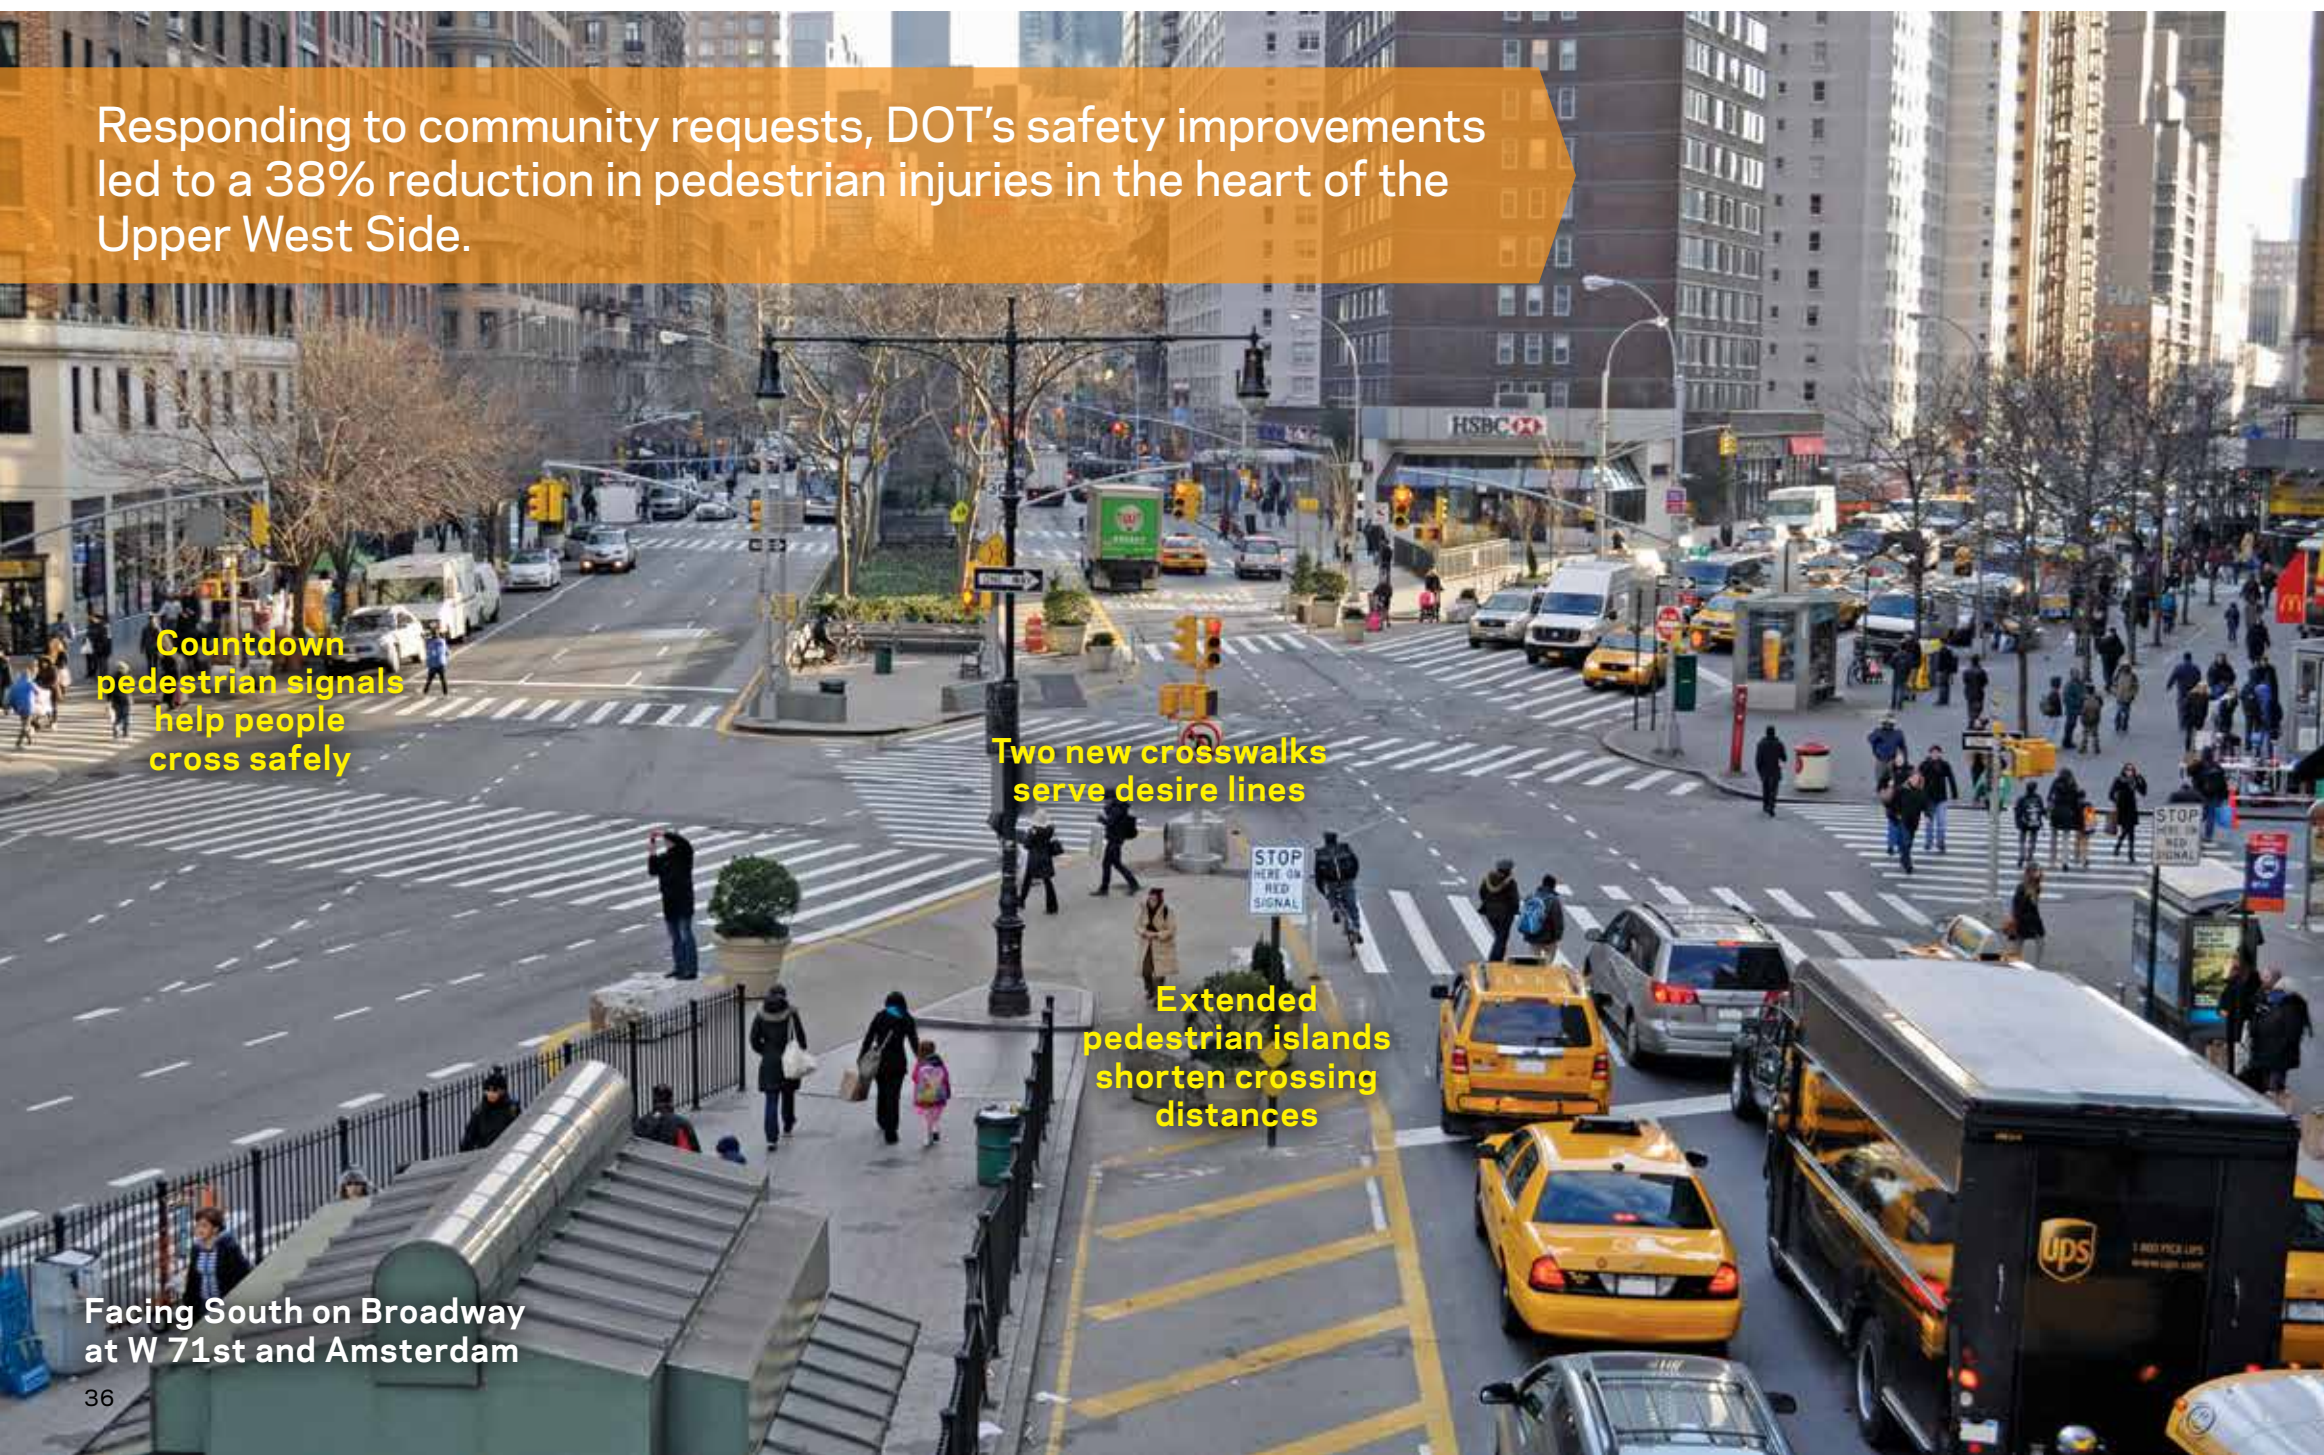
Facing South on Broadway at W 71st and Amsterdam

Countdown pedestrian signals help people cross safely

Two new crosswalks serve desire lines

Extended pedestrian islands shorten crossing distances

DOT created extensions with markings and granite blocks. In addition to providing more pedestrian space, these areas increase people's visibility to traffic and reduce crossing distances. DOT also added two new crosswalks at major pedestrian "desire lines" - routes that had not been designated crossings but which many people used nonetheless. One of these desire lines runs through the center of

the intersection, connecting the subway station with the Broadway Mall to the south. By improving pedestrian access and providing a buffer against passing traffic, DOT's project strengthens the 71st Street Greenstreets and Broadway Malls as functional public spaces.
