228 West 11th Street Application

Docket #187792

228 West 11th Street

Woodwork Paint Analysis

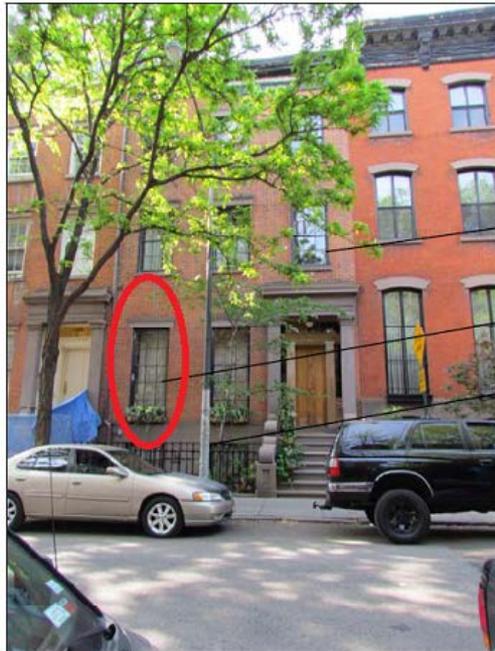
PAINT SAMPLE LOCATIONS

W11-05, 06
 W11-03 **04**
 W11-01, 02

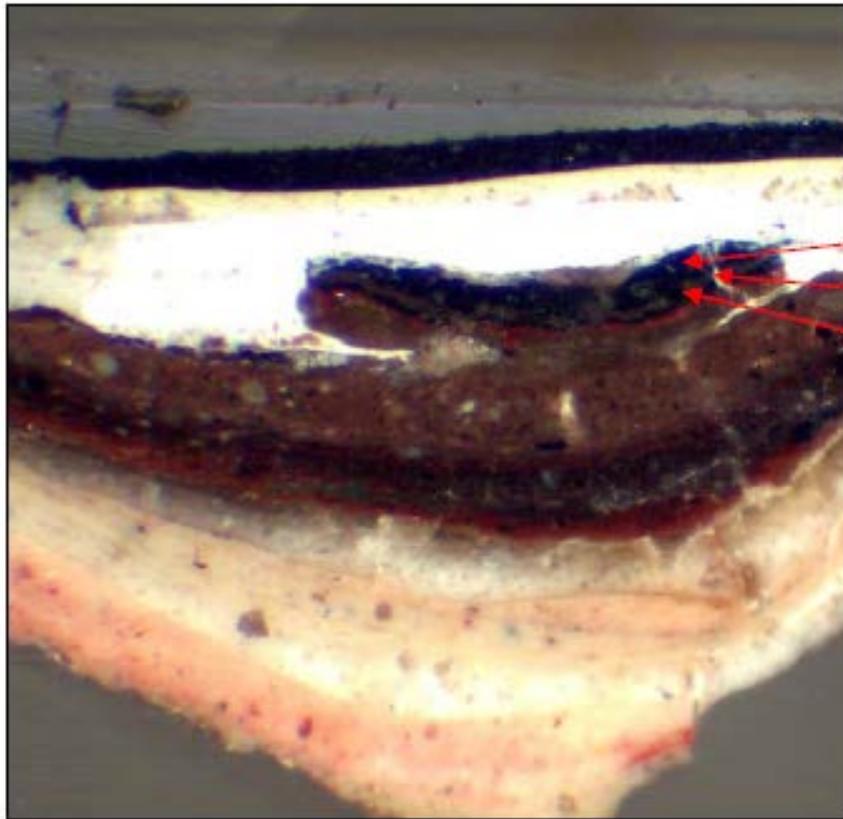
Sample W11-04 under daylight filter

Black first finish and possible second finish.

Brown second finish

Black third finish

SAMPLE NUMBER: W11-04
 LOCATION: 1st Floor Window Frame
 SUBSTRATE: Wood

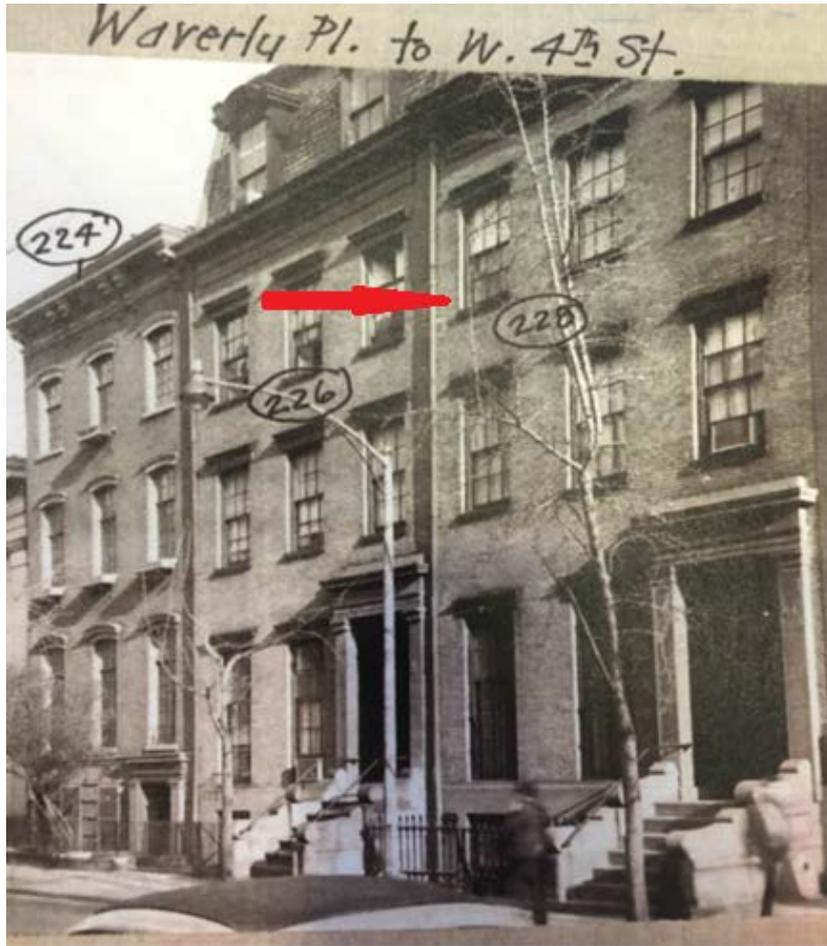
Designation Photo

Designation photo from LPC files shows 228 West 11th Street with dark-painted window frames

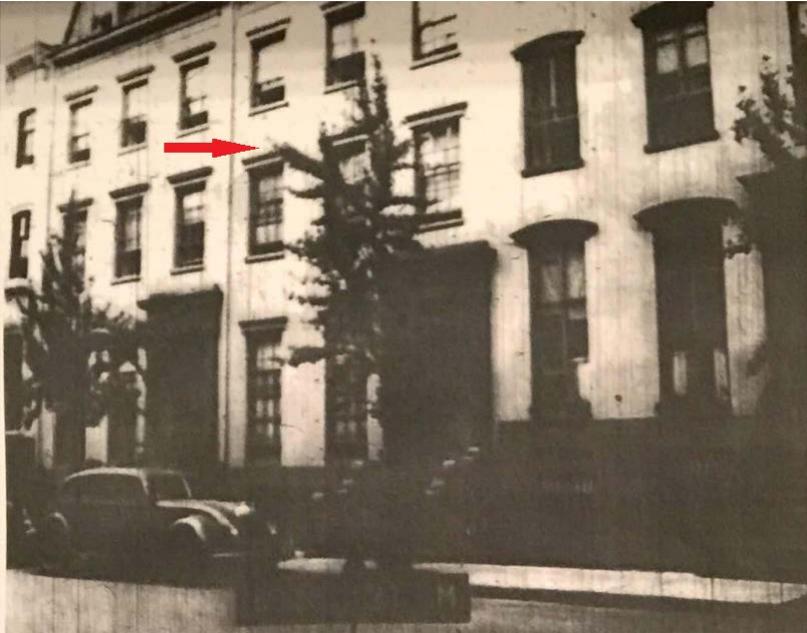
1940s tax photo shows 228 West 11th Street with window frames of indeterminate color

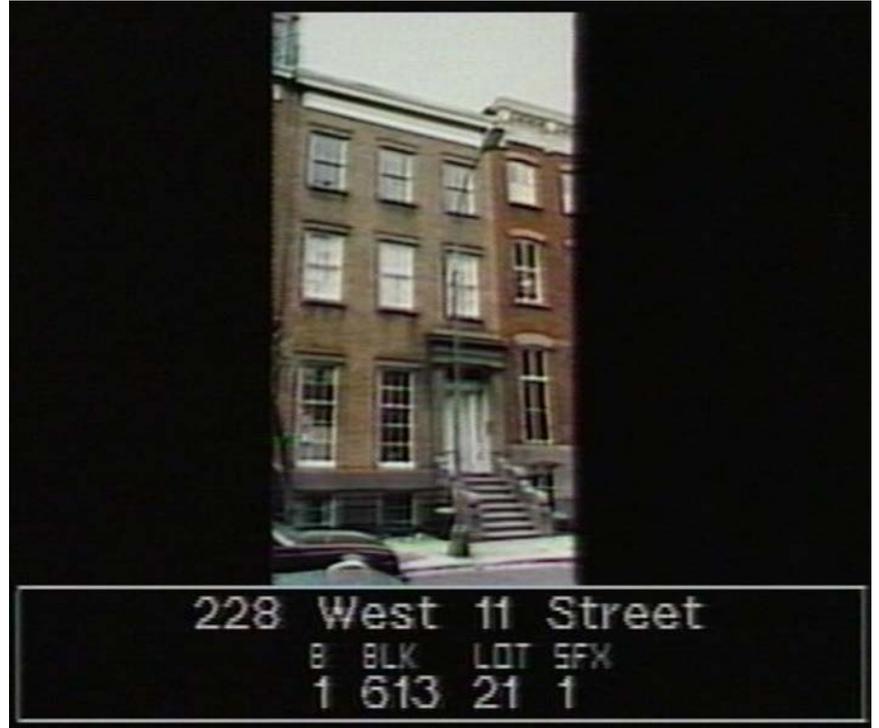
1980s tax photo shows 228 West 11th Street with white or light-painted window frames
