PROSPECT PARK
Wellhouse Reconstruction - Amendment
Cistern Wall

September 13, 2016

--- SCOPE OF WORK

Wellhouse Reconstruction - Amendment
09/13/2016

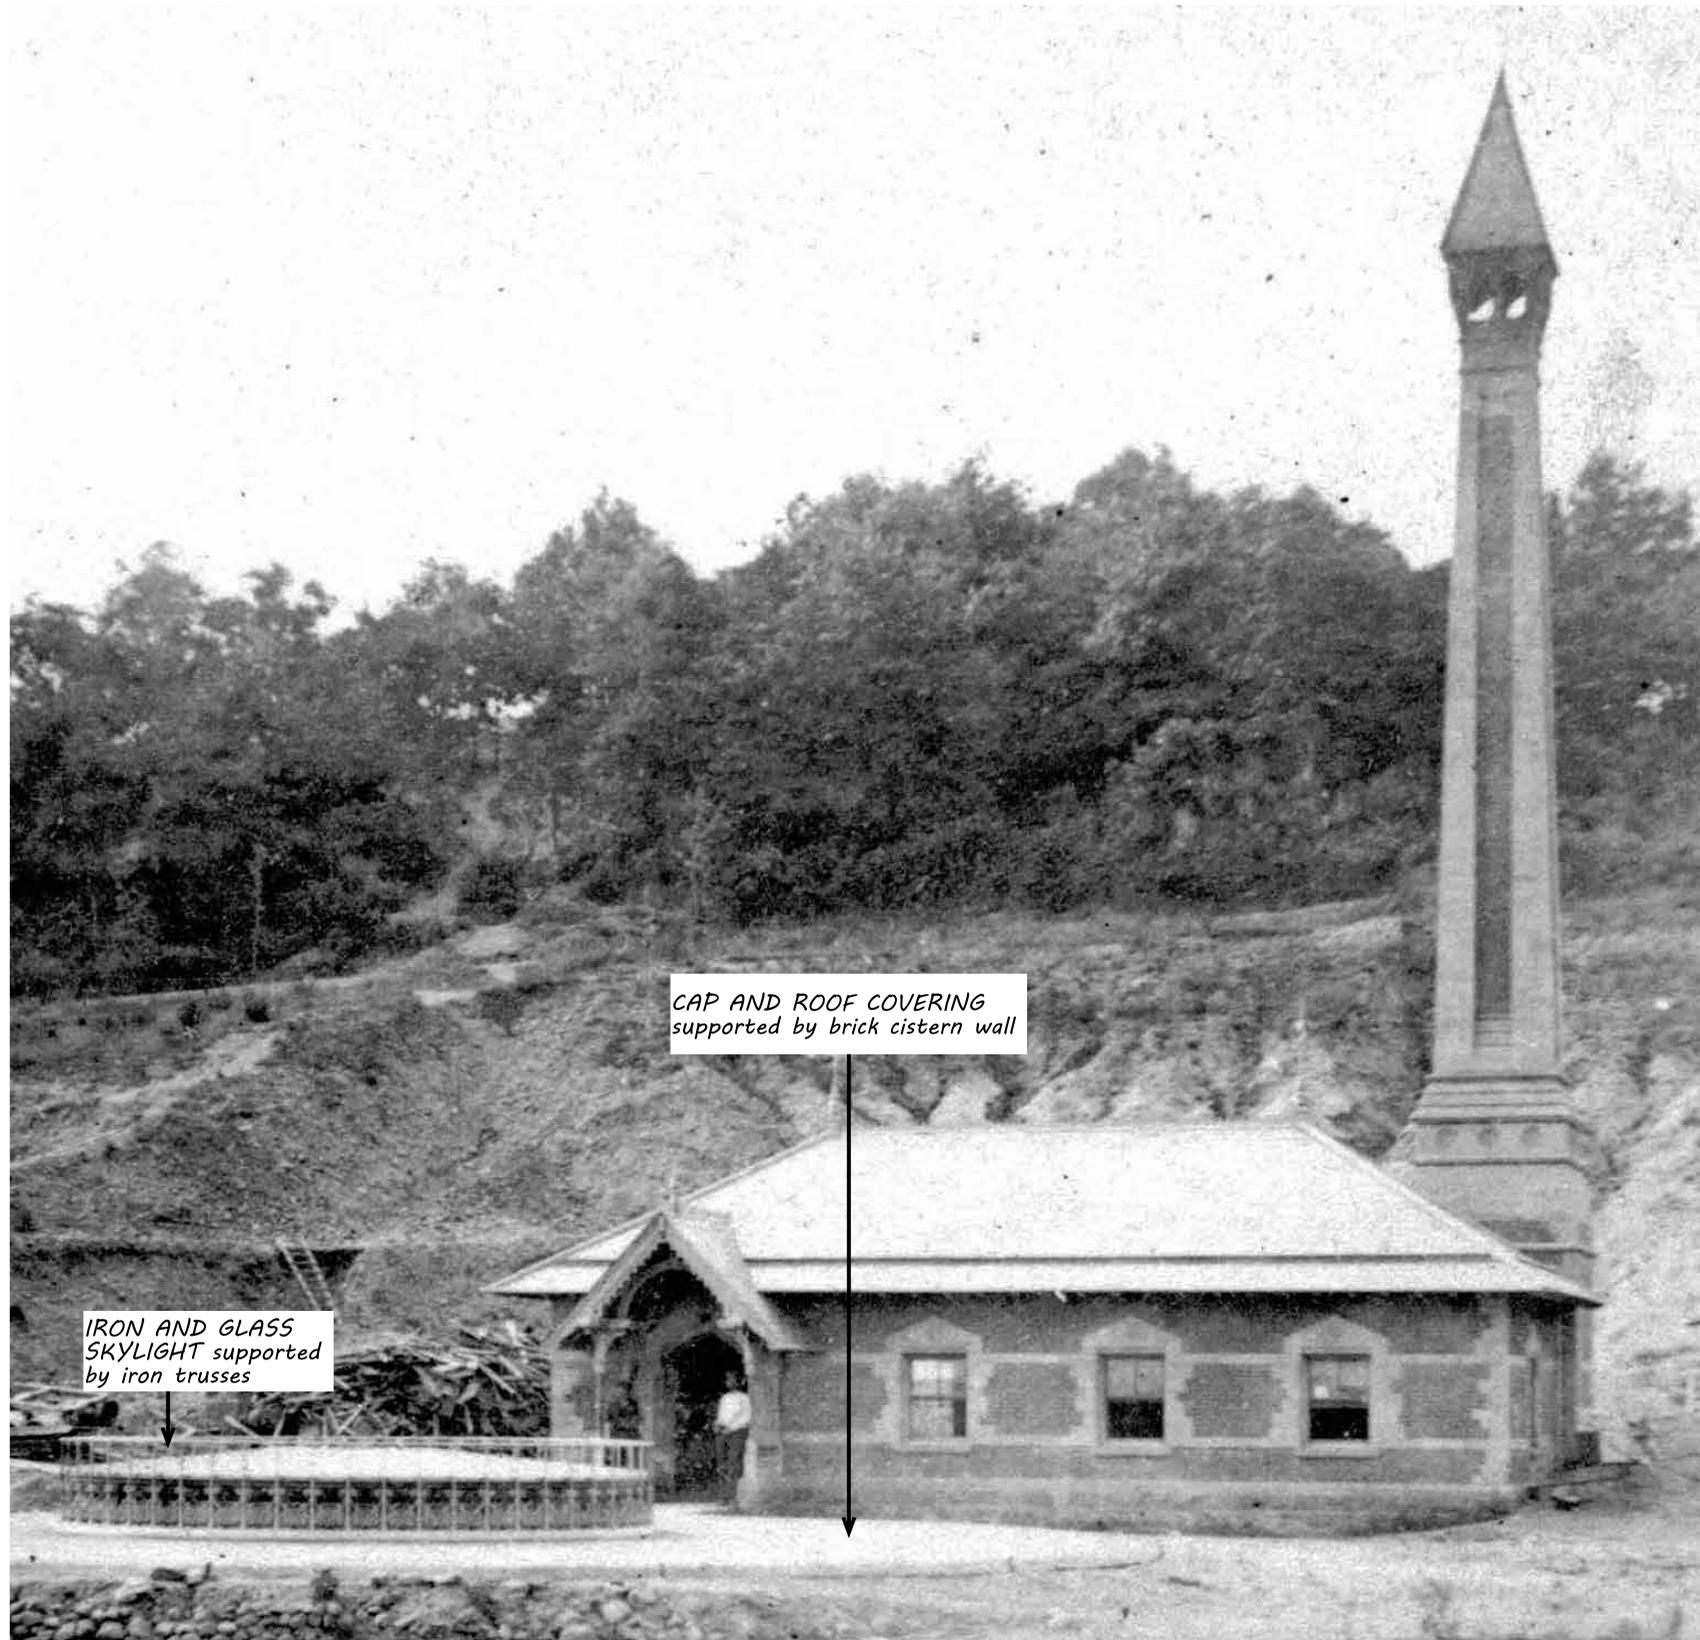
1870 PHOTOGRAPH

CAP AND ROOF COVERING supported by brick cistern wall

IRON AND GLASS SKYLIGHT supported by iron trusses

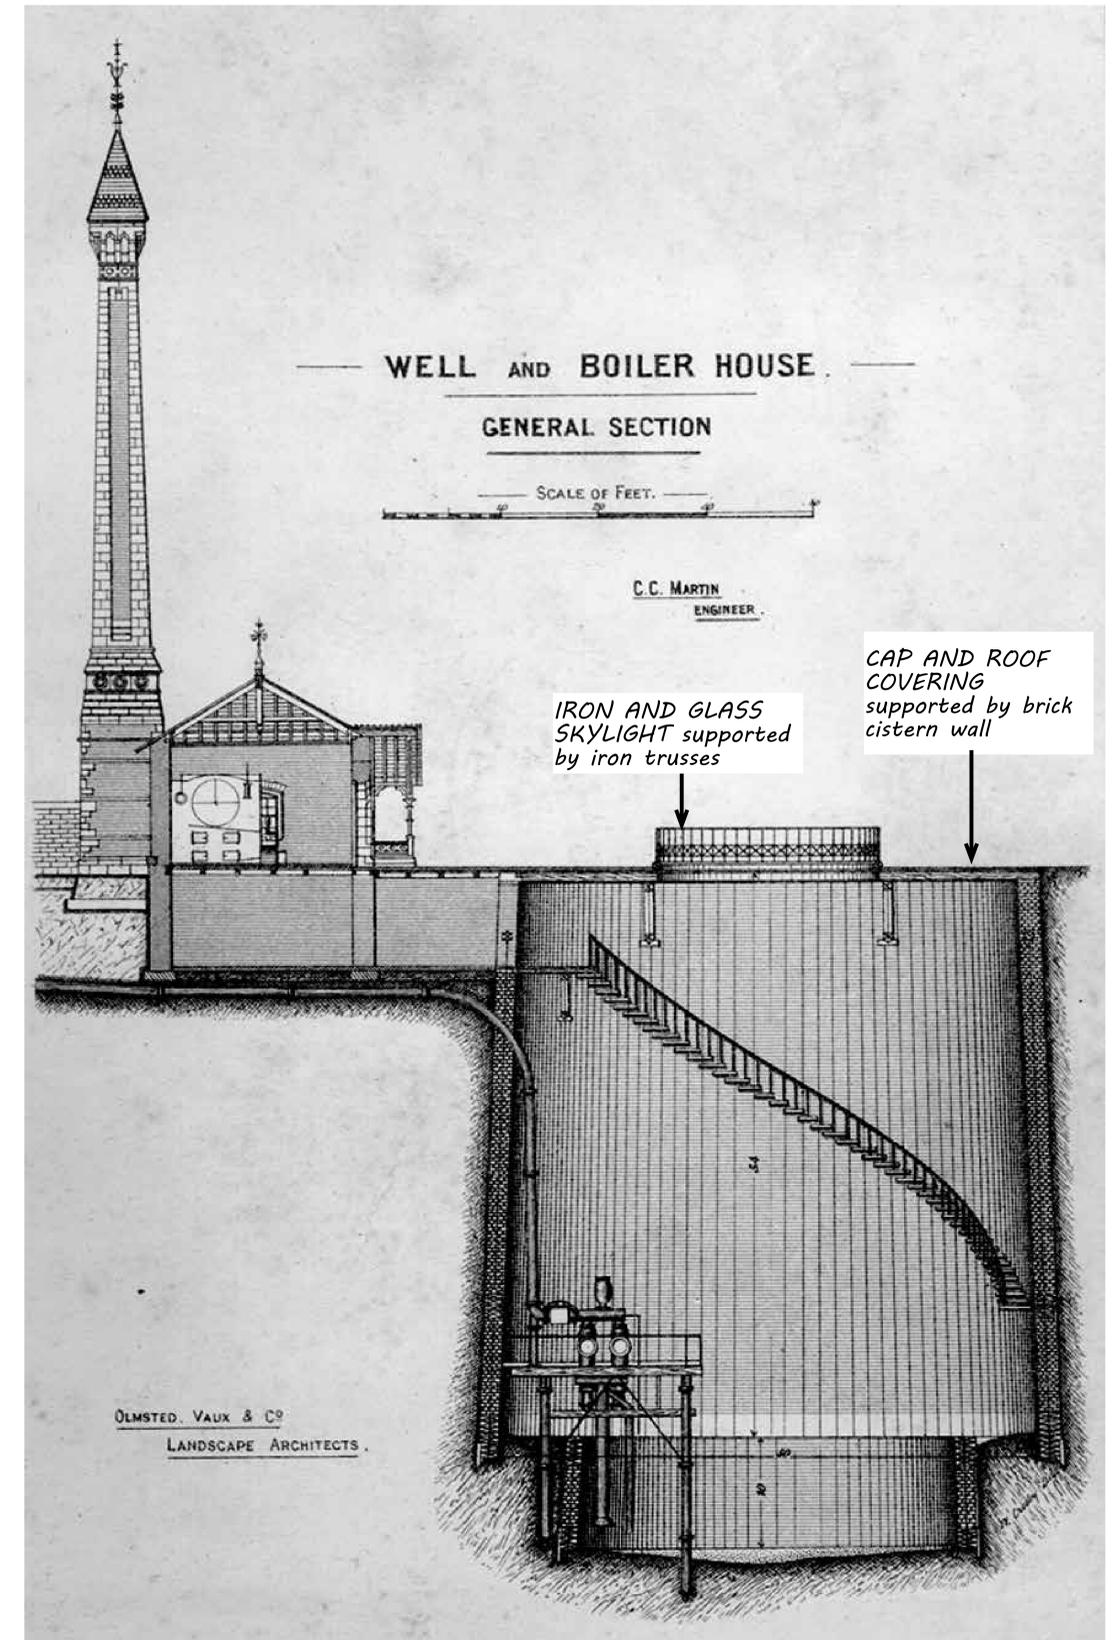
WELL AND BOILER HOUSE.

GENERAL SECTION

IRON AND GLASS SKYLIGHT supported by iron trusses

CAP AND ROOF COVERING supported by brick cistern wall

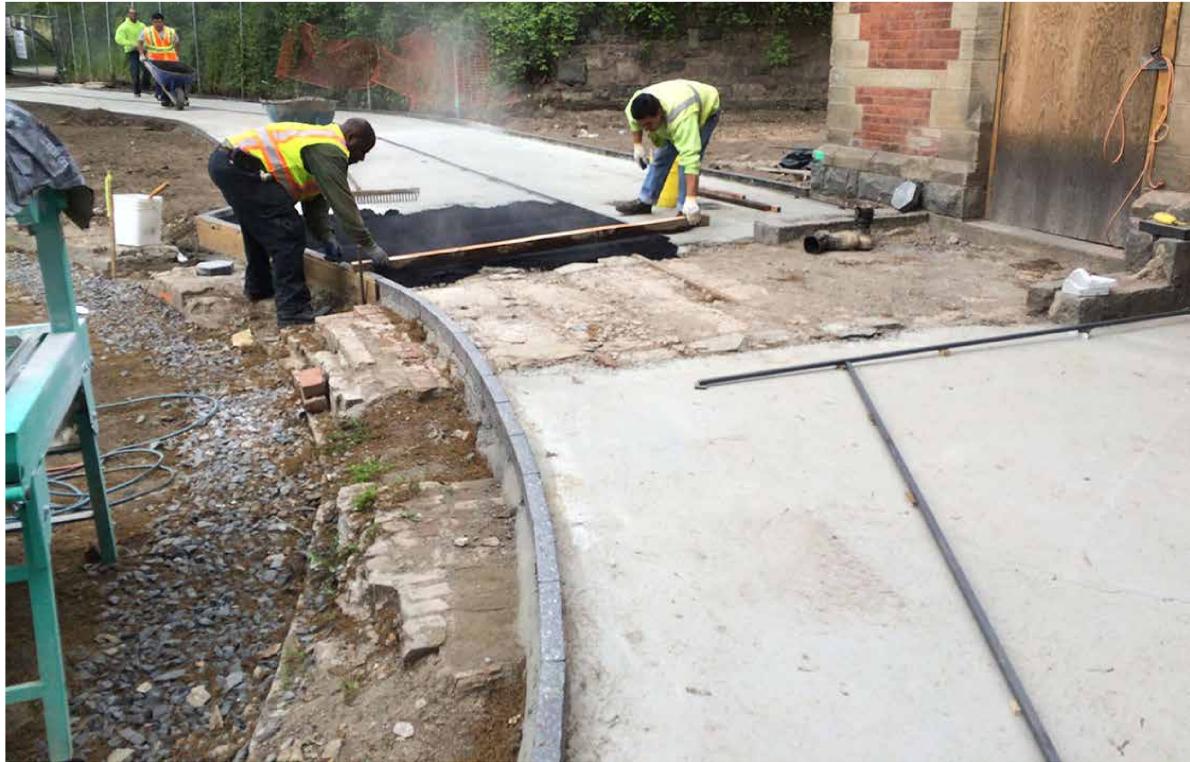
EXISTING CONDITIONS OF CISTERN WALL IN FRONT OF WOMEN'S ENTRANCE

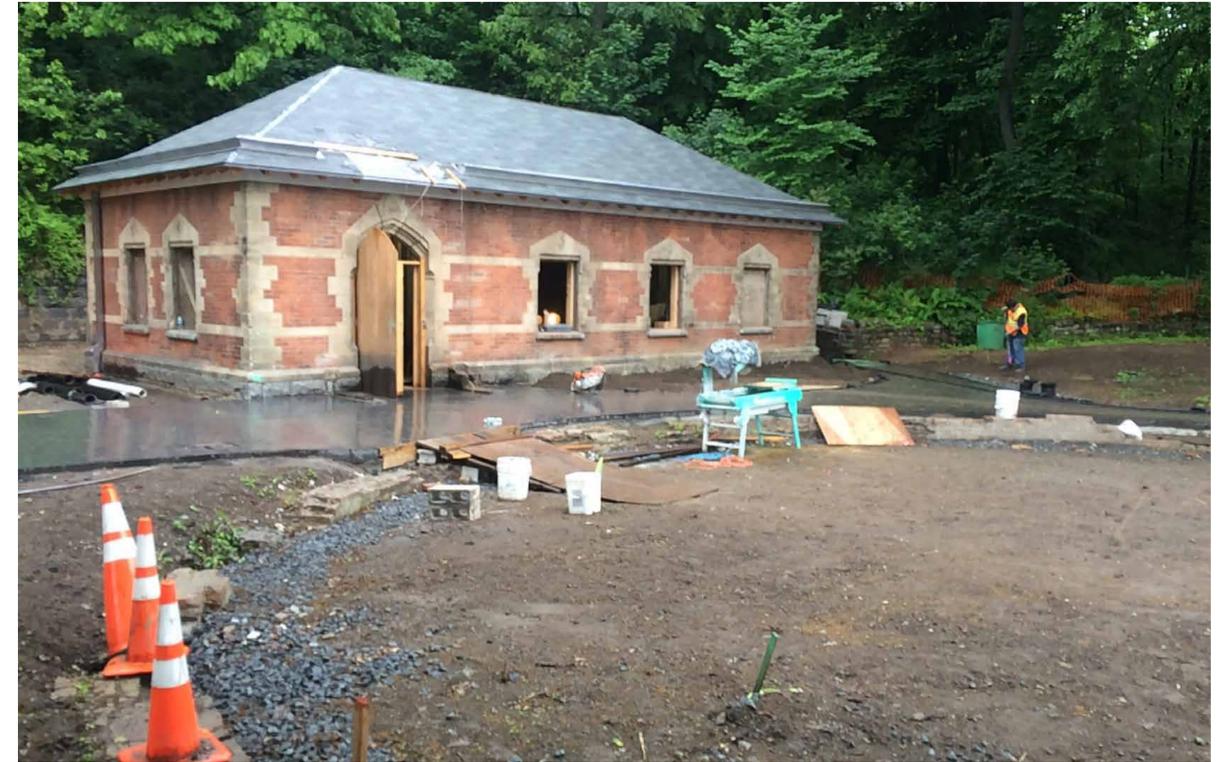
EXISTING CONDITIONS VIEW TOWARDS BUILDING

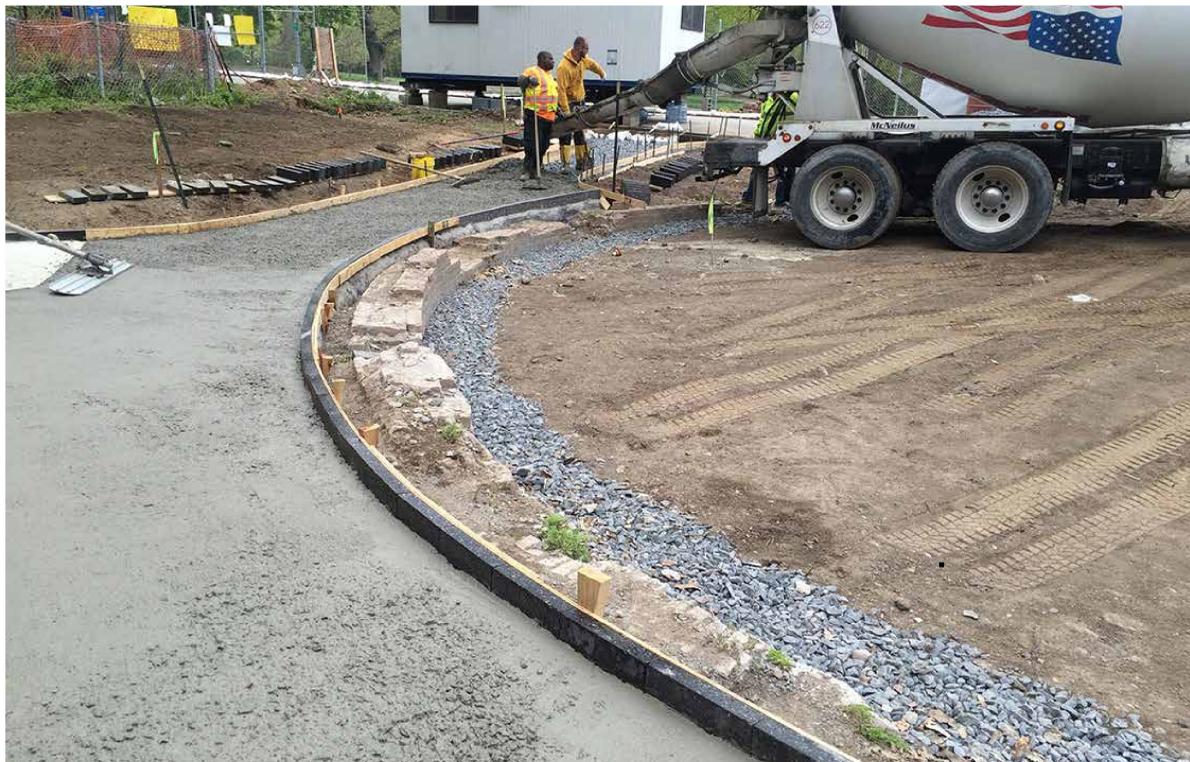
EXISTING CONDITIONS LOOKING NORTHEAST

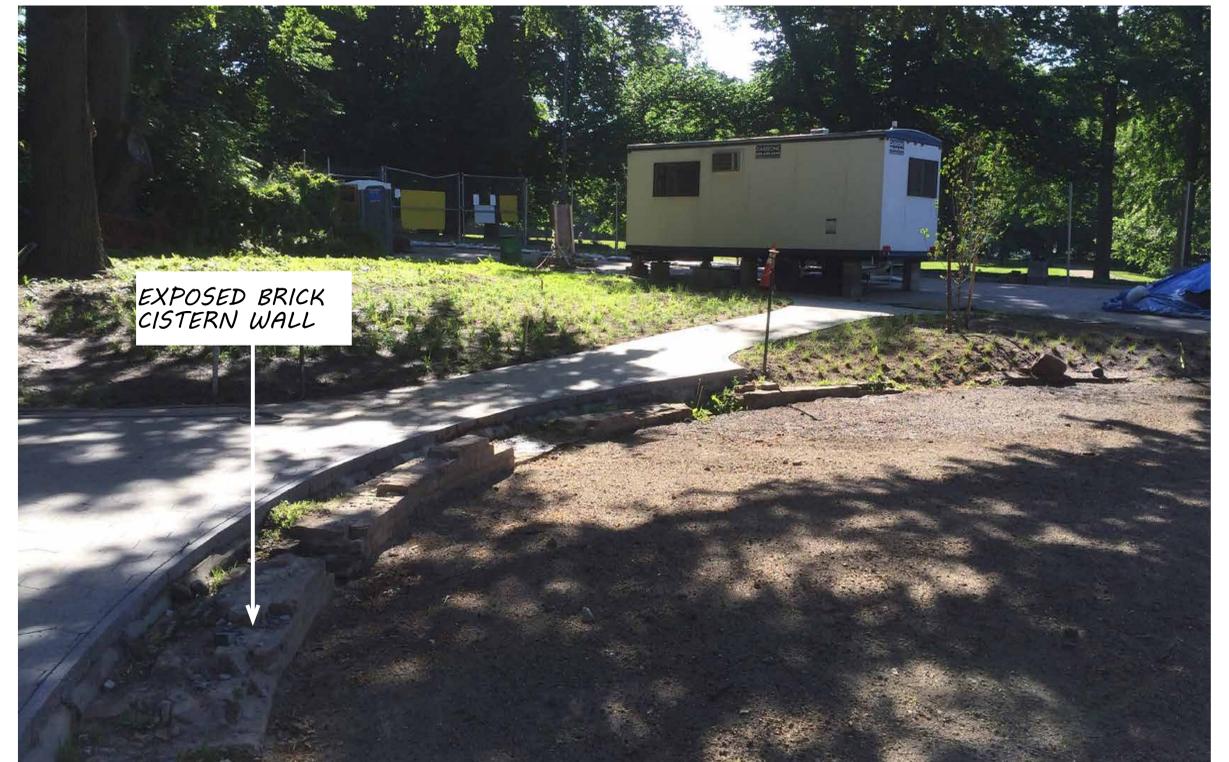
EXISTING CONDITIONS VIEW TOWARDS NORTHEAST - FINISHED PATH

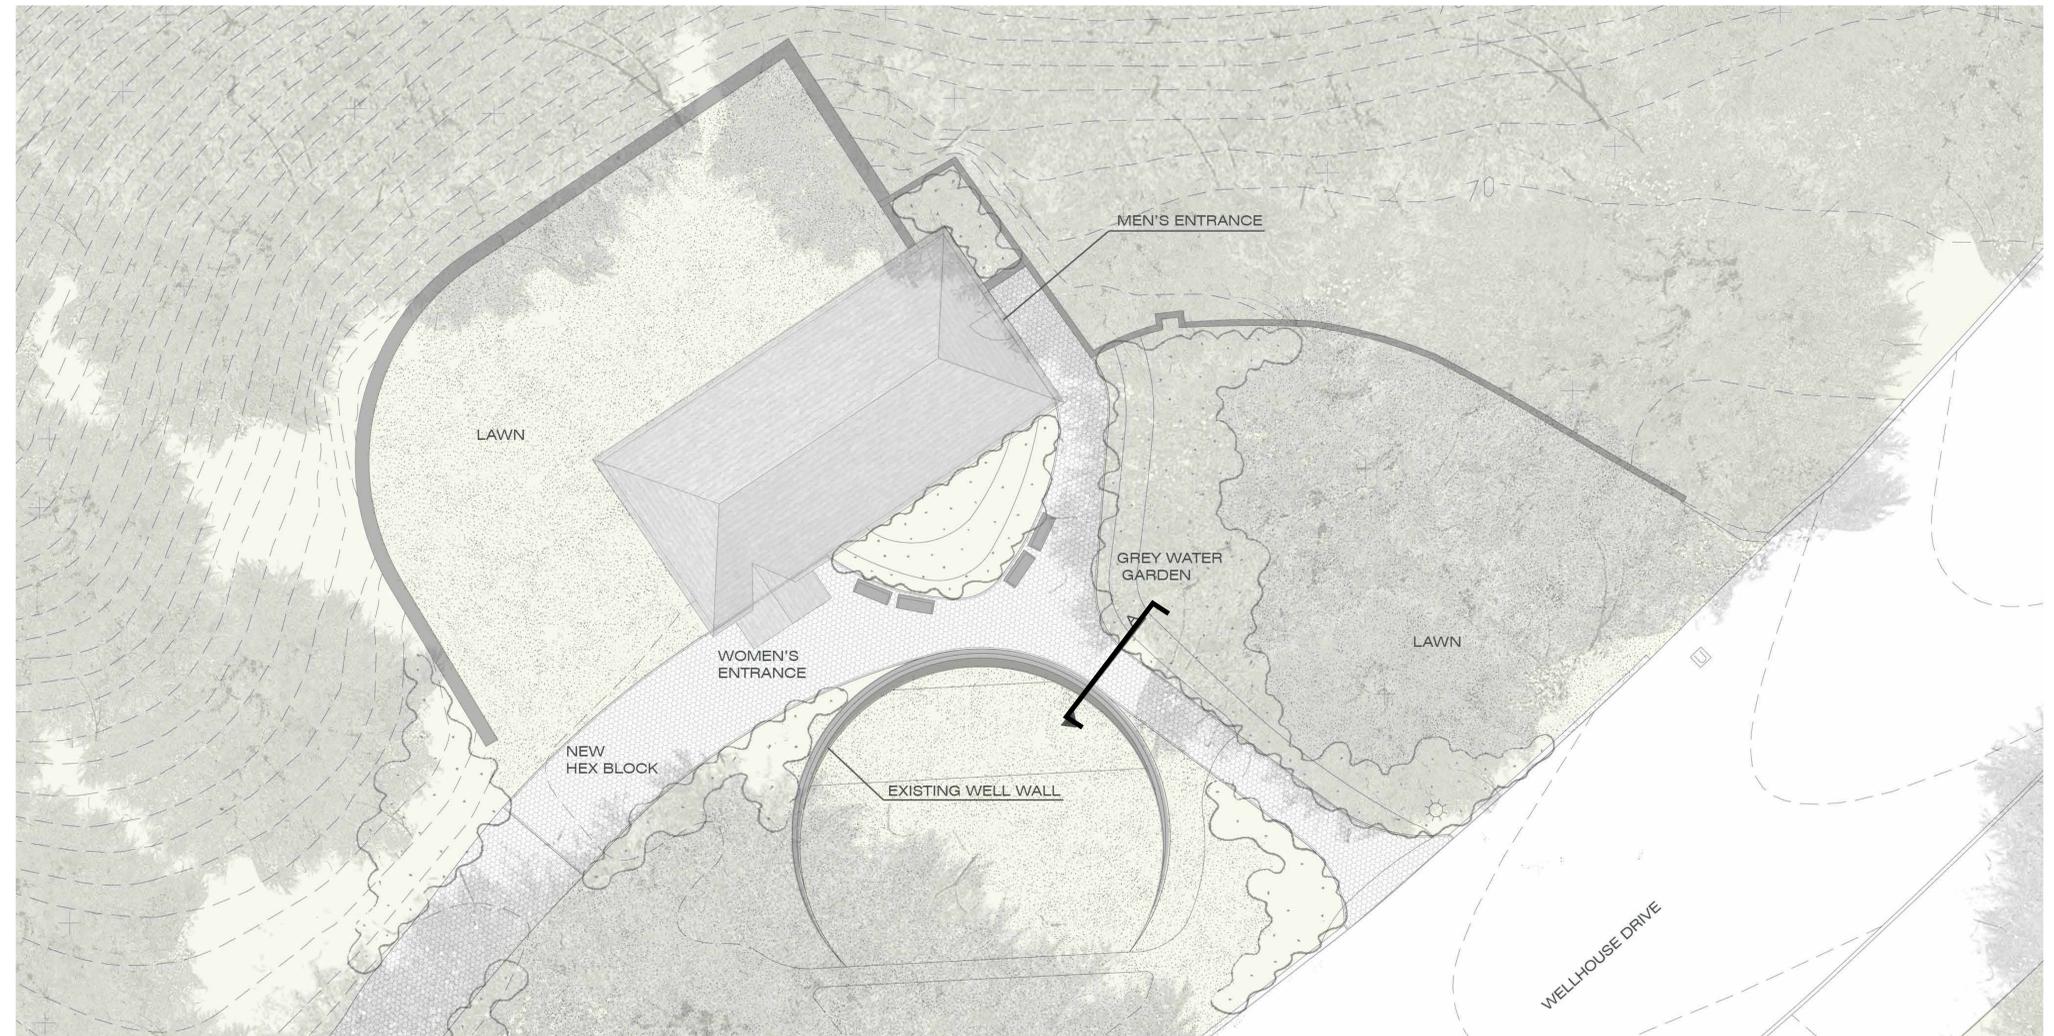
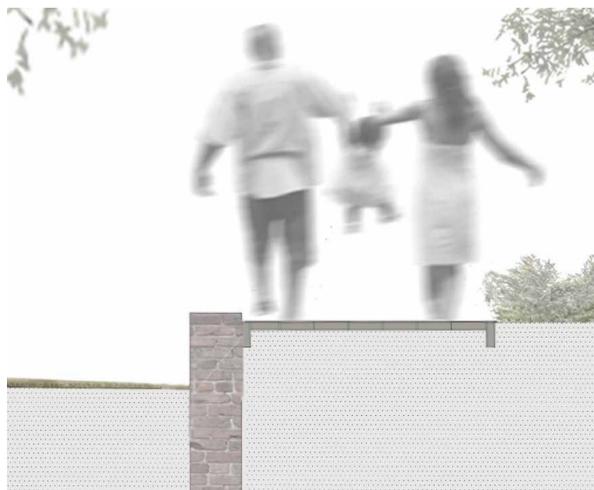
**PREVIOUSLY APPROVED
SECTION THROUGH CISTERN WALL,
NEW PATH, AND GREYWATER GARDEN**

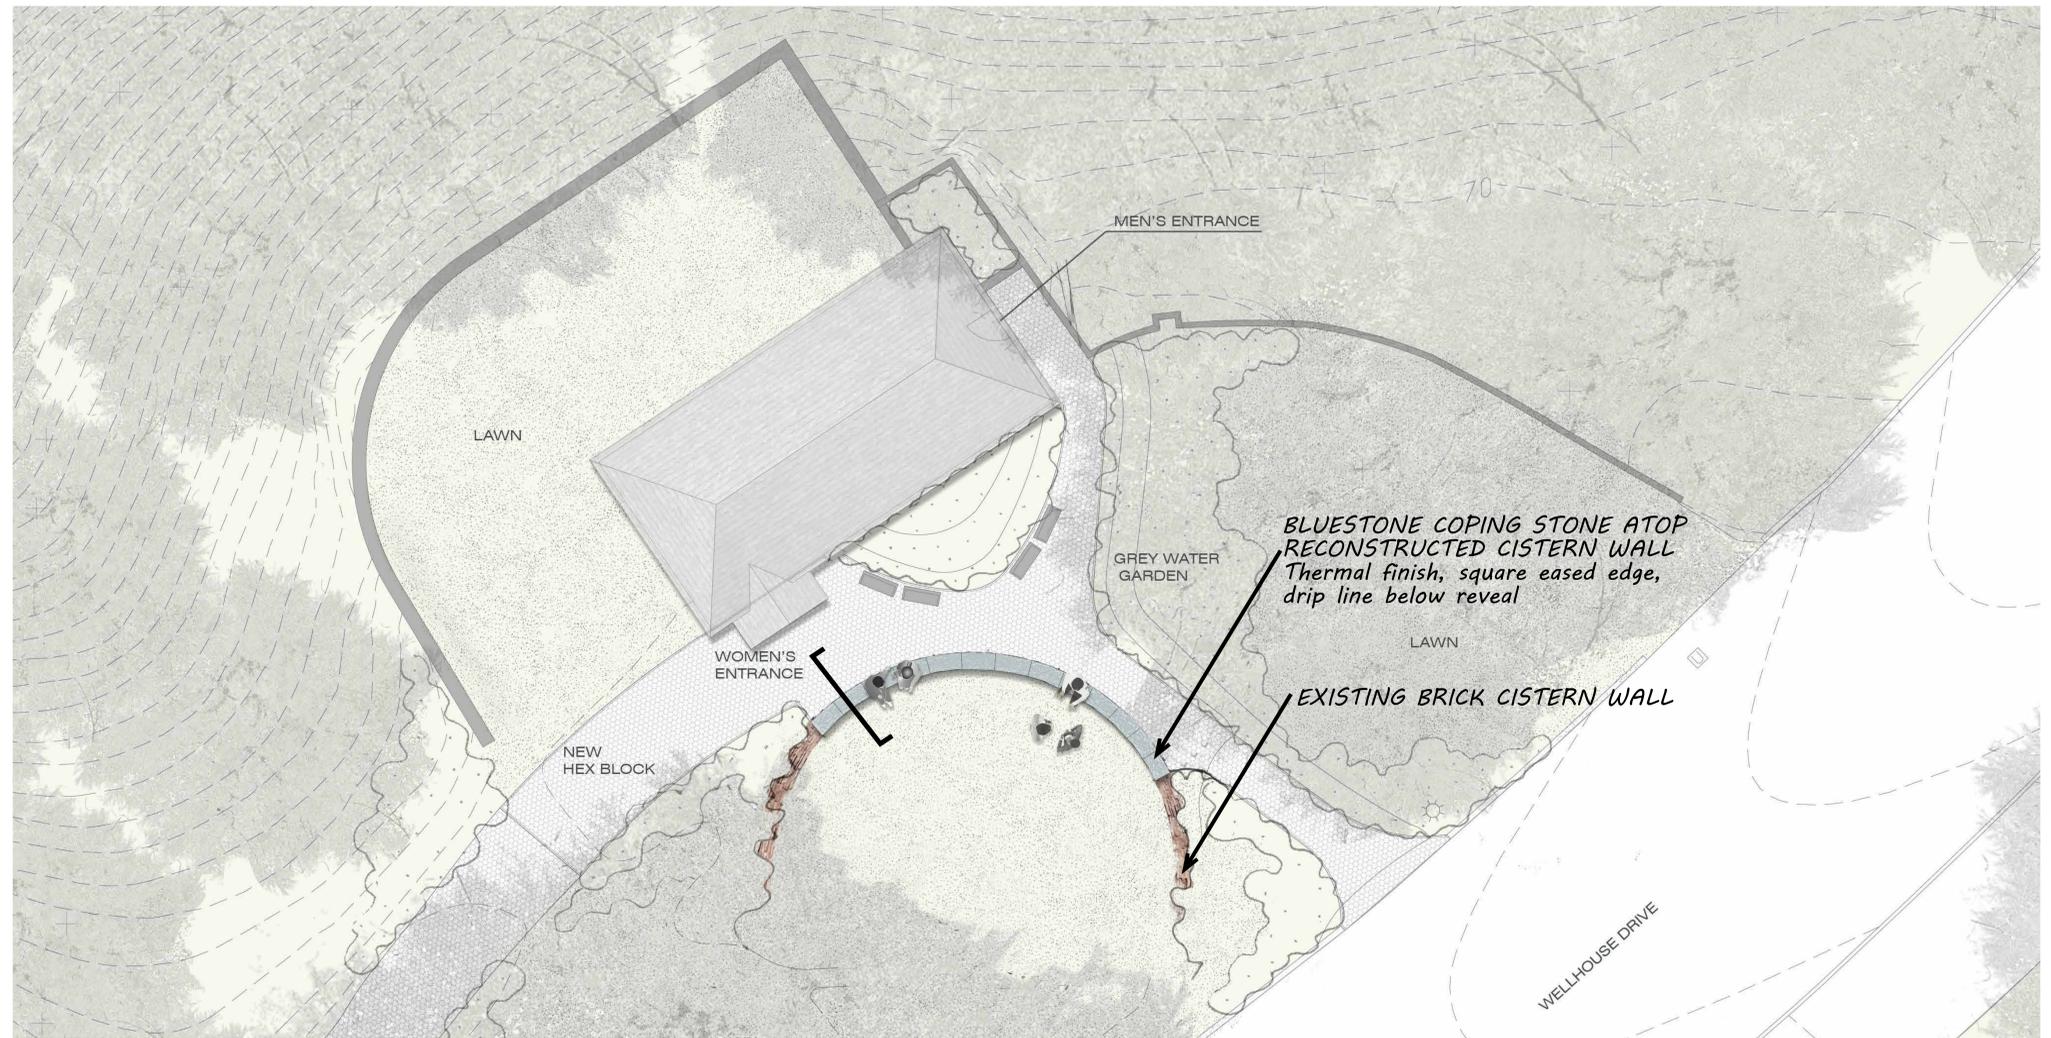
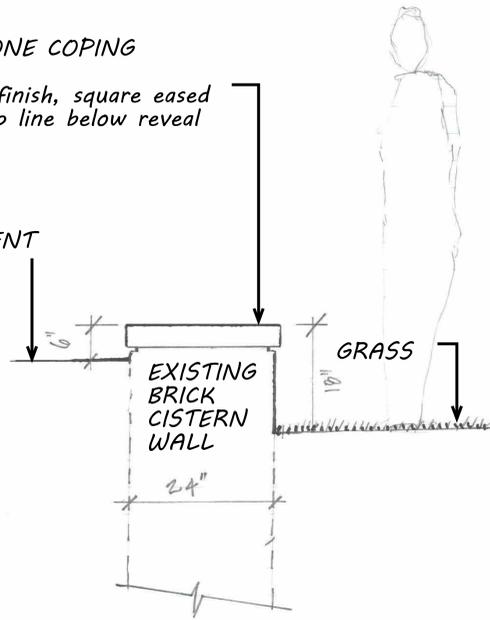
PROPOSED SECTION THROUGH CISTERN WALL AND NEW PATH

BLUESTONE COPING STONE
Thermal finish, square eased edge, drip line below reveal

ADJACENT PAVING

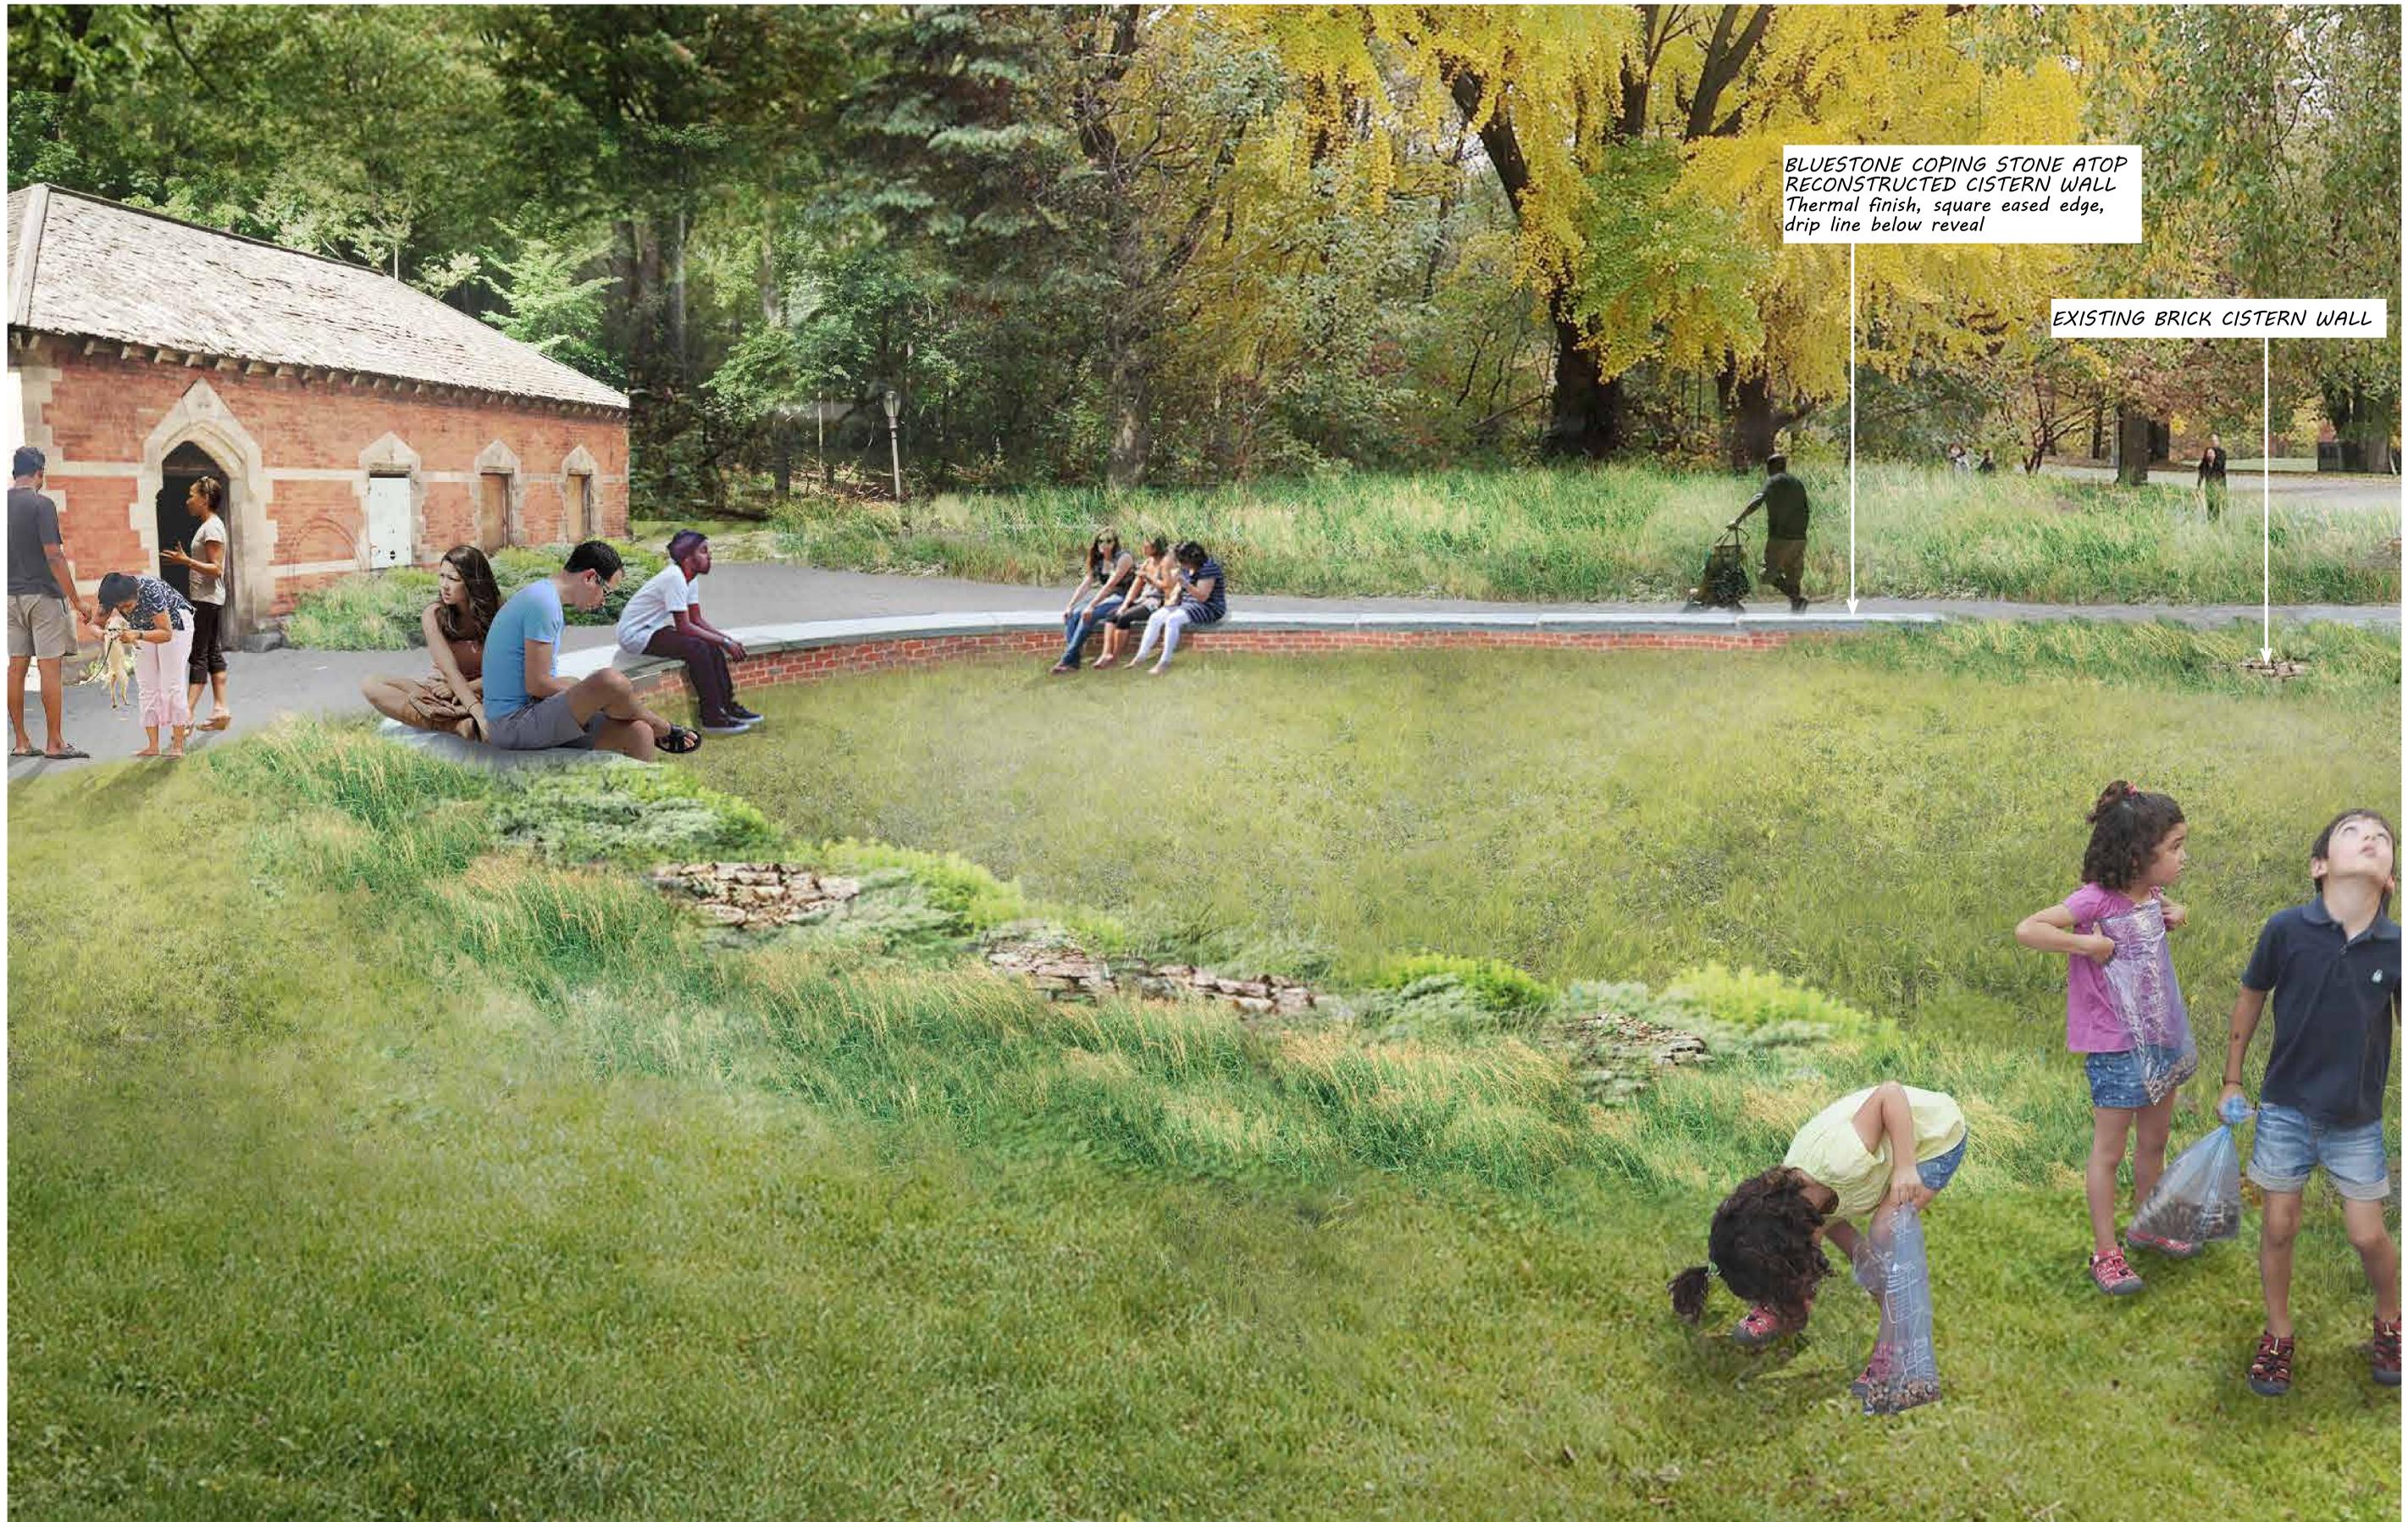
BLUESTONE COPING STONE ATOP
RECONSTRUCTED CISTERN WALL
Thermal finish, square eased edge,
drip line below reveal

EXISTING BRICK CISTERN WALL
