# 16-18 CHARLES STREET

## SPIVAK ARCHITECTS

April 16, 2015

This presentation is to address the following violations associated with the front areaway of 16-18 Charles St.:

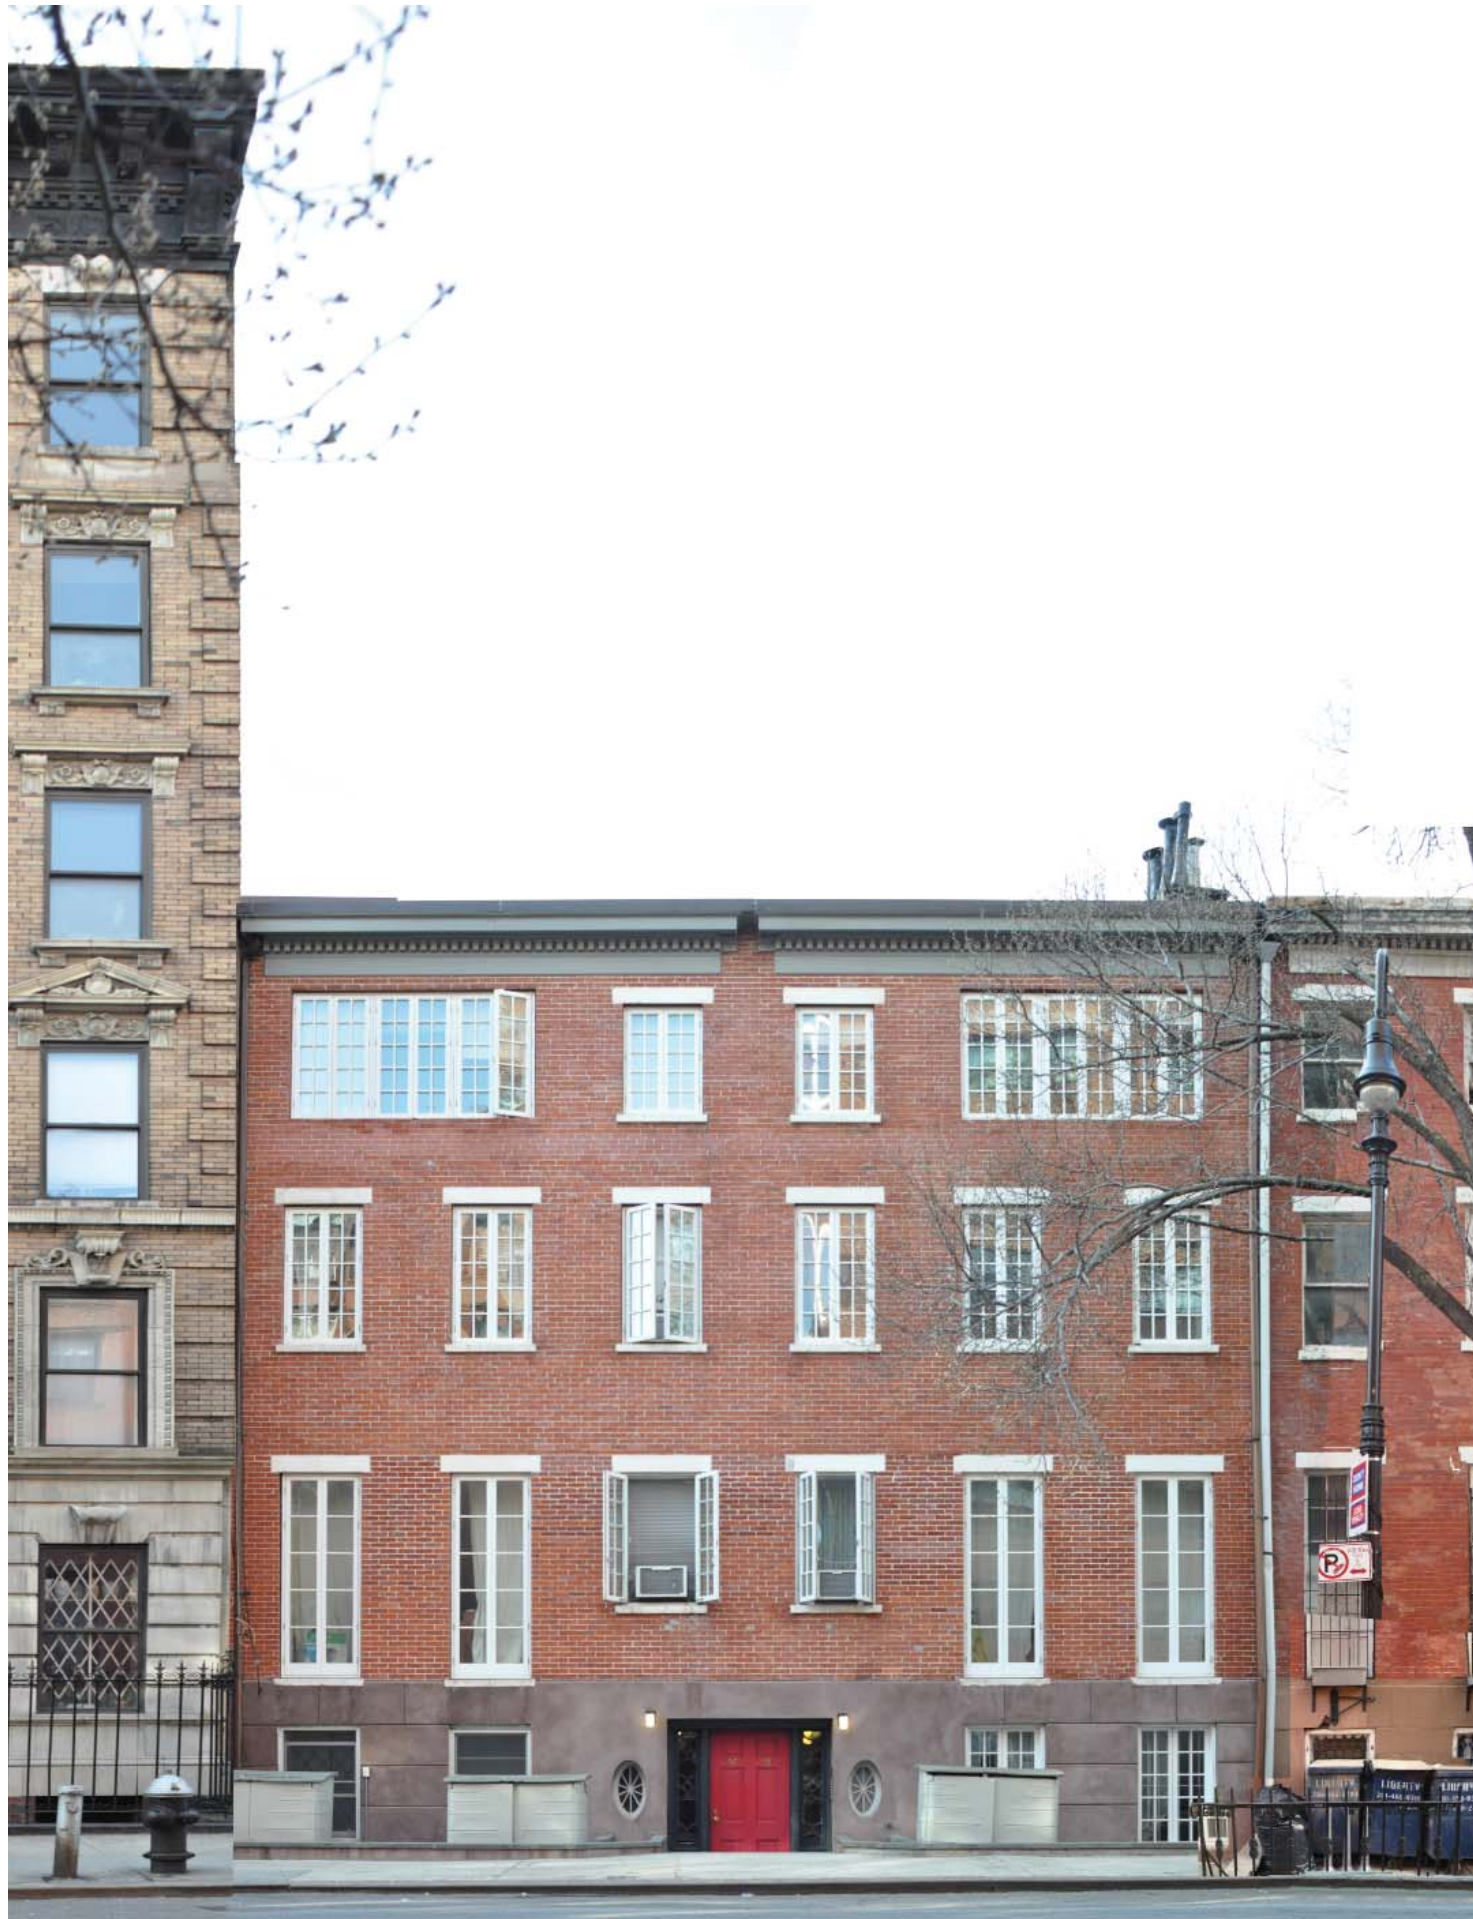
16-18 CHARLES ST., EXISTING FRONT FACADE

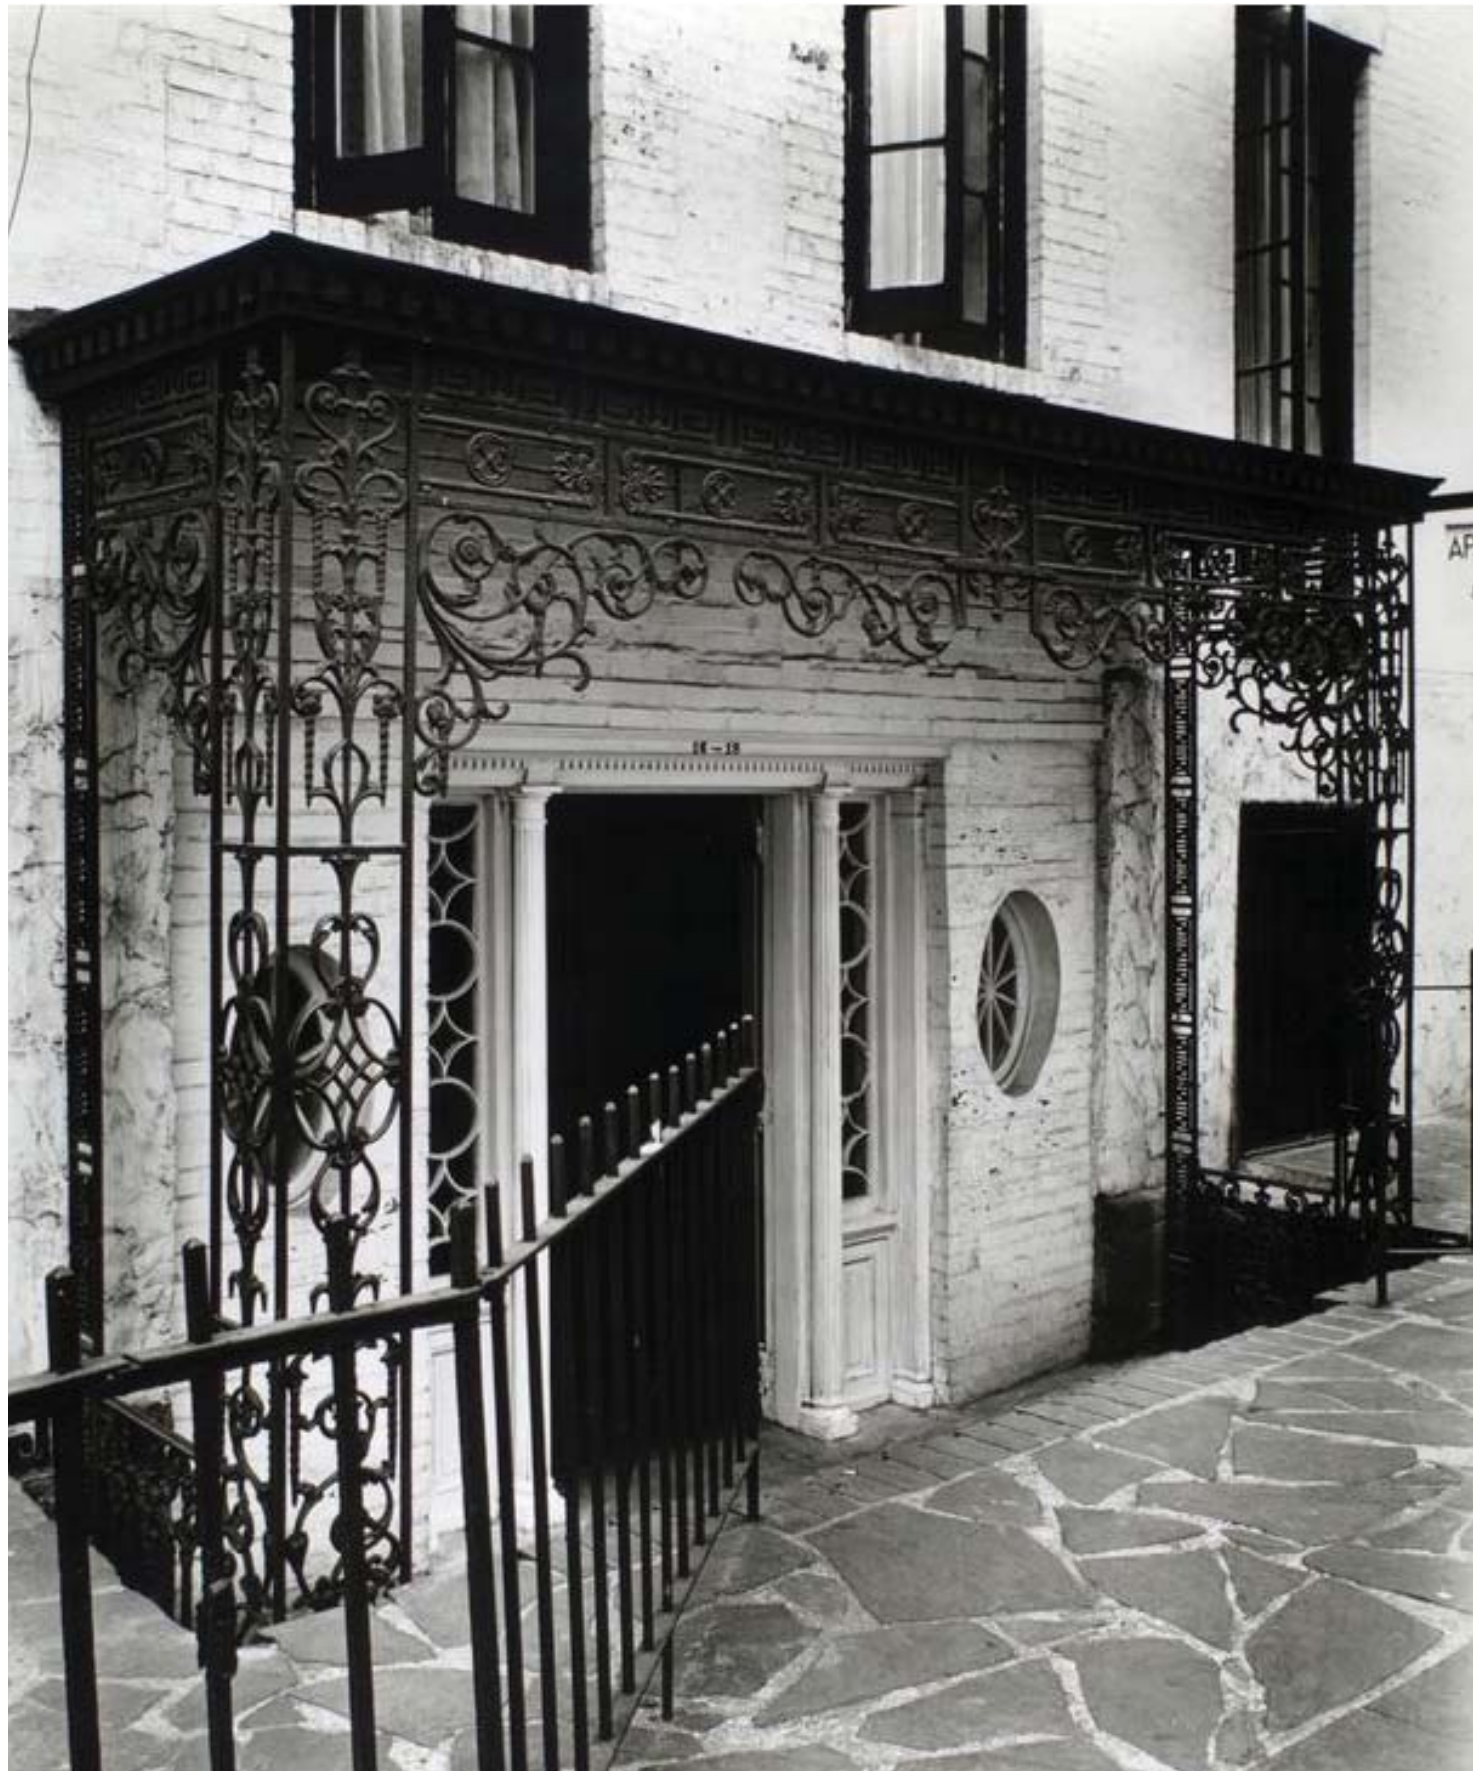
DOORWAY, 16-18 CHARLES ST., JUNE 01, 1938

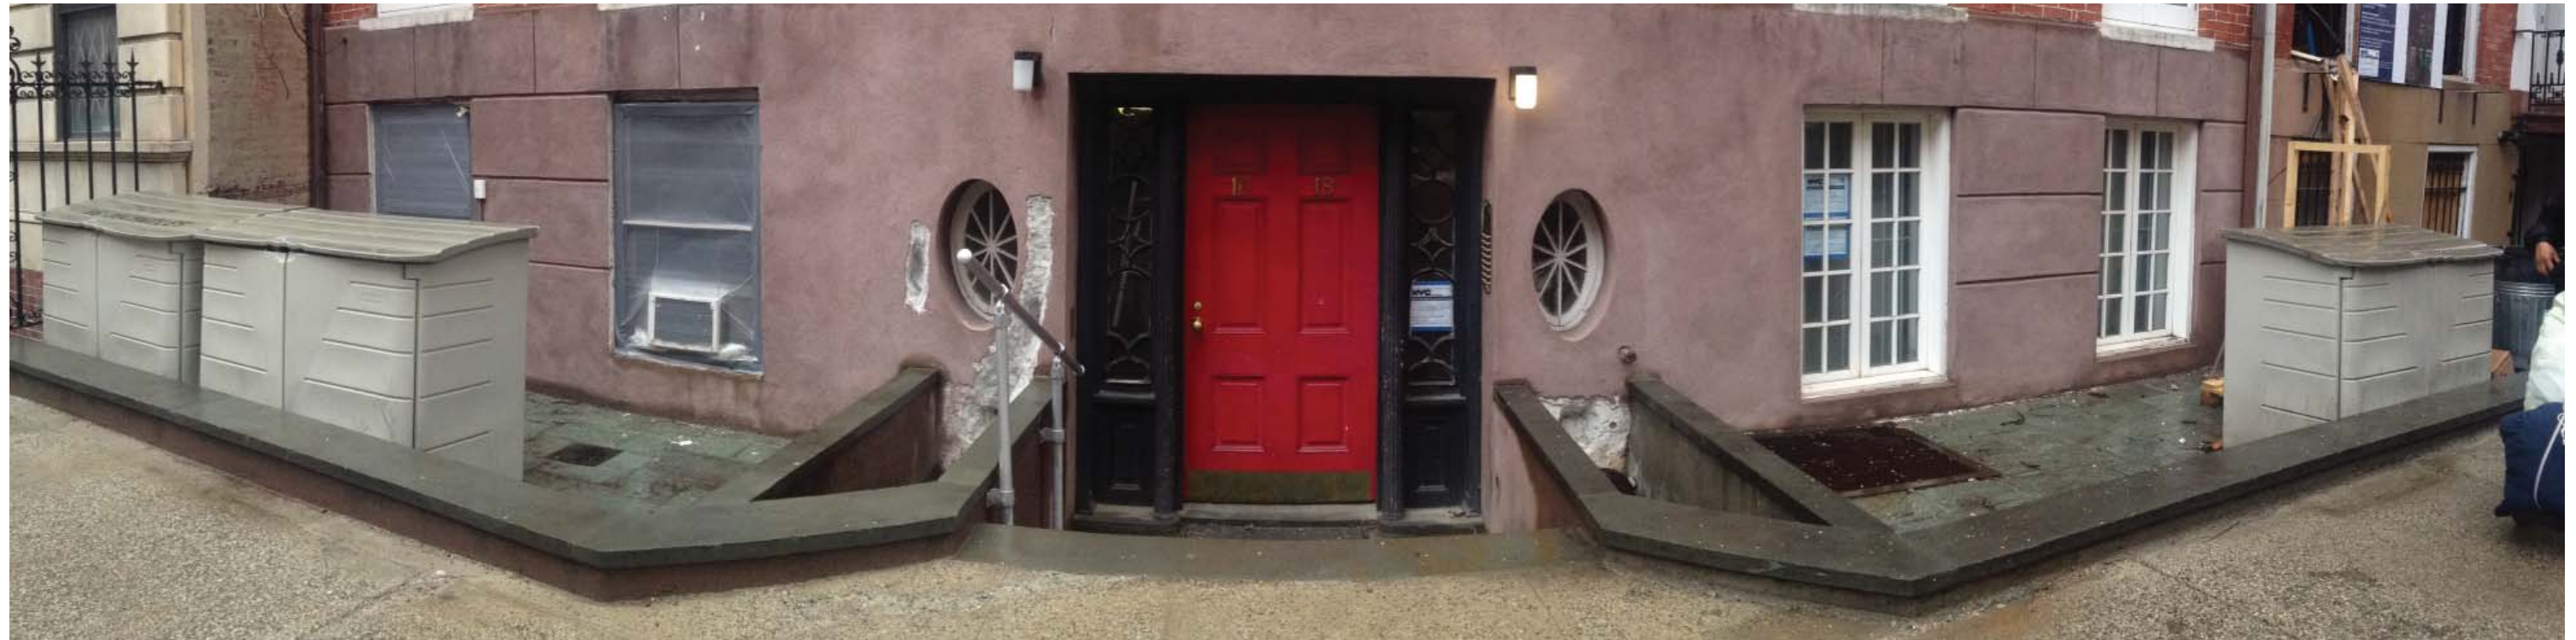
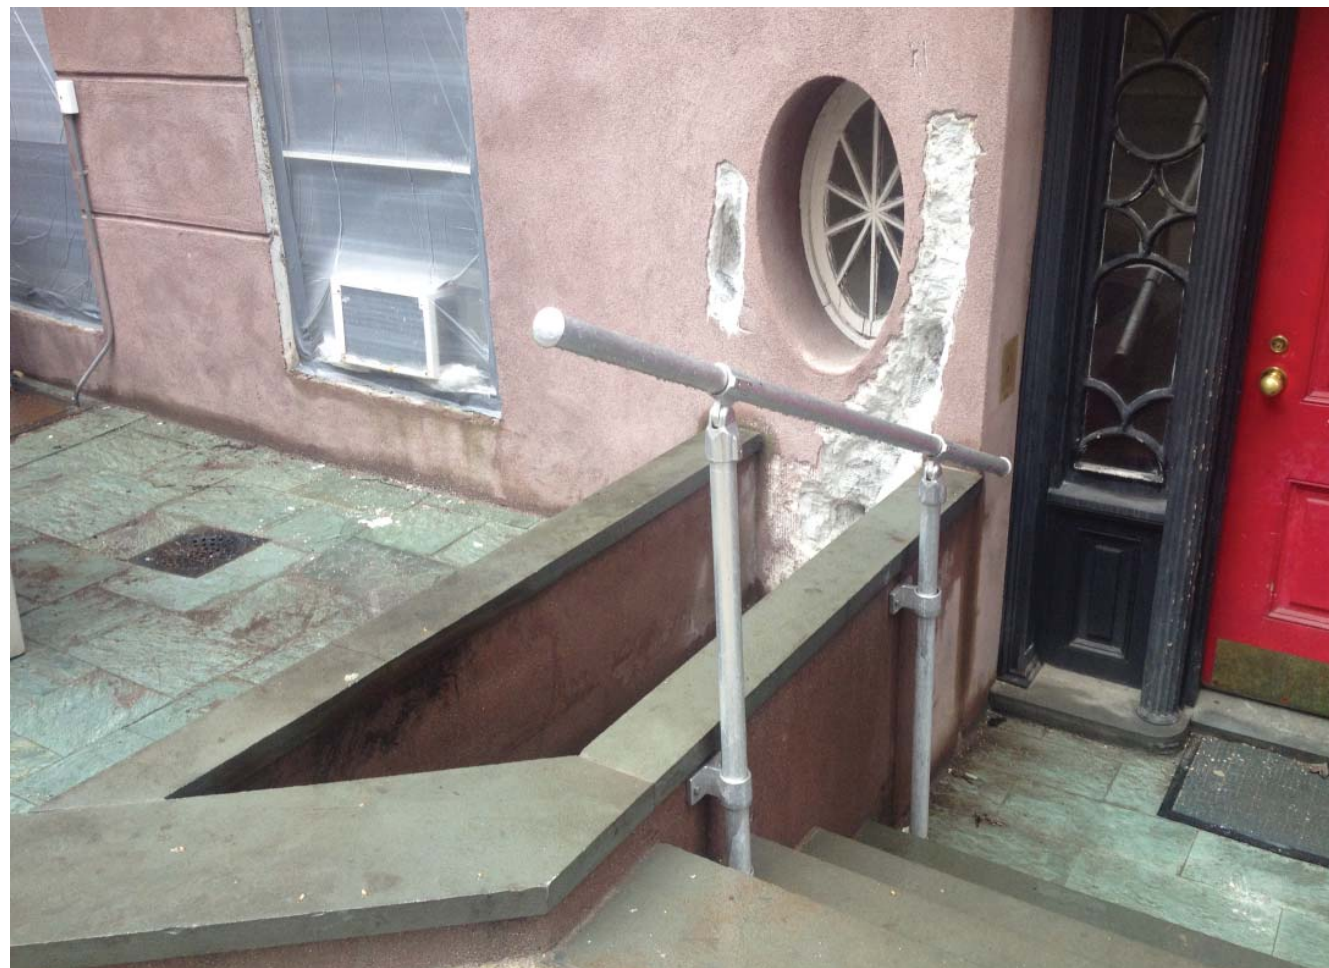
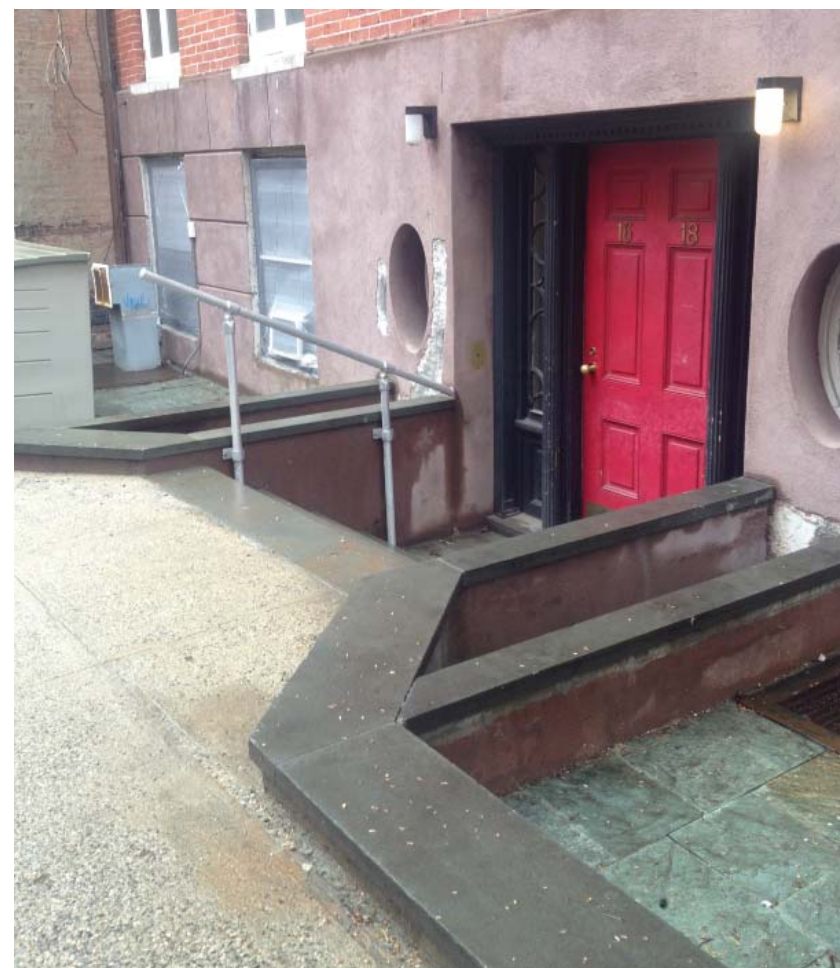
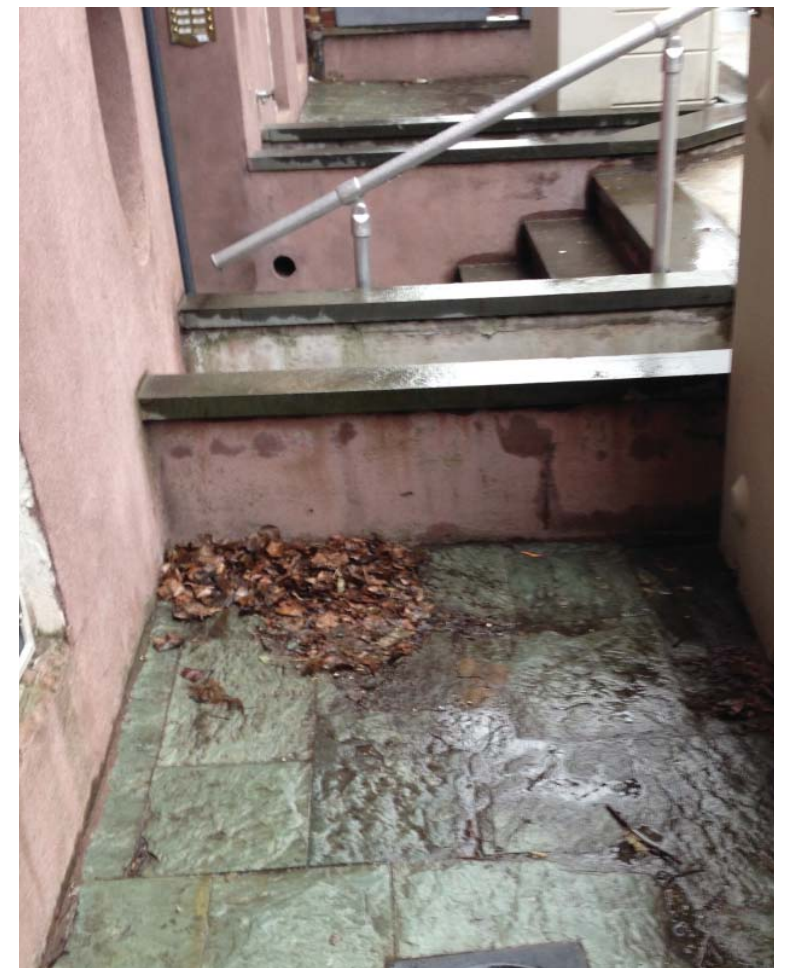
Pictures of Existing Entrance, Planters and Areaway

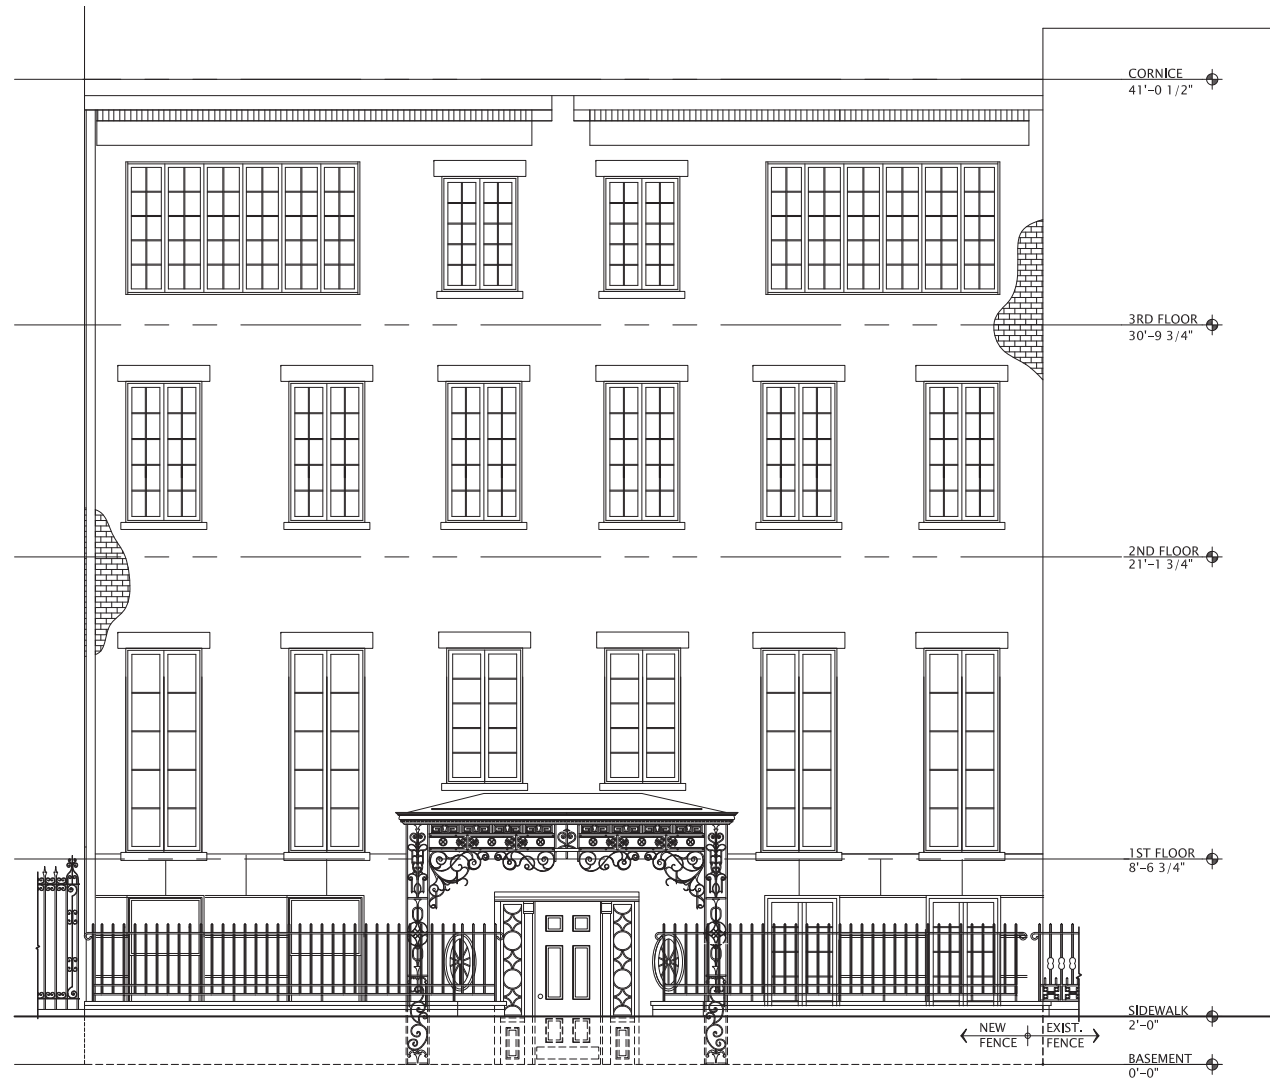
1 PROPOSED FRONT ELEVATION  
1/8"=1'-0"

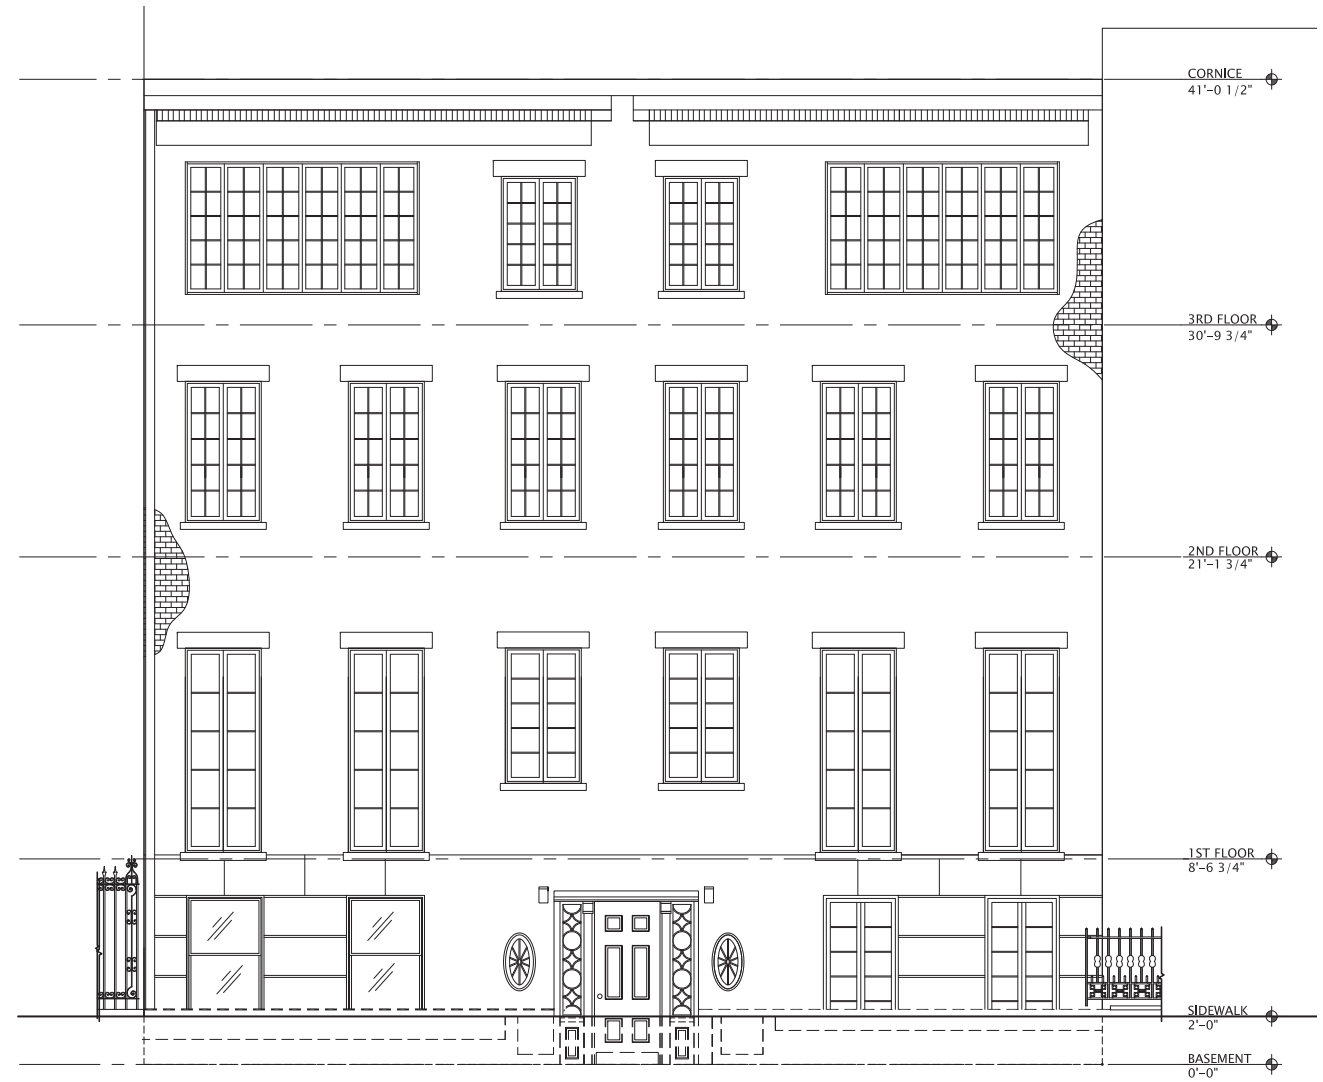
3 EXISTING FRONT ELEVATION  
1/8"=1'-0"

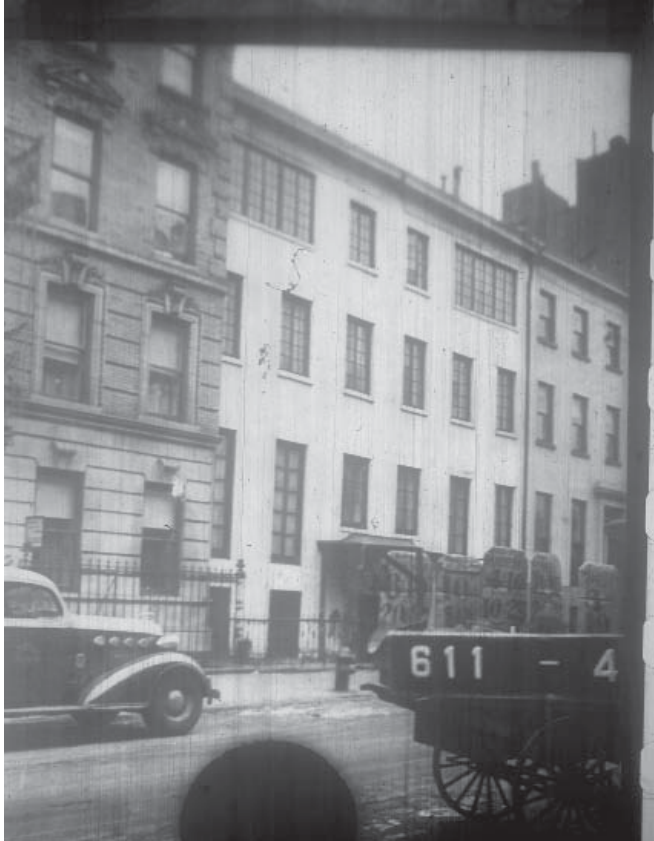
16-18 CHARLES ST., HISTORIC PHOTO

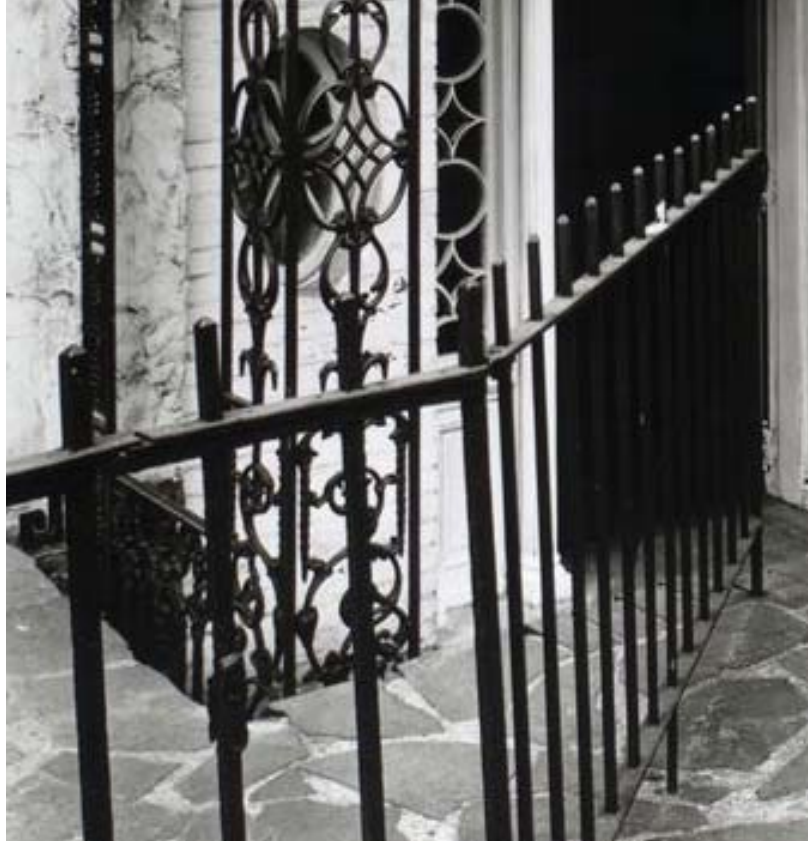
FENCE, HISTORIC PHOTO

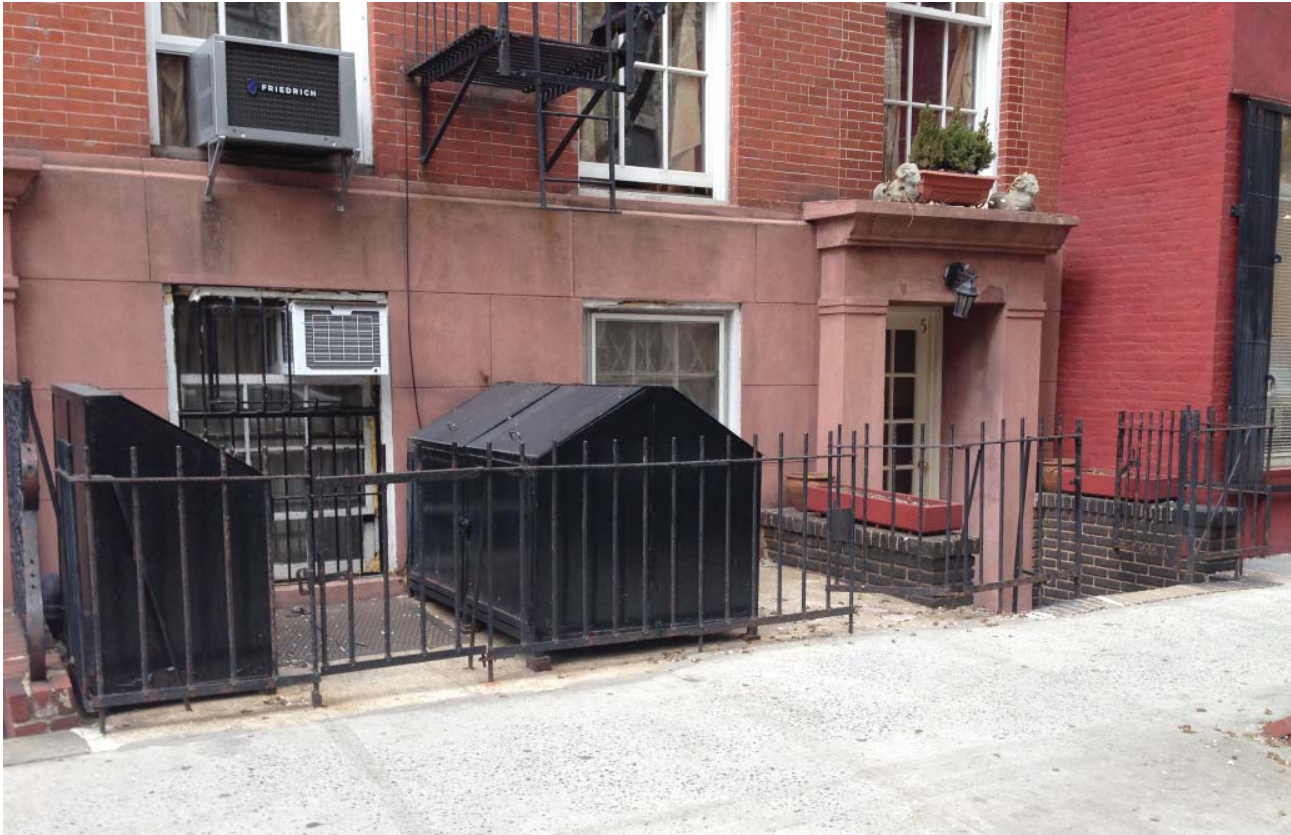
EXISTING FENCE ACROSS THE STREET AT 7 CHARLES ST.

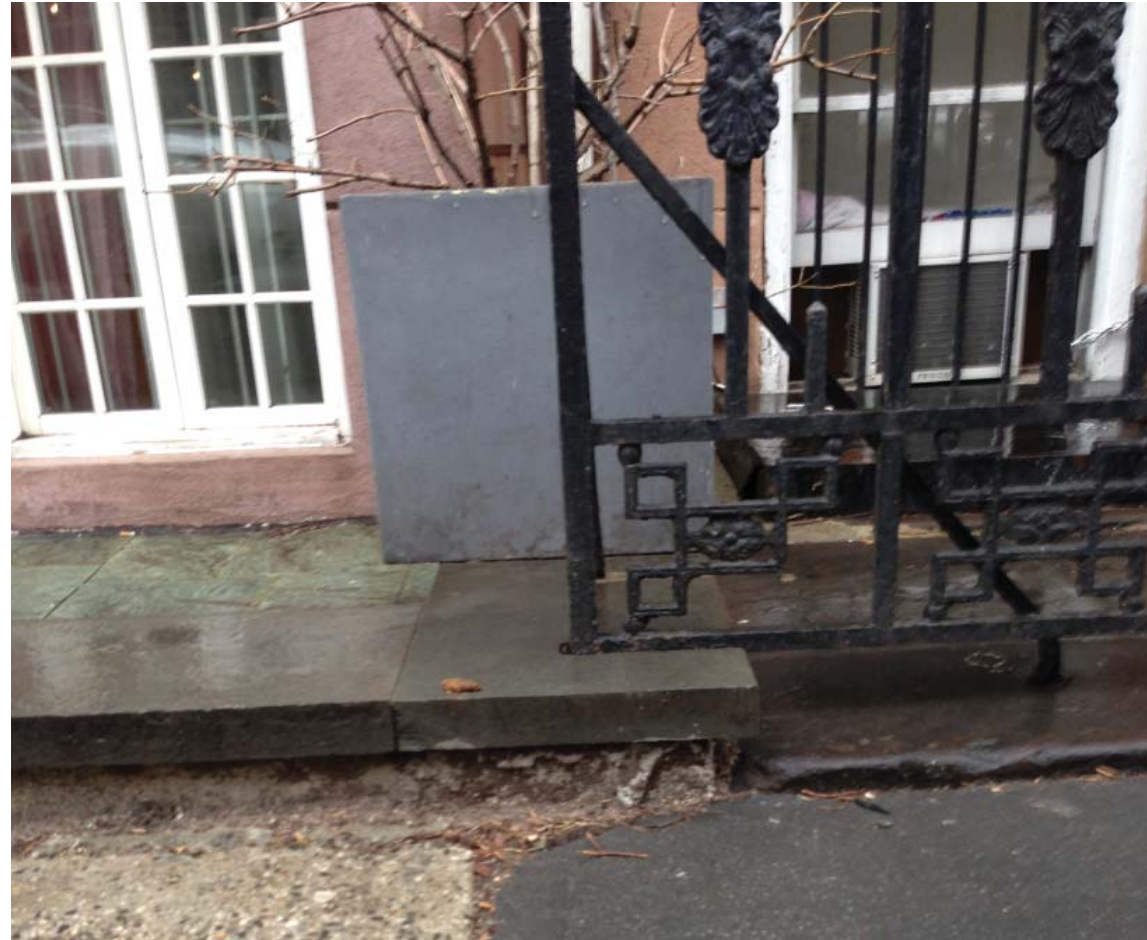
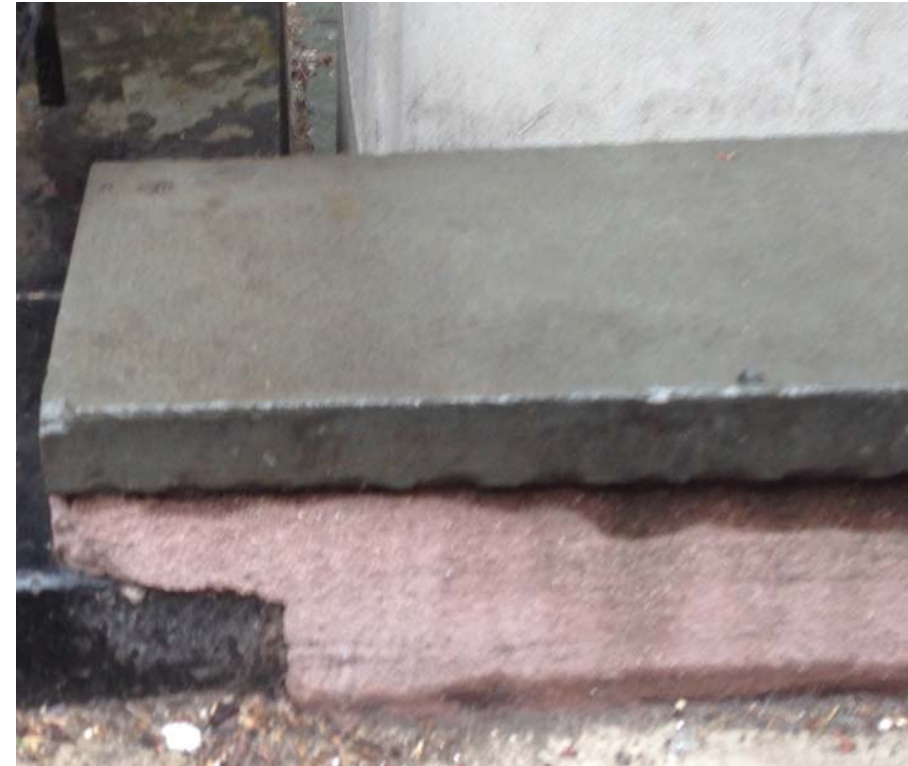
EXISTING CURB

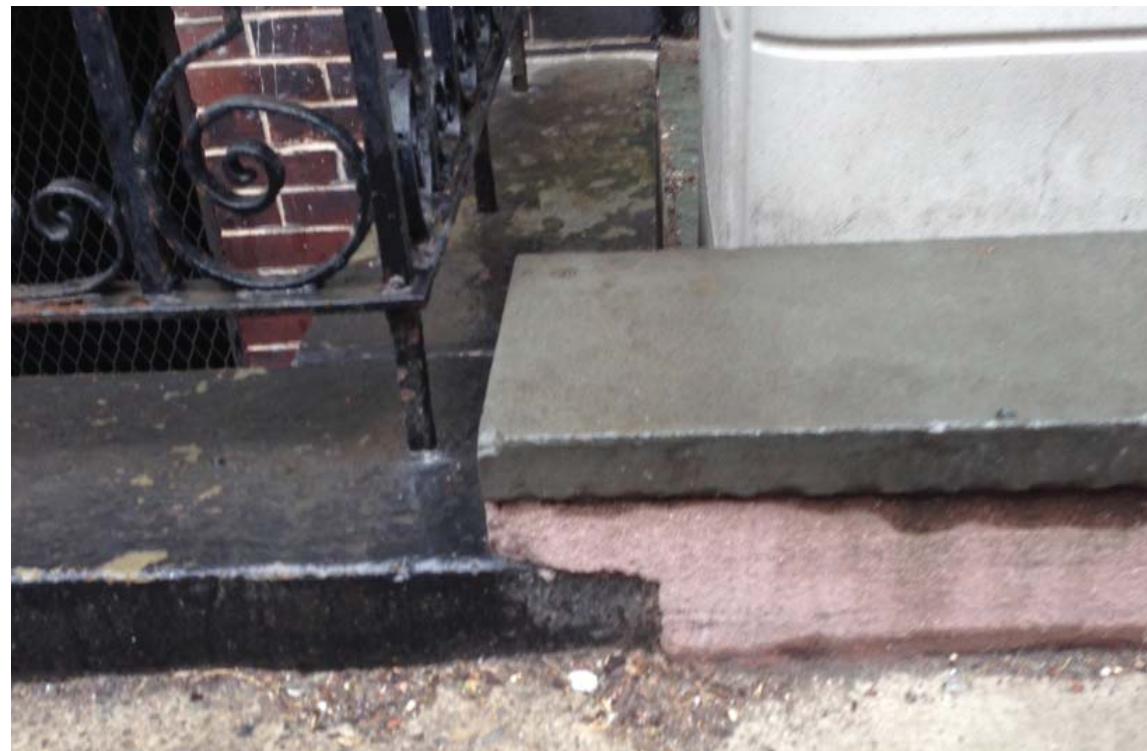
EXISTING AND NEIGHBOURS' CURBS

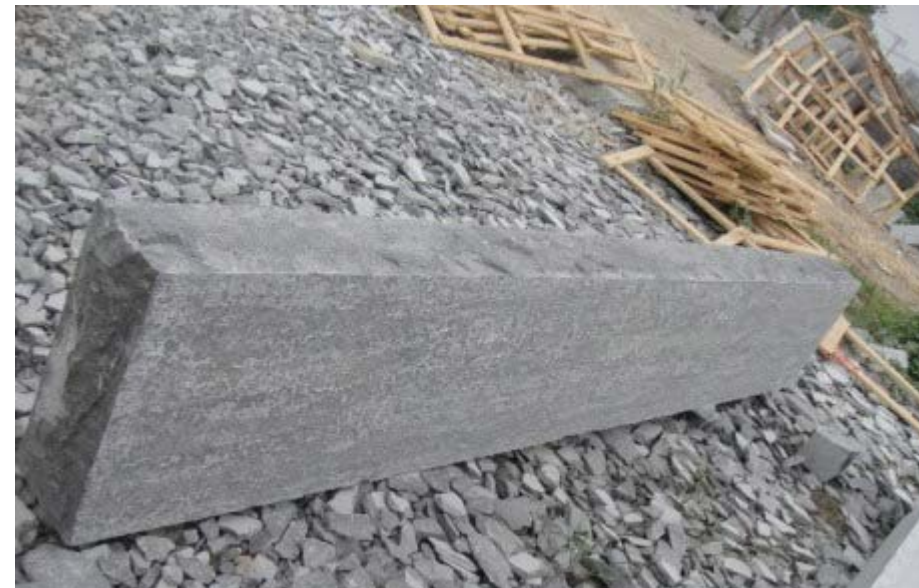
PROPOSED STONE CURB

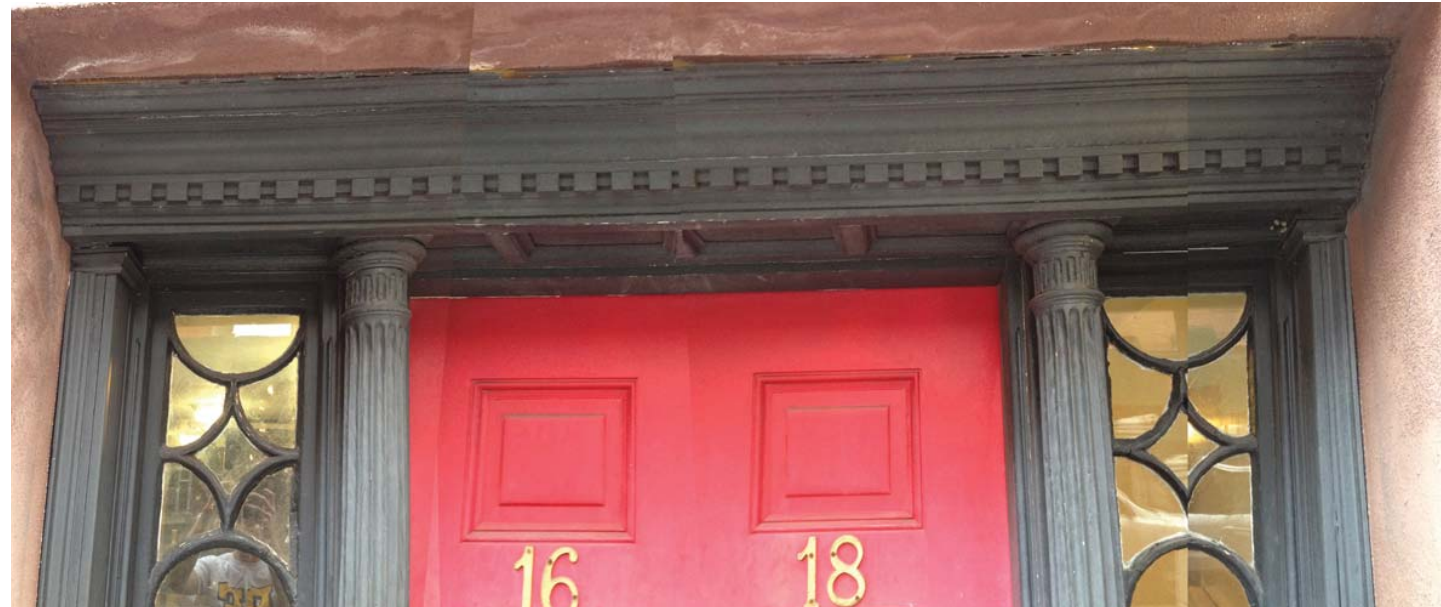
EXISTING DOOR AND SIDELIGHTS

We propose to paint the existing door, door surround and sidelights to reflect the historic colors.

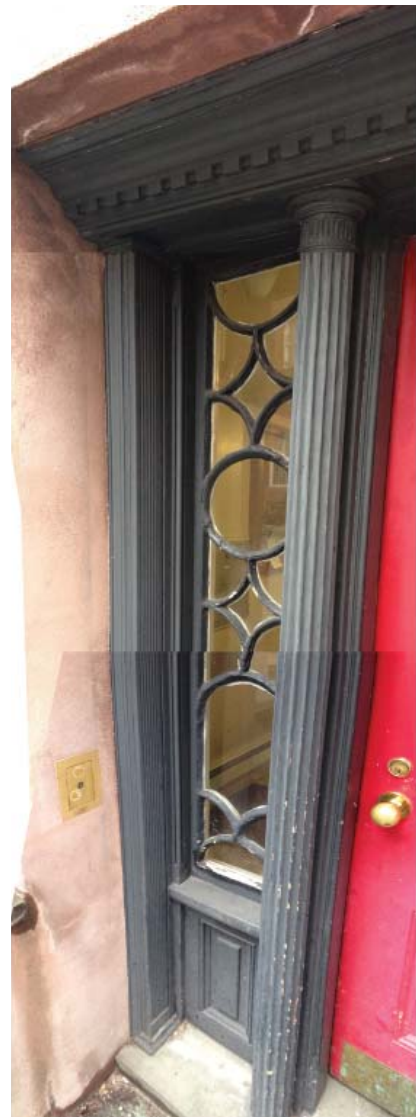
EXISTING SIDELIGHTS

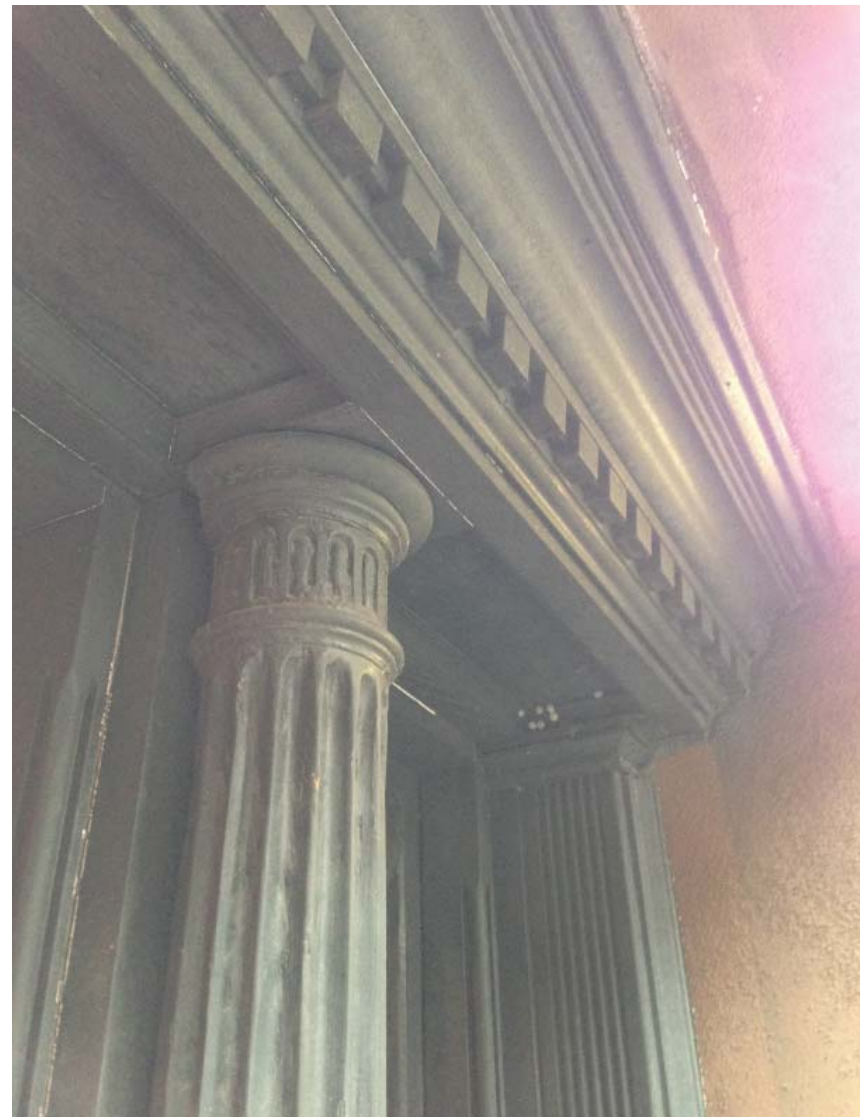
EXISTING DOOR SURROUND

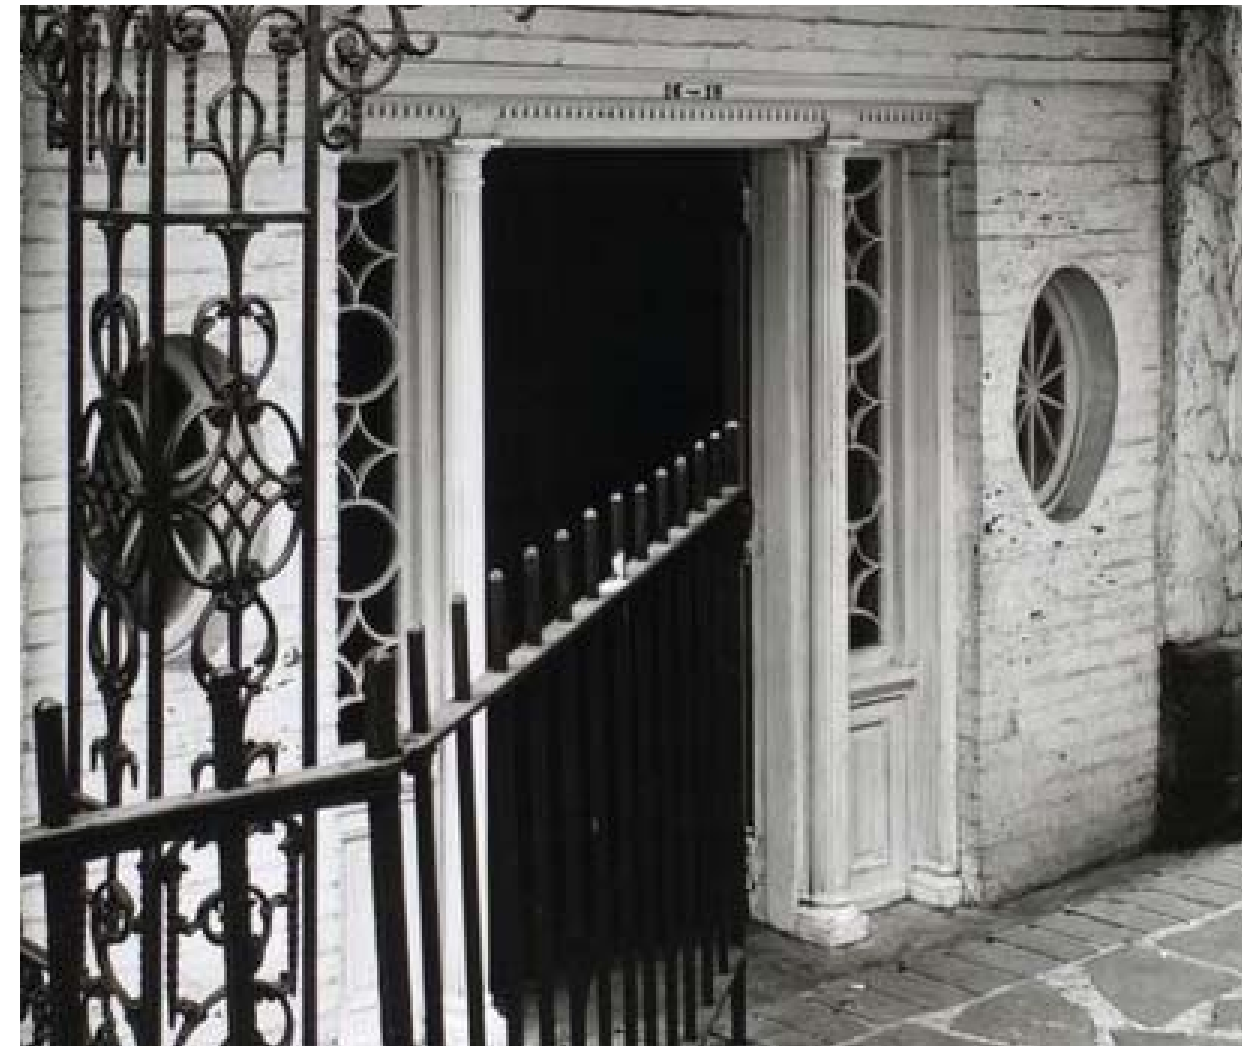
DOOR AND SIDELIGHTS, 1938

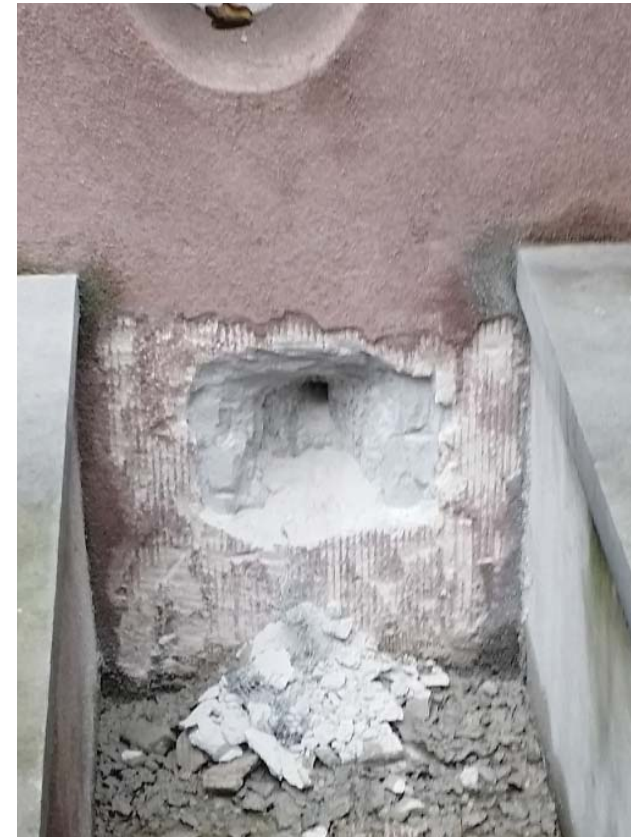
PROBE AT EAST SIDE OF ENTRY

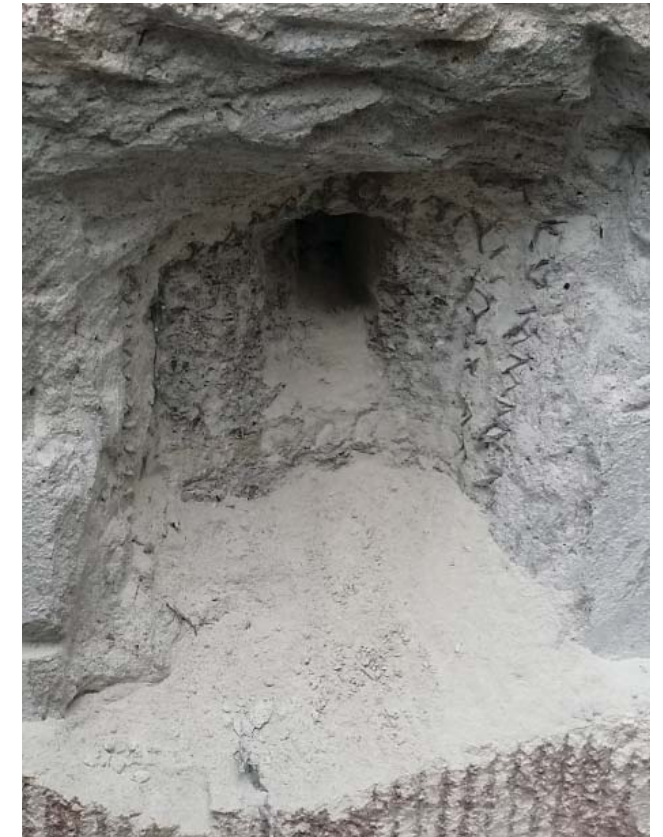
CLOSE UP OF PROBE AT EAST SIDE OF ENTRY
