# 16-18 CHARLES STREET

## SPIVAK ARCHITECTS

April 16, 2015

This presentation is to address the following violations associated with the front areaway of 16-18 Charles St.:

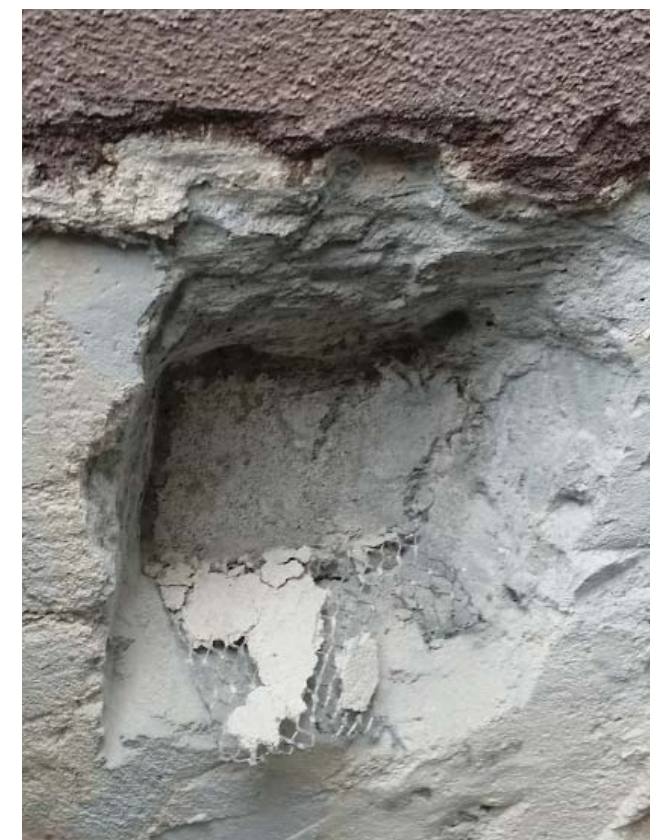
CLOSE UP OF PROBE AT WEST SIDE OF ENTRY

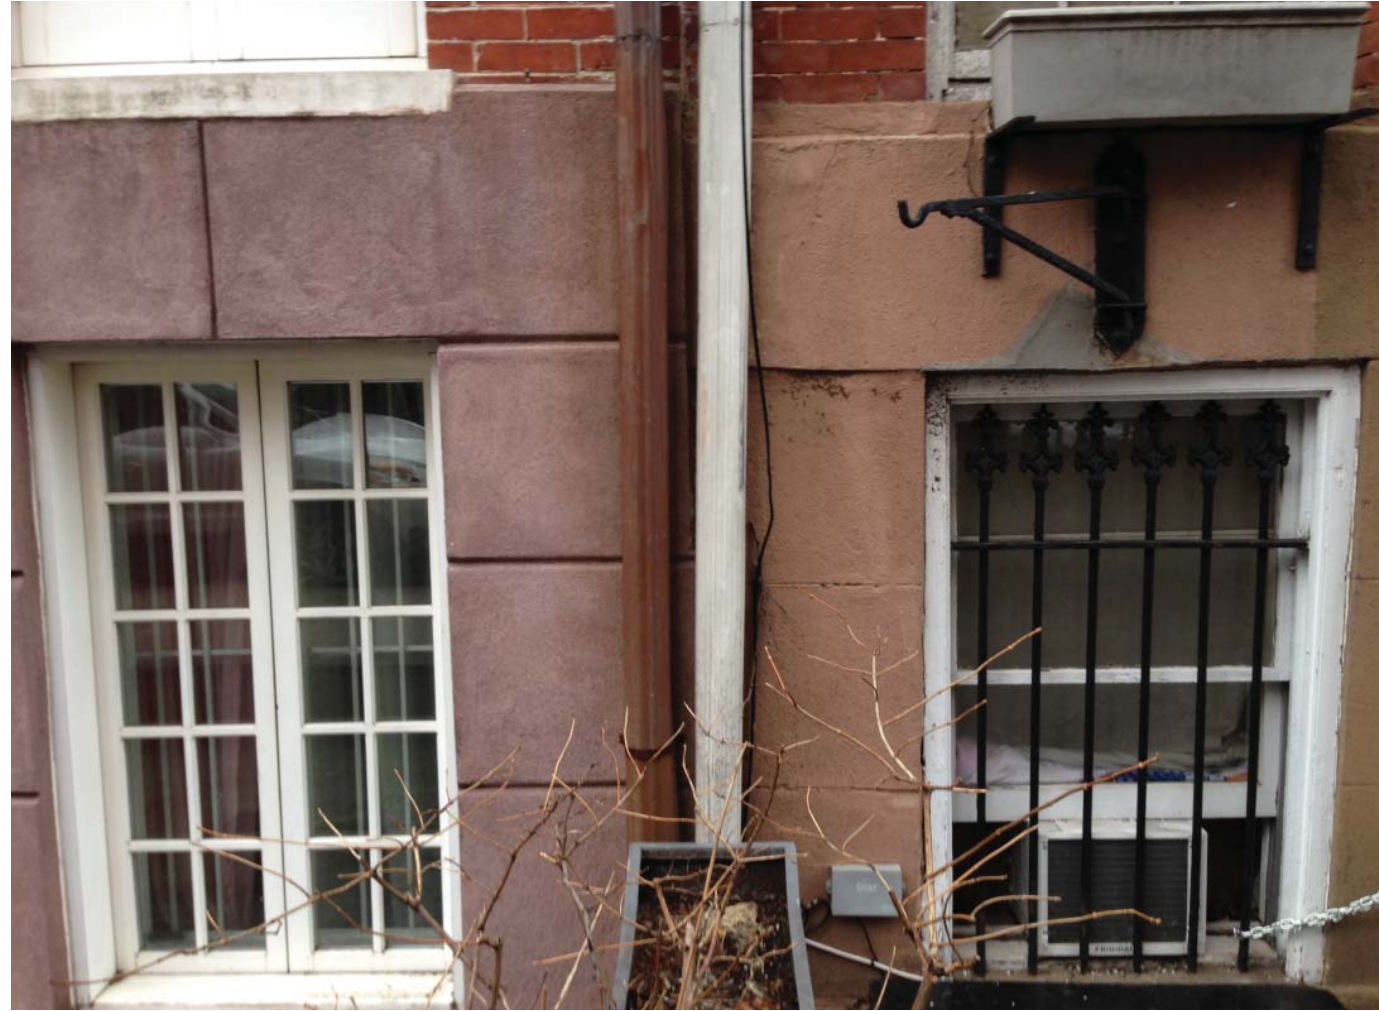
EXISTING STUCCO RUSTIFICATIONS AT 18 CHARLES ST / 20 CHARLES ST.

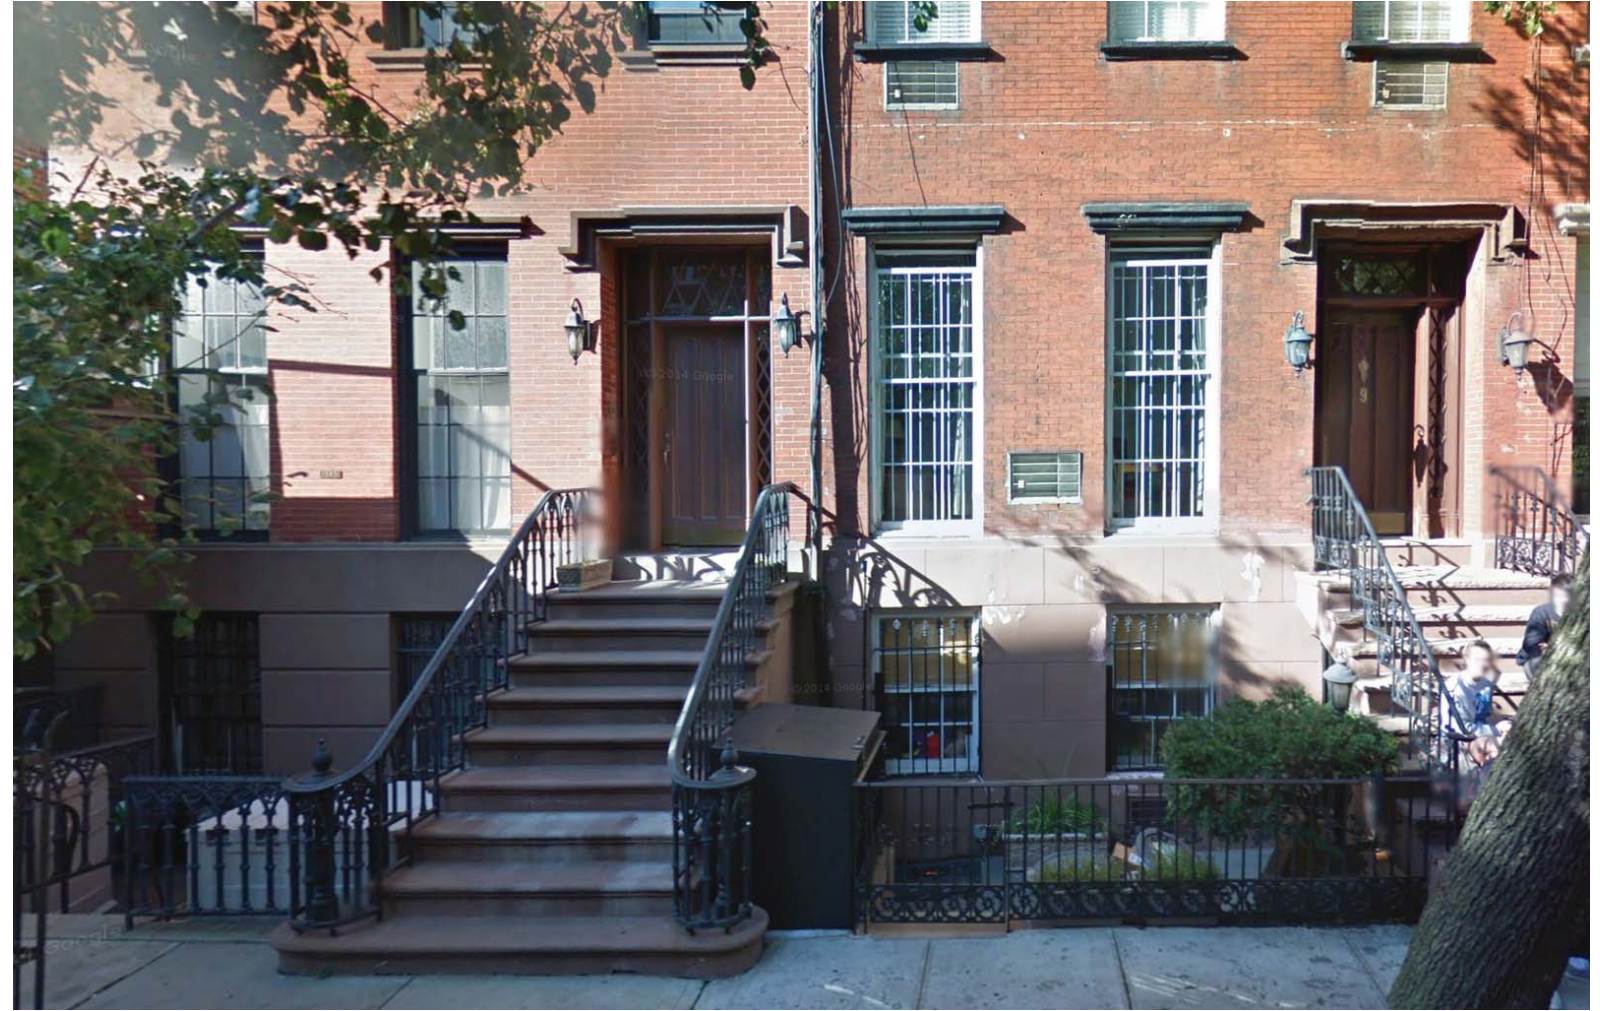
EXISTING STUCCO RUSTIFICATIONS AT 19 CHARLES ST.

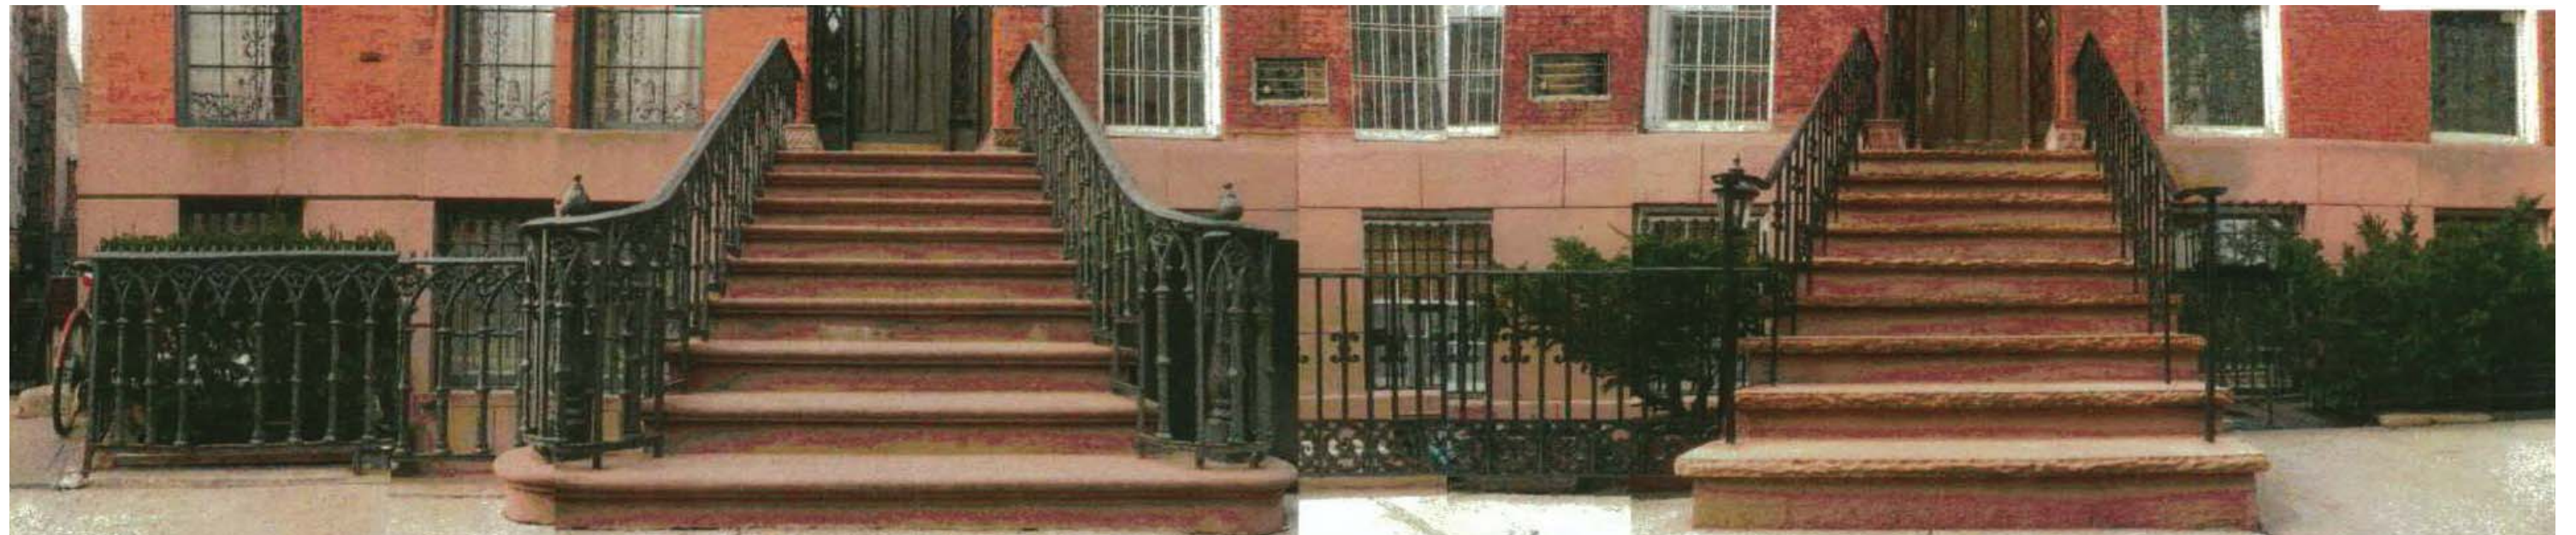
NEIGHBORHOOD PROPERTIES THAT ALSO SHOW STUCCO RUSTIFICATIONS

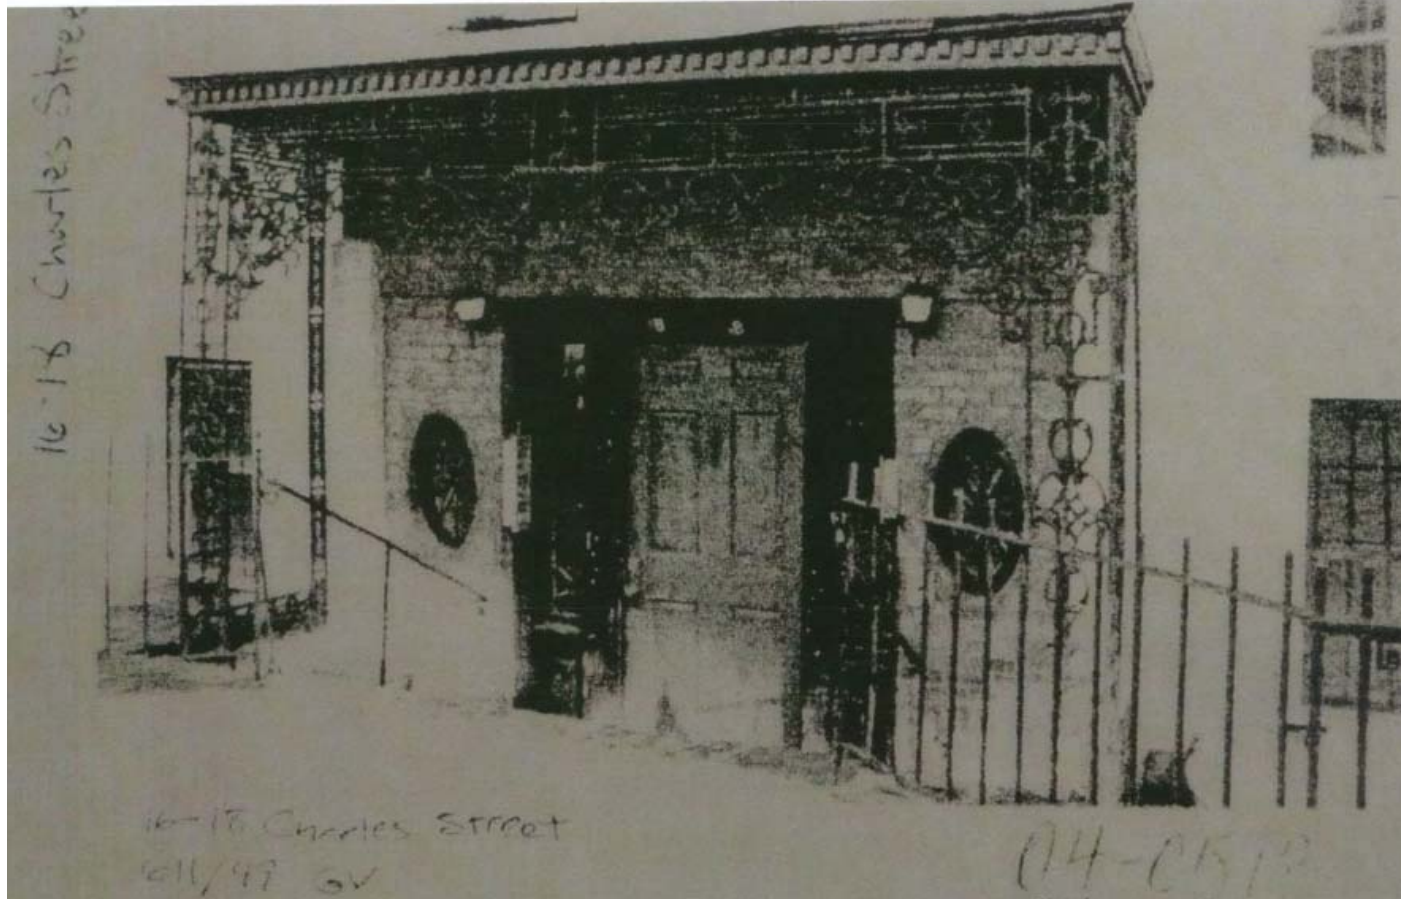
OLD SURFACE MOUNTED INTERCOMS, IMAGE FROM 1999

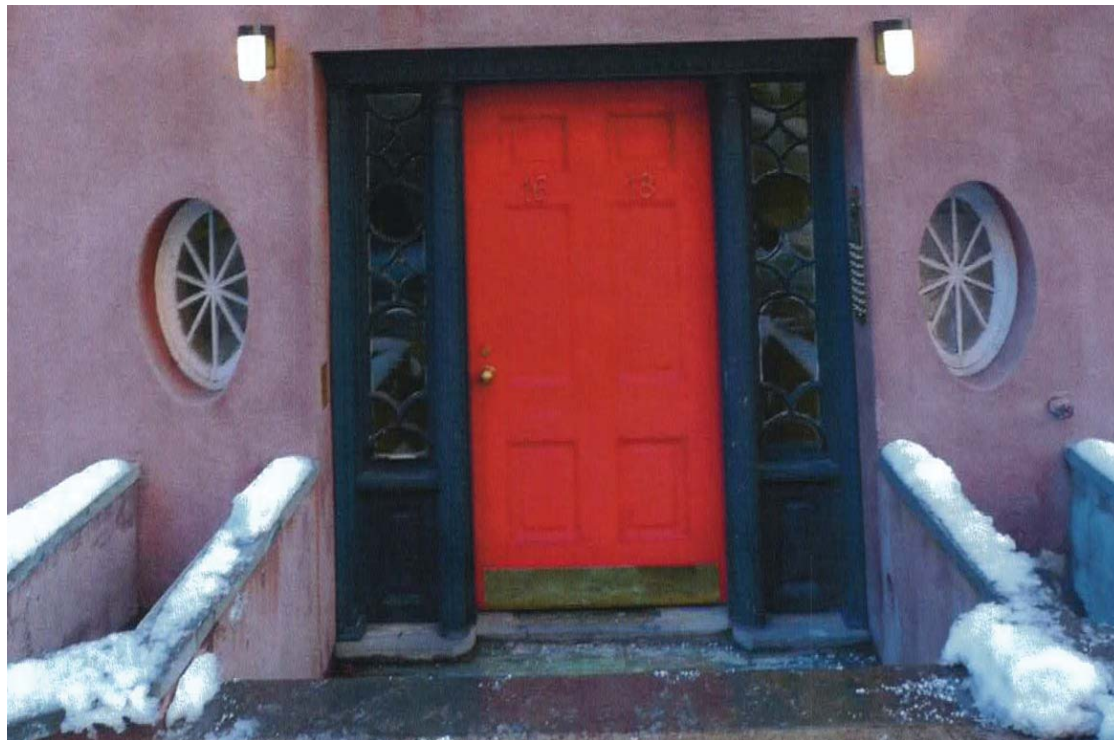
- legalize the intercoms which are currently recessed into the stucco and concrete block, and are not damaging any historic materials.

CURRENT RECESSED MOUNTED INTERCOMES ARE NOT OBTRUSIVE

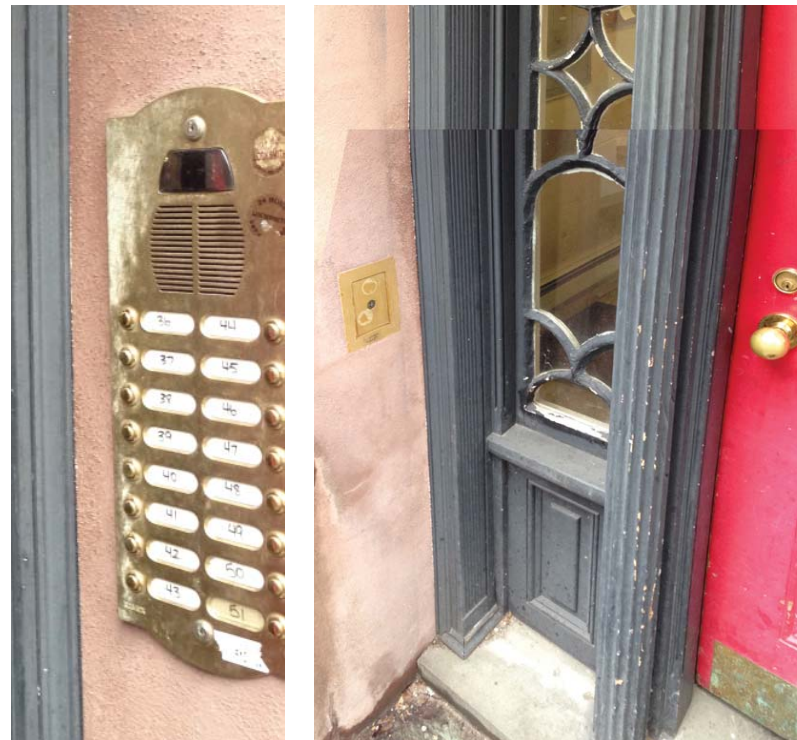
CLOSE UP OF EXISTING INTERCOM AND KEY BOX

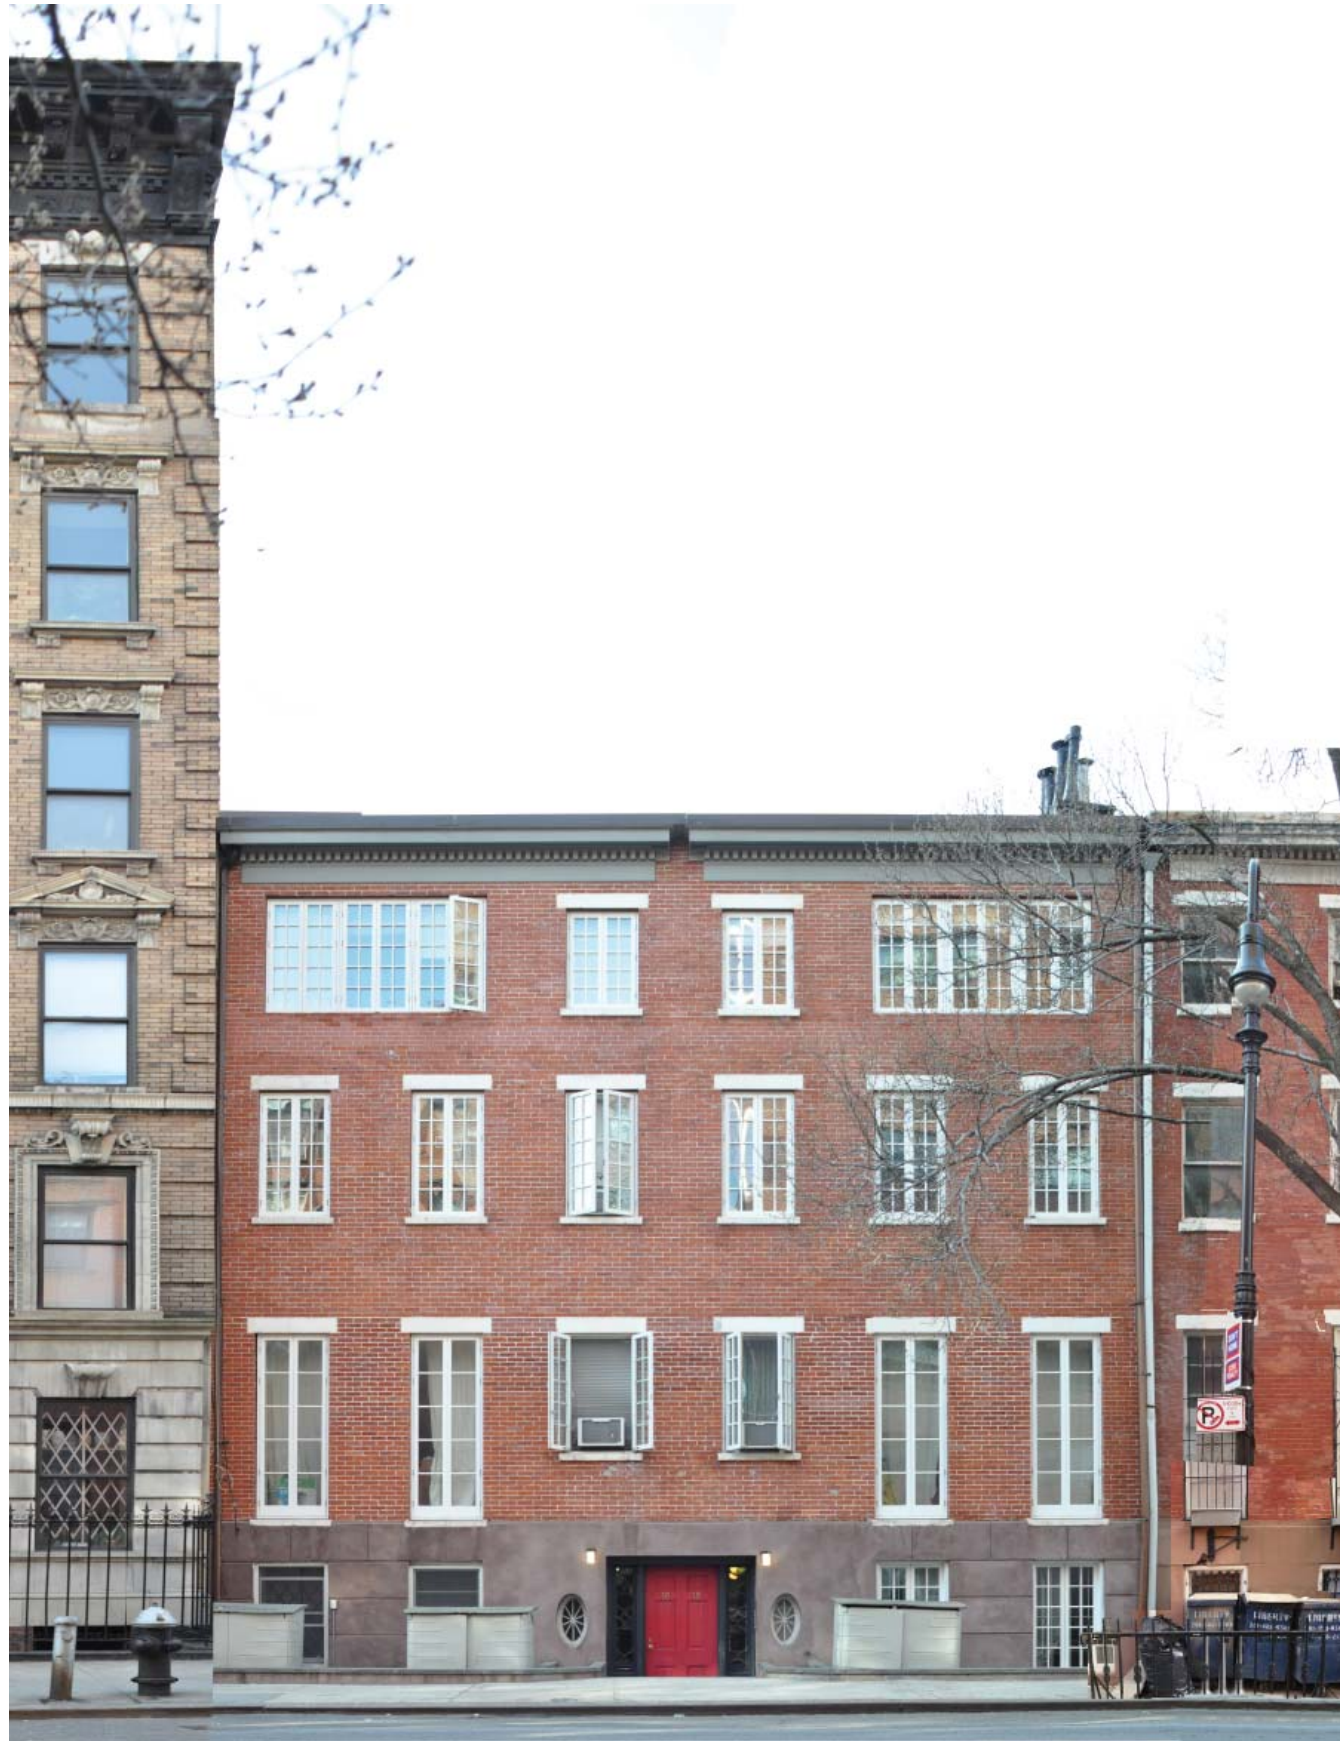
EXISTING ELEVATION

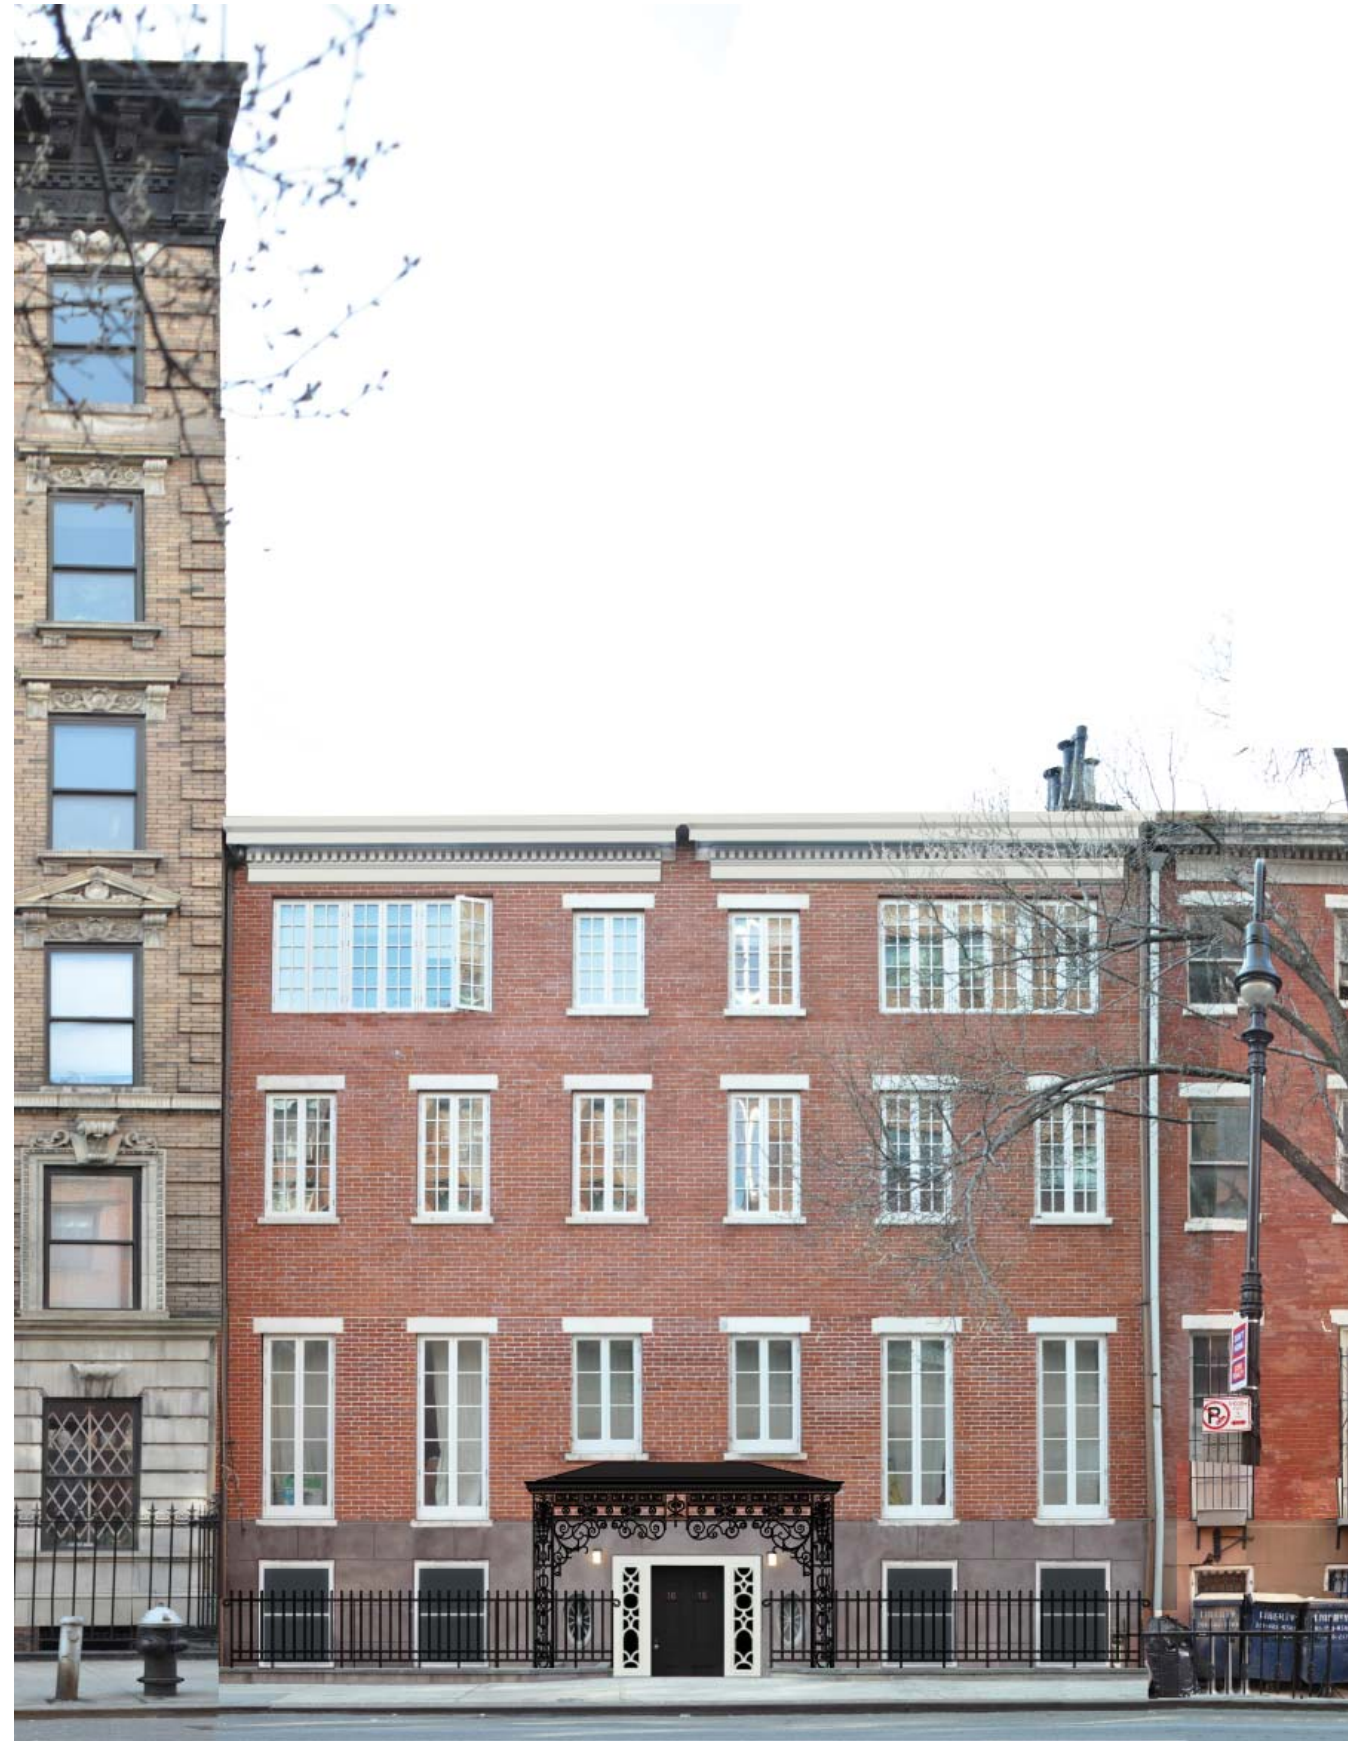
PROPOSED ELEVATION
