44 King Street - New York, NY 10014

PROPOSAL TO MODIFY TOP FLOOR WINDOWS ON REAR FACADE

CHARLTON-KING-VANDAM HISTORIC DISTRICT

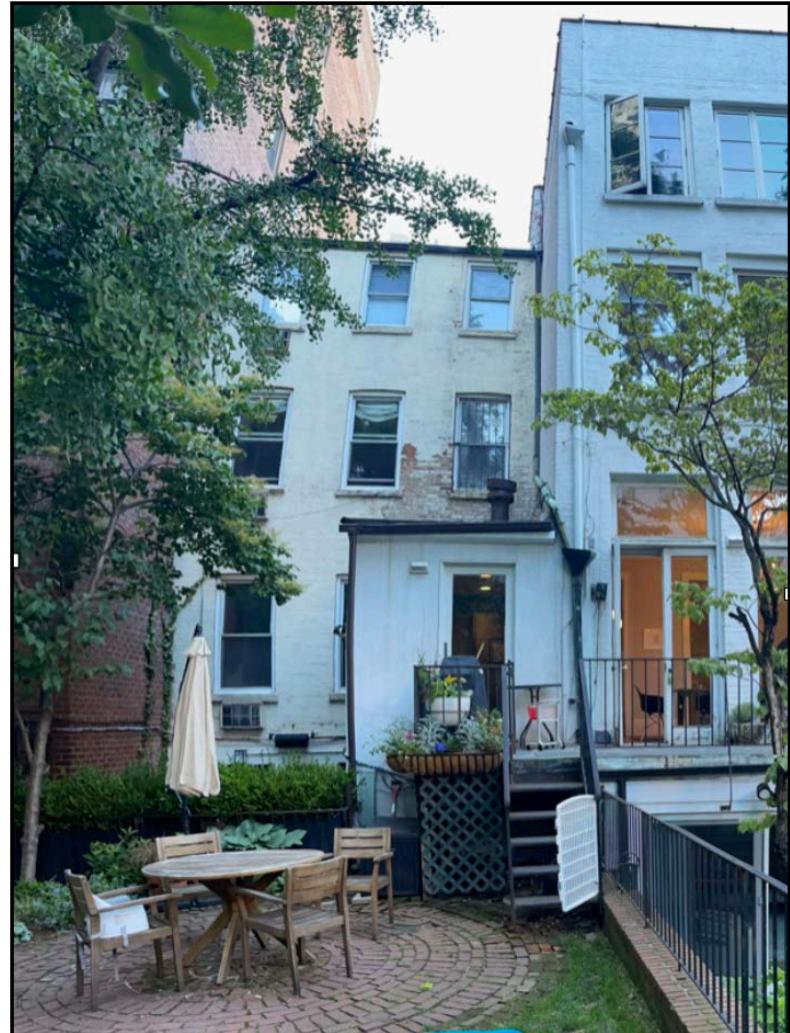
44 KING REAR FACADE

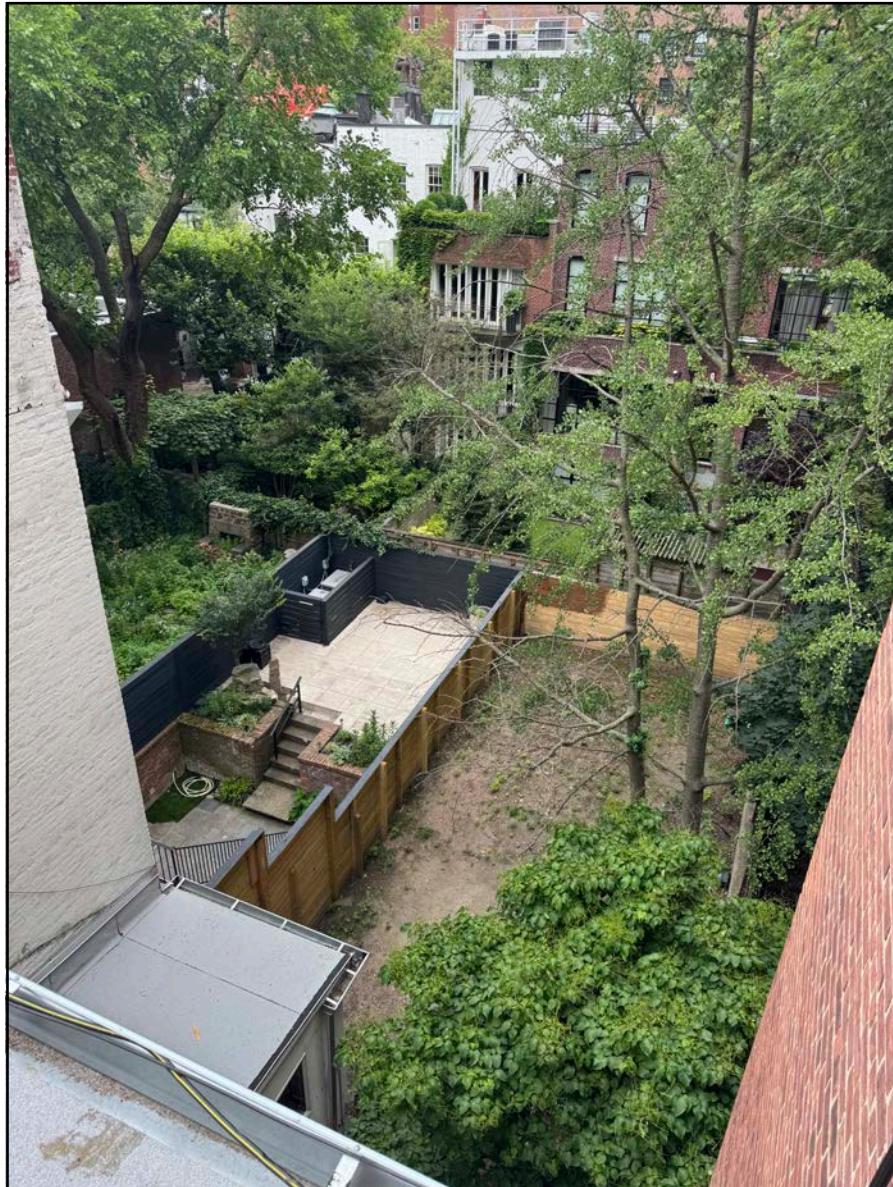
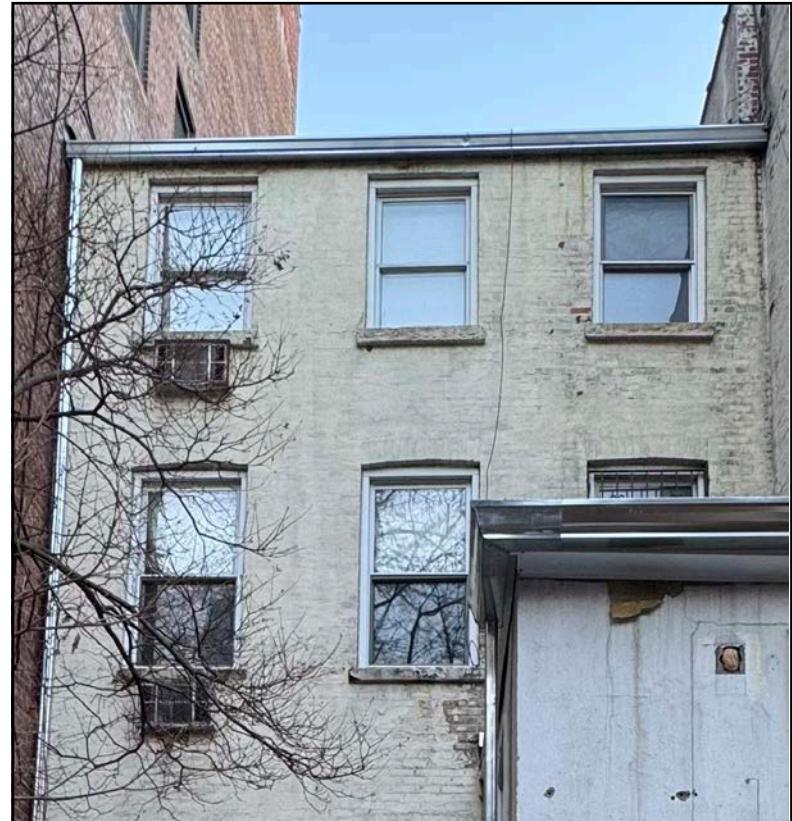
Close Up - 44 King Top Floor Rear Windows

The view from the top floor rear windows shows that there is no visibility from the street.

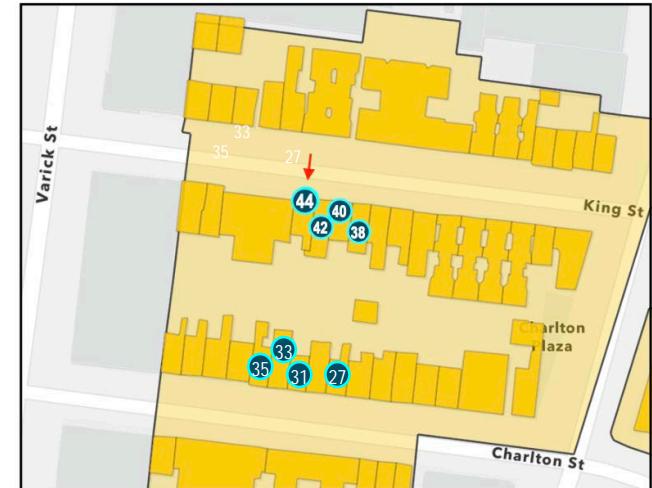
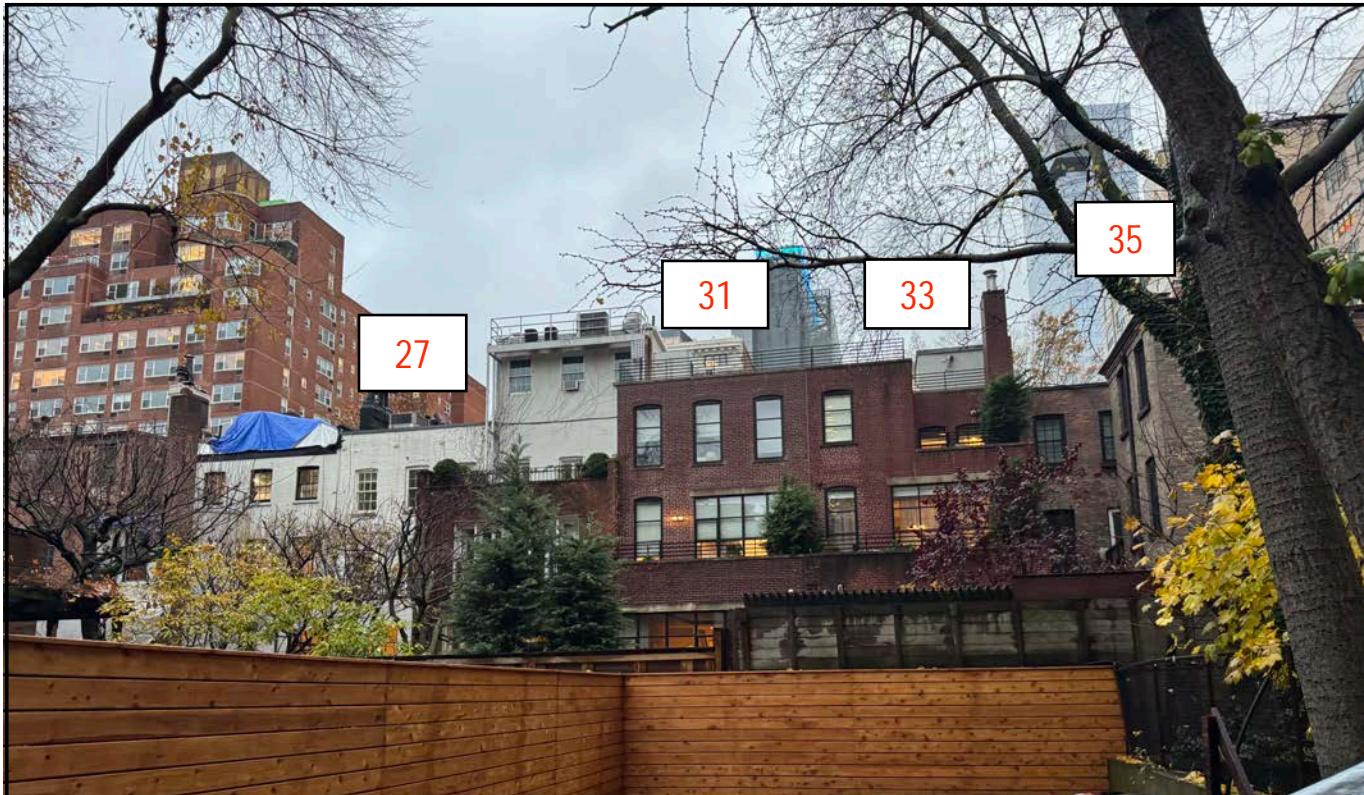
To the south the historical brownstone buildings at 27, 31, 33 and 35 Charlton Street have all modified the top floor windows on their rear facades to match the length of the windows below.
