## I. HAZARDOUS MATERIALS

**CROTONA PARK EIS**  
**HAZARDOUS MATERIALS**  
August 5, 2010

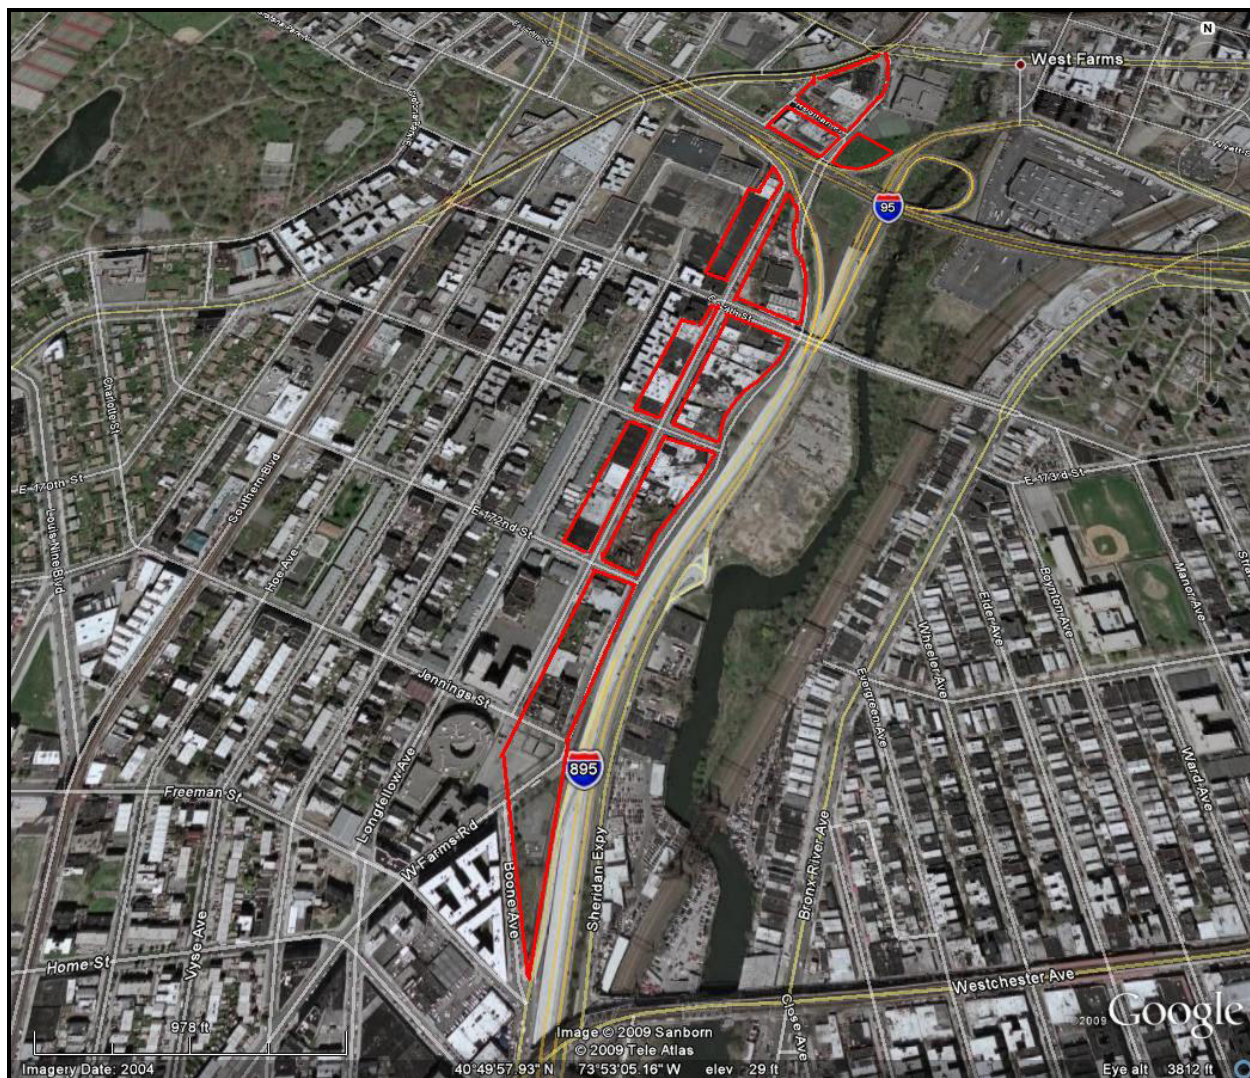
**Figure 1**  
**Crotona Park East Rezoning Area**

The blocks affected by the proposed action are contained within the boundaries of Longfellow Avenue to the west, West Farms Road to the east, Freeman Street to the south, and the intersection of Boston Road and West Farms Road to the north. Figure 1 shows the rezoning area.

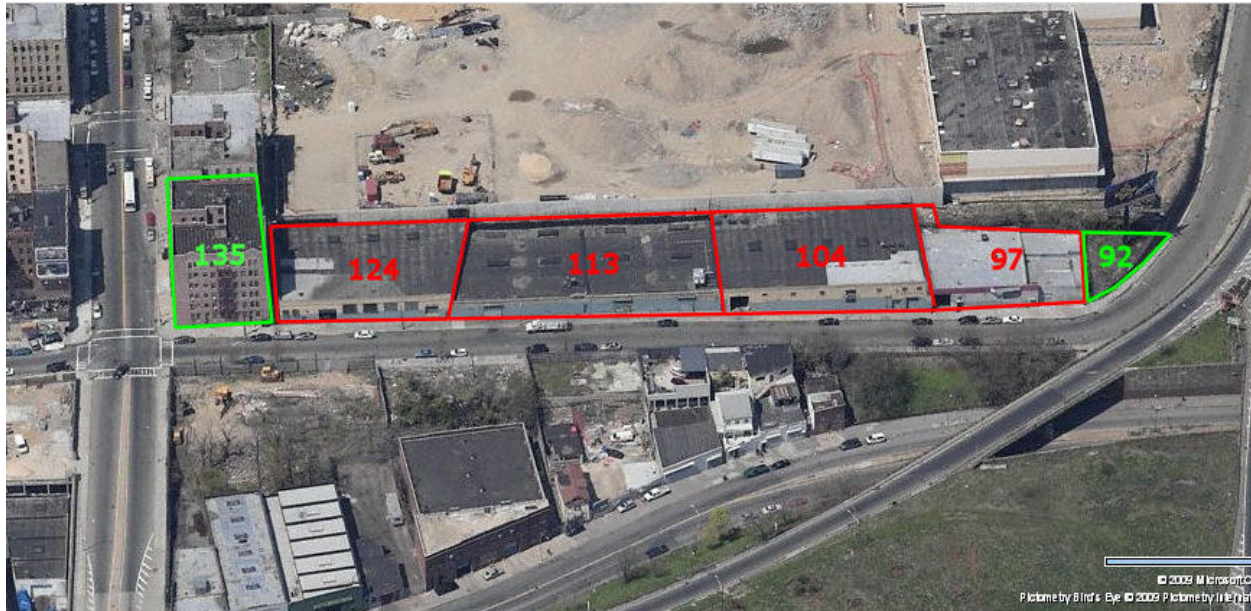
**Figure 2**  
**Block 2998**

*Legend: Red=projected development site, yellow=projected development site owned by applicant, blue=potential development site, green=unaffected site within rezoning area.*

**Lot 124** at 1769 Boone Avenue, is an unidentified one-story brick building constructed around 1931 and in use as a warehouse. It is listed as an E1 warehouse use by the NYC Department of Finance. Sanborn maps have identified the use as wholesale hardware since 1977 or earlier. Lot 124 is listed in the regulatory database as having a UST, which indicates potential for petroleum contamination. An adjacent site that formerly housed a metal works could have caused non-petroleum contamination.

**Lot 135** at 1007-1009 E. 174<sup>th</sup> Street, contains a six-story residential building built around 1924. No use prior to 1924 is identified. Although the history of the site does not indicate contamination with hazardous materials, it is within 150 feet of a site with a UST and sites with historical uses for sheet metal works. Therefore, the potential for both PC and NPC exists.

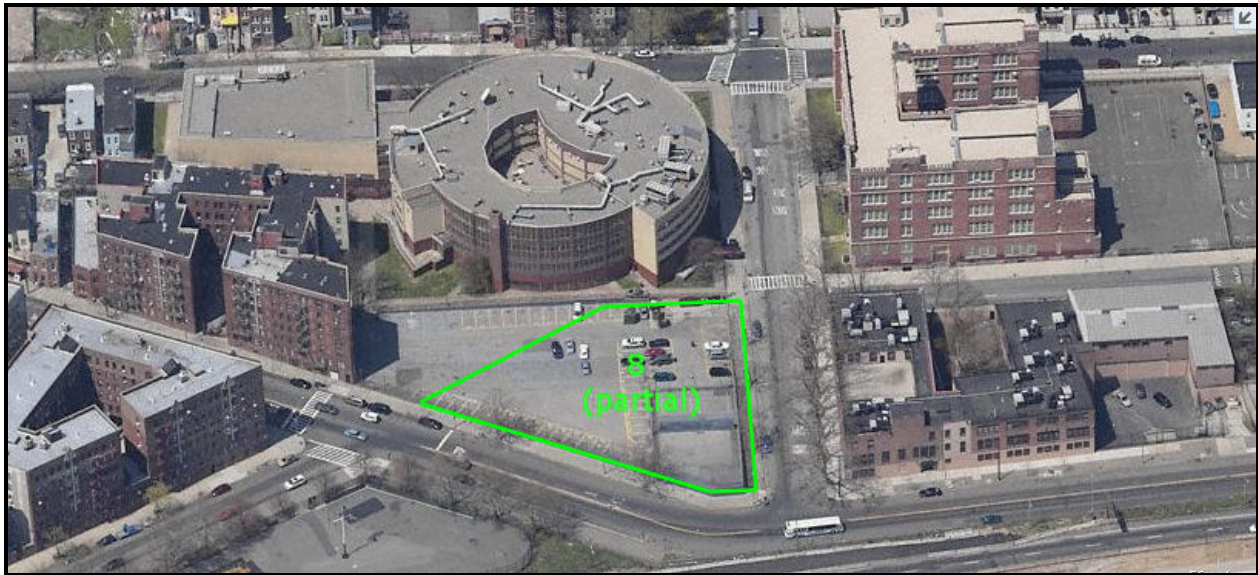
**Figure 3**  
**Block 3007**

*Legend: Red=projected development site, yellow= projected development site owned by applicant, blue=potential development site, green=unaffected site within rezoning area.*

**Lot 8** at 1331-65 West Farms Road, is the site of I.S. 84, which was constructed in 1969. The address also includes 1000-1020 Jennings Street, 1420-1450 Longfellow Avenue, and 1331-1365 West Farms Avenue. The portion of Lot 8 proposed for rezoning was separated from the rest of the block by Boone Avenue until the 1960s; it now contains the school's staff parking lot. The 1950 Sanborn map shows it was the site of a gasoline station with three tanks, several auto repair establishments, and a large private parking garage. These establishments included the addresses for 1000-1020 Jennings Street, 1351-1365 West Farms Road, and 1432-1436 Boone Avenue. Both PC and NPC would be associated with these uses.

The remainder of Lot 8 is not proposed for rezoning. Historically, it was on the other side of Boone Avenue and laid out with numerous small lots by the early 1900s. A large cement block factory was located in the central part of the lot, at 1435 Boone Avenue, in 1915. The 1950 map also shows a sewing machine repair shop at 1439 Boone Avenue and a print shop at 1435 Boone Avenue. Both PC and NPC would be associated with print shop and sewing machine uses.

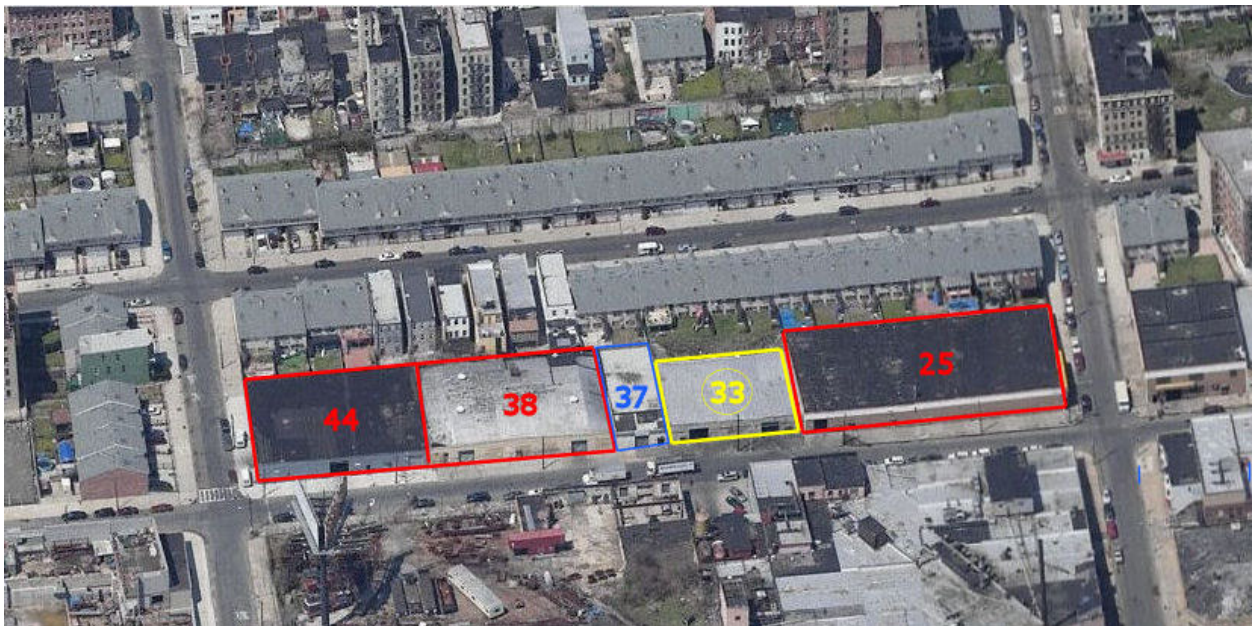
**Figure 4**  
**Block 3009**

*Legend: Red=projected development site, yellow= projected development site owned by applicant, blue=potential development site, green=unaffected site within rezoning area.*

**Lot 25.** Lot 25 at 1006 E. 173<sup>rd</sup> Street, is improved with a 1-story building constructed around 1931. Its current use as an auto body and repair shop has been present since approximately 1998. Two 550-gallon gasoline USTs are on-site. In 1950 this building was a 140-car garage and repair center. It was subsequently converted to a warehouse until about 1996. On the 1998 through 2007 Sanborn maps, the lot is shown as an auto repair and warehousing facility. The 2008 Sanborn map shows it as a garage. PC and NPC would be associated with the present and historic uses.

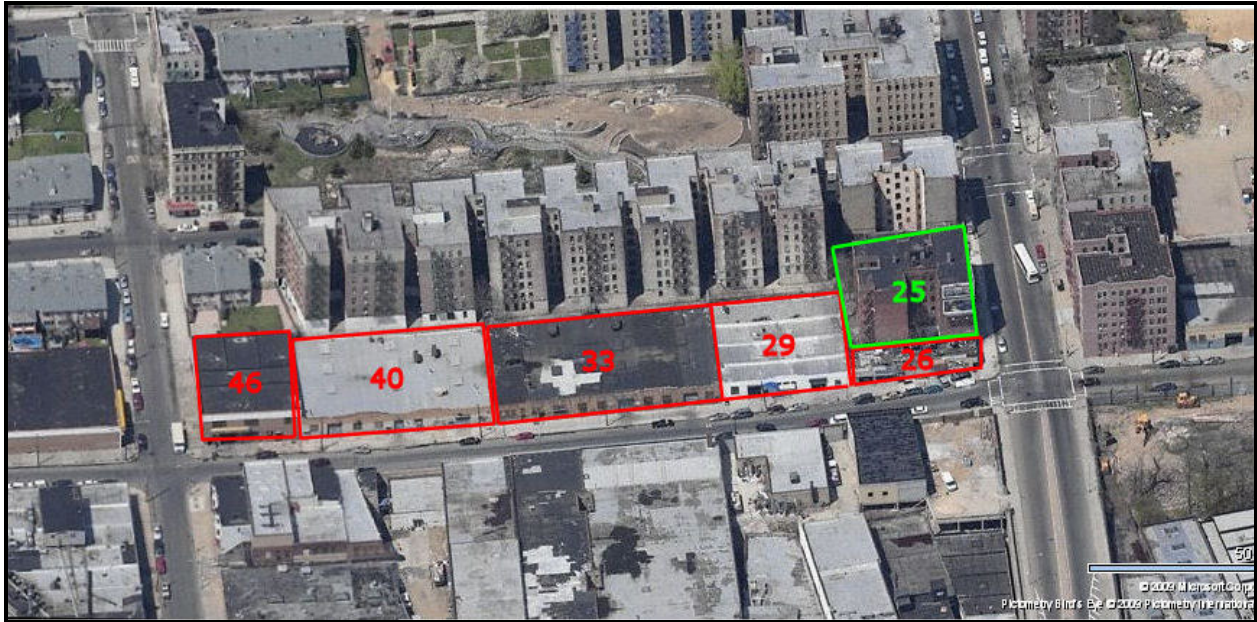
**Figure 5**  
**Block 3010**

Current. Block 3010 is bounded by E. 174<sup>th</sup> Street to the north, Boone Avenue to the east, E. 173<sup>rd</sup> Street to the south, and Longfellow Avenue to the west. Land uses along Longfellow Avenue are residential while the land uses along Boone Avenue are industrial and auto-oriented. The lot numbers are shown in Figure 5.

*Legend: Red=projected development site, yellow= projected development site owned by applicant, blue=potential development site, green=unaffected site within rezoning area.*

**Lot 25.** Lot 25 at 1016 E. 174<sup>th</sup> Street is improved with a 5-story residential building constructed around 1924. No non-residential uses were identified for this lot. However, adjacent uses included auto repair and factory uses, which could be sources of PC and NPC.

**Lot 26.** Lot 26 at 1711 Boone Avenue contains a one-story commercial structure that is occupied by the Boone Auto Body and Fender Repair Shop. According to information available on the NYC Open Accessible Space Information System, it was built in 1924. This information conflicts with the 1950 Sanborn map, which shows the lot as vacant. The 1977 Sanborn map shows an auto repair facility operating on a portion of this lot. A second building was added in the 1980s, and it also became an auto repair facility. In 1997, a 275-gallon AST for oil was installed. The presence of the tank and the site's use as an automotive repair facility is a potential source of contamination for both petroleum and non-petroleum compounds.

**Lot 46.**at 1661 Boone Avenue is improved with a two-story building constructed in 1931. Currently, it houses a General Mechanic/N.Y.S. Inspection auto repair facility. The 1950 Sanborn Map shows this was the location of Finkel Umbrella Frame Company, Inc., which manufactured outdoor products. By 1998 the building had been converted to auto repair uses. The site's former uses are a potential source of contamination with both PC and NPC.

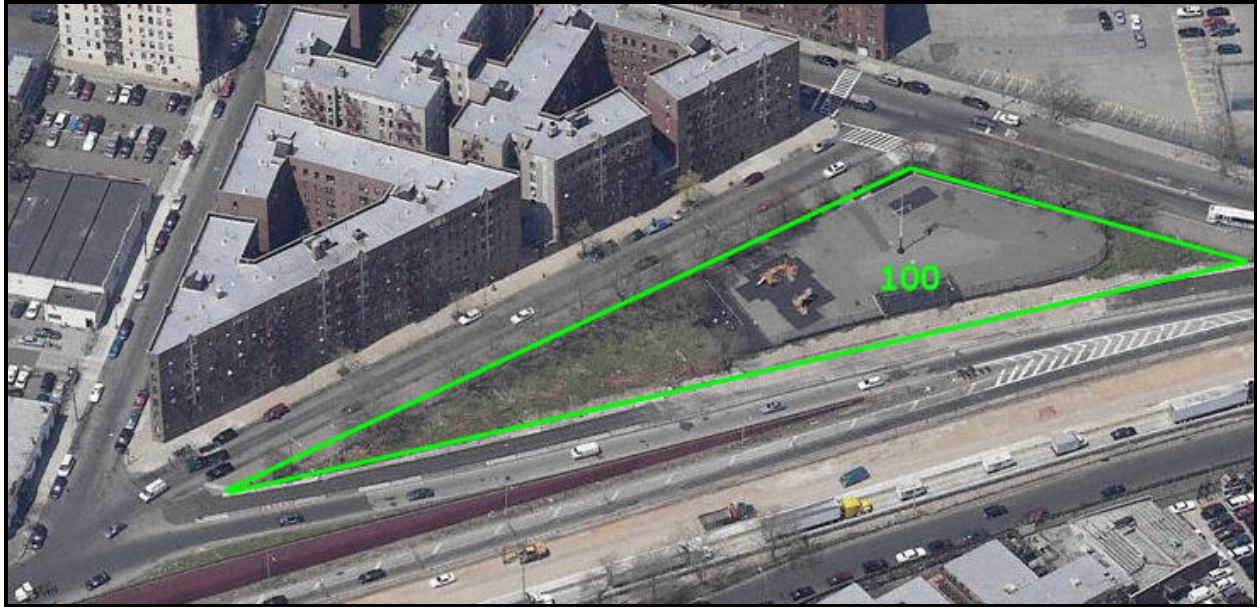
**Figure 6**  
**Block 3012**

*Legend: Red=projected development site, yellow= projected development site owned by applicant, blue=potential development site, green=unaffected site within rezoning area.*

**Lot 100**, the only block on the lot, is the Daniel Boone Playground. The northern half is a paved playground, and the southern half is a grassy area with benches. By 1915, the northern half of Lot 100 was developed with single family homes, and the southern portion of the lot had a group of buildings identified as manufacturing of poles, ladders, and portable buildings. The Olin J. Stephens coal and lumber yard across the street included a 250-gallon underground gasoline tank as well as a garage for repairs.

By 1950, the northern tip of the lot was developed with a gasoline station with three 550-gallon buried gasoline tanks, while the southern half of Lot 100 had two large warehouses -- one for wine, the other furniture -- and a contractor's garage. The coal yard across the street had been replaced by a manufacturer of concrete slabs, a filling station with three gasoline tanks, and an auto repair shop.

Lot 100 was reduced in size and cleared of development during construction of I-895. The Daniel Boone Playground opened in 1963. The building across the street housing a concrete slab manufacturer also was diminished in size and evolved into its present use as an auto parts warehouse and yard. The auto repair shop across the street remains, but the filling station has become a used car lot. The presence of auto-oriented and industrial uses on or adjacent to Lot 100 could be a source of PC and NPC on the site.

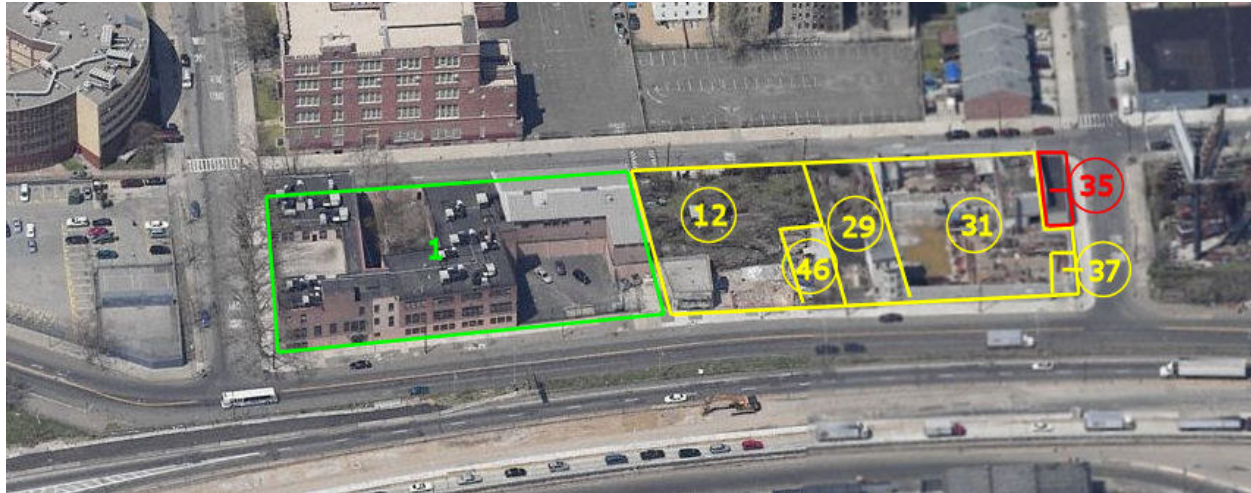
**Figure 7**  
**Block 3013**

*Legend: Red=projected development site, yellow= projected development site owned by applicant, blue=potential development site, green=unaffected site within rezoning area.*

**Lot 1**, at 1021 Jennings Street, contains three buildings that house the Fannie Lou Hamer Freedom High School. Originally, the site was developed in 1924 with a building labeled Altro Work Shops, a sheltered workshop where workers sewed uniforms. Two more buildings were added by 1977. Altro remained until the mid-1980s, after which the site's use is unidentified until 1985, when the buildings were converted into the high school. Land uses on the other side of West Farms Road included a manufacturer of plastic castings in 1950, which was subsequently replaced by a welding and boiler repair establishment. Because Lot 1 is adjacent to an automotive repair facility, as well as two former gas stations, it may have been contaminated with PC and NPC.

**Lot 12**, 1471 West Farms Road, currently is the site for an auto junk yard along with an auto/electrical repair center. The one-story building was built in 1964. Sanborn maps indicate that a gas station was present until 2002. The site's historical uses as a gas station and automotive repair facility are a potential source of contamination with both petroleum and non-petroleum compounds.

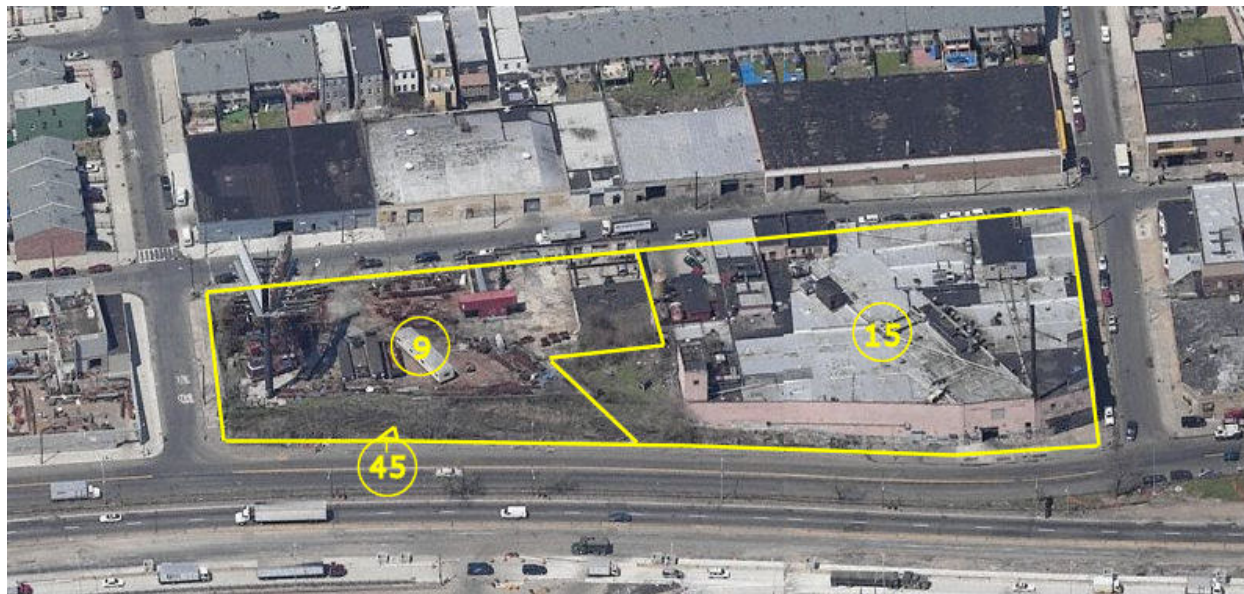
**Figure 8**  
**Block 3014**

*Legend: Red=projected development site, yellow= projected development site owned by applicant, blue=potential development site, green=unaffected site within rezoning area.*

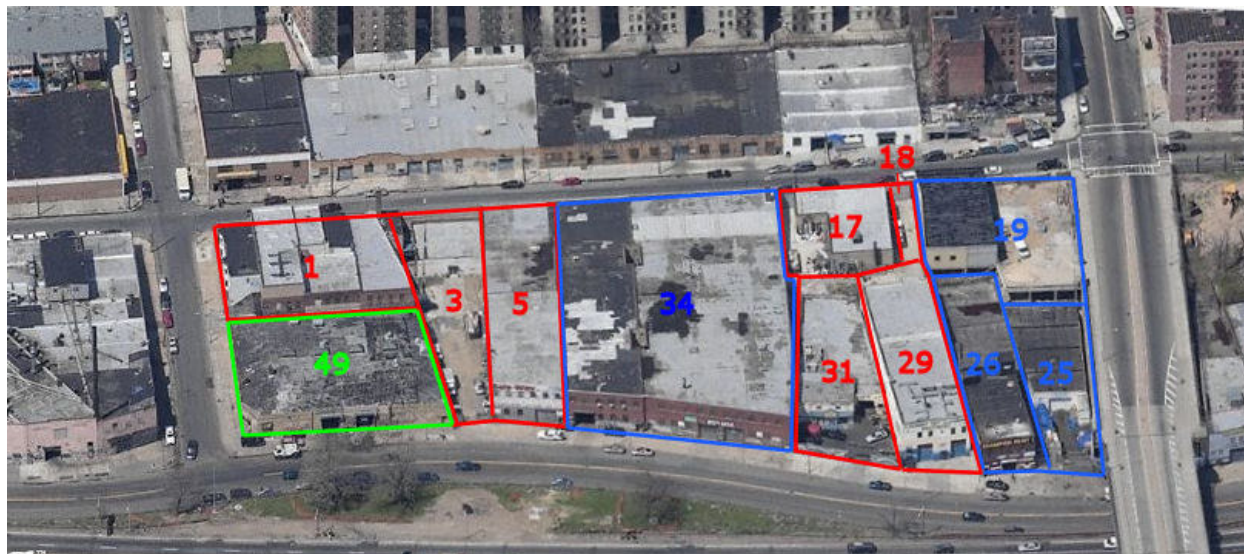
**Figure 9**  
**Block 3015 (south)**

*Legend: Red=projected development site, yellow= projected development site owned by applicant, blue=potential development site, green=unaffected site within rezoning area.*

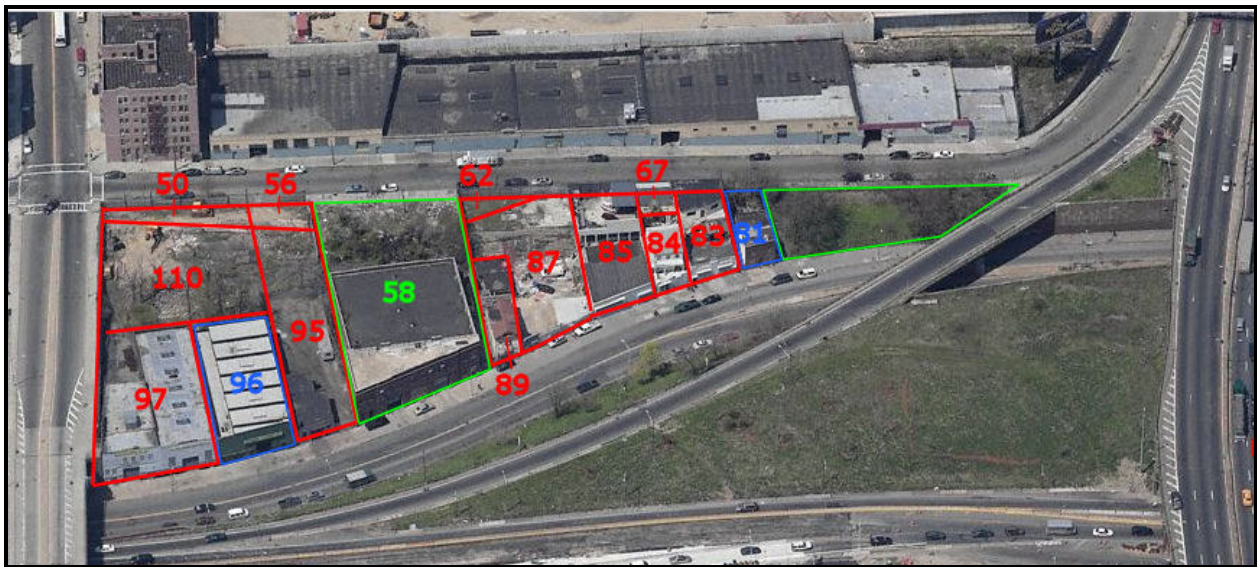
**Figure 10**  
**Block 3015 (north)**

*Legend: Red=projected development site, yellow= projected development site owned by applicant, blue=potential development site, green=unaffected site within rezoning area.*
