Cooper Ave/73rd Pl/78th Ave

Commissioner Janette Sadik-Khan, New York City Department of Transportation
Presented to Community Board 5, April 24th, 2012
Pedestrian Projects Group

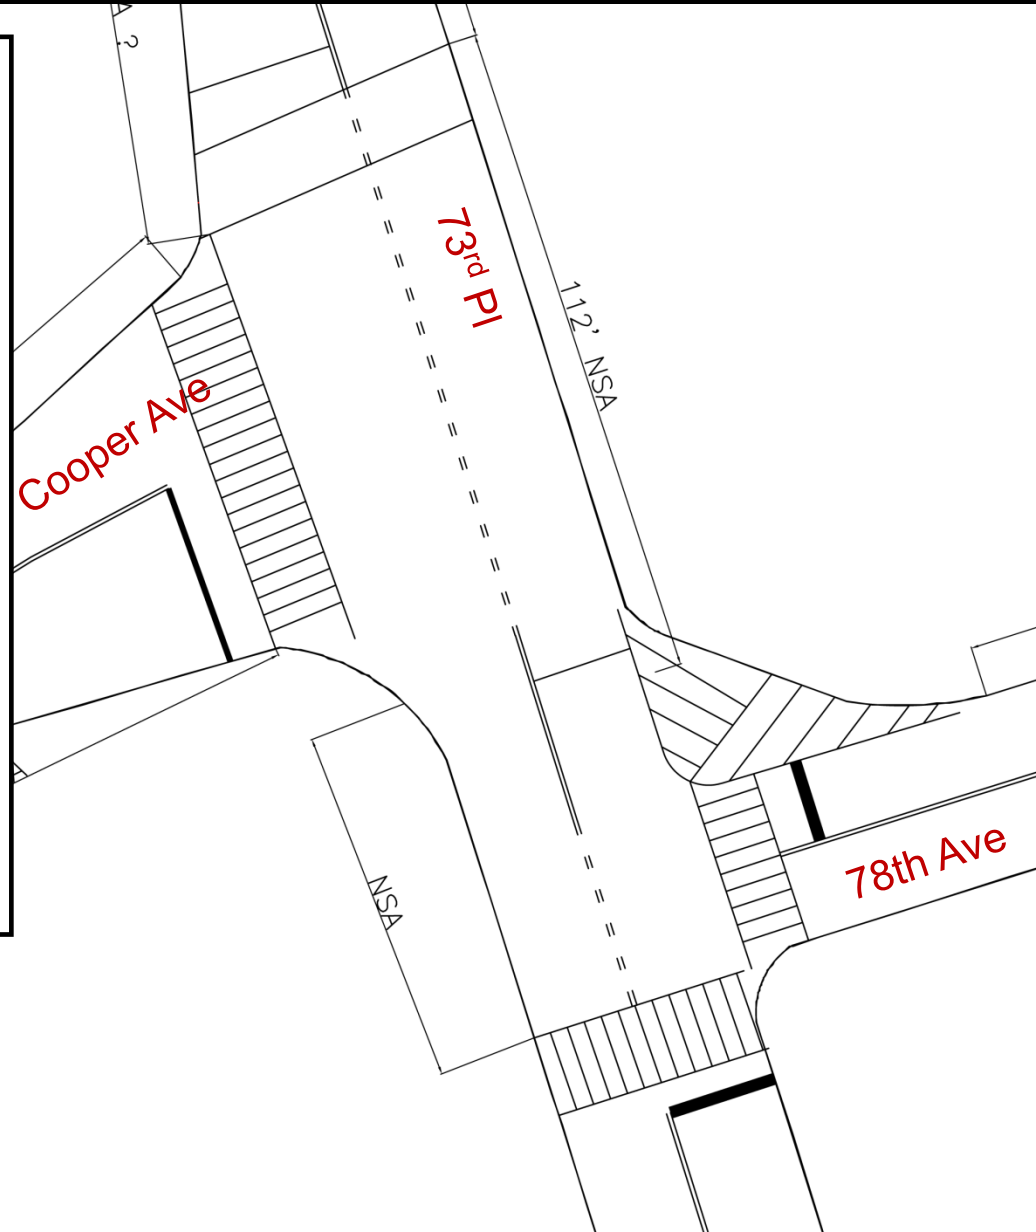
Large number of pedestrians crossing where there is no crosswalk.

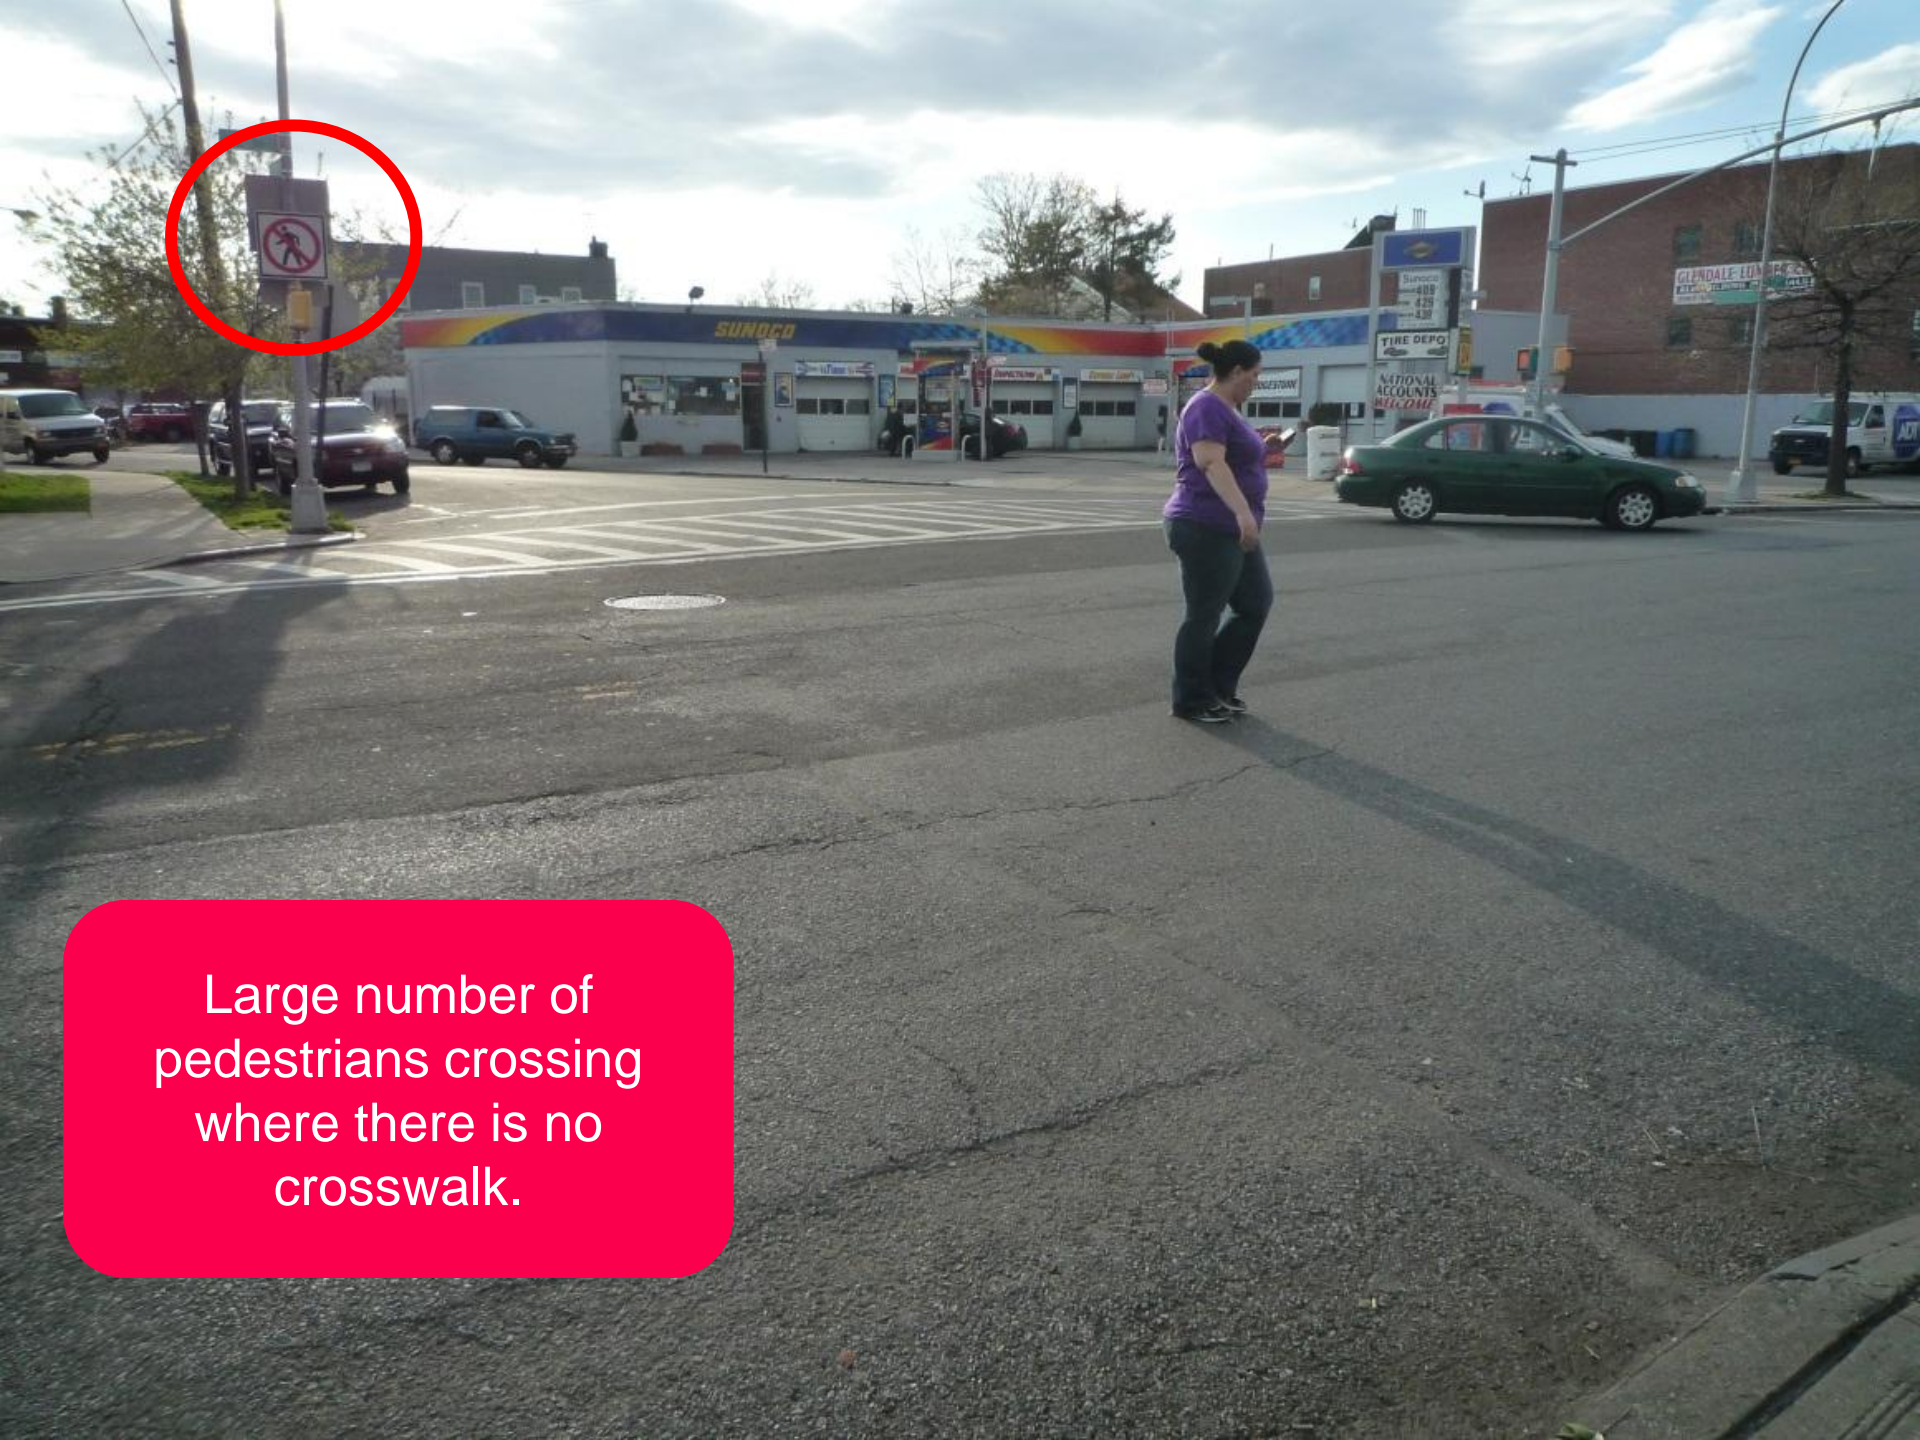
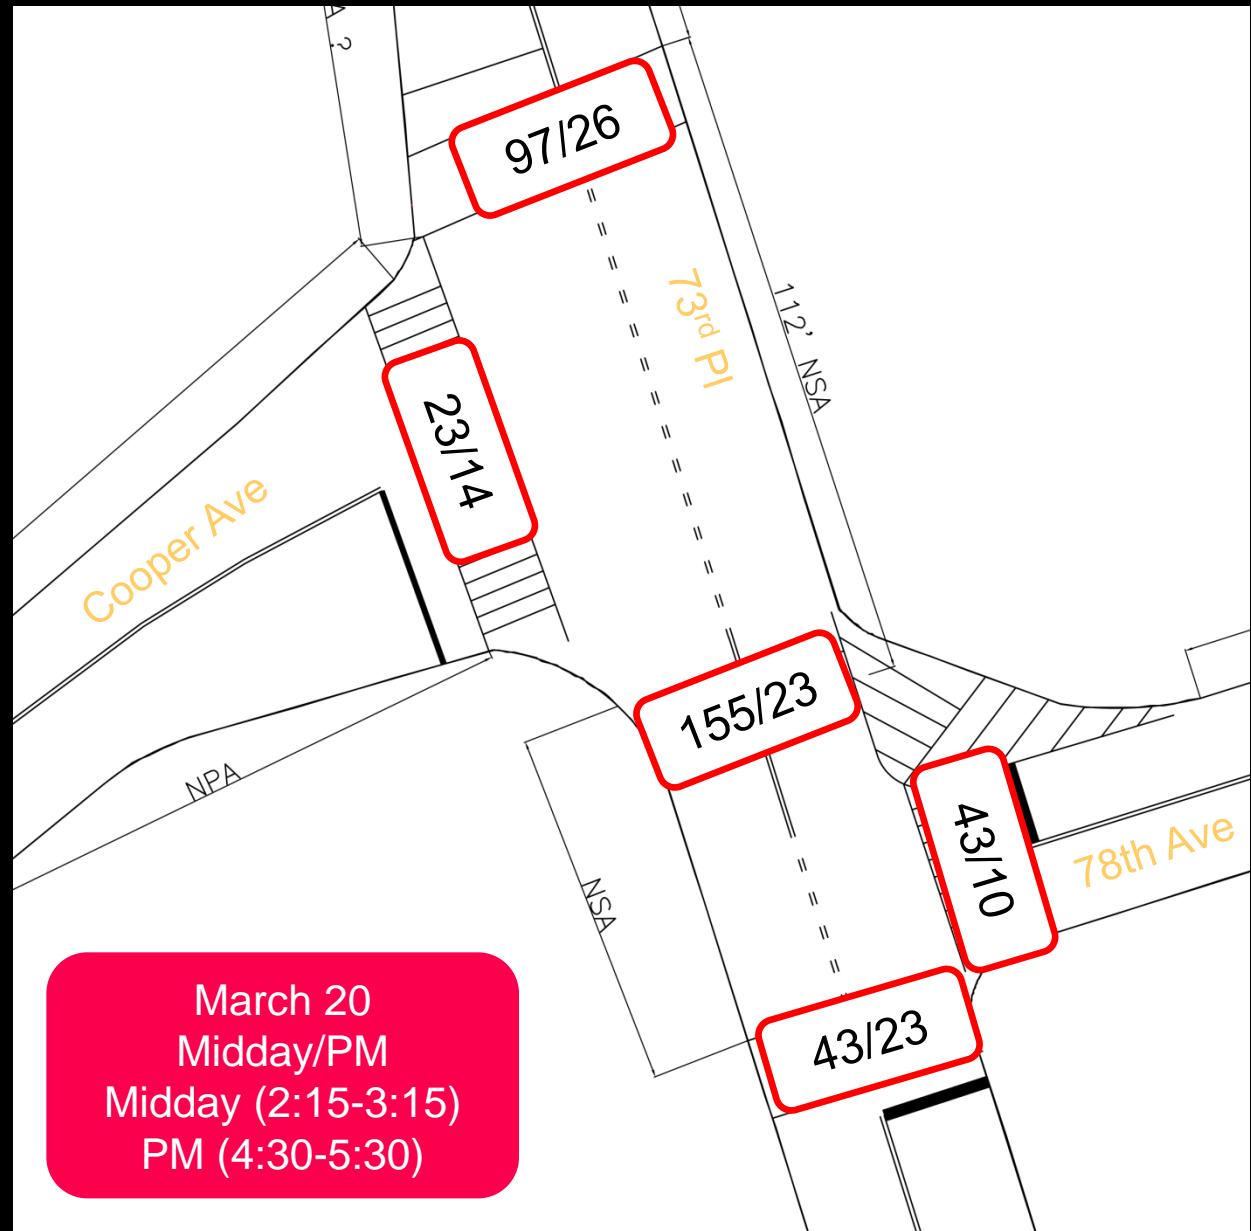
Pedestrian Counts

No crosswalk at point
of highest volume

Mostly children
crossing after I.S. 119
lets out

March 20
Midday/PM
Midday (2:15-3:15)
PM (4:30-5:30)

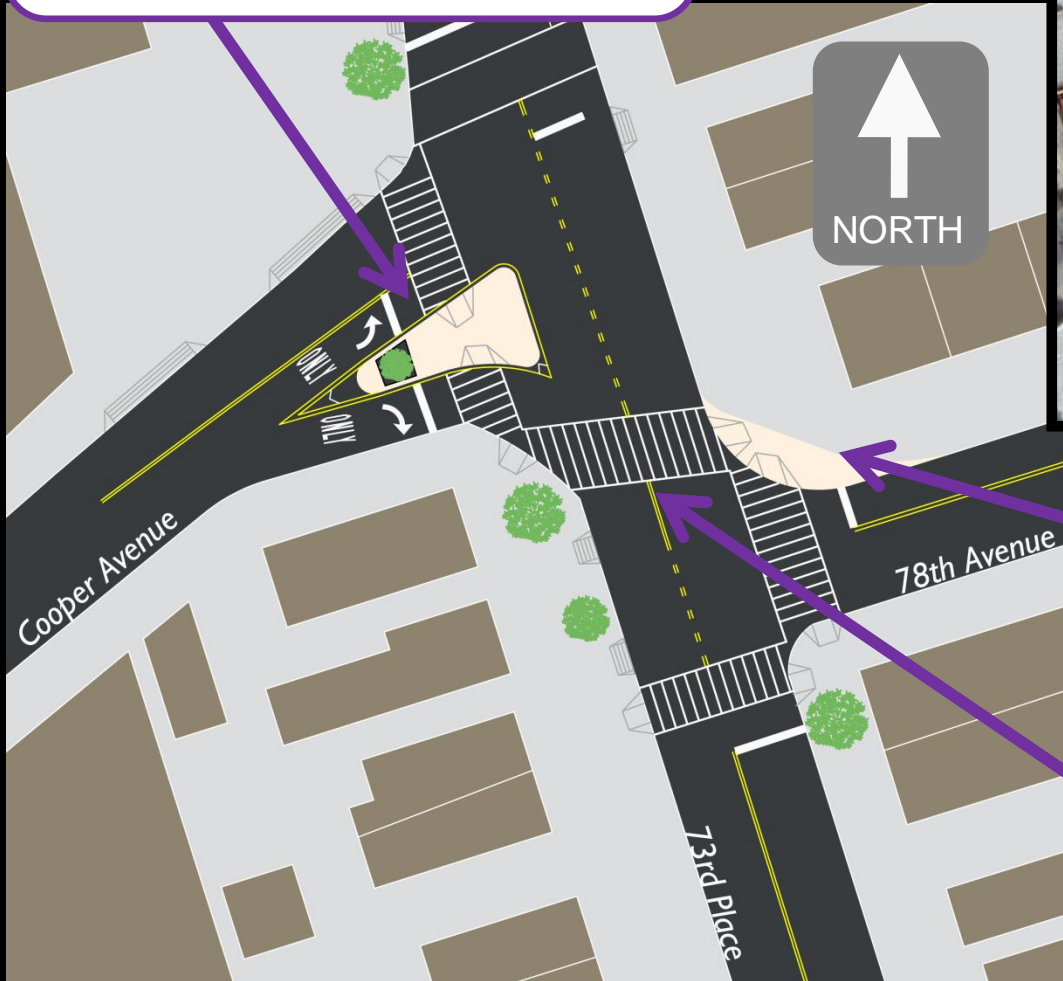
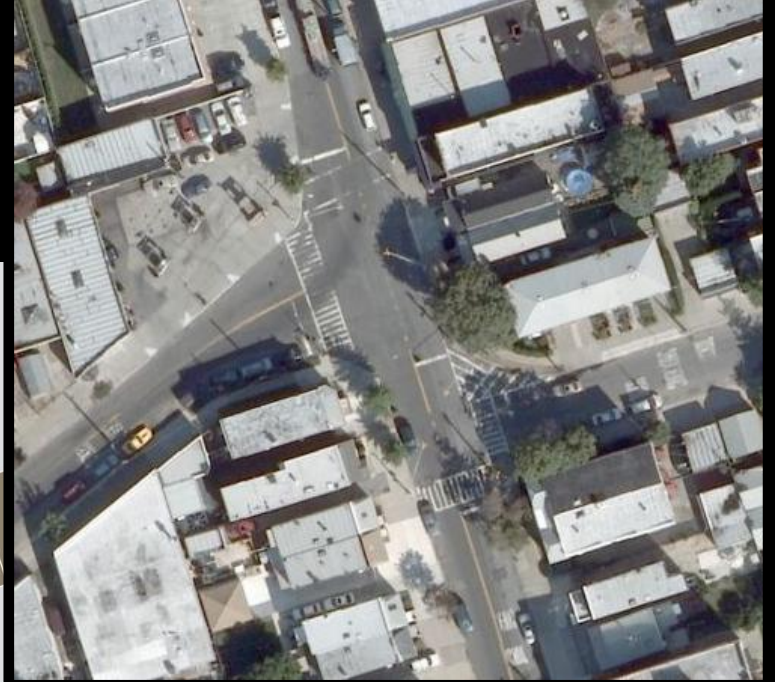
Cooper Ave Proposal

New island for pedestrian safety + blocks straight movement from 78th Avenue

Shorten crossing with expanded curb

New Crosswalk
