Daylighting and Street Safety: An Analysis

**VISION
ZERO**  
**Building a
Safer City**

NEW YORK CITY

January 2025

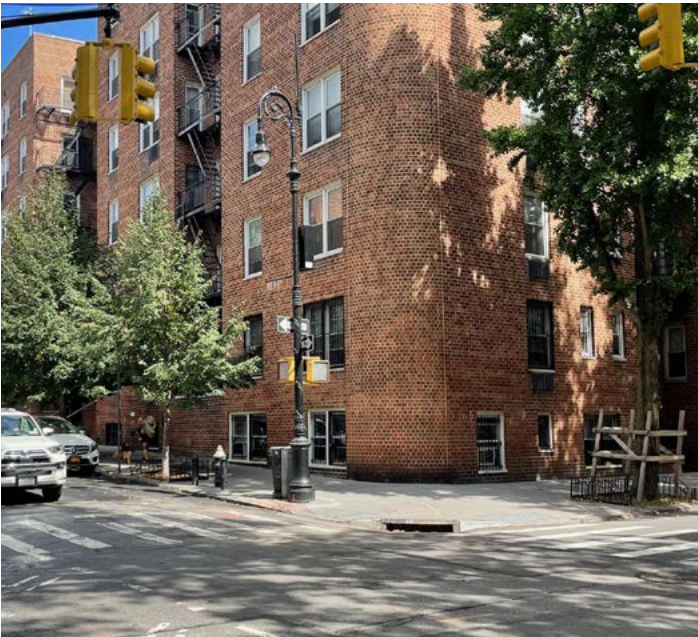
Hydrant zones

Restricted parking adjacent to crosswalks via fire hydrants and bus stops

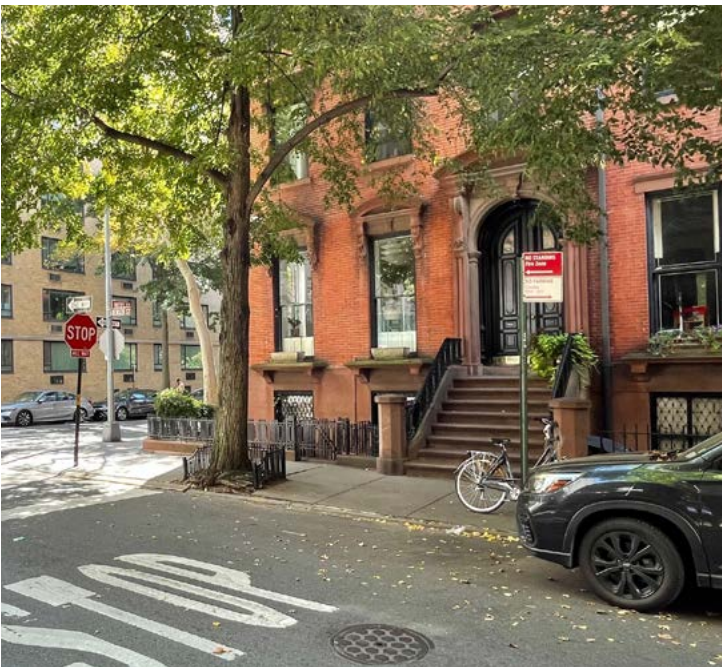
Sign-only daylighting

Restricting parking adjacent to crosswalks using signage only

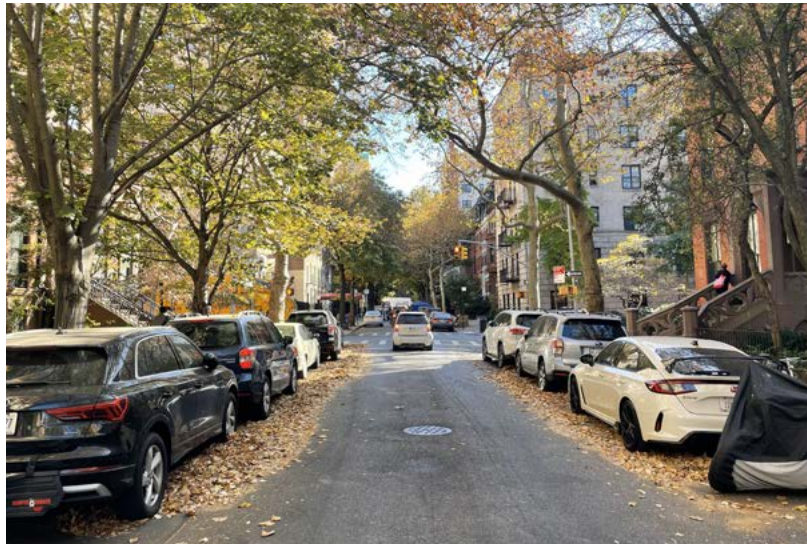
Example of a “tight” feeling street, where visibility and vehicle movement is restricted
