# CONSTRUCTION ADVISORY: IMPROPERLY CONSTRUCTED STONE BALUSTRADES

ISSUE: 2022-001

12.05.22

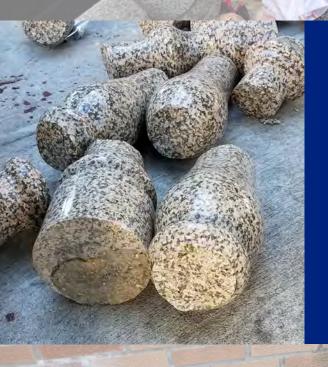
## STONE BALUSTRADES CAN BE VERY DANGEROUS IF NOT INSTALLED PROPERLY

Stone balustrades are heavy and can be very dangerous if not installed properly. It is important to have a structural engineer, architect, or licensed contractor inspect your balustrade or handrail. Arrange for repair immediately if any of the following is observed:

- loose or wobbly parts
- cracks in the stone, especially at the posts or balusters
- broken pieces or visible displacement
- if you suspect that your balusters or posts were installed without proper anchorage/ties.

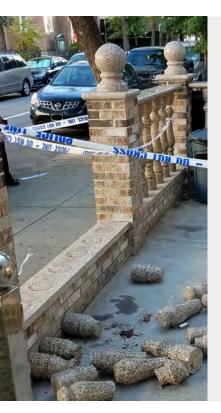
A stone balustrade is a stone railing or fence system that is comprised of individual stone posts that are topped with a stone rail. Depending on the style, there may also be other components such as a bottom rail.

- It was found that the collapsed stone balustrades were not constructed in accordance with NYC Construction Codes, which require anchorage/ties (such as threaded rods) at the stone baluster connections.
- there was only glue/adhesive used. This improper connection was the main contributing factor in the collapses.
- In each photo, only glue was used at the stone baluster connections. This type of improper connection and lack of anchorage was the main contributing factor in the collapses.
- Similar stone balustrades are very common in the five boroughs.
