PARKS WITHOUT BORDERS  
SCHEMATIC DESIGN PROPOSAL

# Jackie Robinson Park

Located between 145th & 155th Streets  
between Edgecombe & Bradhurst Avenues  
in the Borough of Manhattan

NYC LANDMARKS PRESERVATION COMMISSION FULL HEARING  
June 6, 2017

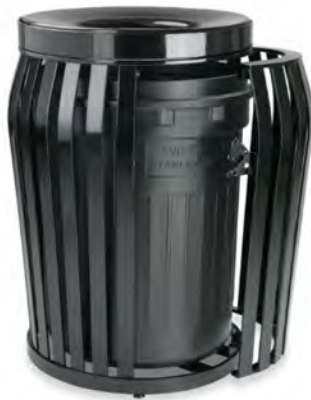
WIRE BASKET AND METAL  
BARREL TRASH RECEPTACLES  
TO BE REPLACED WITH "PUBLIC  
SPACE" MODEL

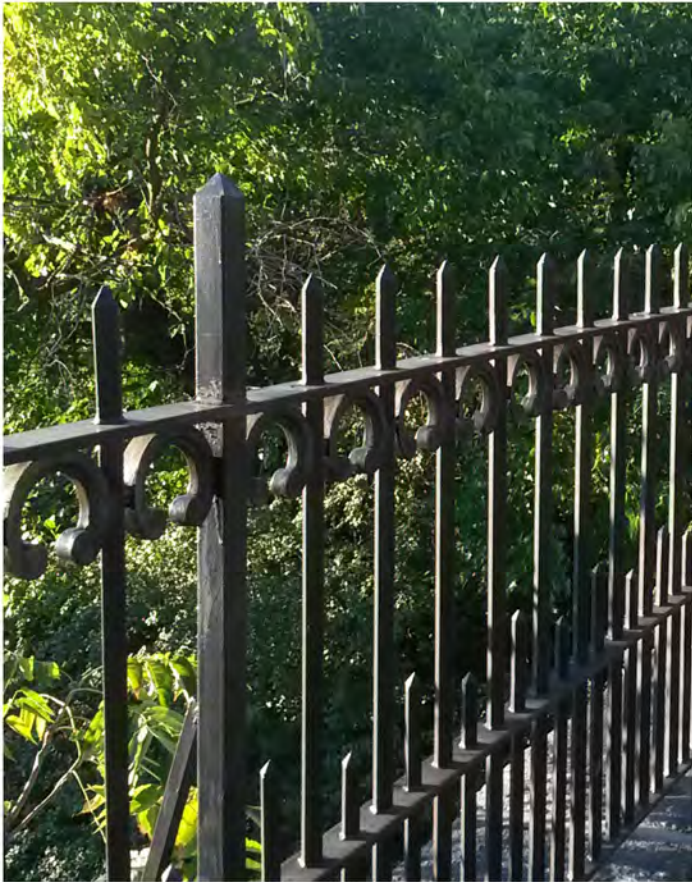
4'-0" HT DECORATIVE STEEL FENCE WITH CAST  
HORSESHOES, HISTORICALLY EXTENDED  
THE FULL LENGTH OF EDGECOMBE AVENUE.  
CURRENTLY FOUND ALONG EDGECOMBE  
AVENUE ONLY NORTH OF 150TH STREET.

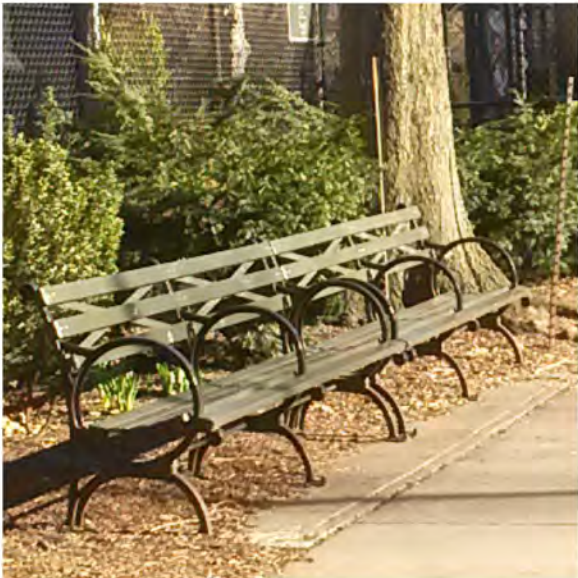
1939 WORLD'S FAIR BENCH  
CURRENTLY FOUND THROUGHOUT  
JACKIE ROBINSON PARK

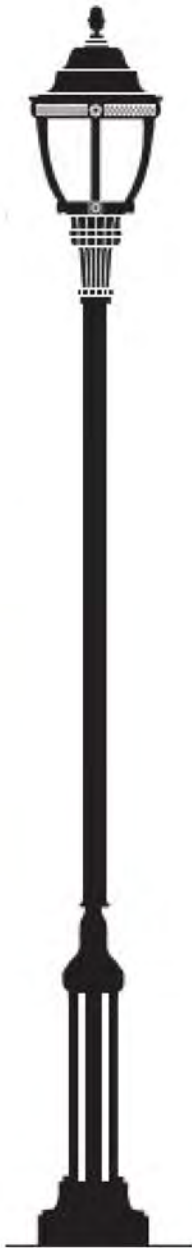
NYC DOT STANDARD TYPE "B" LAMP  
NEW LIGHTING TO MATCH EXISTING

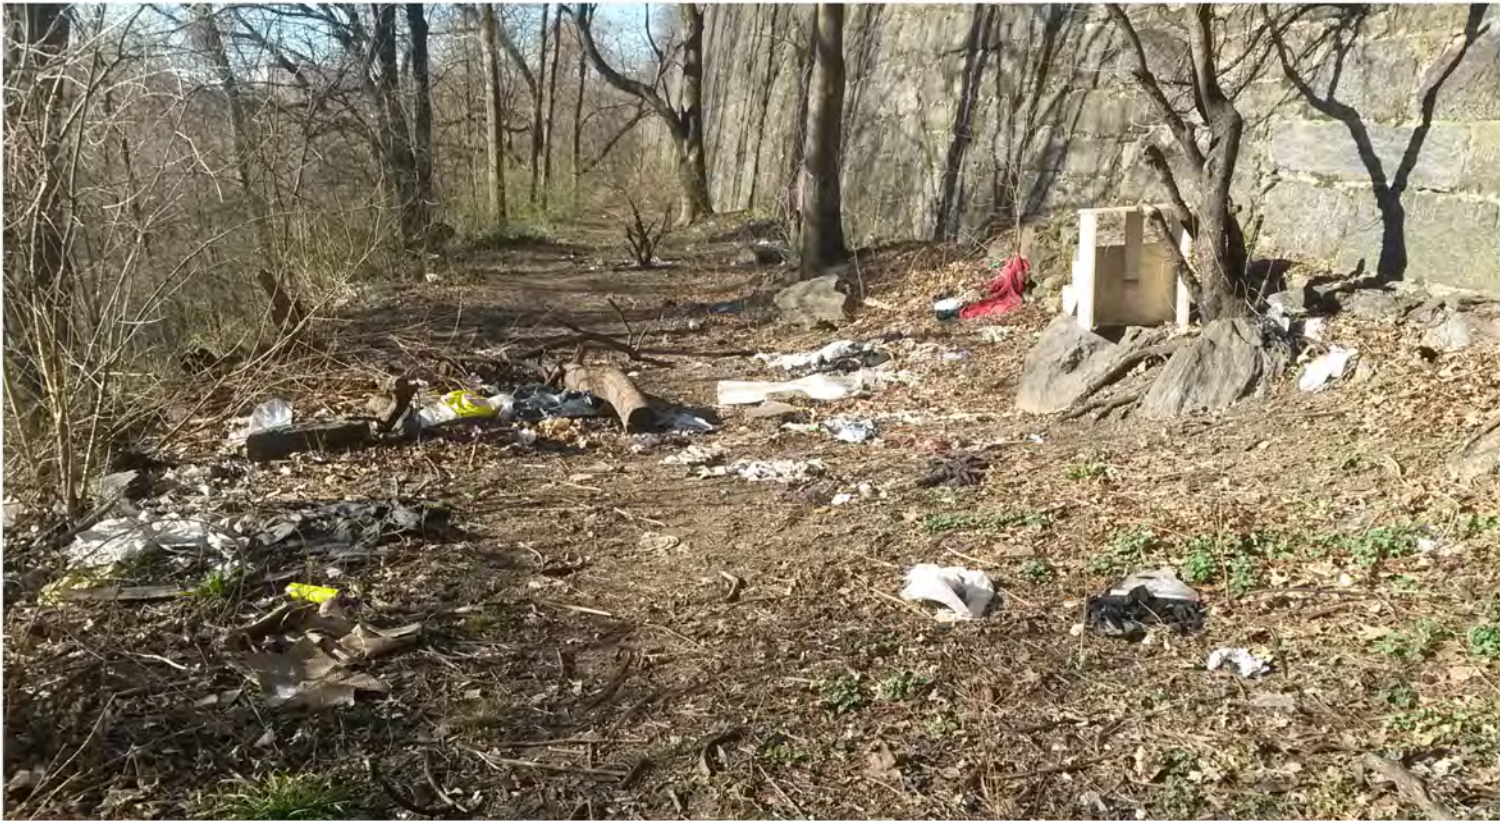
EXISTING CONDITIONS - PATH BELOW EDGECOMBE PROMENADE TO 152ND STREET AND BRADHURST AVENUE (CLOSED)

- Reconstruct pathway to enable safe public access
- Cut back overgrown vegetation to open views and sight lines
- Provide lighting and seating

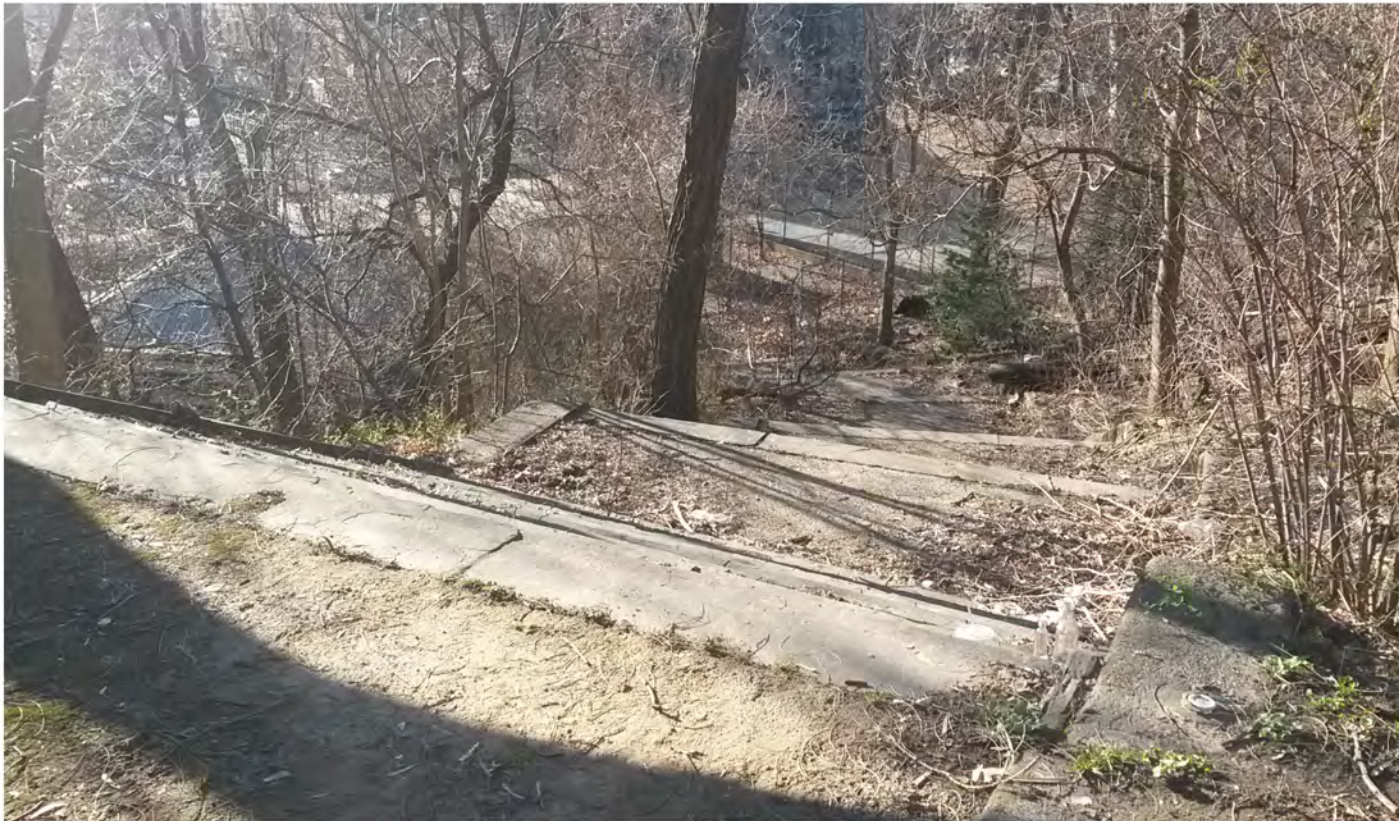
EXISTING CONDITIONS - BLUESTONE STEPS TO 152ND STREET AND BRADHURST AVENUE (CLOSED)

- Remove and reset step risers to enable safe public access
- Reconstruct cheek wall where necessary
- Provide lighting and hand rails

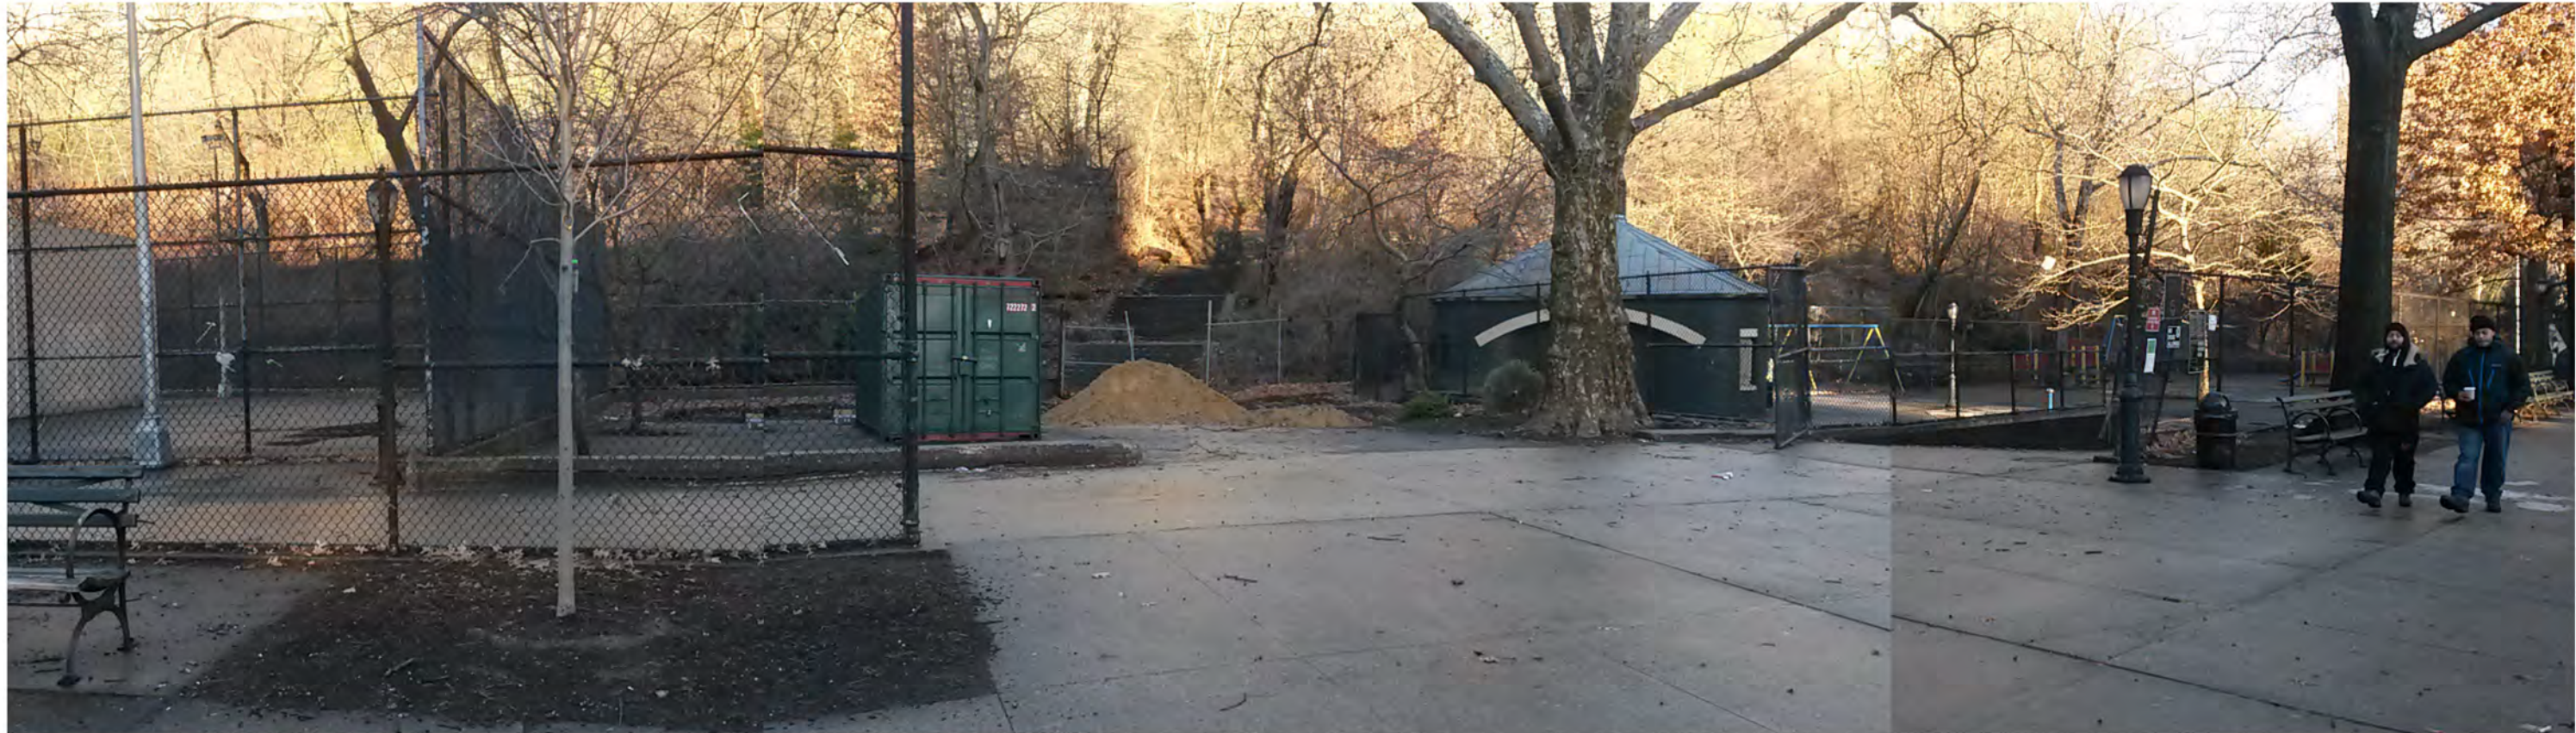
EXISTING ENTRANCE AT 152ND STREET AND BRADHURST AVENUE (PARTIALLY CLOSED)

- Create welcoming, accessible, well-lit gateway and seating area
- Improve access to sports fields and playground
- Remove or replace fencing

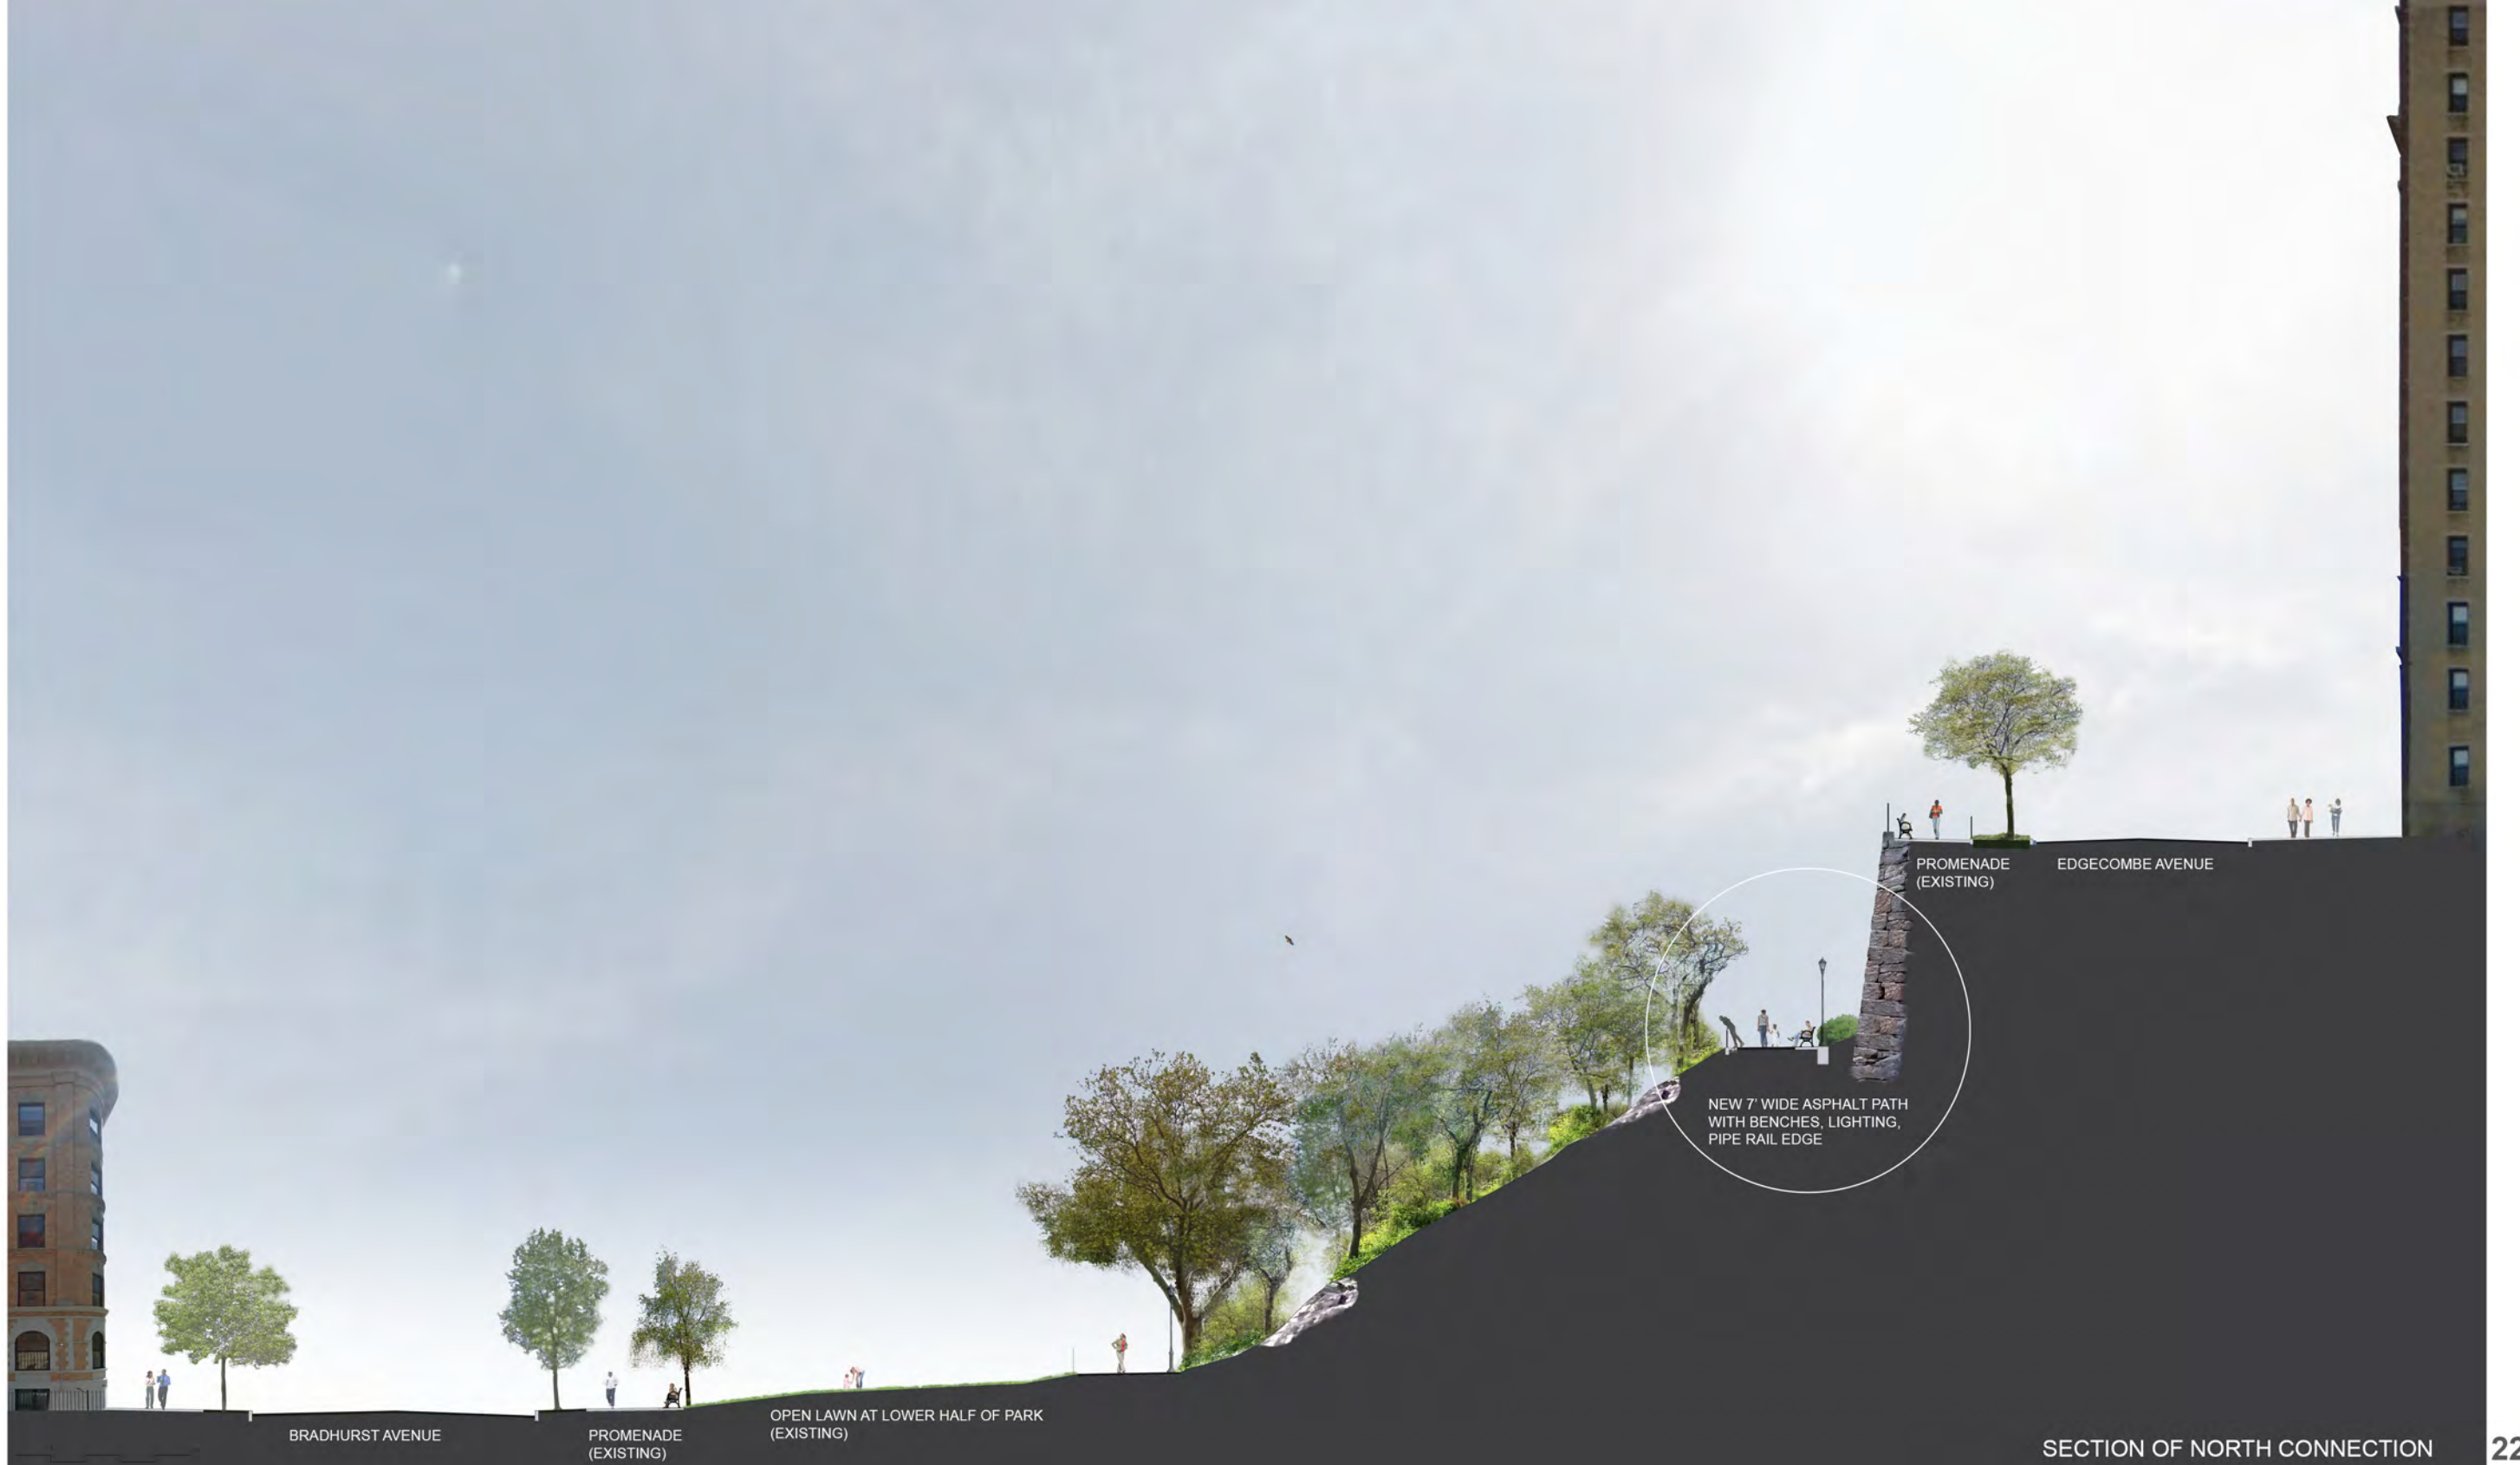
REOPEN NORTH CONNECTION  
PROPOSED PATH LIGHTING

NEW LIGHTING  
SPACED MAX 75'

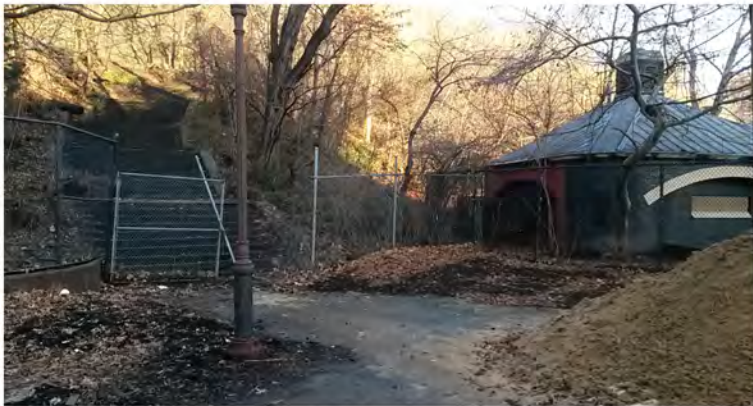
**BRADHURST PLAZA BRADHURST AVENUE AT 152ND STREET**  
**EXISTING CONDITIONS**

- UNDESIGNED ENTRY SPACE**
- NO SEATING OPPORTUNITIES
  - HIGH, DERELICT CHAIN LINK FENCING
  - UNCLEAR, UNWELCOMING ACCESS TO SPORTS FACILITIES AND PLAYGROUND
  - STAIRWAY ACCESS CLOSED
  - UNEVEN PAVEMENT COVERED WITH DEBRIS

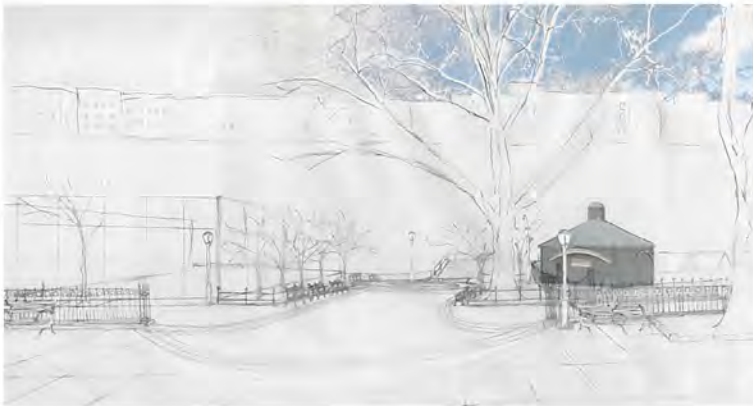
**BRADHURST PLAZA BRADHURST AVENUE AT 152ND STREET**  
**PROPOSED DESIGN**

**CREATE WELCOMING, ACCESSIBLE ENTRY PLAZA**

- CREATE NEW SEATING AREA
- REMOVE OR REPLACE CHAIN LINK FENCING
- IMPROVE ACCESS TO SPORTS AND PLAYGROUND

**REPAVE PLAZA**

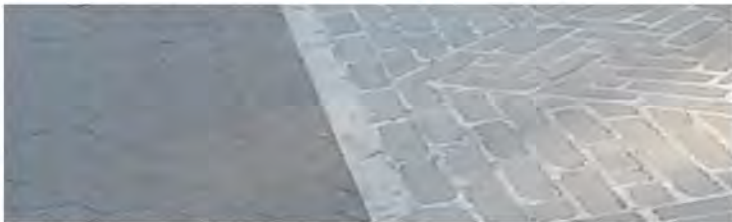
MATERIALS: ADA GRANITE BLOCK WITH HEX PAVERS

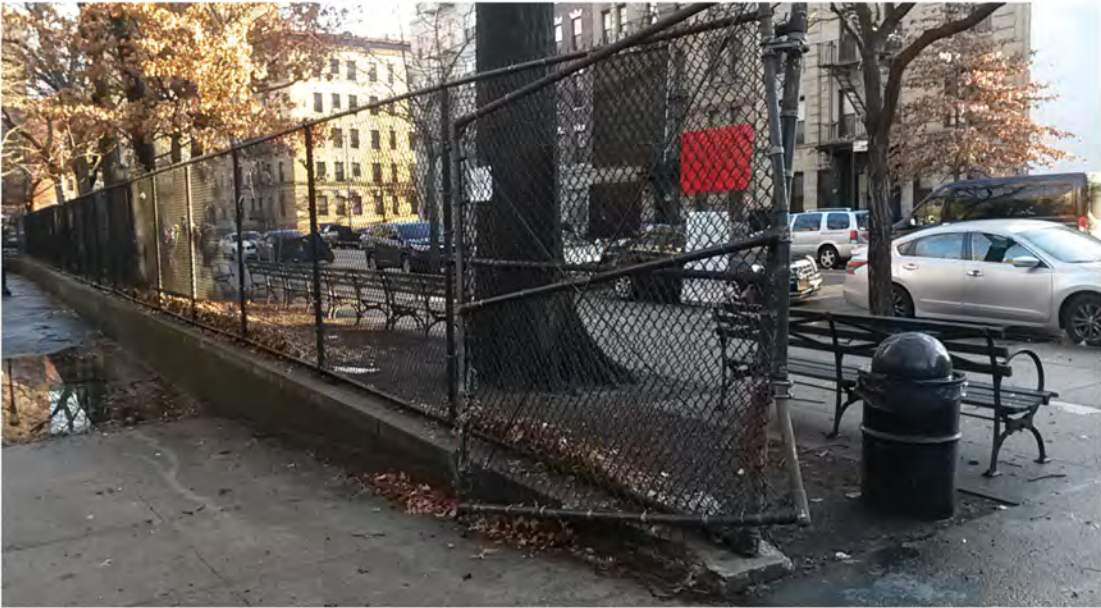
8 FT CHAIN LINK FENCE AROUND PLAYGROUND

BROKEN 8FT CHAIN LINK GATE TO PLAYGROUND

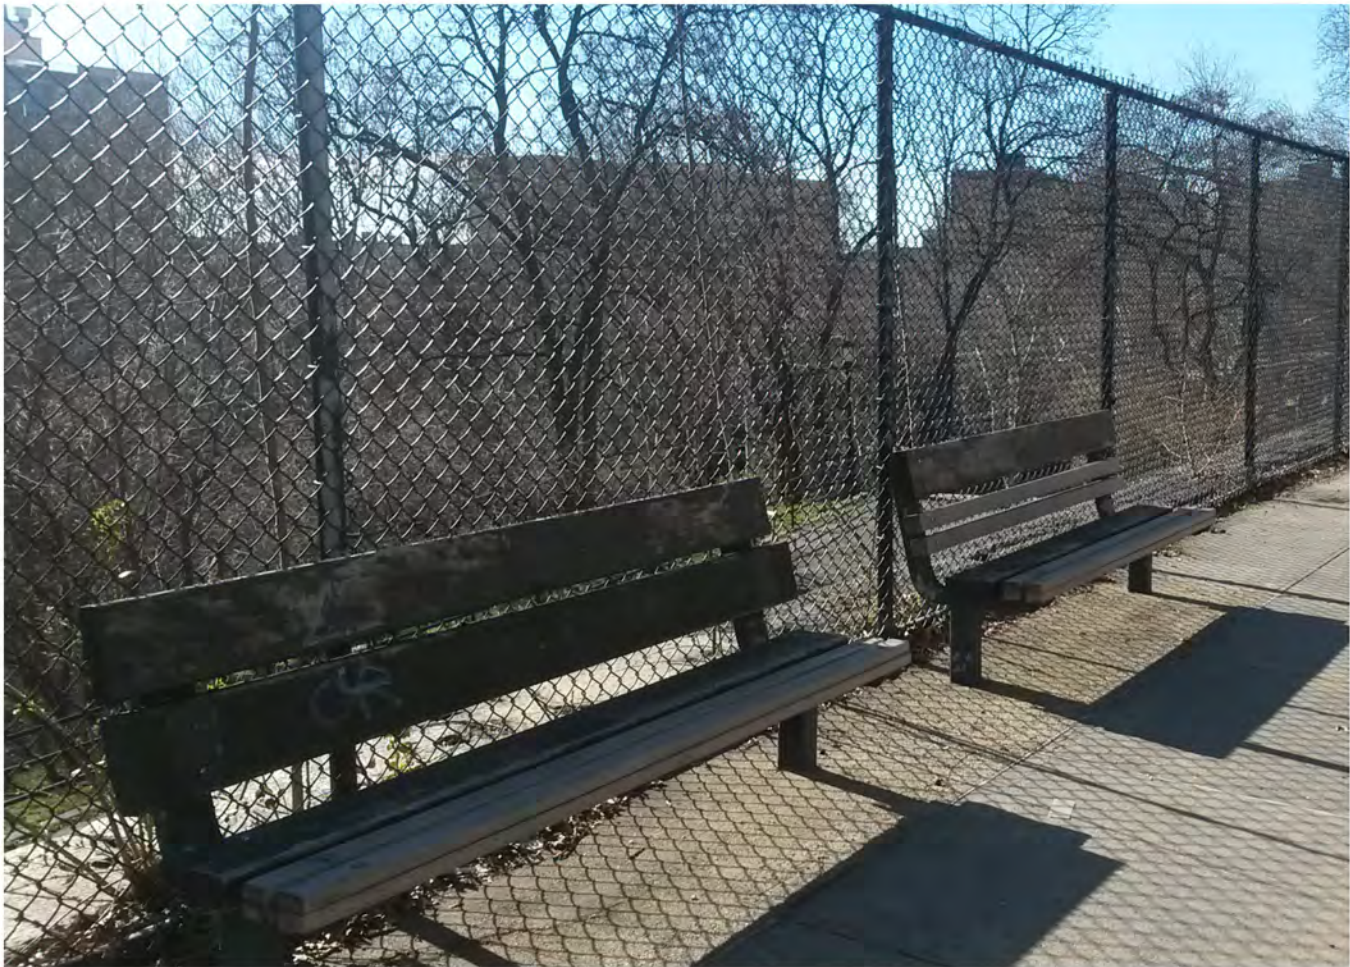
EXISTING CONDITIONS - 8FT CHAIN LINK FENCE ALONG EDGECOMBE AVENUE PROMENADE (SOUTH)

- Replace chain link fence with low decorative steel to match historic fence and northern Edgcombe Avenue, modified for improved safety and increased transparency
- Replace old benches with 1939 World’s Fair style to match northern Edgcombe (ADD ALTERNATE)

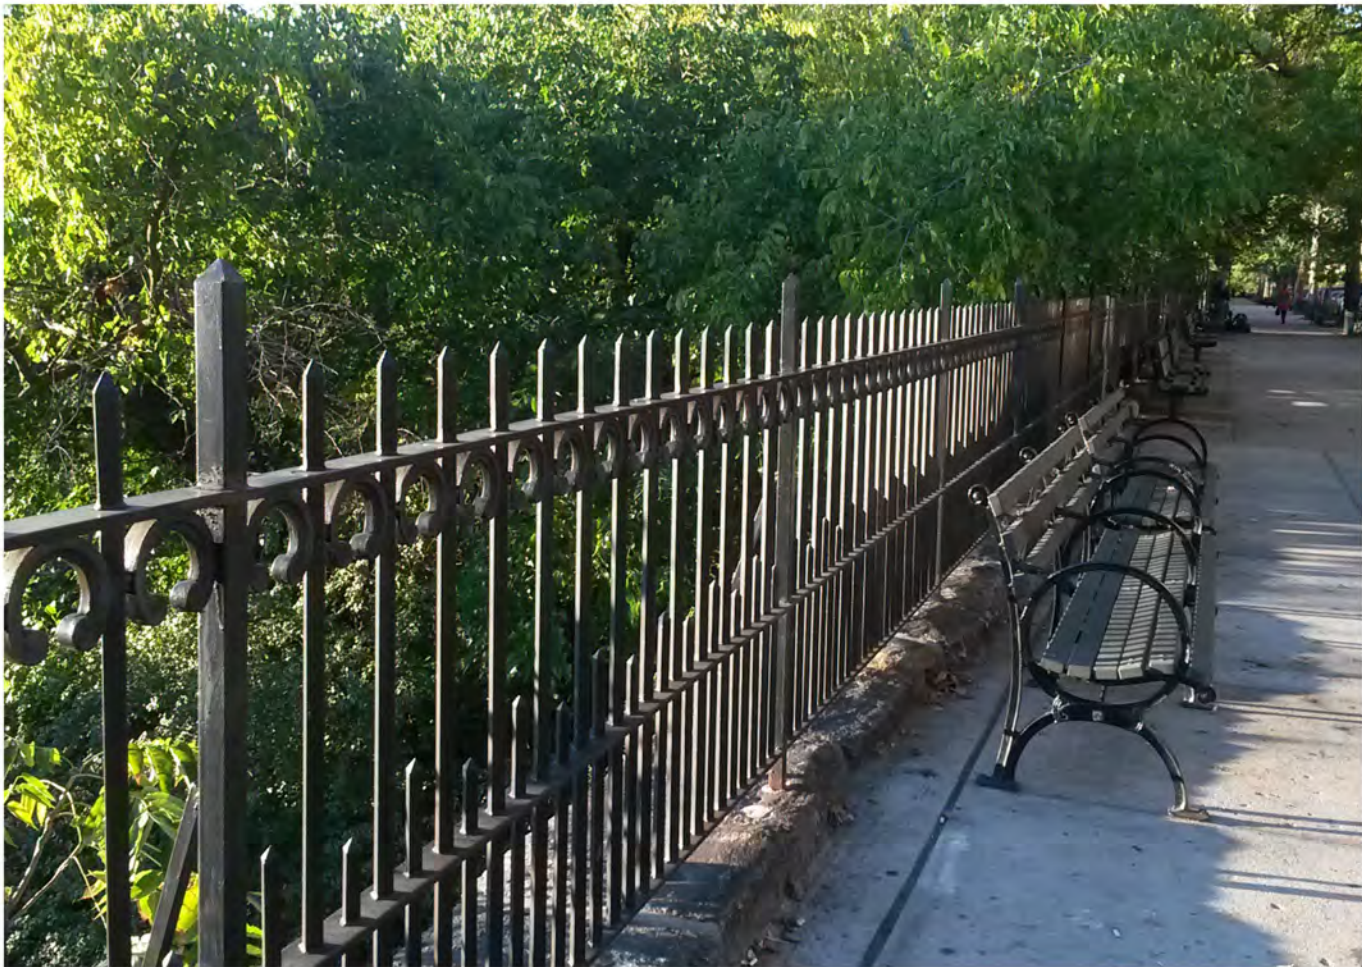
EXISTING CONDITIONS - DECORATIVE STEEL 'HORSESHOE' FENCE AND 1939 WORLD'S FAIR BENCHES

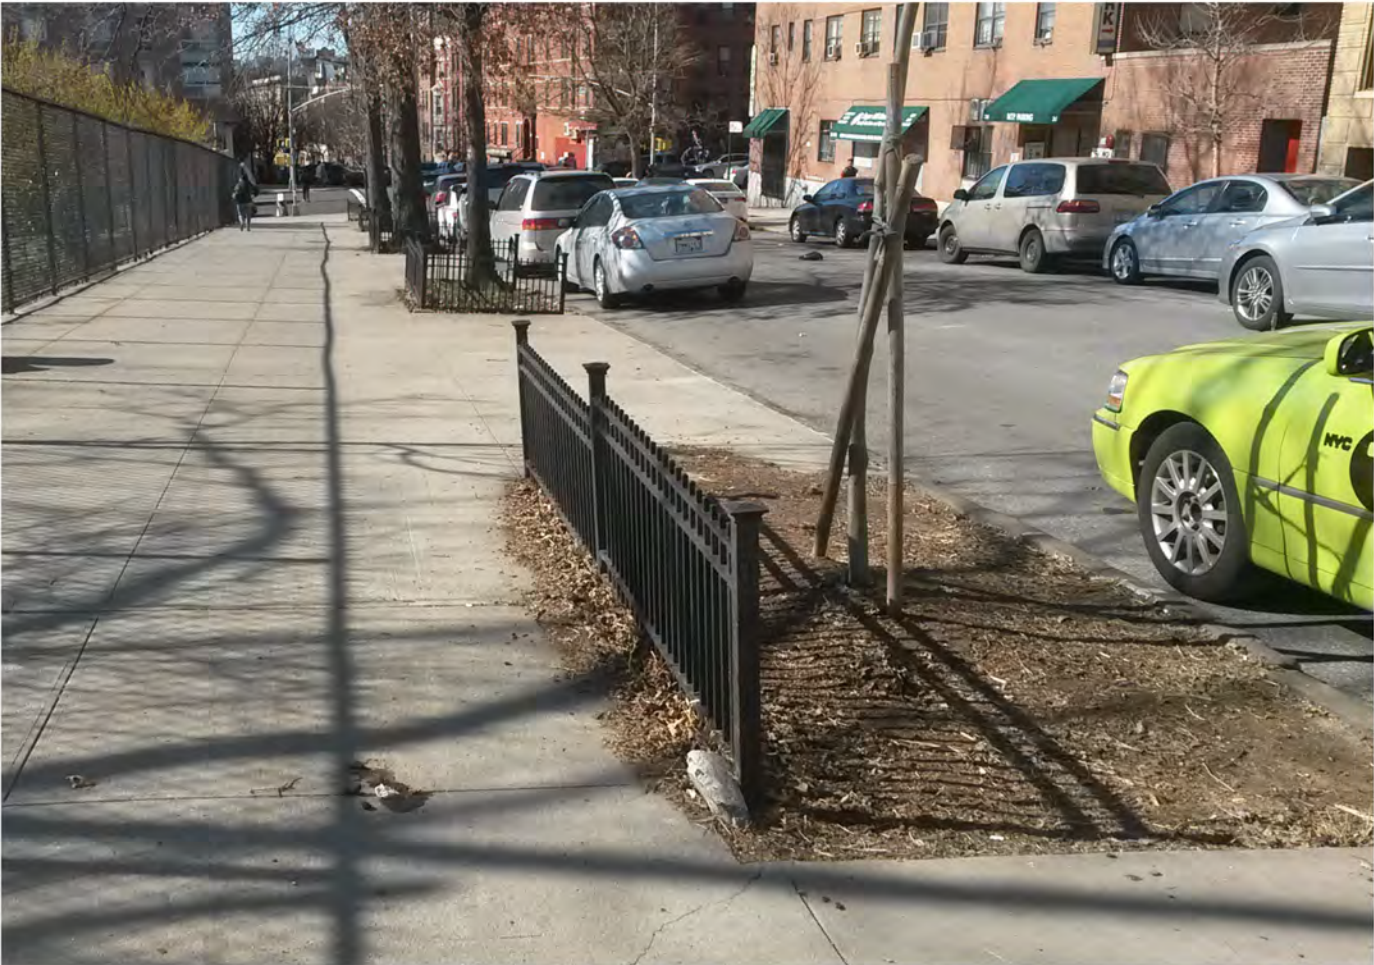
EXISTING CONDITIONS (SOUTH) - DERELICT OR MISSING TREE GUARDS

- Match tree guard and Belgian block border improvements made to northern Edgcombe Avenue (modified with 3-sided step-down tree guard design)

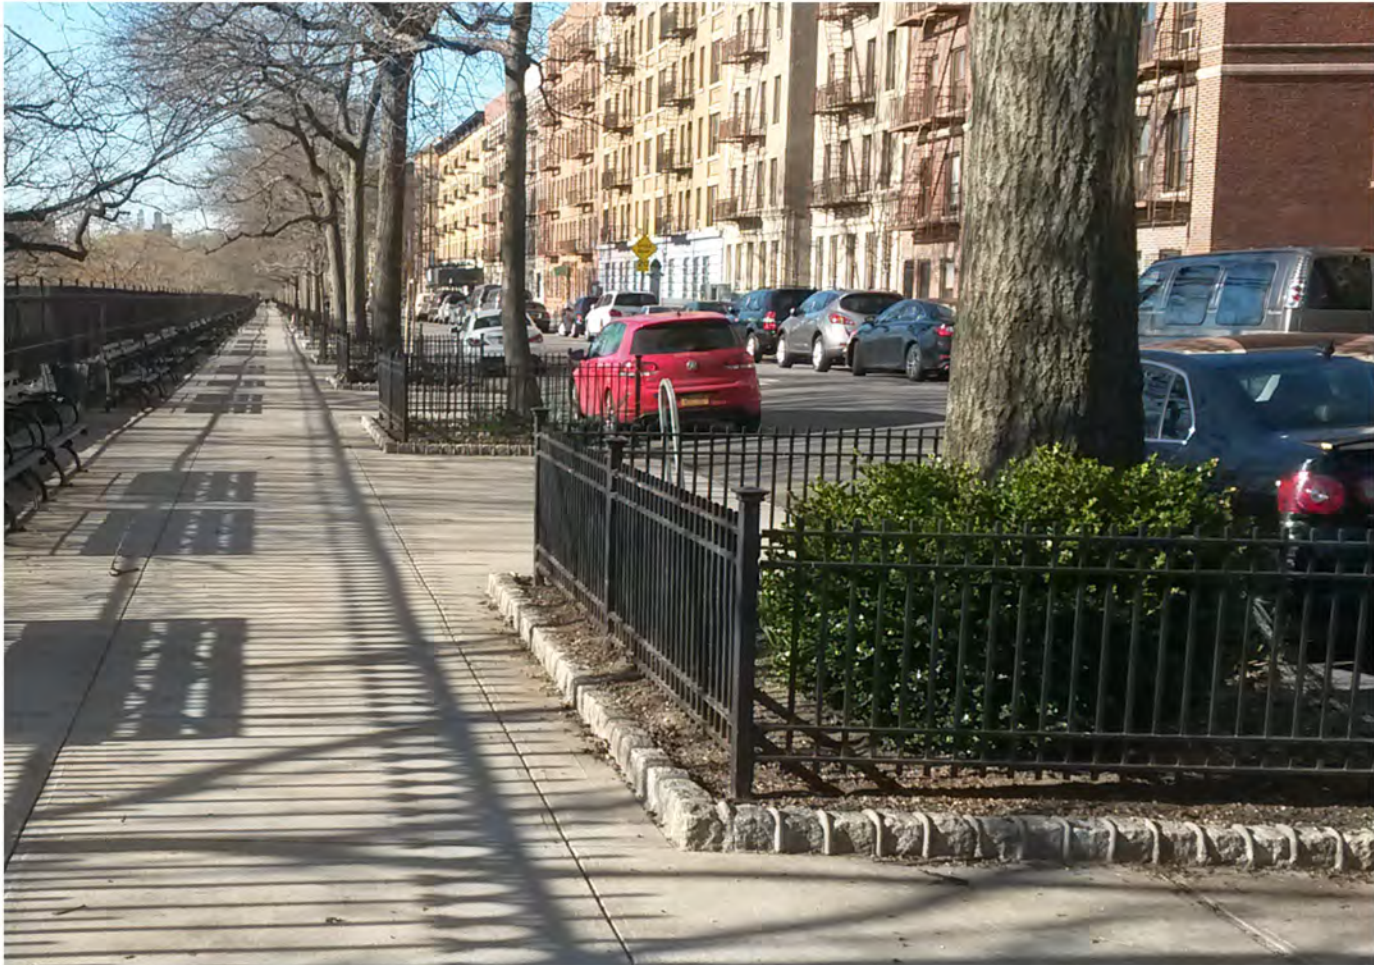
EXISTING CONDITIONS (NORTH) - GENEROUS TREE BEDS WITH STEEL GUARD AND BELGIAN BLOCK EDGE

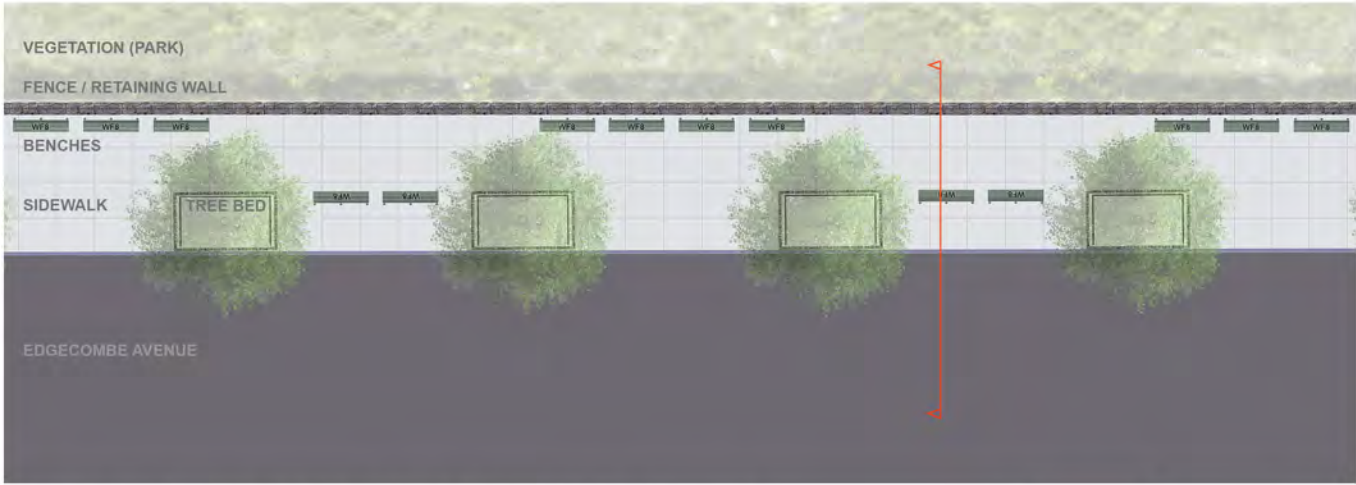
EDGECOMBE AVENUE BORDER - PROPOSED TYPICAL PLAN

- Replace 8ft chain link fence with 4ft decorative steel to match historic fence and northern Edgcombe Avenue, modified for improved safety and increased transparency
- Repair retaining wall and sidewalk where needed

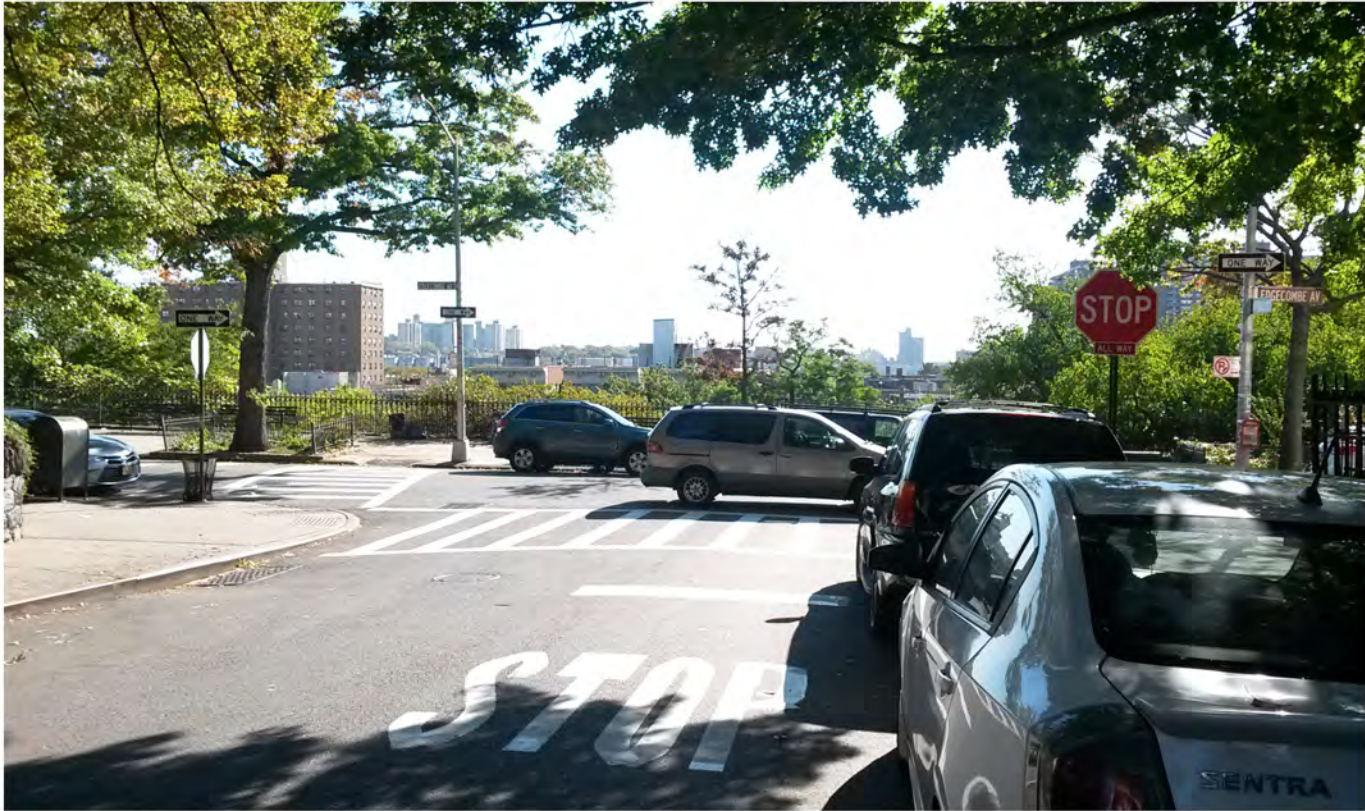
EXISTING CONDITIONS - 150th STREET AND EDGECOMBE AVENUE

- Add way-finding signage at 150th Street and at park entrance
- Add piers at park entrance to improve visibility

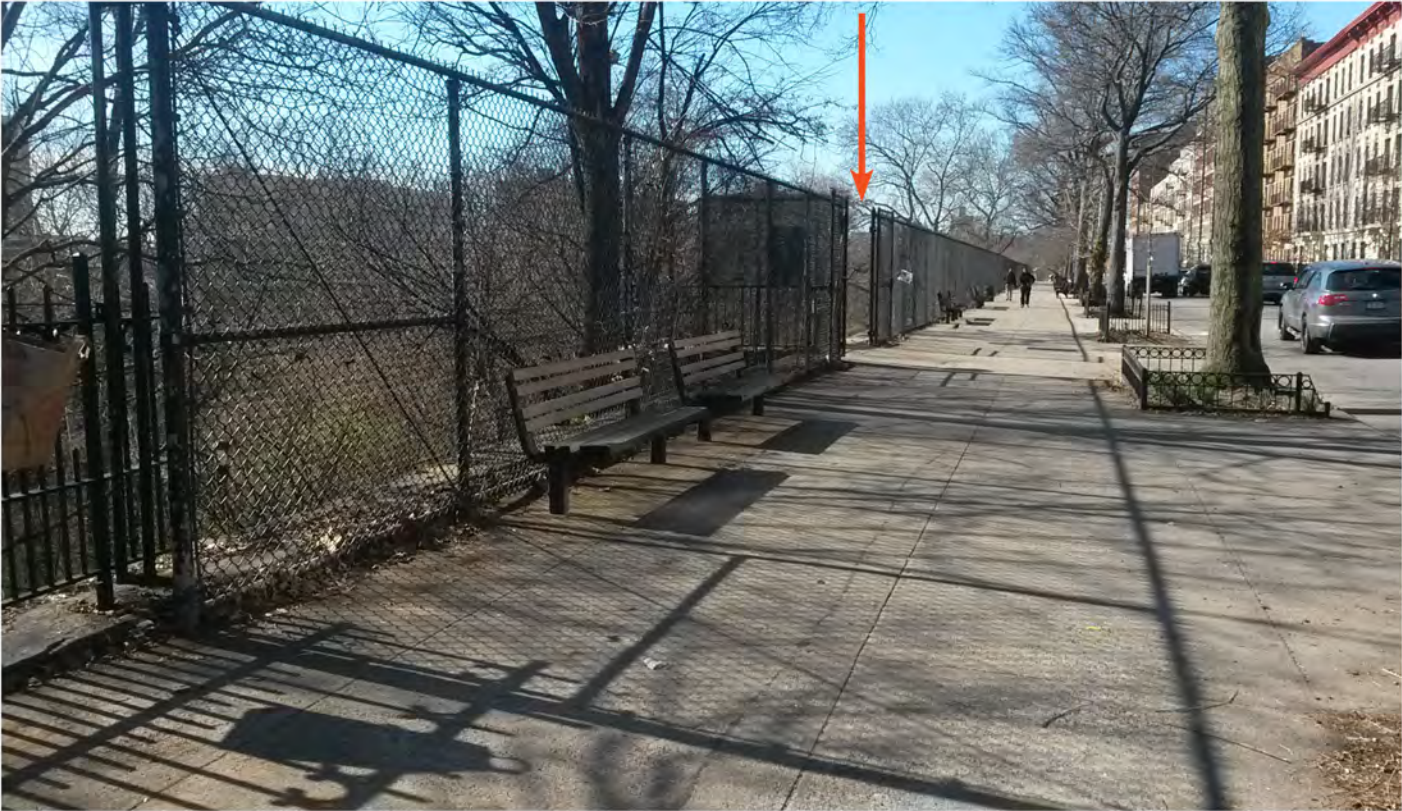
EXISTING CONDITIONS - VIEW TOWARDS ENTRANCE

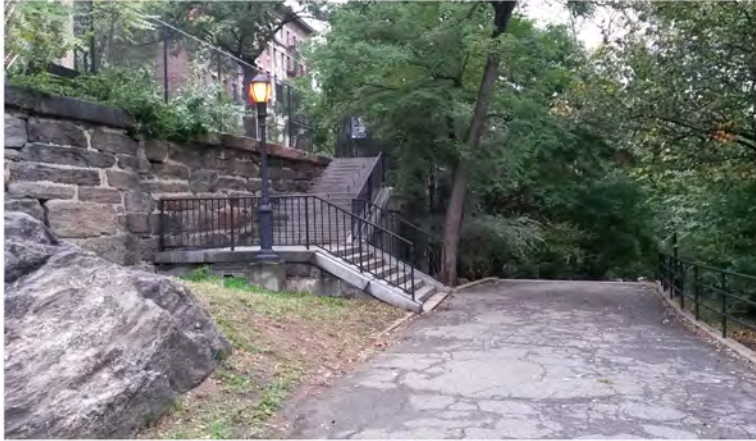
EXISTING ENTRANCE FROM BELOW

- Create welcoming gateway
- Replace 8ft chain link with 4ft decorative steel
- Increase entrance visibility with stone piers (stone material to complement existing granite coping and retaining wall)
- Add way-finding signage
- Repave sidewalk

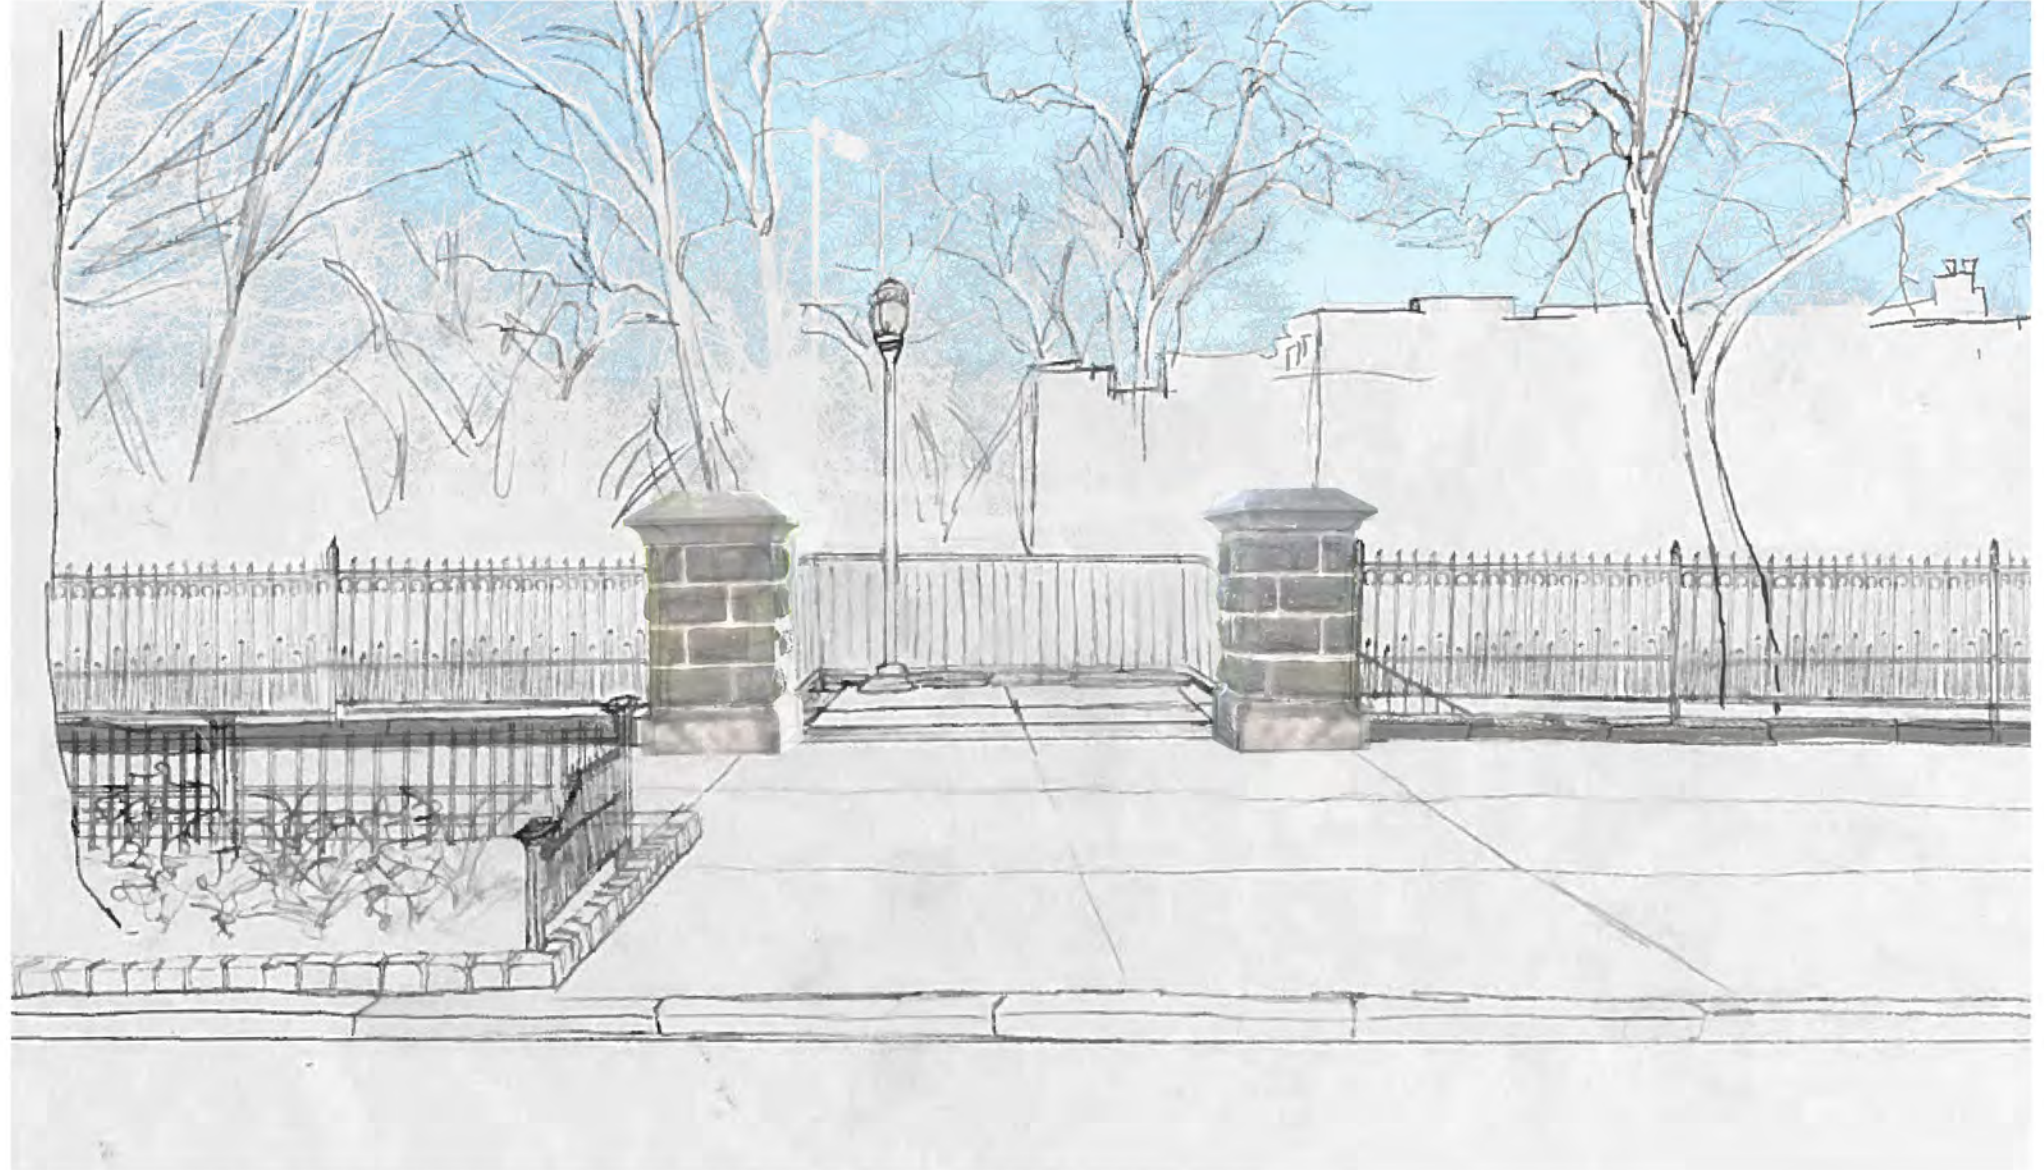
PROPOSED ENTRANCE SKETCH - EDGECOMBE AVENUE ENTRANCE NEAR 150TH STREET
