PARKS WITHOUT BORDERS  
SCHEMATIC DESIGN PROPOSAL

# Jackie Robinson Park

Located between 145th & 155th Streets  
between Edgecombe & Bradhurst Avenues  
in the Borough of Manhattan

NYC LANDMARKS PRESERVATION COMMISSION FULL HEARING  
June 6, 2017

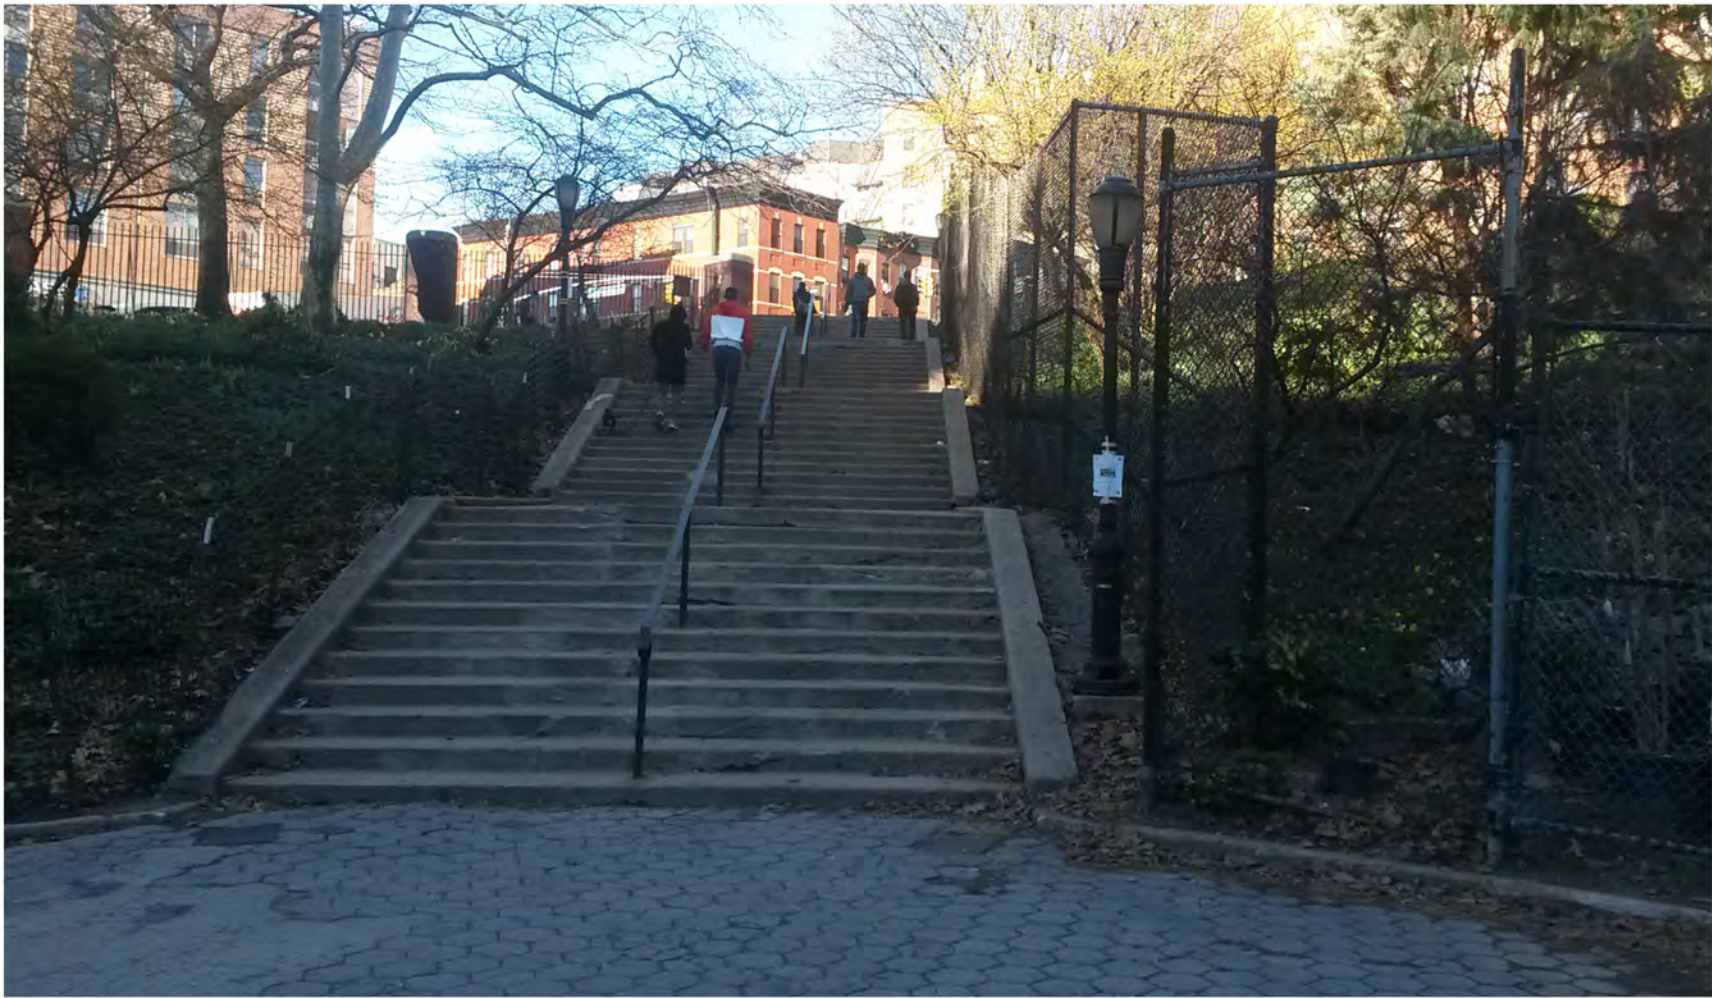
EXISTING CONDITIONS

- Reconstruct stairway and railings
- Remove chain link and temporary range fencing

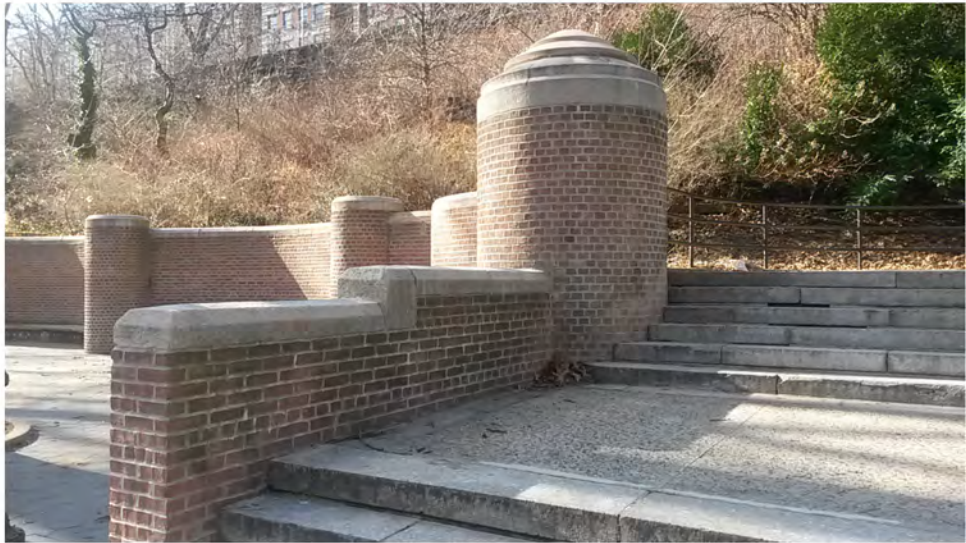
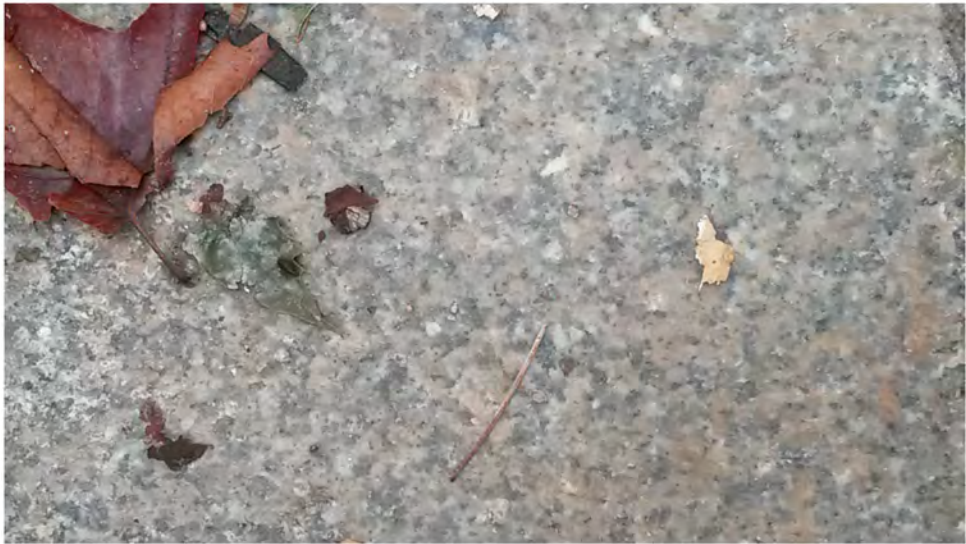
EXAMPLE: GRANITE STEPS AT BANDSHELL JACKIE ROBINSON PARK

PROPOSED MATERIALS: GRANITE TO MATCH NEARBY STEPS

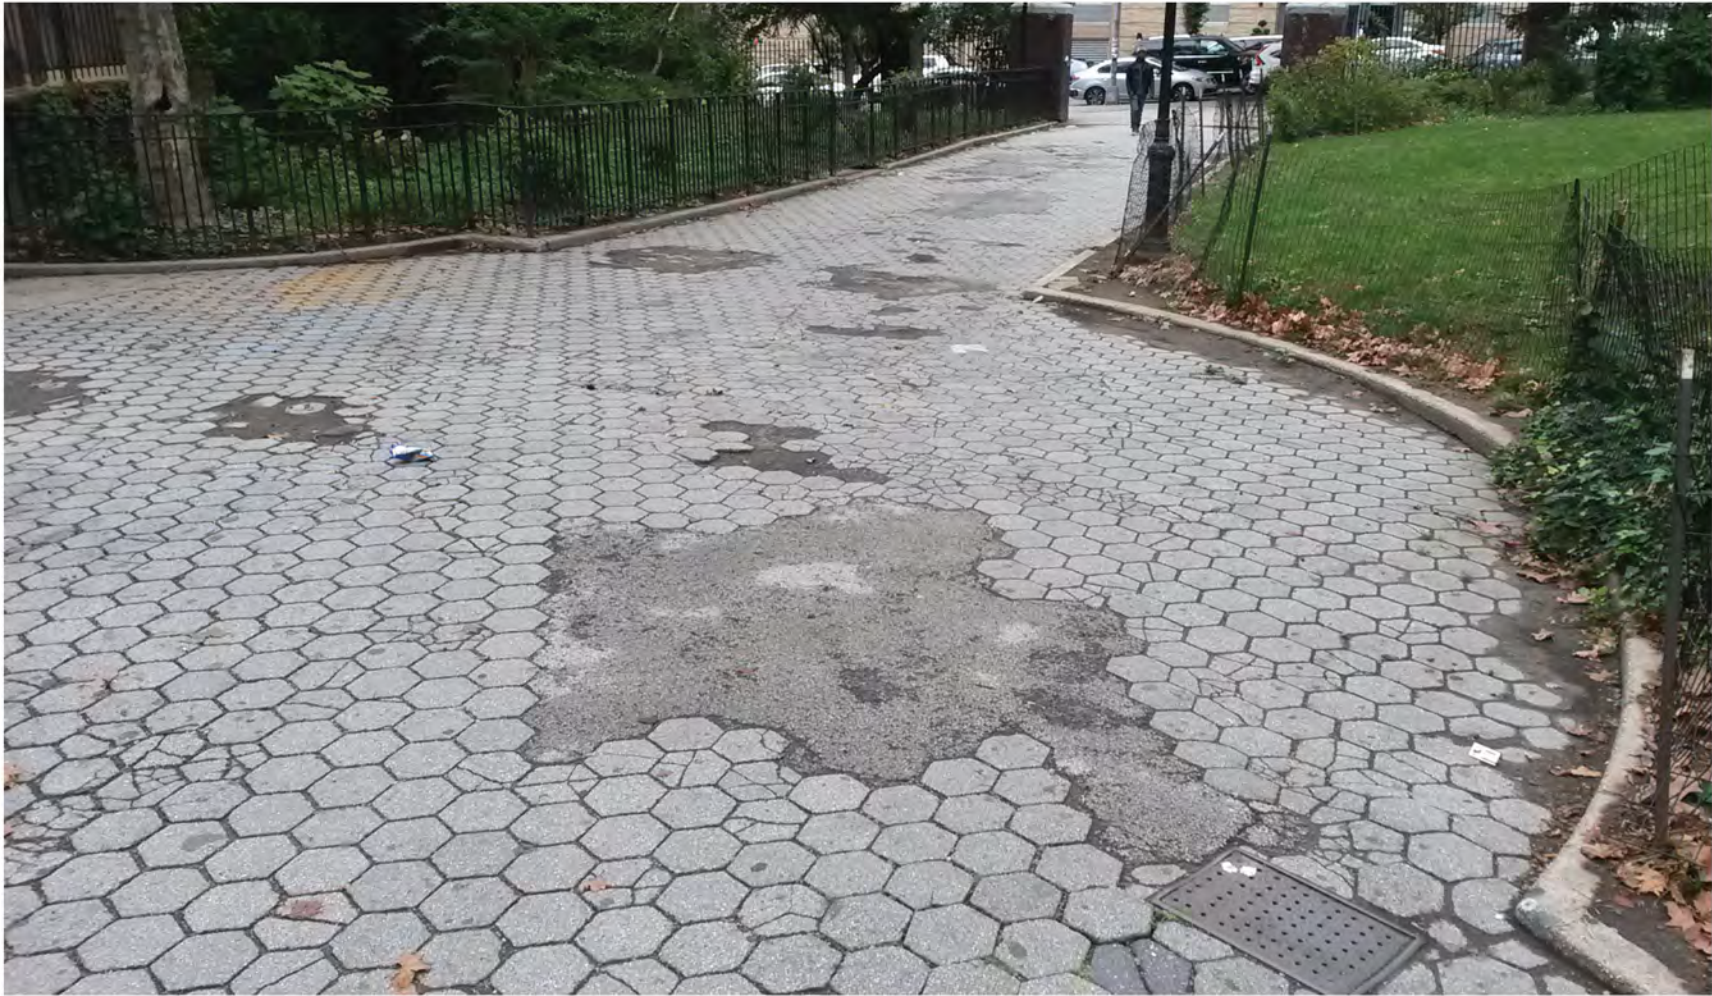
EXISTING CONDITIONS

- Repave path, improving ADA access to pool and rec center
- Remove / replace fencing
- Add seating

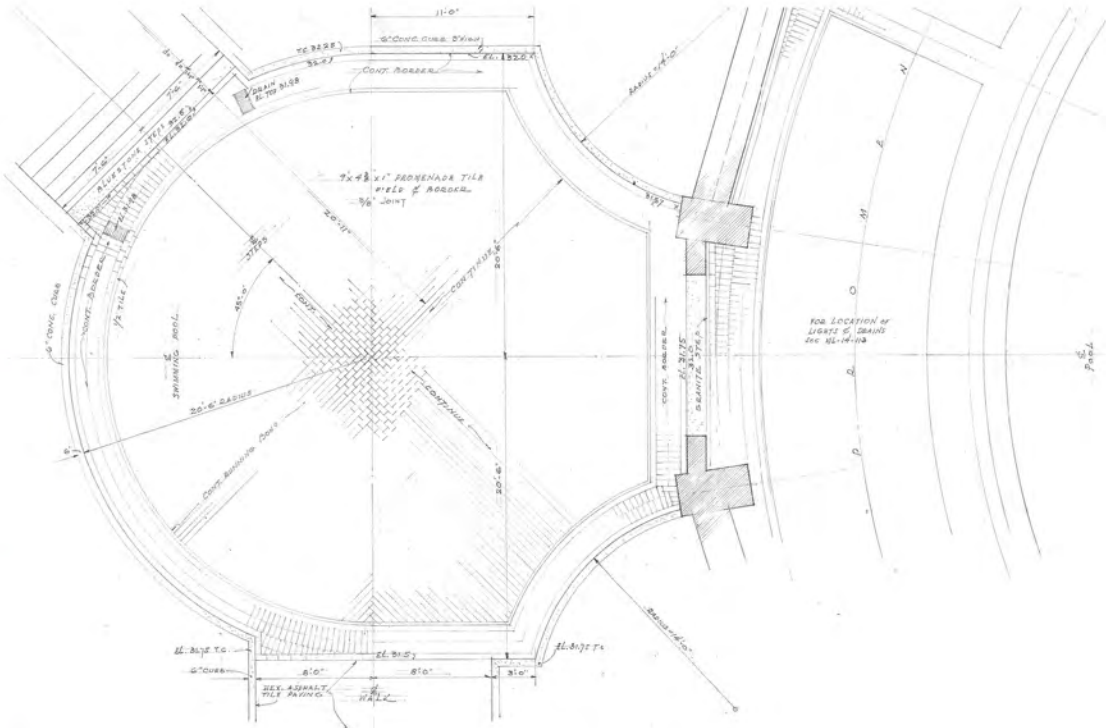
PROPOSED PAVING PATTERN TO MATCH ORIGINAL DESIGN

MATERIALS: ADA GRANITE BLOCK WITH HEX PAVERS

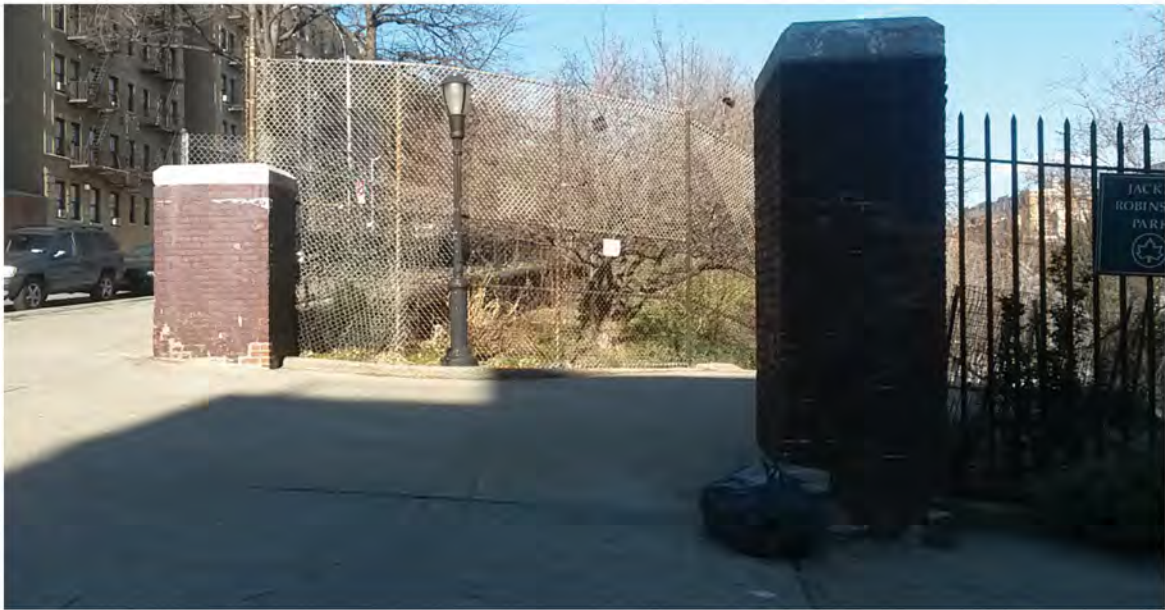
**SOUTH-WEST ENTRANCE 145TH STREET AND EDGEcombe AVE  
EXISTING CONDITIONS**

EXISTING ENTRANCE

- SOUTH-WEST ENTRANCE**
- LARGE BRICK PIERS BLOCK VIEWS INTO PARK
  - HIGH CHAIN LINK FENCE UNSIGHTLY
  - HIGH SPIKED FENCE UNWELCOMING
  - ENTRANCE IS NARROW AND AWKWARDLY SHAPED

**STAIRWAY IN DISREPAIR**

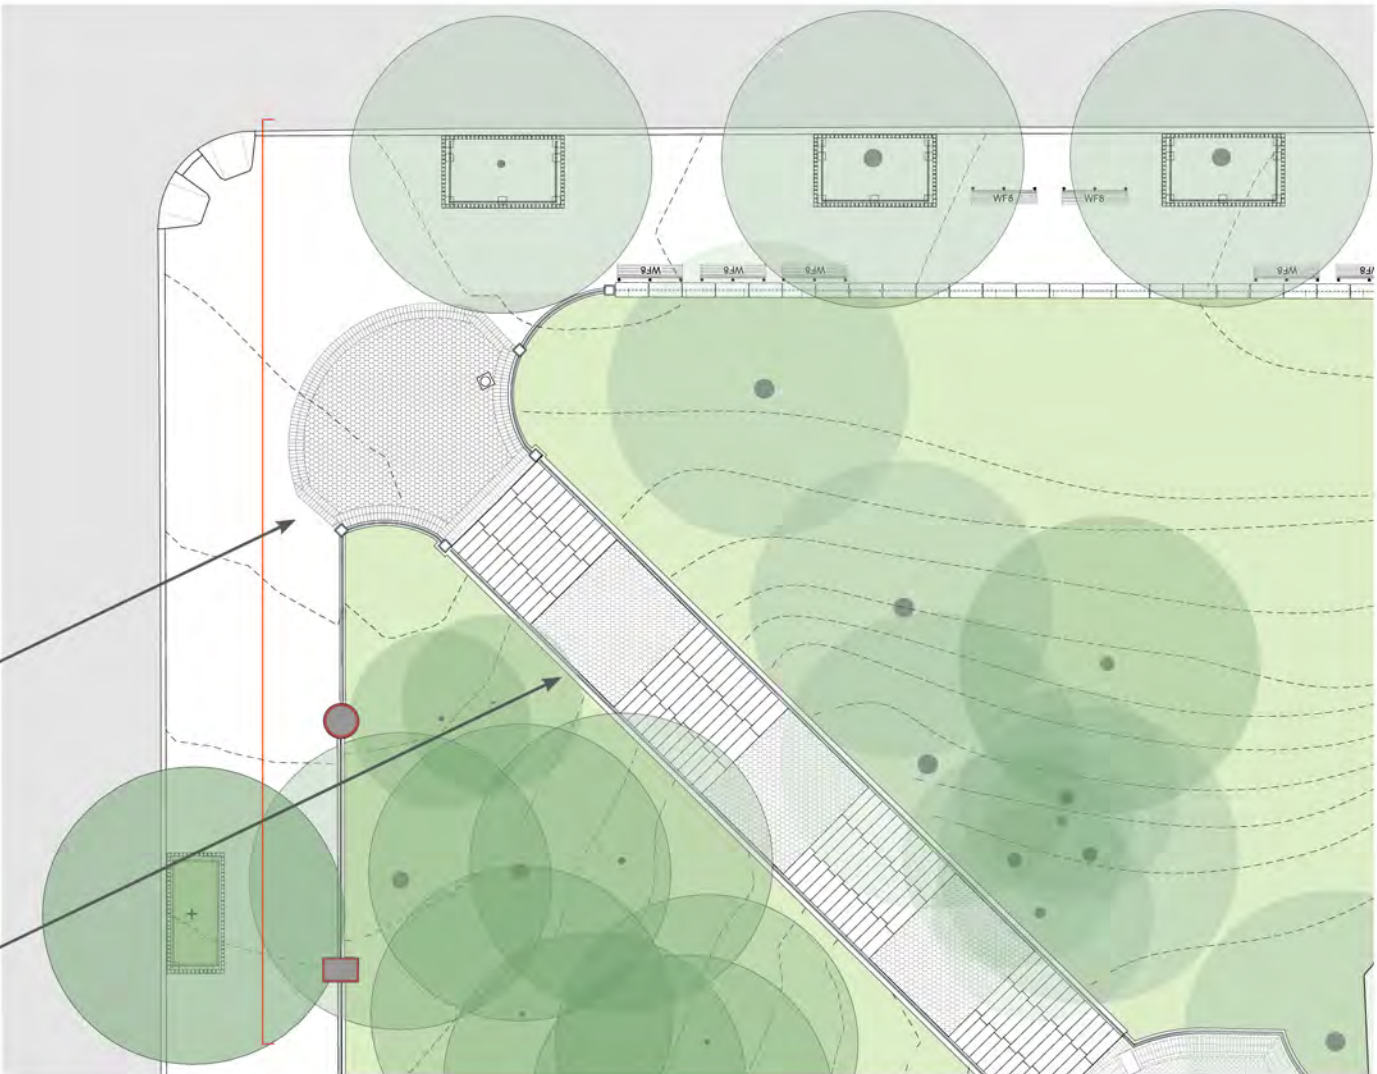
**SOUTH-WEST ENTRANCE 145TH STREET AND EDGECOMBE AVE  
PROPOSED DESIGN**

**CREATE WELCOMING ENTRANCE**

- REMOVE TWO LARGE BRICK PIERS
- REMOVE CHAIN LINK FENCING, LOWER SPIKED FENCING
- SOFTEN CORNERS AND CREATE SYMMETRY
- ADD PAVING PATTERN TO ECHO LOWER LANDING

**RECONSTRUCT STAIRWAY**

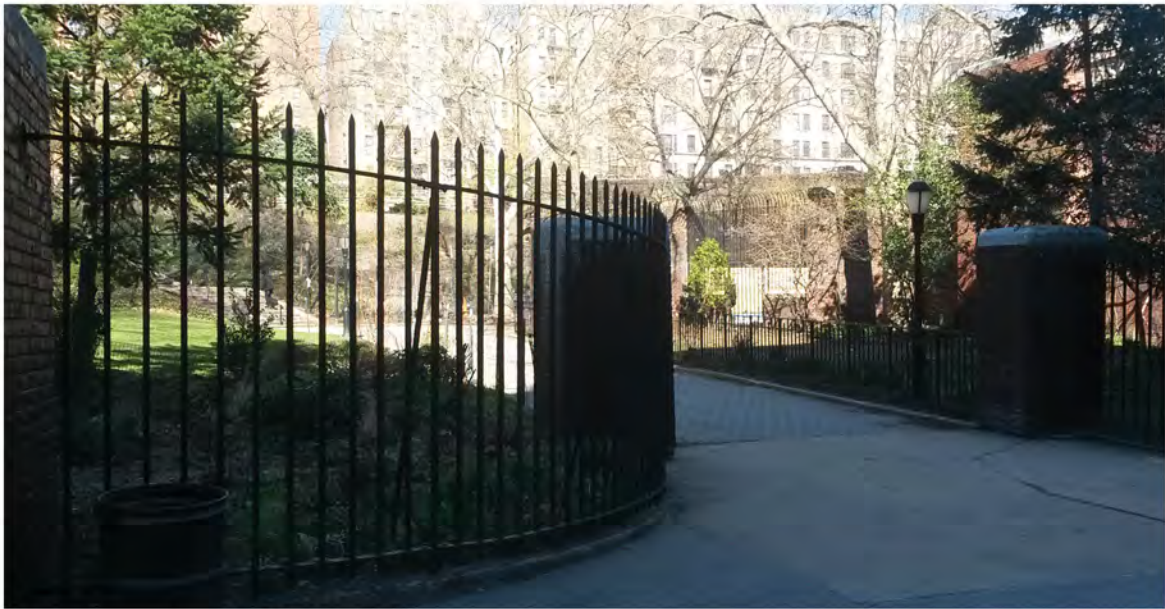
SOUTH-EAST ENTRANCE BRADHURST AVENUE NEAR 146TH STREET  
EXISTING CONDITIONS

EXISTING CONDITIONS

- SOUTH-EAST ENTRANCE
  - LARGE BRICK PIERS BLOCK VIEW
  - HIGH SPIKED FENCE UNWELCOMING
  - UNEVEN PAVEMENT
- SIDEWALK IN DISREPAIR
- UNPROTECTED TREE BEDS

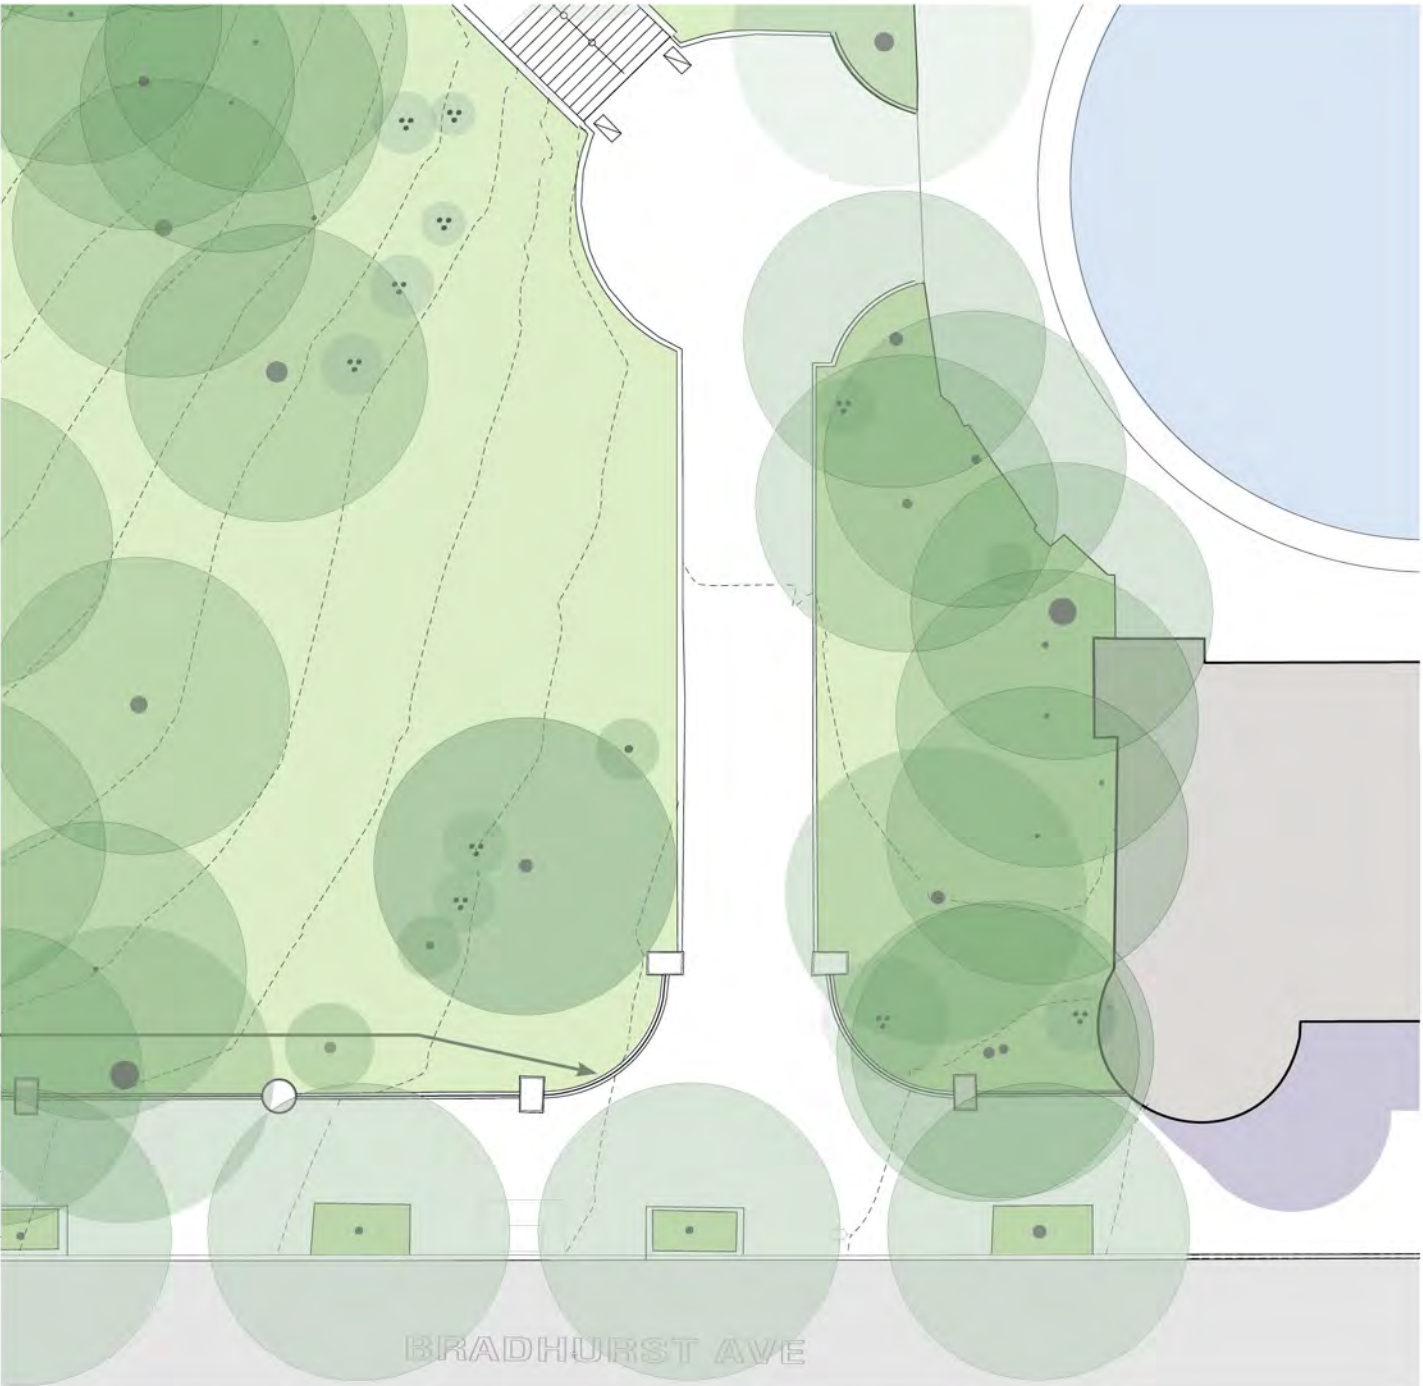
SOUTH-EAST ENTRANCE BRADHURST AVENUE NEAR 146TH STREET  
PROPOSED DESIGN

CREATE WELCOMING ENTRANCE

- REMOVE INNER TWO LARGE BRICK PIERS
- EXTEND PAVING PATTERN INTO SIDEWALK
- LOWER FENCING AT ENTRANCE

REPAVE SIDEWALK

PROTECT TREE BEDS

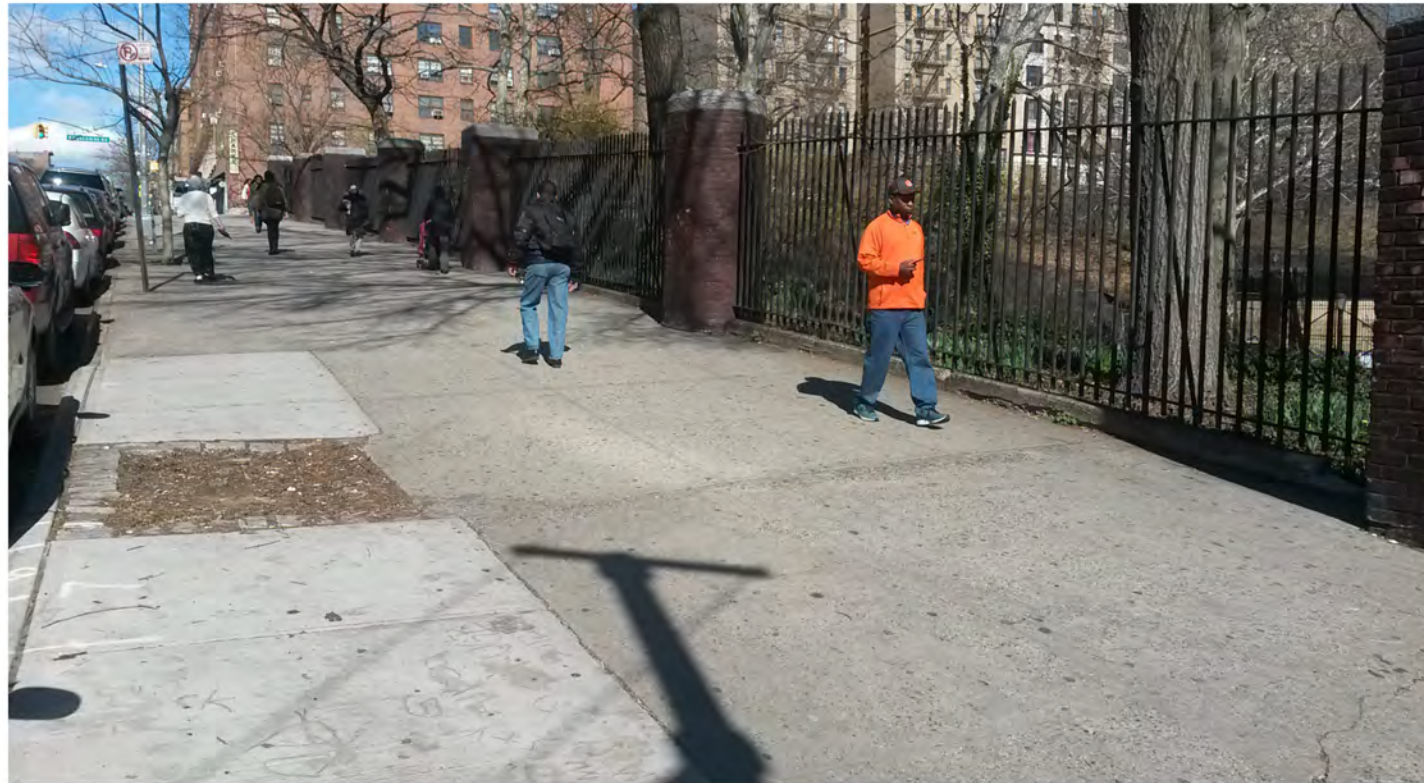
EXISTING CONDITIONS - 145TH STREET BORDER

- Replace 8ft steel spikes with low decorative fence
- Remove existing brick piers
- Repave sidewalk, plant street trees, protect tree beds

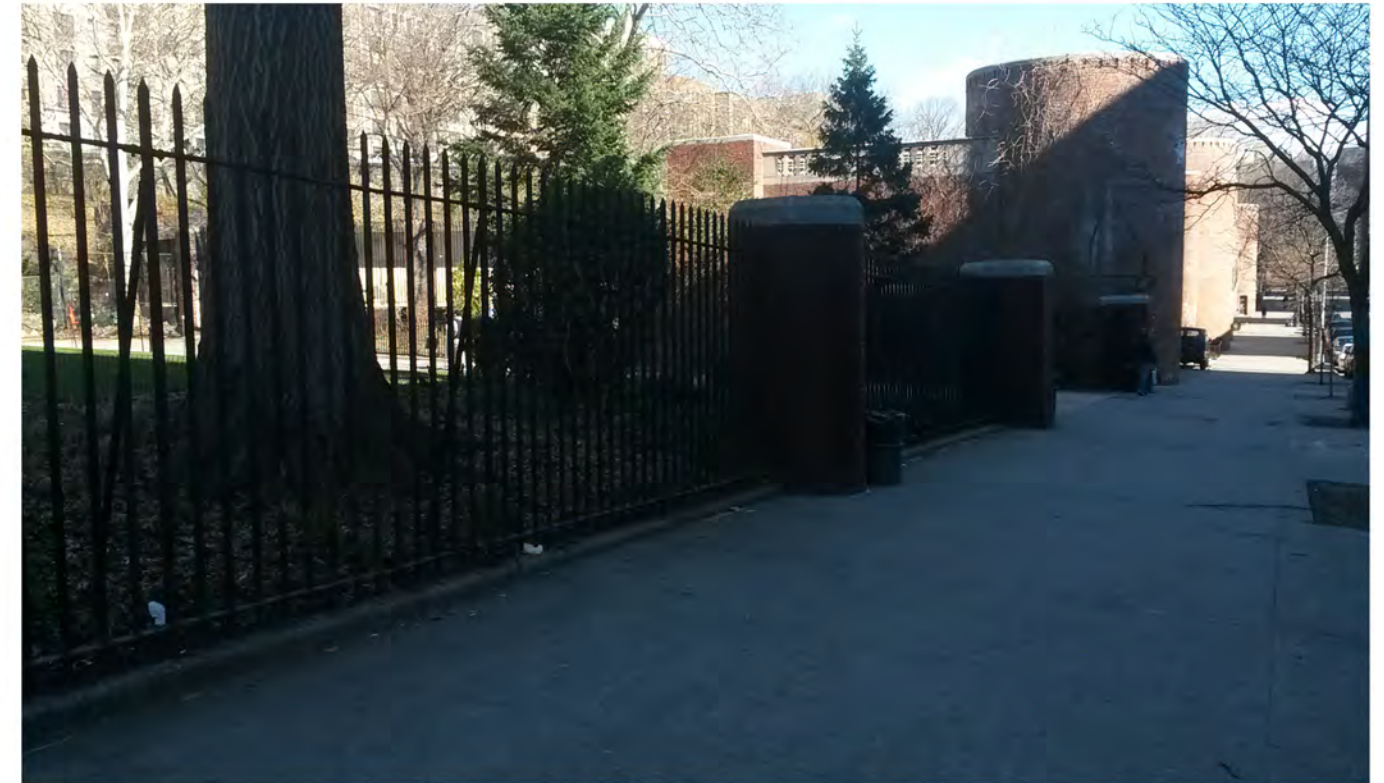
EXISTING CONDITIONS - BRADHURST AVENUE BORDER BELOW 146TH STREET

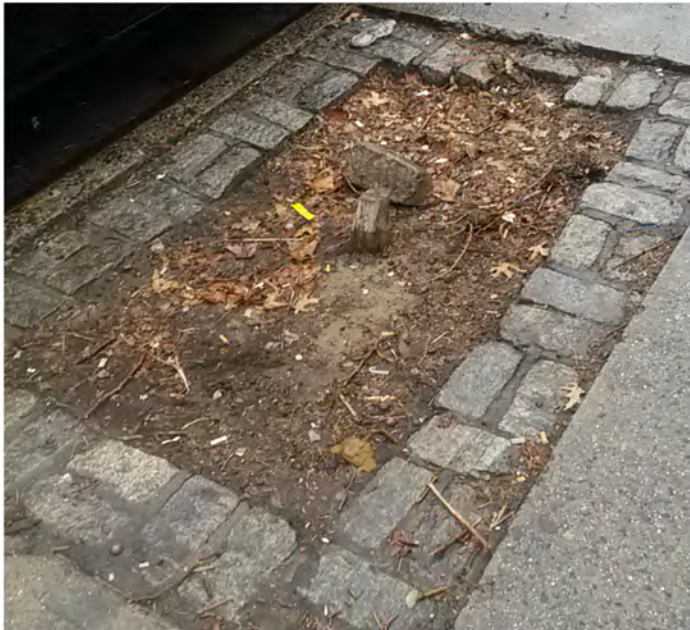
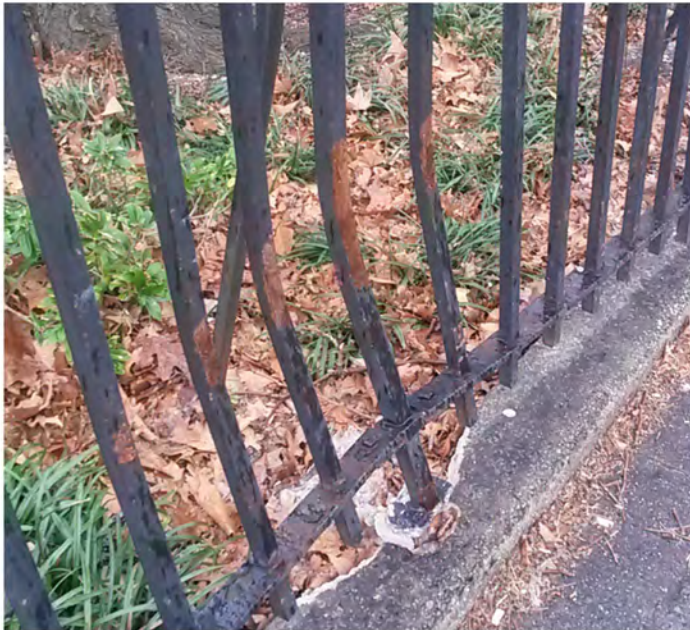
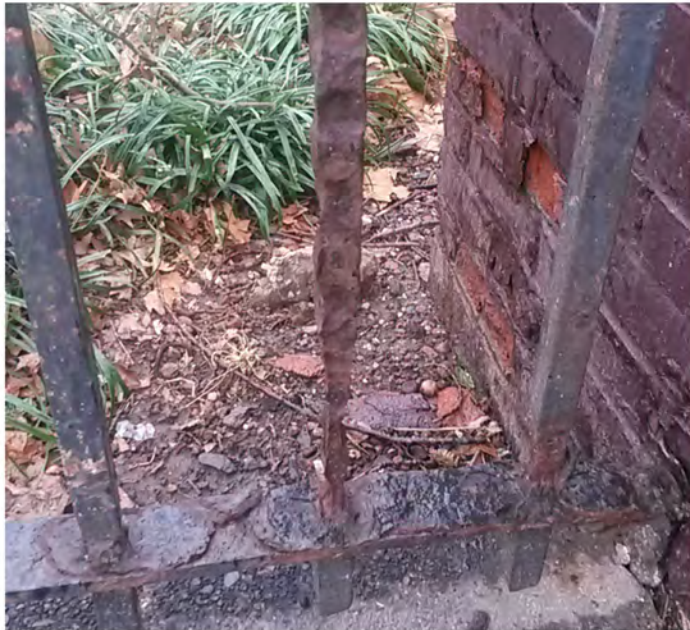
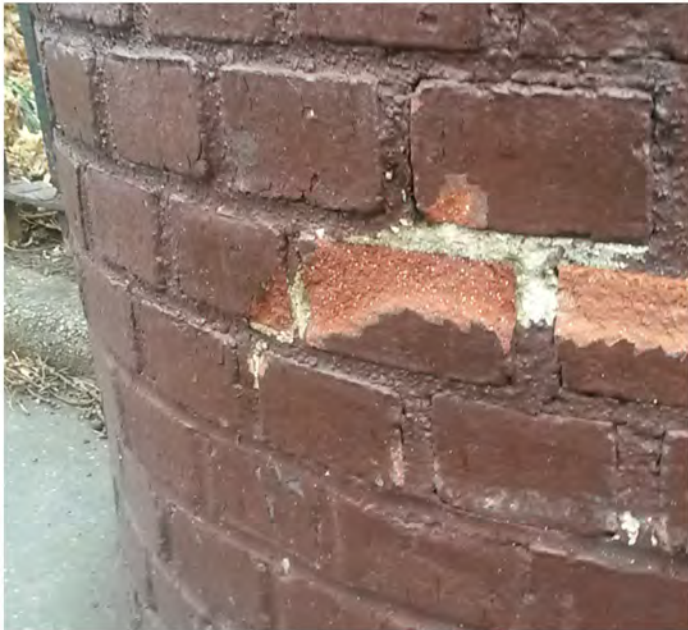
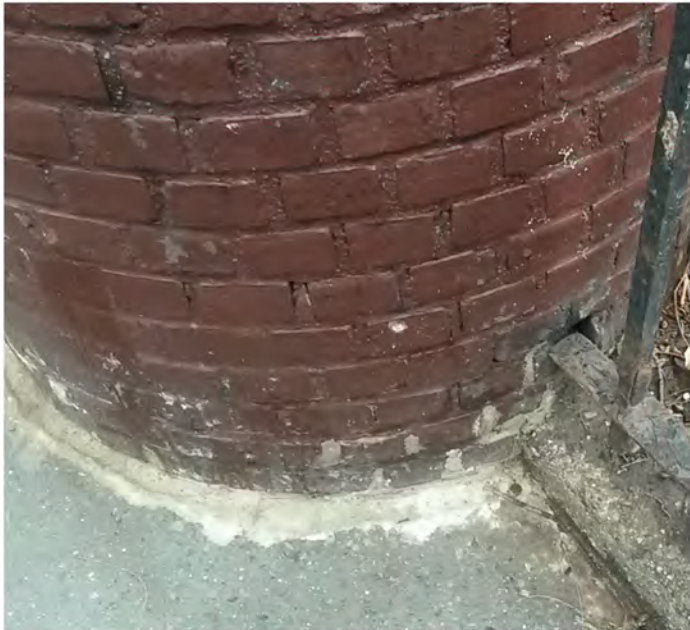
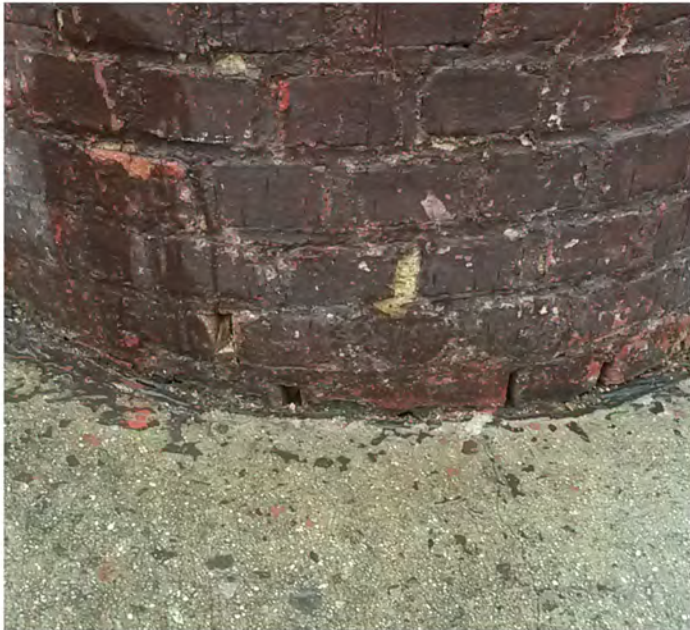
EXISTING CONDITIONS - BRICK PIERS, STEEL FENCE AND TREE PIT

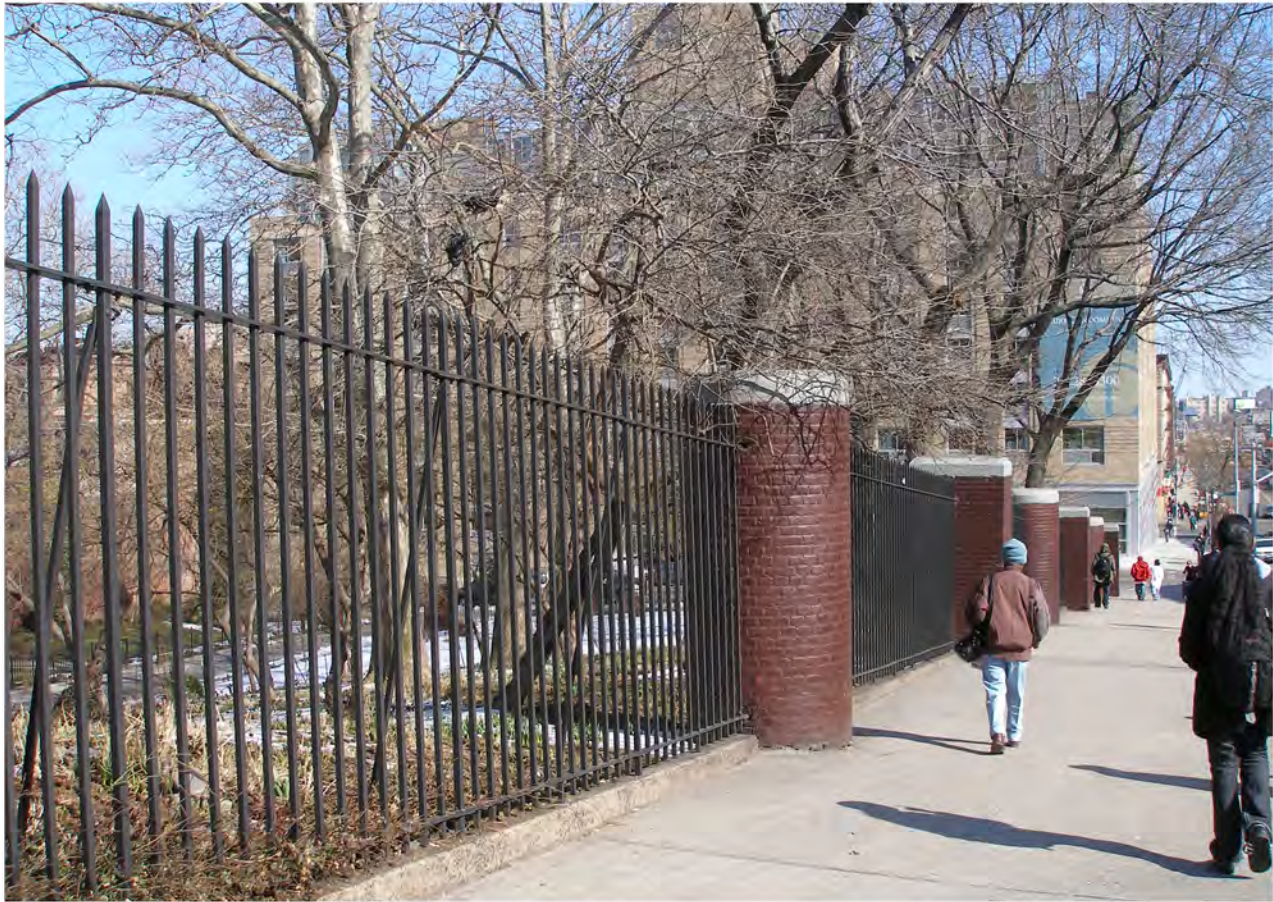
EXISTING CONDITIONS - 145TH STREET

- Improve park relationship to major neighborhood corridor
- Replace 8ft steel spikes with low decorative fence
- Remove existing brick piers and replace with new, smaller piers in scale with lower fence
- Repave sidewalk and create protected tree beds

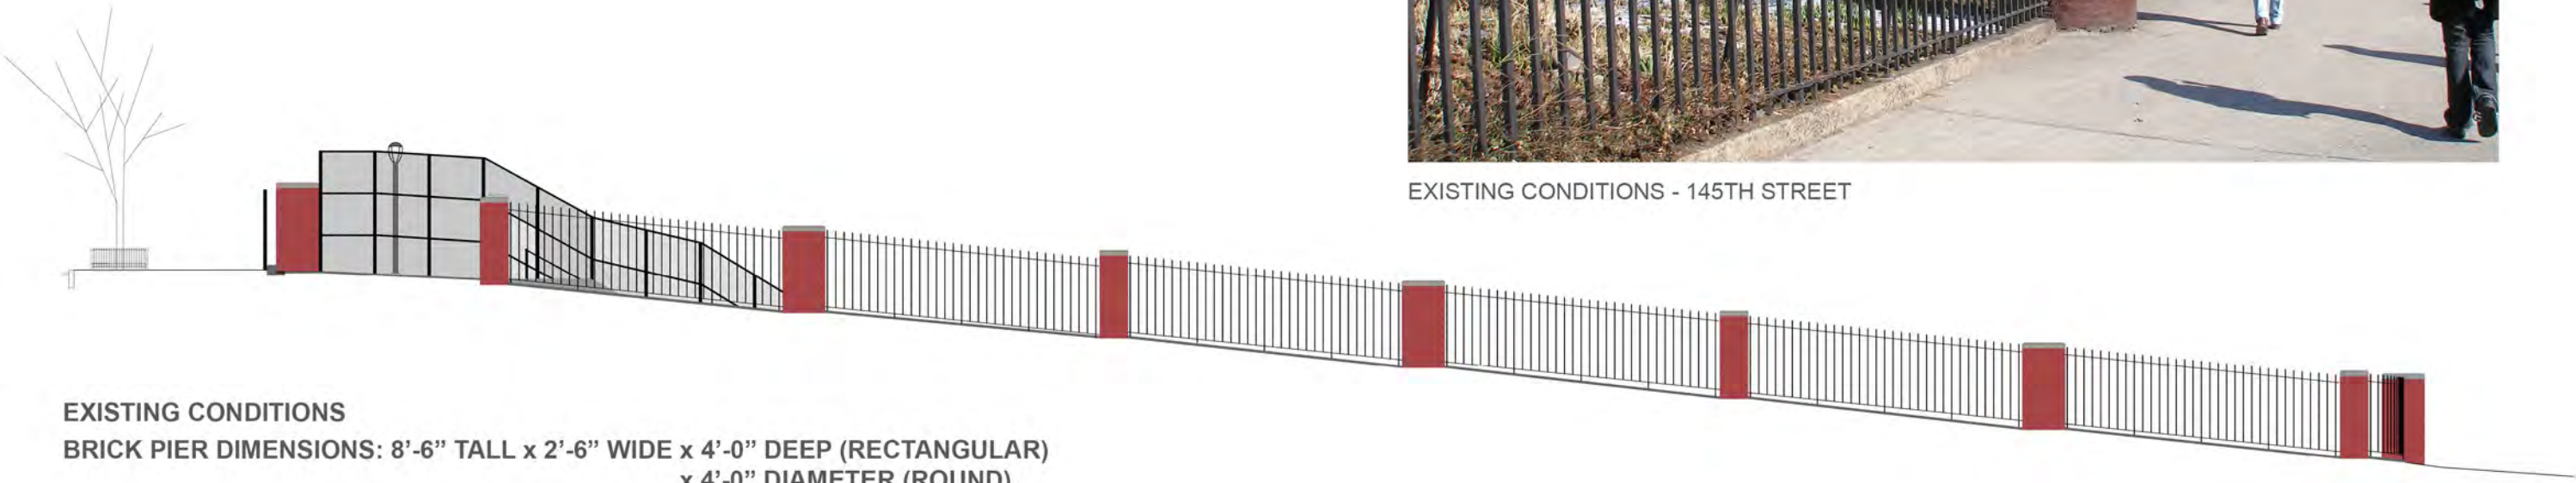
EXISTING CONDITIONS  
BRICK PIER DIMENSIONS: 8'-6" TALL x 2'-6" WIDE x 4'-0" DEEP (RECTANGULAR)  
x 4'-0" DIAMETER (ROUND)

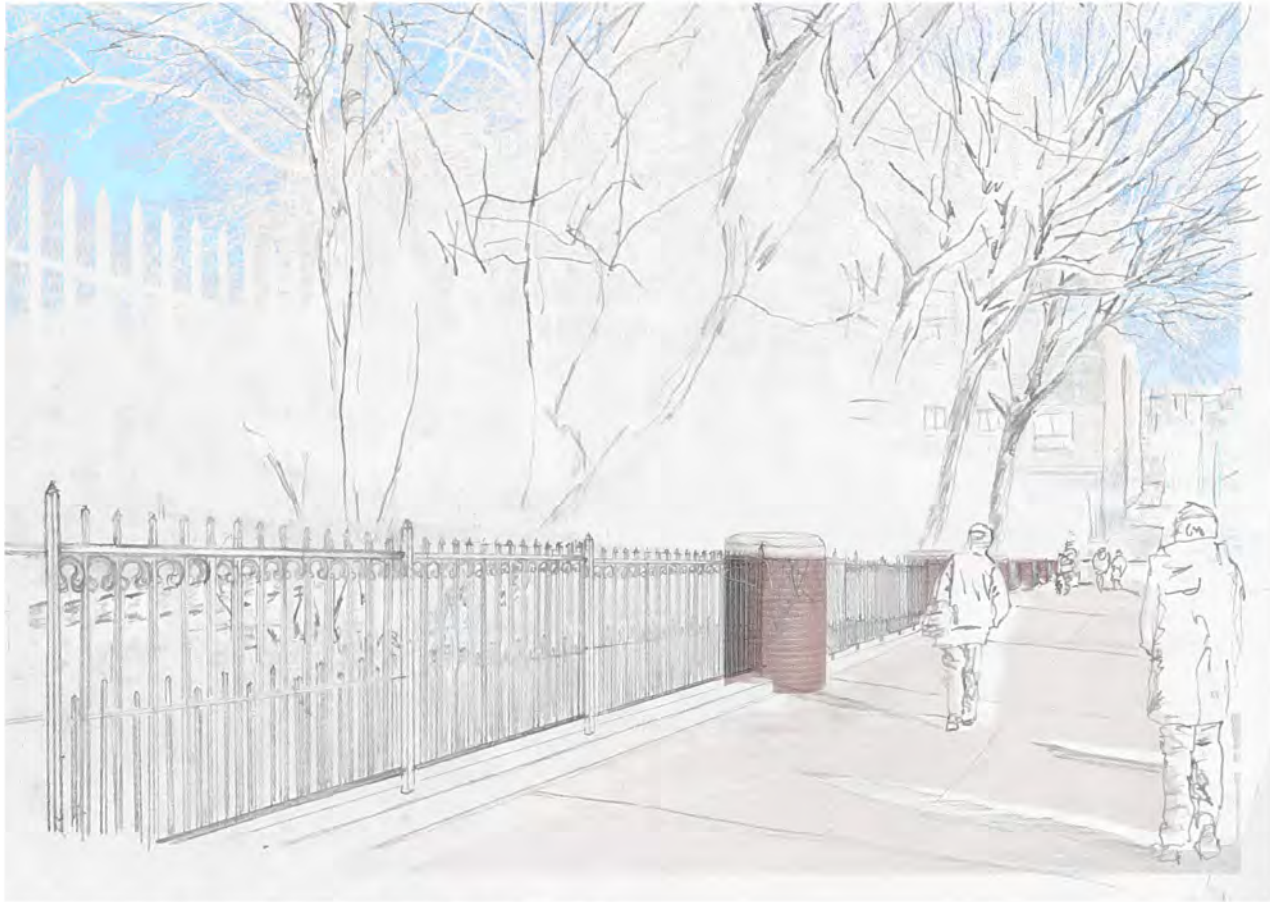
- Improve park relationship to major neighborhood corridor
- Replace 8ft steel spikes with low decorative fence
- Remove existing brick piers and replace with new, smaller piers in scale with lower fence
- Repave sidewalk and create protected tree beds

PROPOSED BORDER SKETCH - 145TH STREET

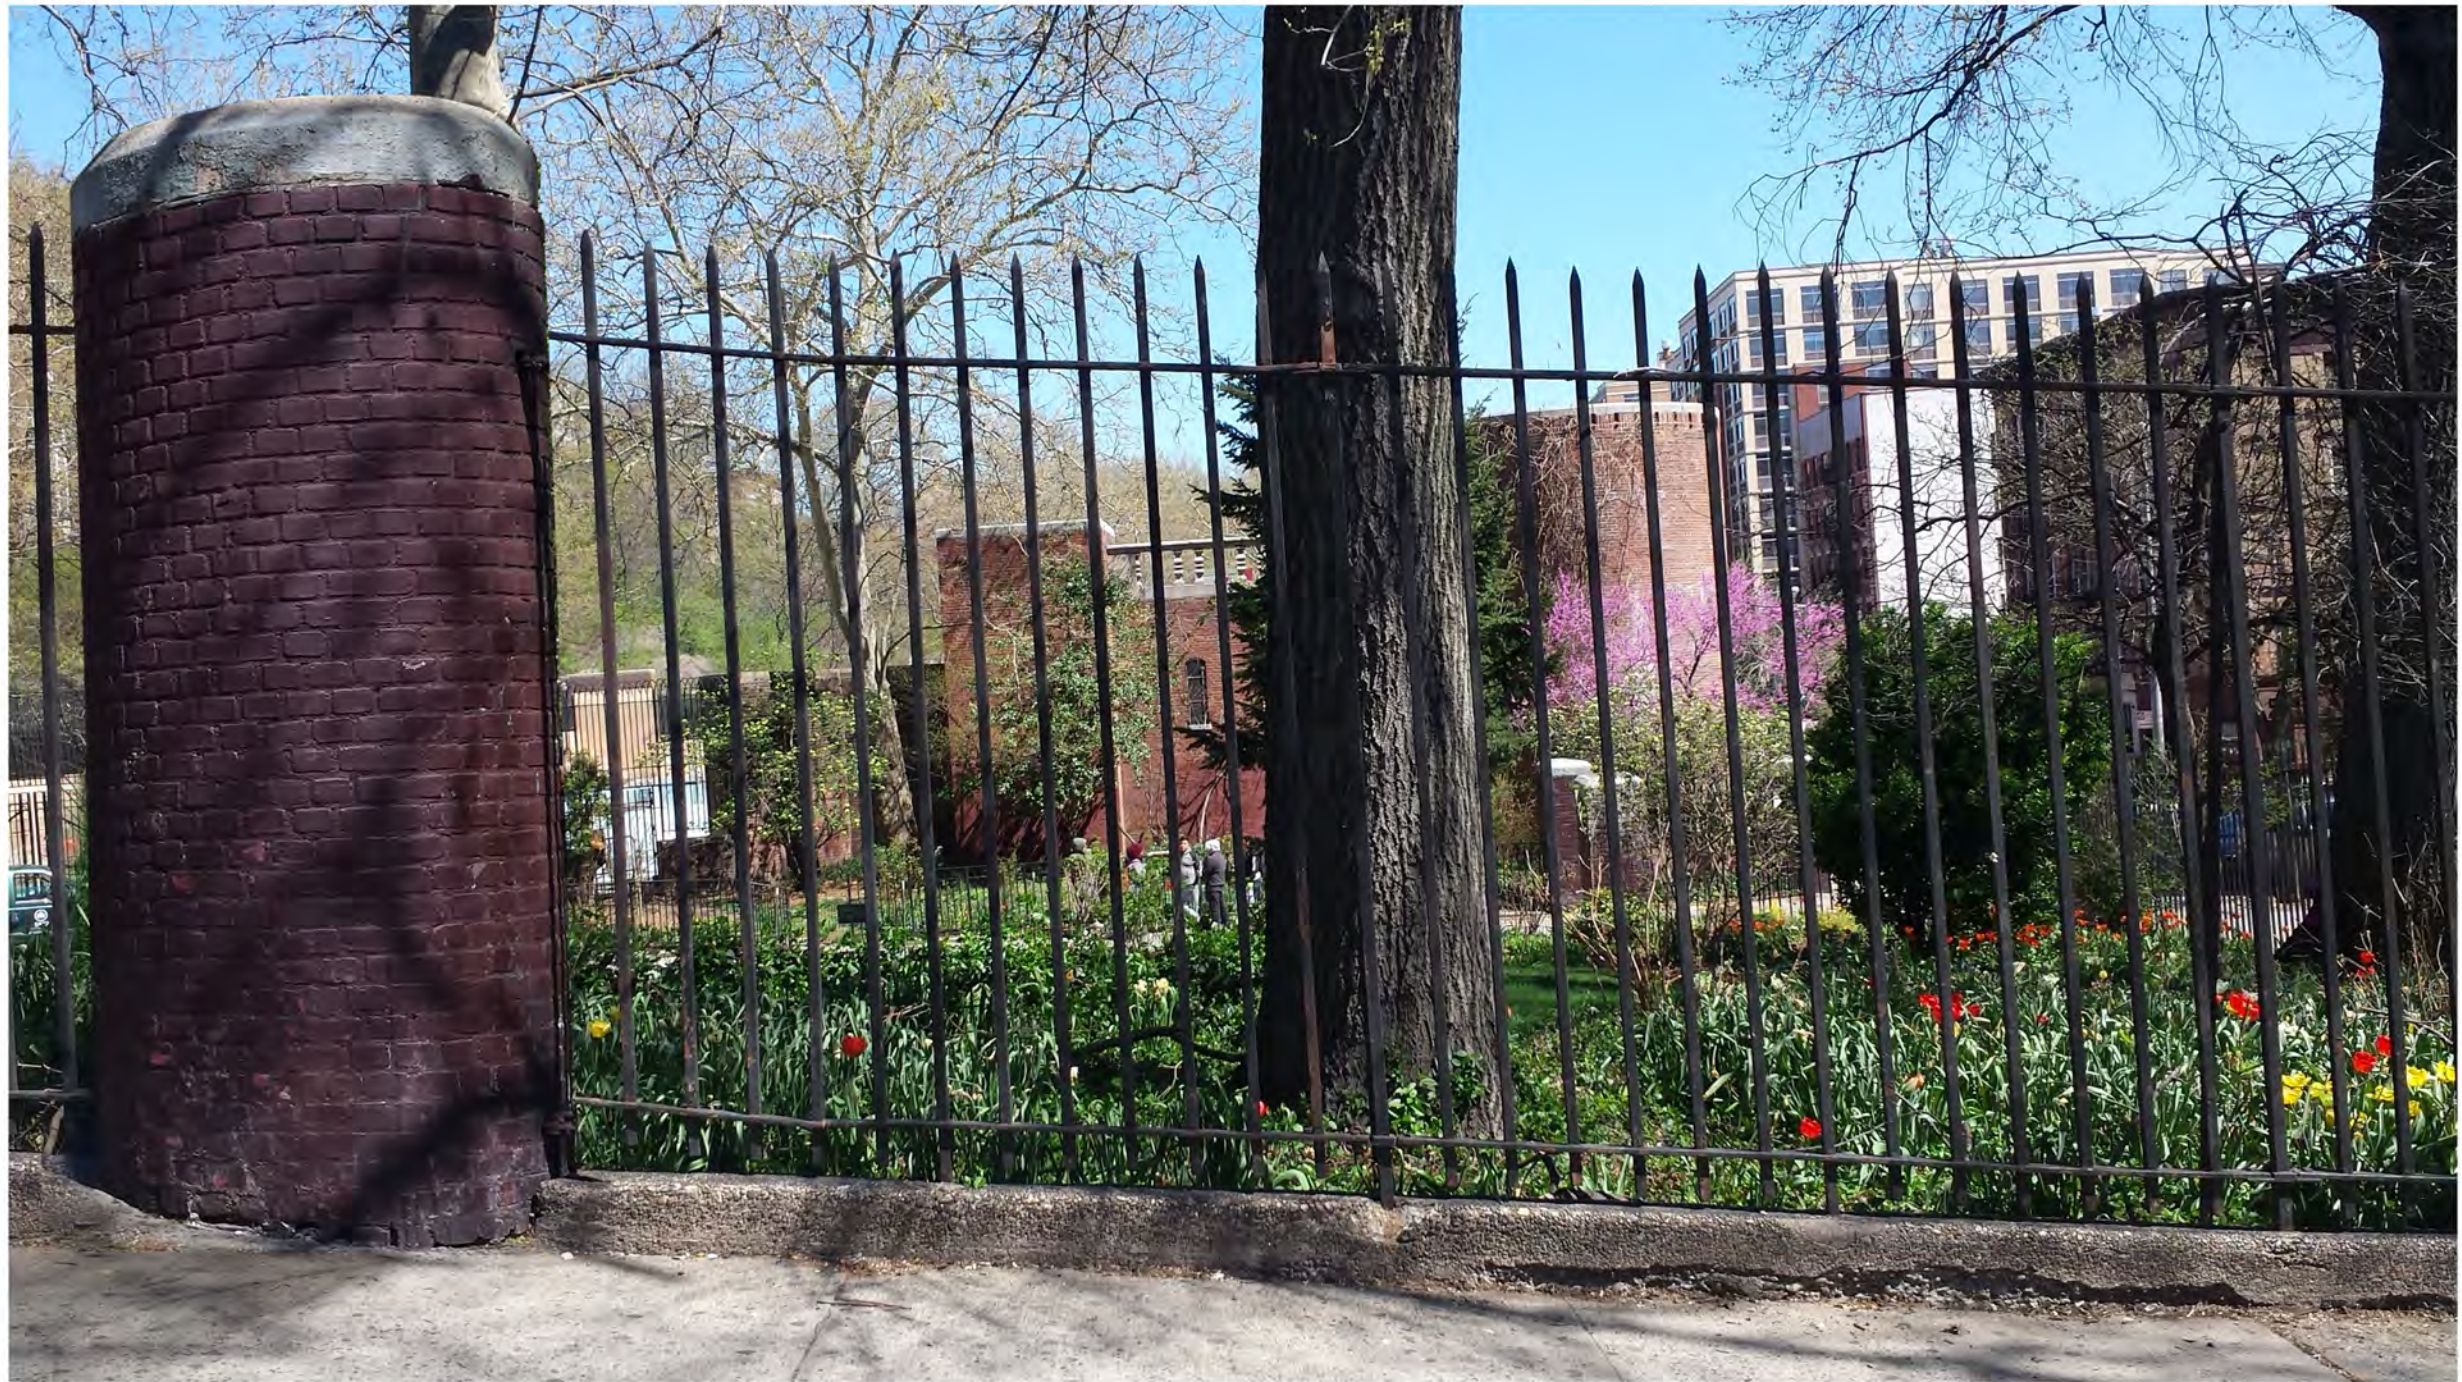
EXISTING CONDITIONS
