PARKS WITHOUT BORDERS  
SCHEMATIC DESIGN PROPOSAL

# Jackie Robinson Park

Located between 145th & 155th Streets  
between Edgecombe & Bradhurst Avenues  
in the Borough of Manhattan

NYC LANDMARKS PRESERVATION COMMISSION FULL HEARING  
June 6, 2017

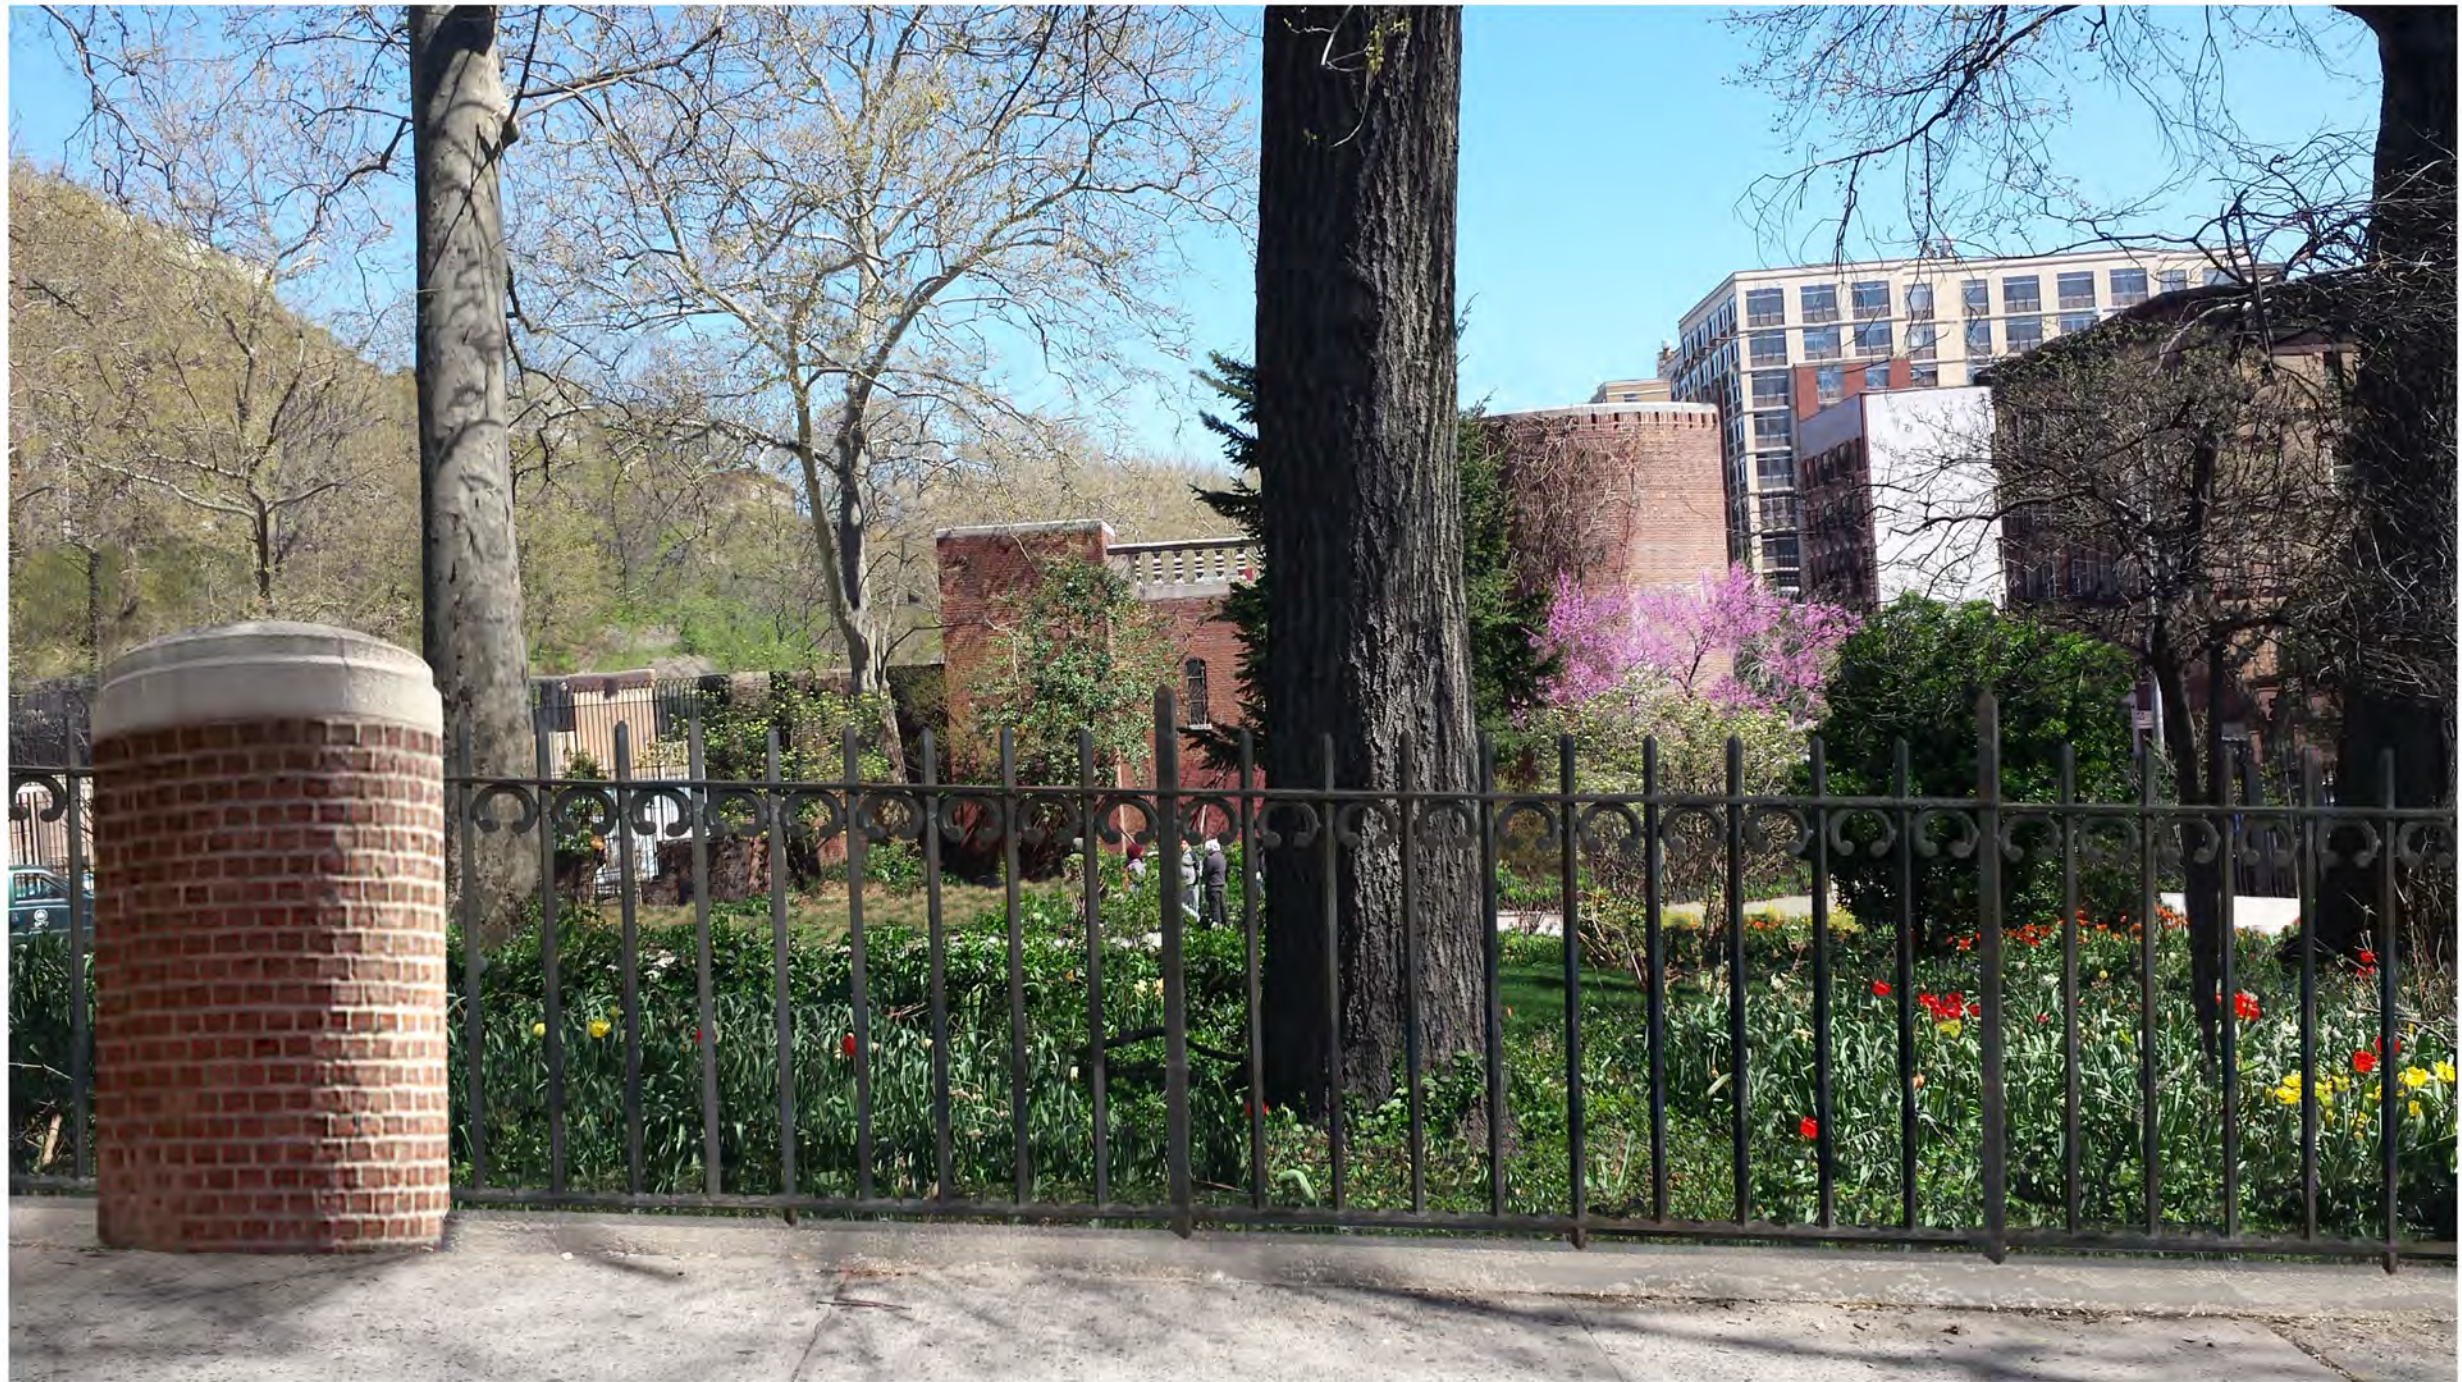
PROPOSED (ADD ALTERNATE)  
EXTEND LOW BORDER FENCE WITH SMALLER BRICK PIERS
