WARDS ISLAND WASTEWATER TREATMENT PLANT, MANHATTAN, NY

CHAPTER 2: WASTEWATER TREATMENT PLANTS

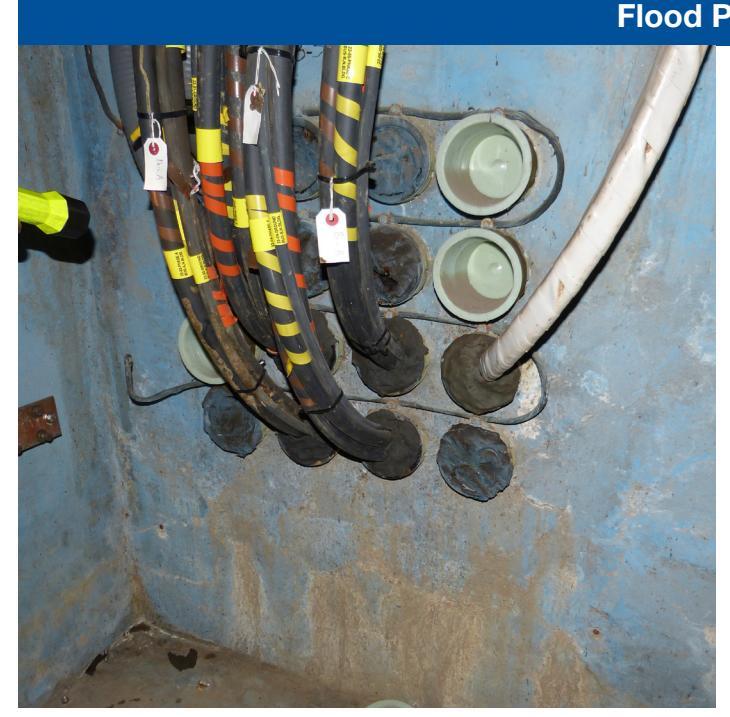
Electrical conduits in the basement of the Main Building provided a pathway for floodwaters during Hurricane Sandy.

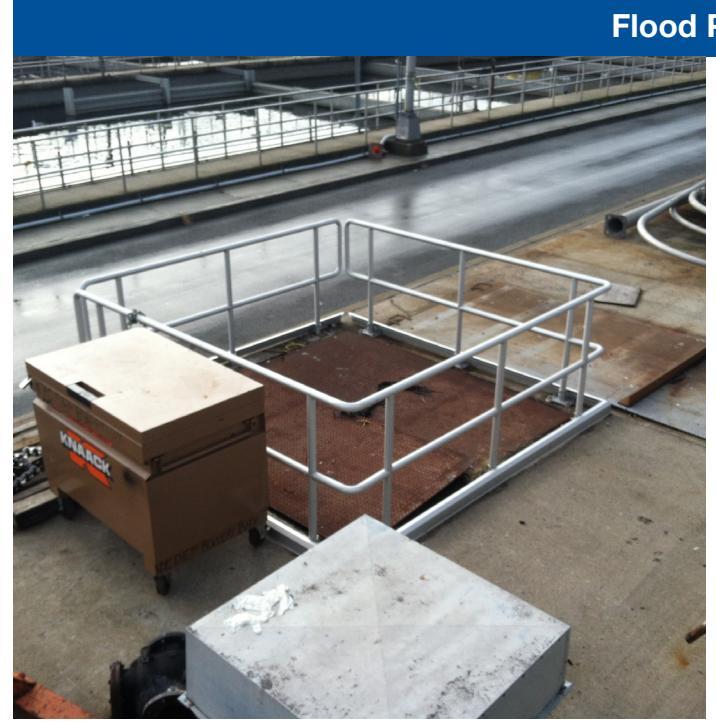
Typical hatch at grade level leading to tunnel system

Since many of the areas at Bowery Bay contain critical infrastructure, often elevating and flood-proofing were chosen as strategies since they provide a high degree of protection. In locations where not all infrastructure could be elevated or flood-proofed, additional strategies were chosen that protect openings into the plant areas. In addition, since Bowery Bay is susceptible to flood damage from an interconnected tunnel system, sealing doors and hatches leading to the tunnel is recommended. Providing more robust coverings and seals would greatly reduce this risk and prevent floodwaters from entering the tunnel system, traveling throughout the plant, and damaging target pieces of equipment in basements.

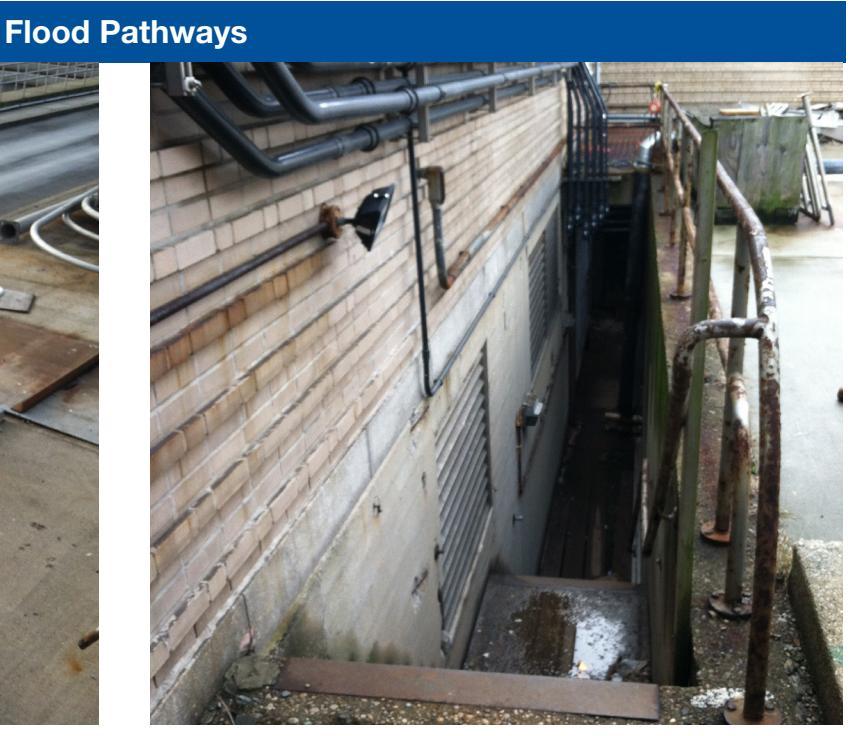
Stairway at grade leading to the Main Building

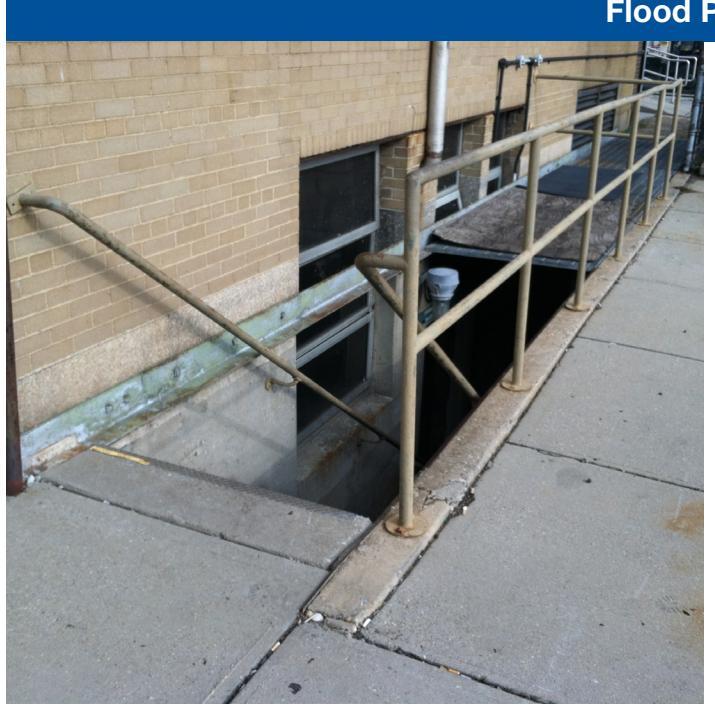
Access stairway to the basement and gas booster room of the Pump and Power Building

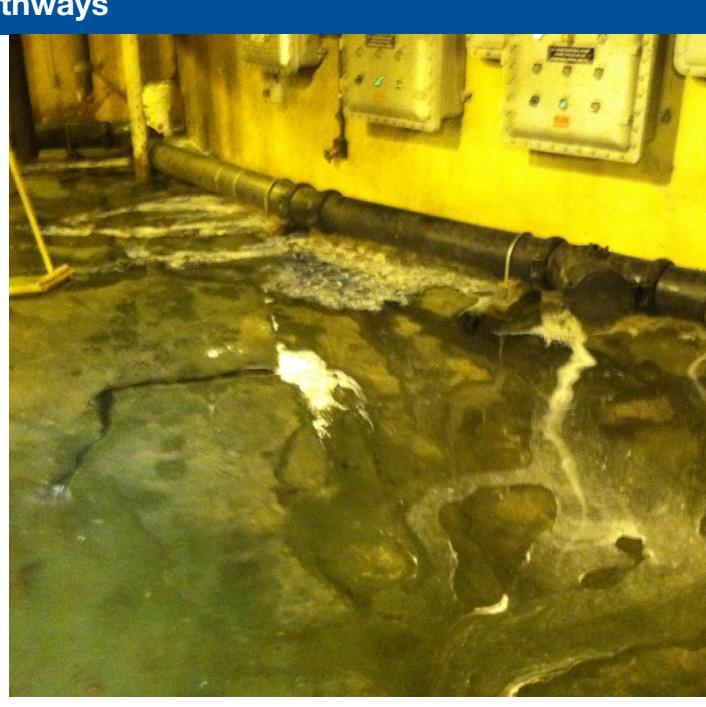
Sinkholes developed near the Sludge Storage Area after Hurricane Sandy. Groundwater may present a flood risk during the next critical flood event

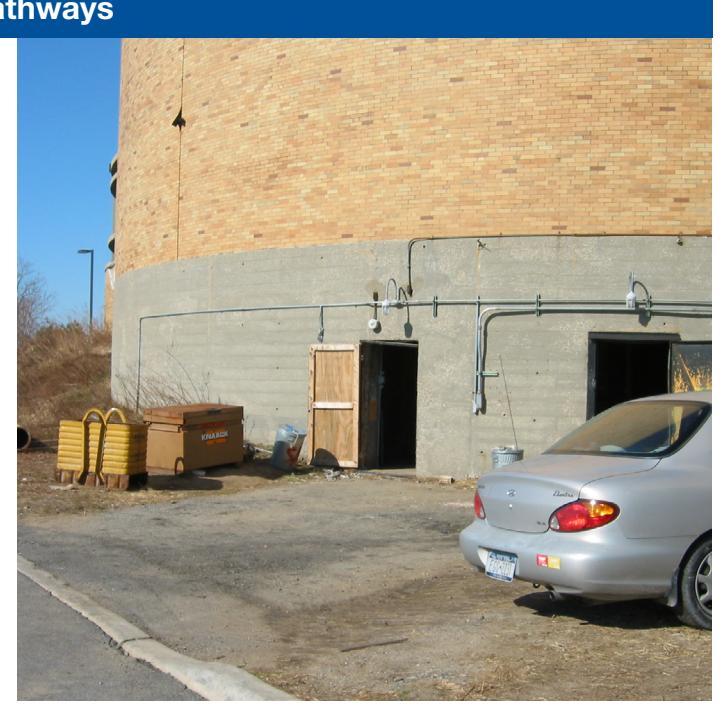
Access doors to the Sludge Storage Tanks next to the East River

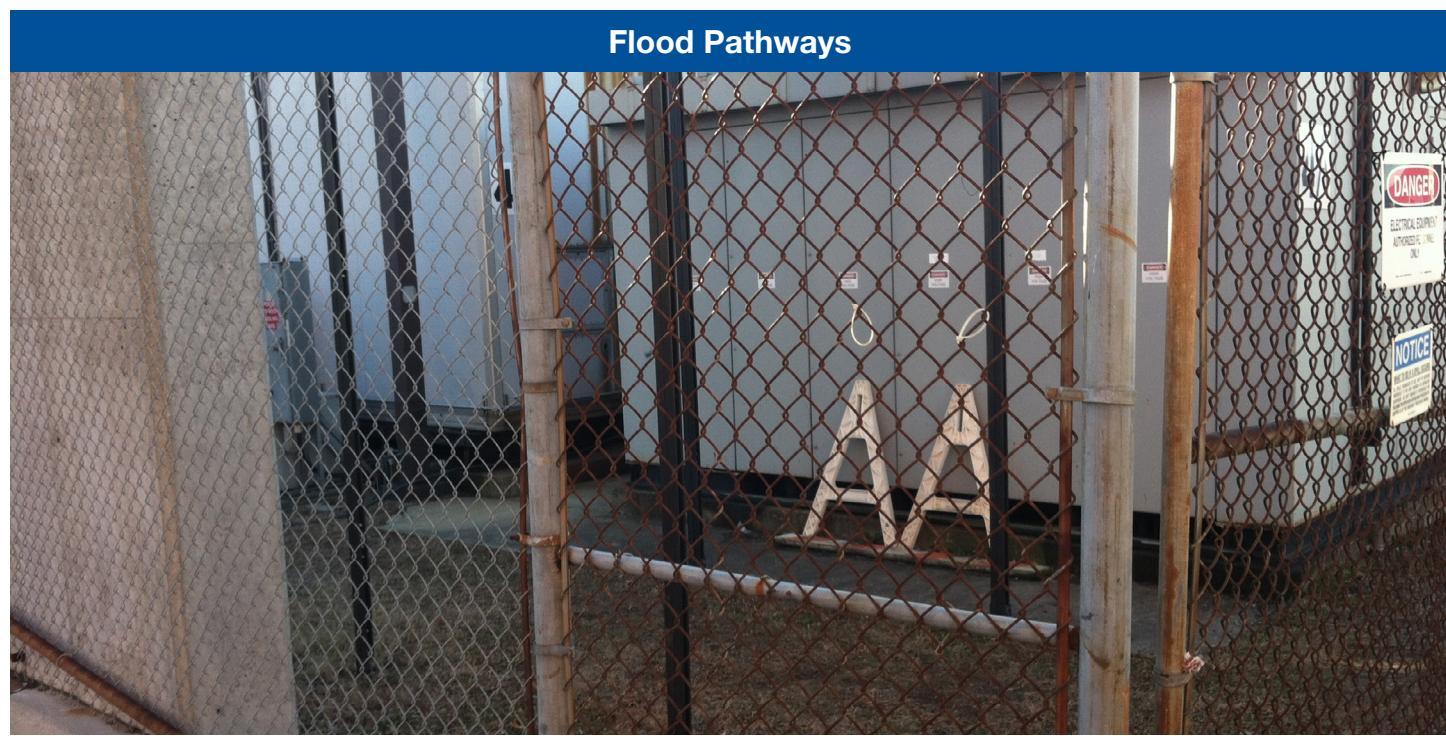
The Unit Substation adjacent to the Return Sludge Pump Station #3 would be flooded at grade level during the critical flood event.

This favorable cost comparison provides strong economic support for using sandbags along the substation to minimize service disruptions in Queens during flood events, reduce sewage bypasses, and protect public health.

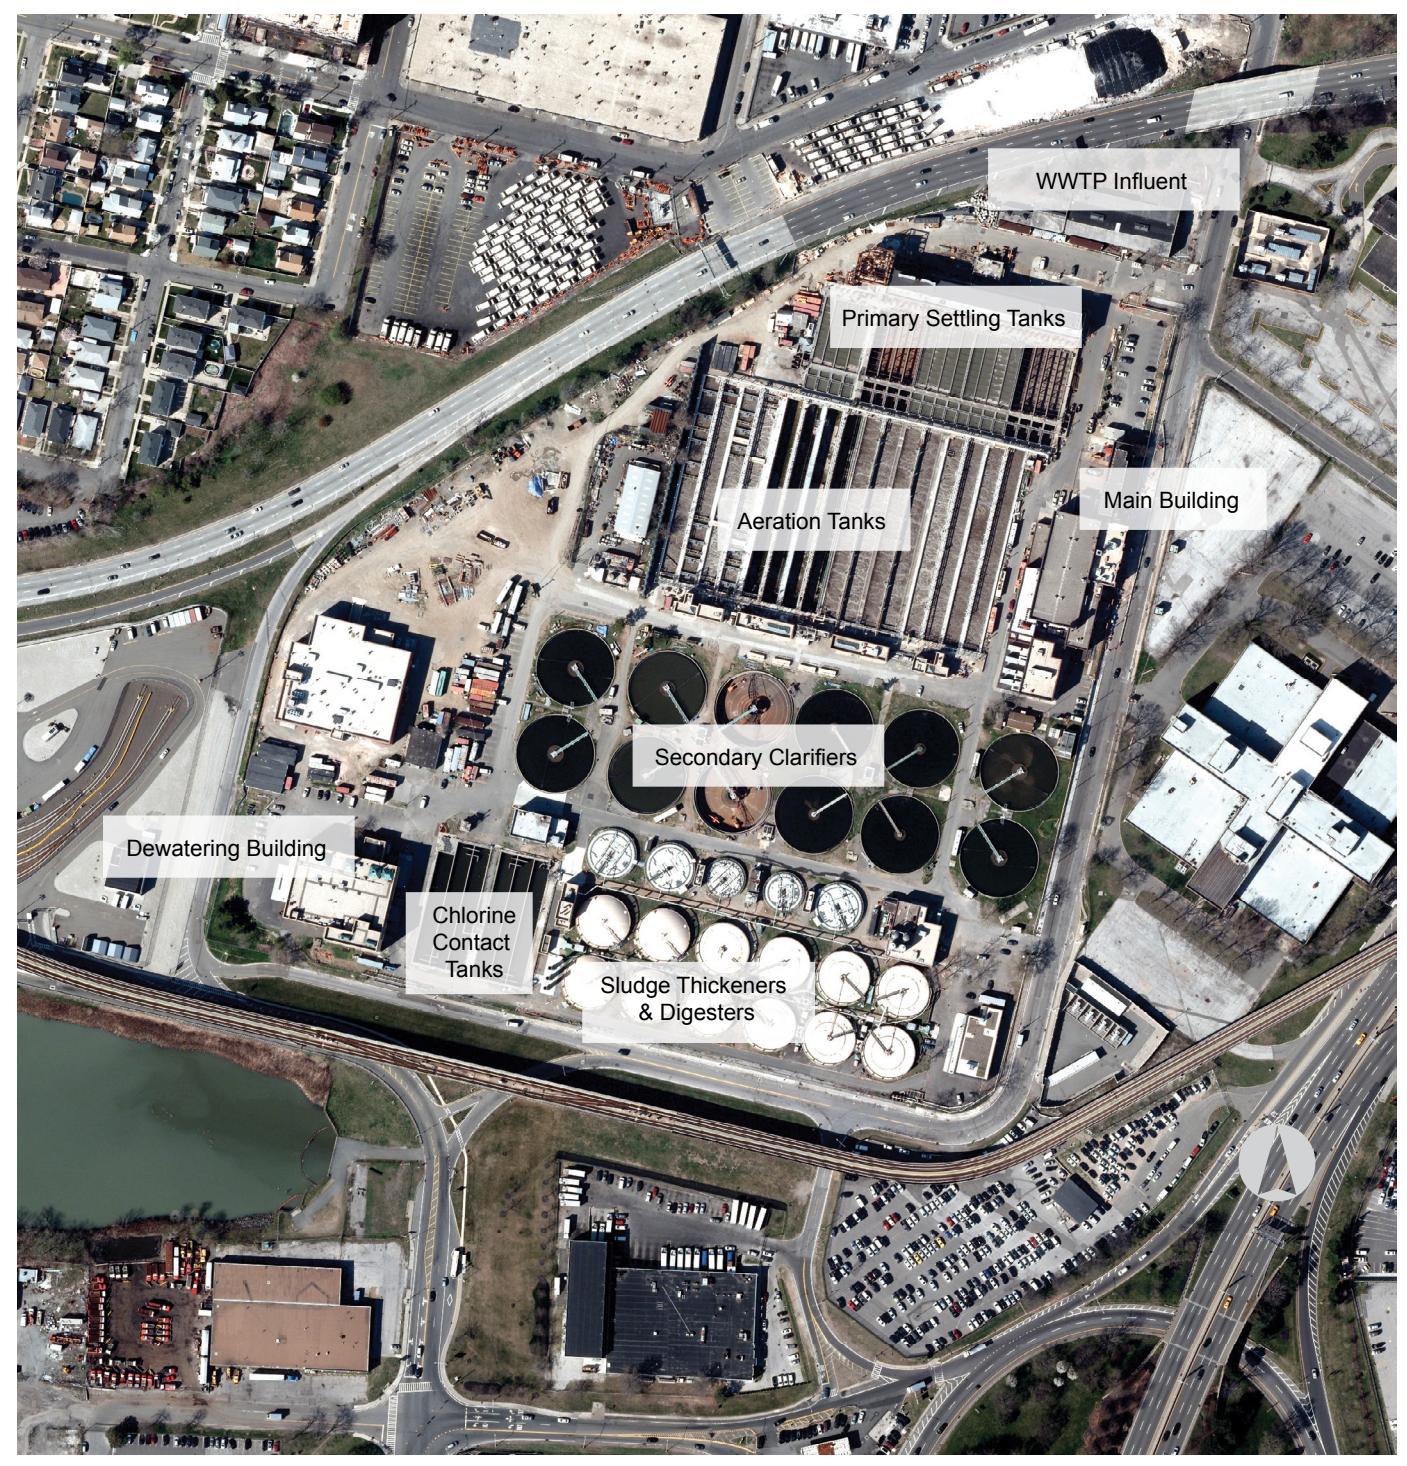
The Jamaica Wastewater Treatment Plant did not sustain any damage due to flooding during Hurricane Sandy.

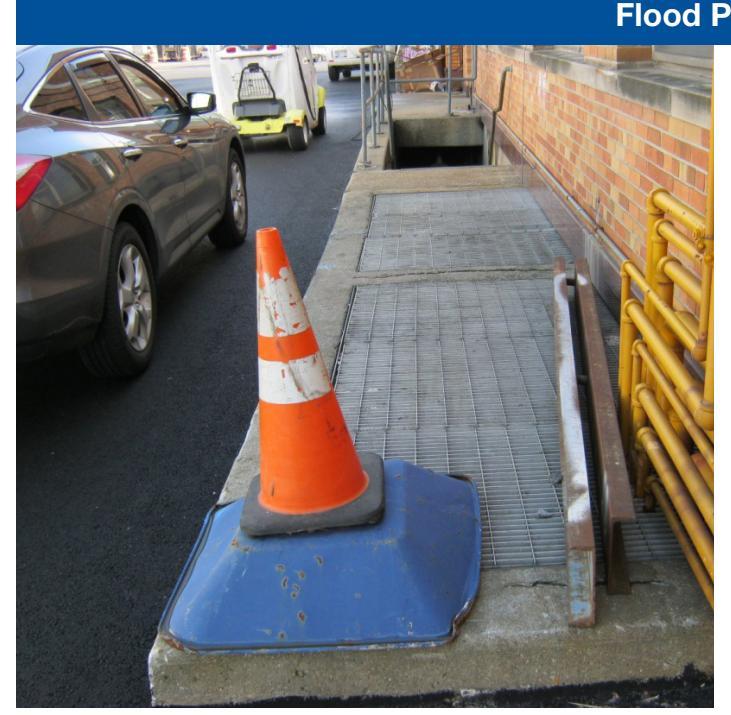
Basement access and floor grates on the perimeter of the Main Building

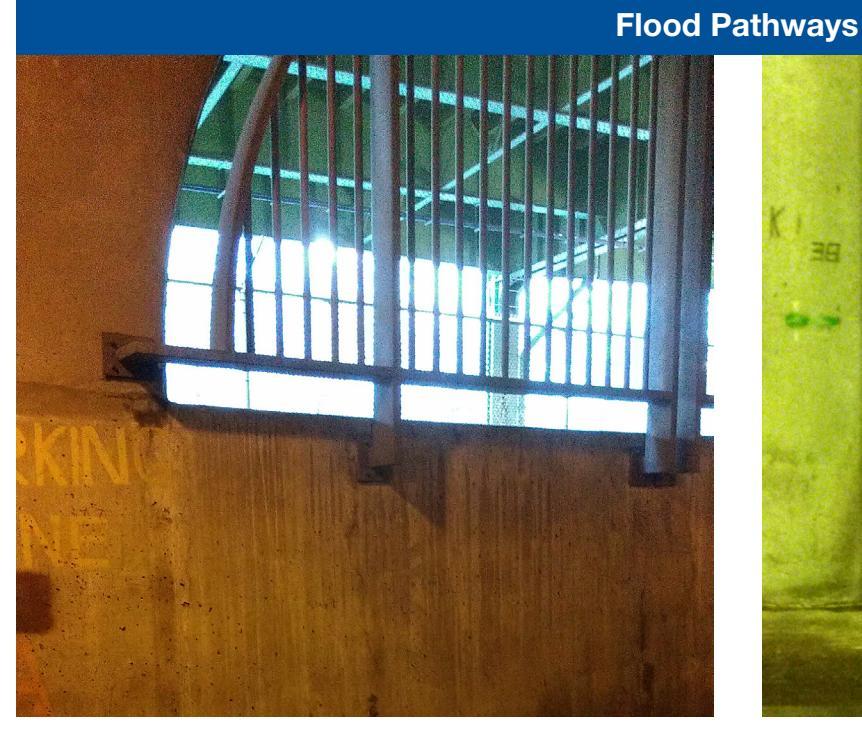
Arched windows around the perimeter of the ground level (EL 5) are considered pathways for flooding.

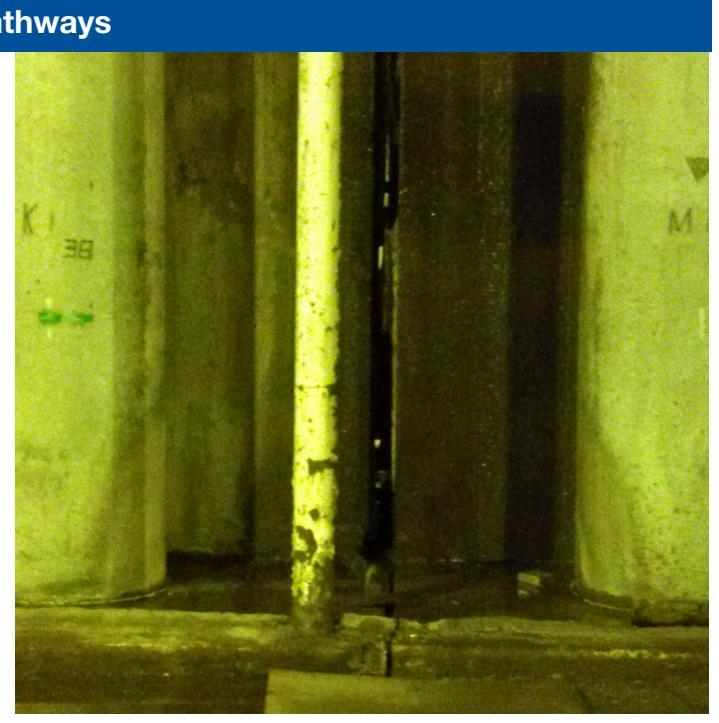
Expansion joints are flood pathways as experienced during Hurricane Sandy.

North River experienced major flooding as a result of Hurricane Sandy. During the peak of the storm, as depicted in the figure below, floodwater forced its way through a manhole that ruptured on the first floor and through expansion joints near the Thickeners, which flooded the first floor of the plant with one foot of water. Fortunately, the engines that supply power to the main wastewater pumps are located on the second floor, and were not damaged. The Electrical Substation has raised doors, yet it flooded with less than 1 inch of water through cracks and other small pathways in the walls. Plant staff monitored the water level in the Electrical Substation throughout the storm and contacted Con Edison as a precautionary measure in case power to the plant had to be shut down. The plant did not lose power; however, certain critical components were proactively shut down for up to 7 hours to prevent short circuiting in case the water level continued to rise. Water flooded the low-lying areas of the building first, including the Raw Influent Pump Dry Well through the first floor stairwells. It was at this point that plant staff turned off the electricity in critical plant areas. Once it was safe to restore power to the facility, a single pump was used to empty the dry well, and maintenance was performed on the remaining pumps when the dry well was emptied. After the storm, floodwater on the first floor flowed out of the plant through the ruptured manhole and through the various drains and sump pumps.

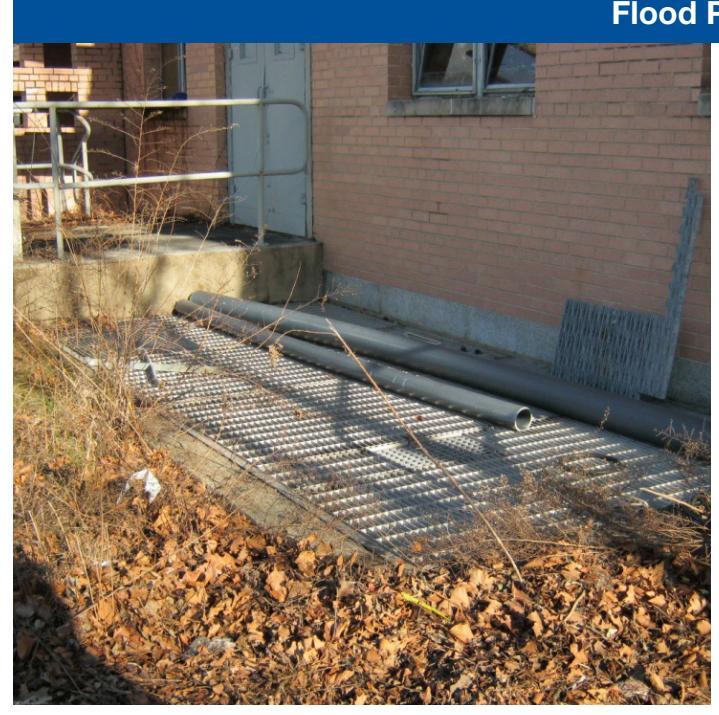
Floor grate outside of the Maintenance Building

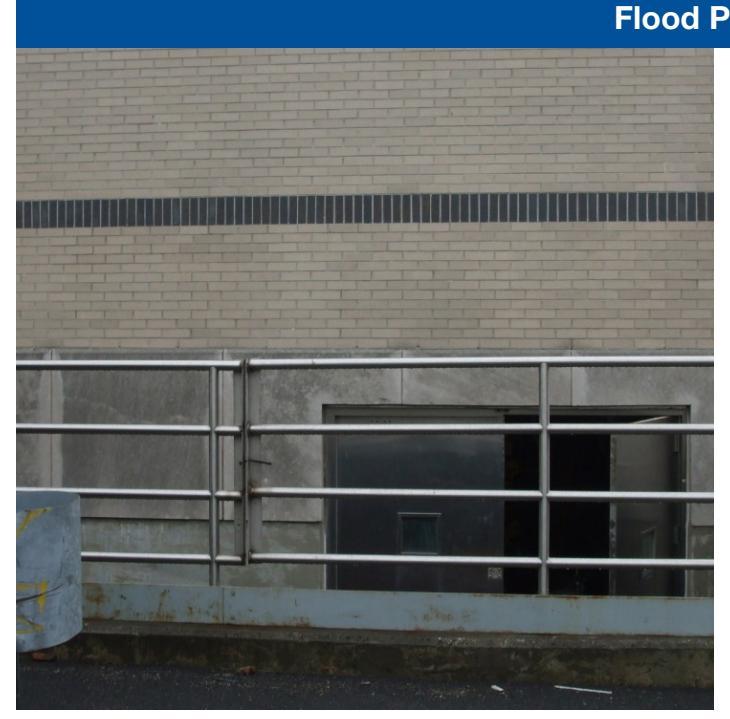
A pathway for flooding is around the perimeter of the Administration Building.

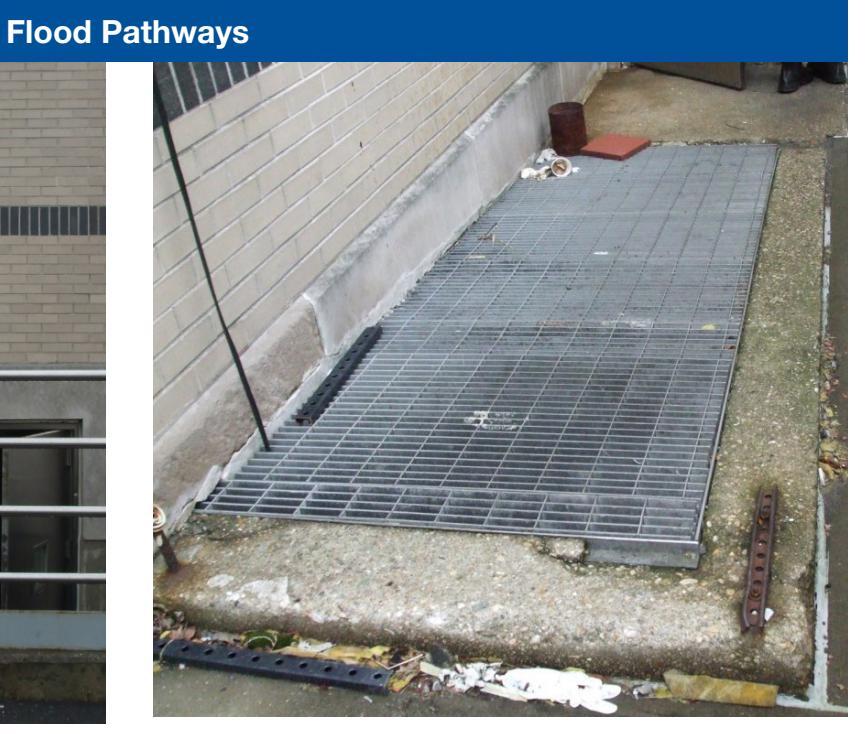
Floor grates near the Generator Room may allow floodwater to enter.

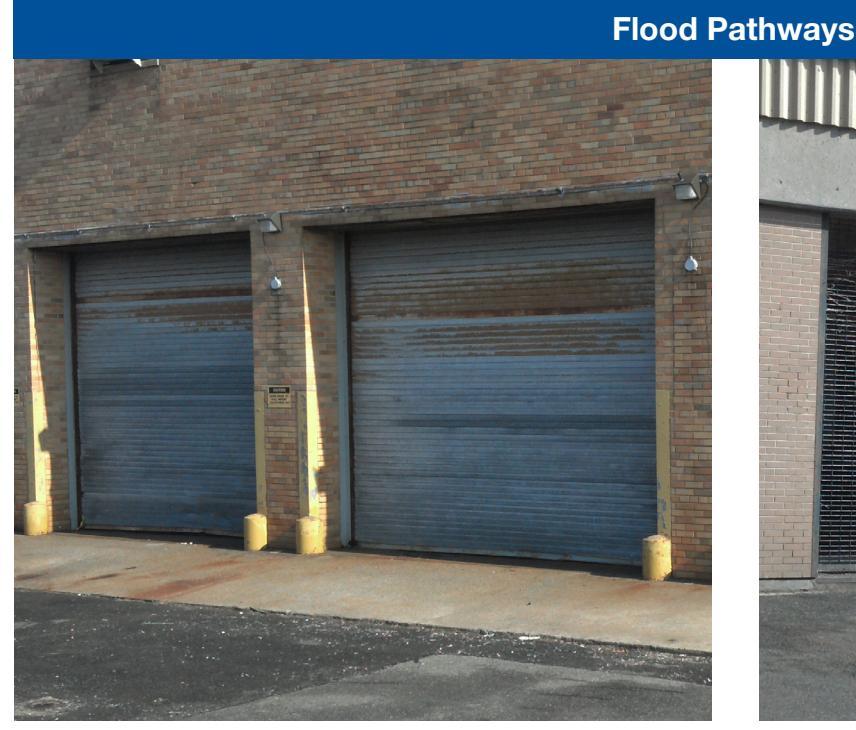
Rollup doors on the Sludge Storage Building adjacent to Jamaica Bay are potential pathways for flooding as experienced during Hurricane Sandy. The Sludge Storage Building is also an access point into the plant's interconnected tunnel system.

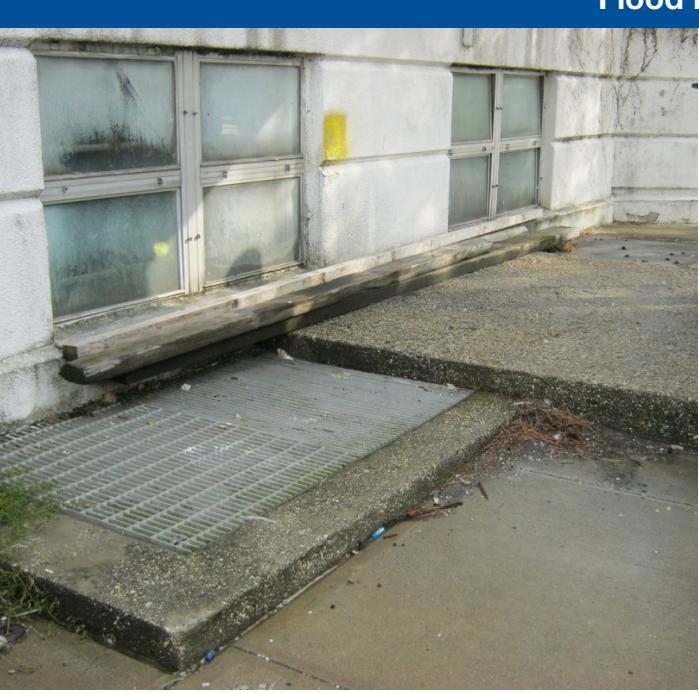
Grate and windows leading to the basement of the Sludge Thickener Building and tunnel system

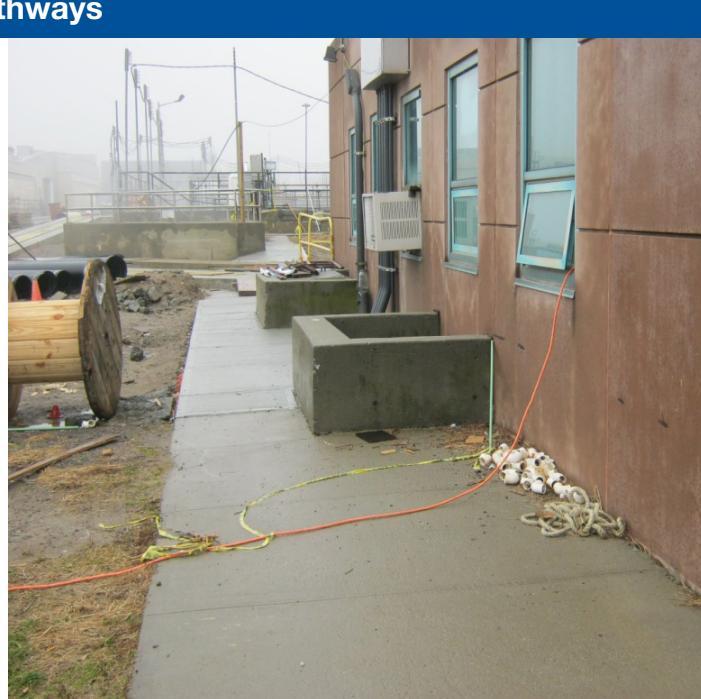
Basement access ways into the Chlorine Building

The Chlorine Building, in particular, requires robust protection as it would experience several feet of flooding under the critical flood event and contains numerous pieces of equipment needed to disinfect wastewater. As such, waterproofing chemical feed pumps and sealing the building with water-tight windows and doors is recommended. Likewise, the Grit Building and Thickener Building are also key locations that require several protection measures, since they have thresholds below the critical flood which lead to the tunnel system.

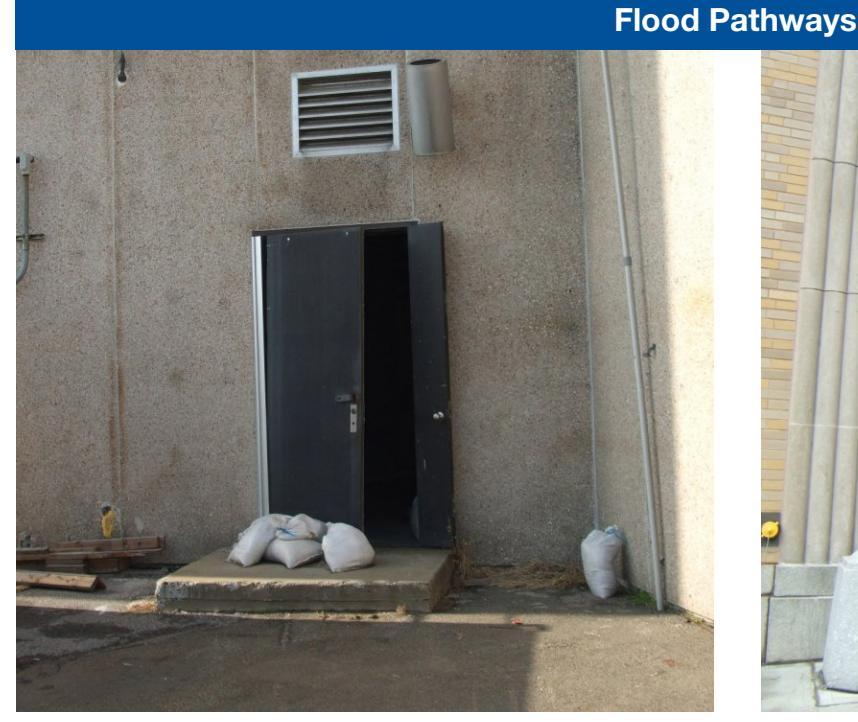
Access door leading to the equipment rooms in the Sludge Storage Tank Building
