**Public Notice Regarding Section 106 Review of
Proposed Supportive and Affordable Housing Project at 839 St. Marks Avenue, Brooklyn NY
Seeking Public Comment**

EXISTING CONDITIONS ASSESSMENT
for
839 ST. MARK'S AVENUE
CROWN HEIGHTS
BROOKLYN, NY 11213

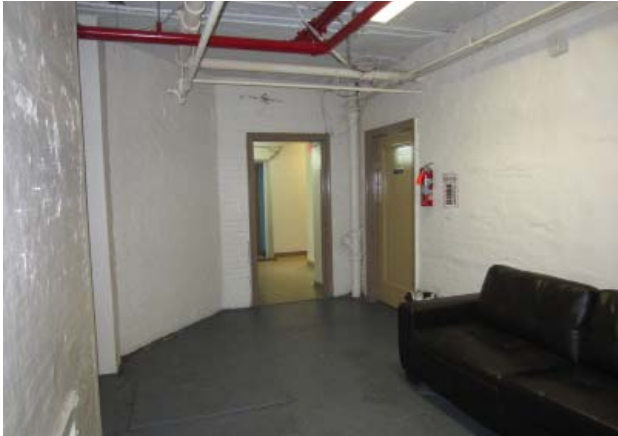
Fig. III-C-14 Room C05 Corridor

C05 Corridor	Poured concrete with painted blue/gray finish.	Painted white brick with some areas of plaster overtop of brick.	Painted metal.	N/A	Painted white plaster.	Hanging fluorescent fixtures.		N/A
Existing Condition	<i>Fair Condition with various areas of paint splatters and needs cleaning. There are areas of cracking and deterioration.</i>	<i>Fair Condition with soiling along bottom and several areas where coating is peeling. The plaster has detached in several areas exposing brick underneath.</i>	<i>Fair Condition with some areas of paint chipping.</i>	<i>N/A</i>	<i>Good Condition.</i>	<i>Good Condition.</i>		<i>N/A</i>

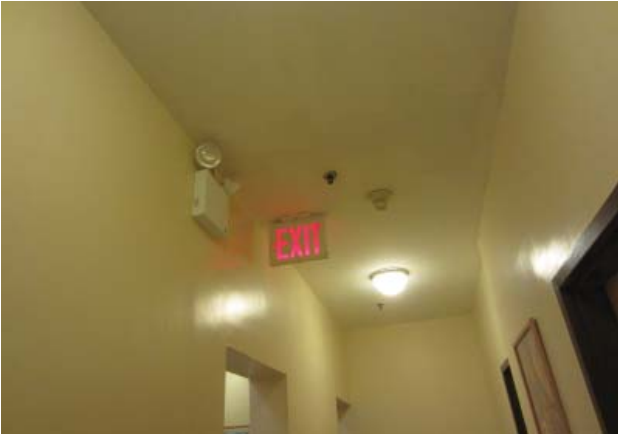
Fig. III-C-68 Room 205 Corridor ceiling

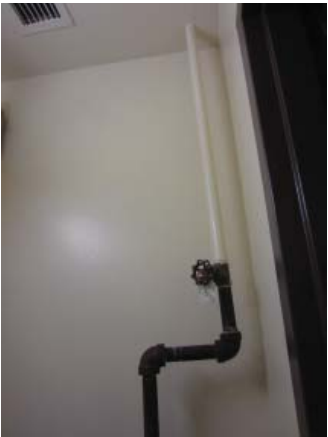
Fig. III-C-102 Room 217 Janitor's Closet pipe for utility sink

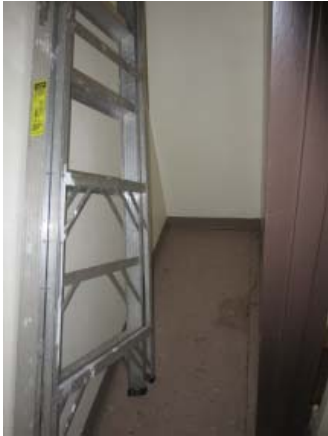
Fig. III-C-103 Room 218 Closet

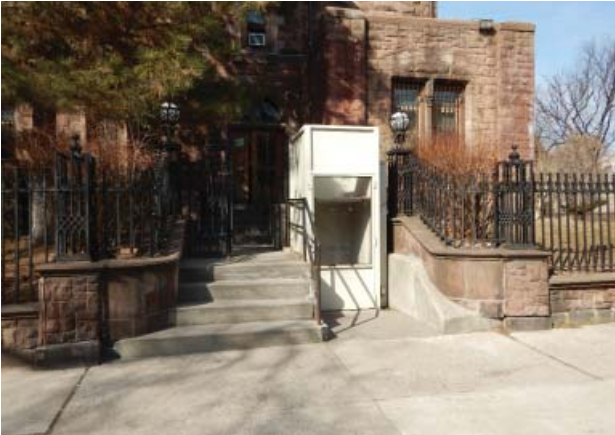
Fig. III-C-188 South Elevation handicap lift

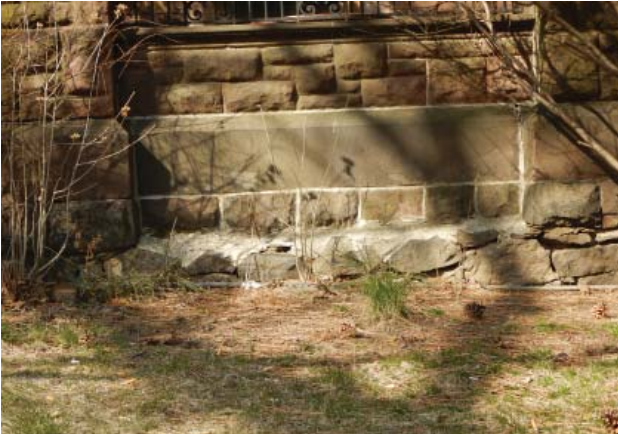
Fig. III-C-191 South Elevation water table detail

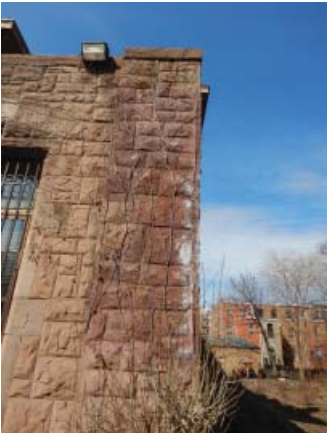
Fig. III-C-192 South Elevation detail of one story front projection

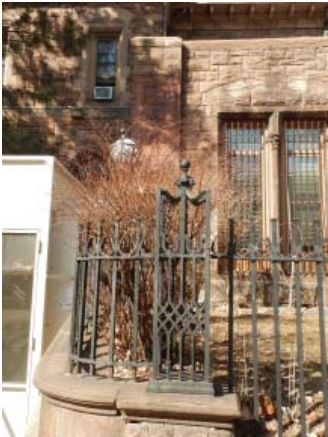
Fig. III-C-195 South Elevation detail of fence

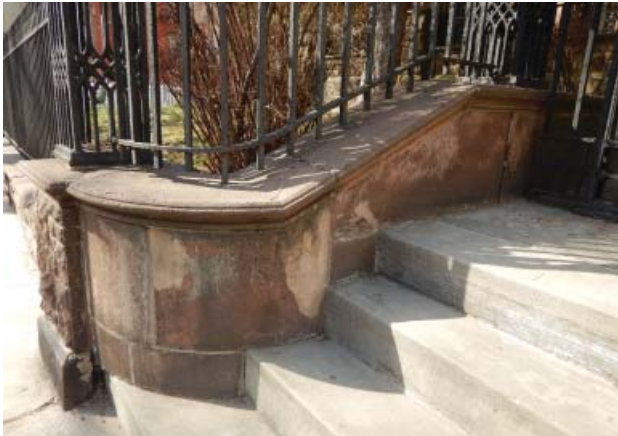
Fig. III-C-196 South Elevation detail of concrete steps and knee wall

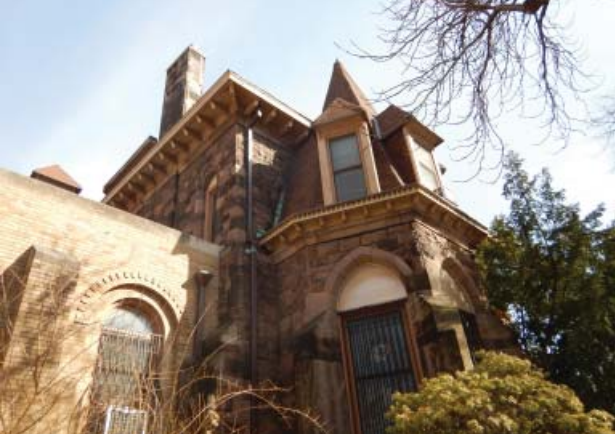
Fig. III-C-193 West Elevation bay projection

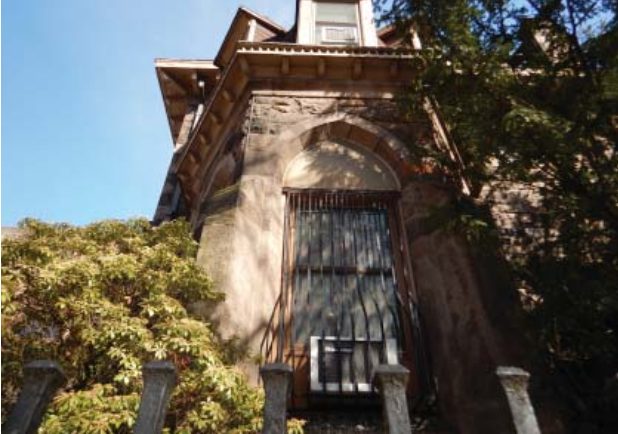
Fig. III-C-194 West Elevation bay window detail of Room 102

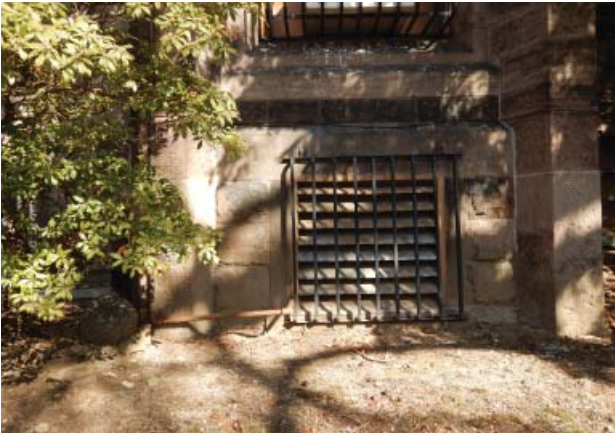
Fig. III-C-195 West Elevation window vent detail of Room C03

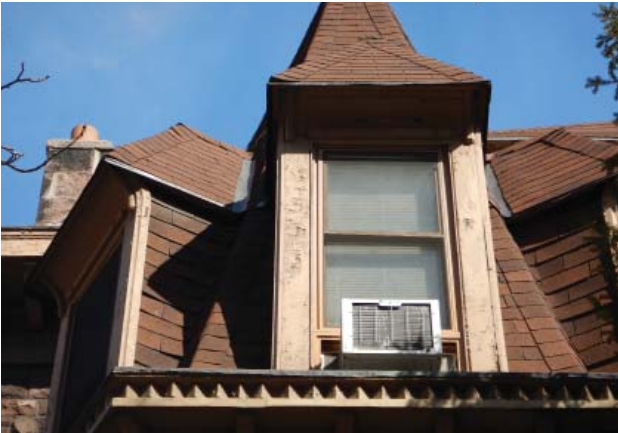
Fig. III-C-196 West Elevation bay projection detail
