# Saint Bartholomew's Church and Community House

**Landmarks Presentation for Restoration and Continued Maintenance**

Prepared for the Landmarks Preservation Commission

Acheson  
Doyle  
Partners Architects

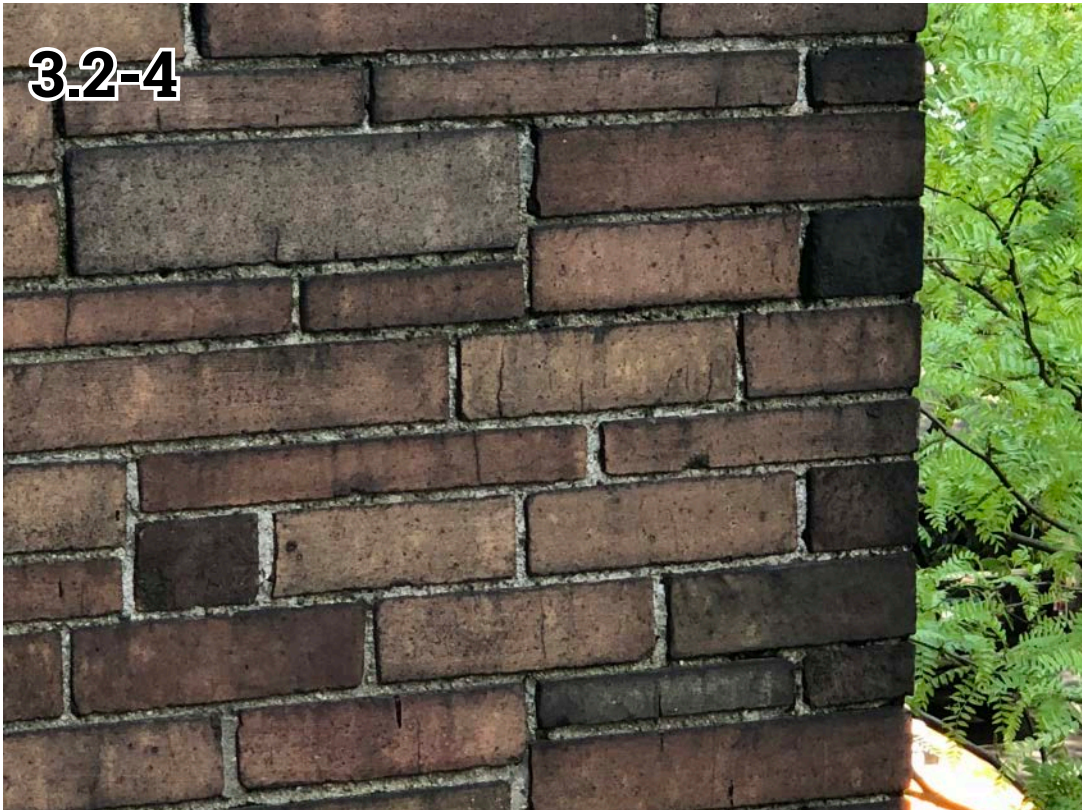
### 3.2-3 Heavily Deteriorated Mortar, Gallery Walk

- Internal Masonry Water Infiltration
- Mortar Joint Failure

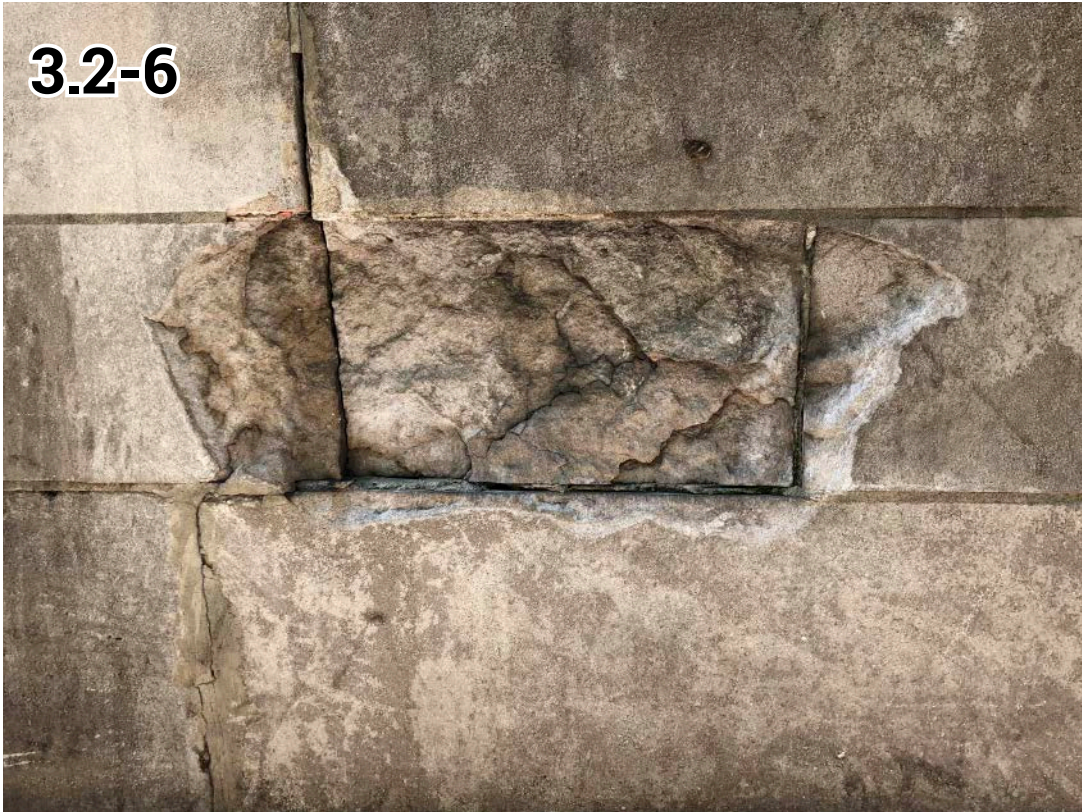
### 3.2-6 Cracked Limestone Wall

- Limestone Block Chipping and Spalling.
- Selective Repairs to be Considered
- General Masonry Cleaning Recommended

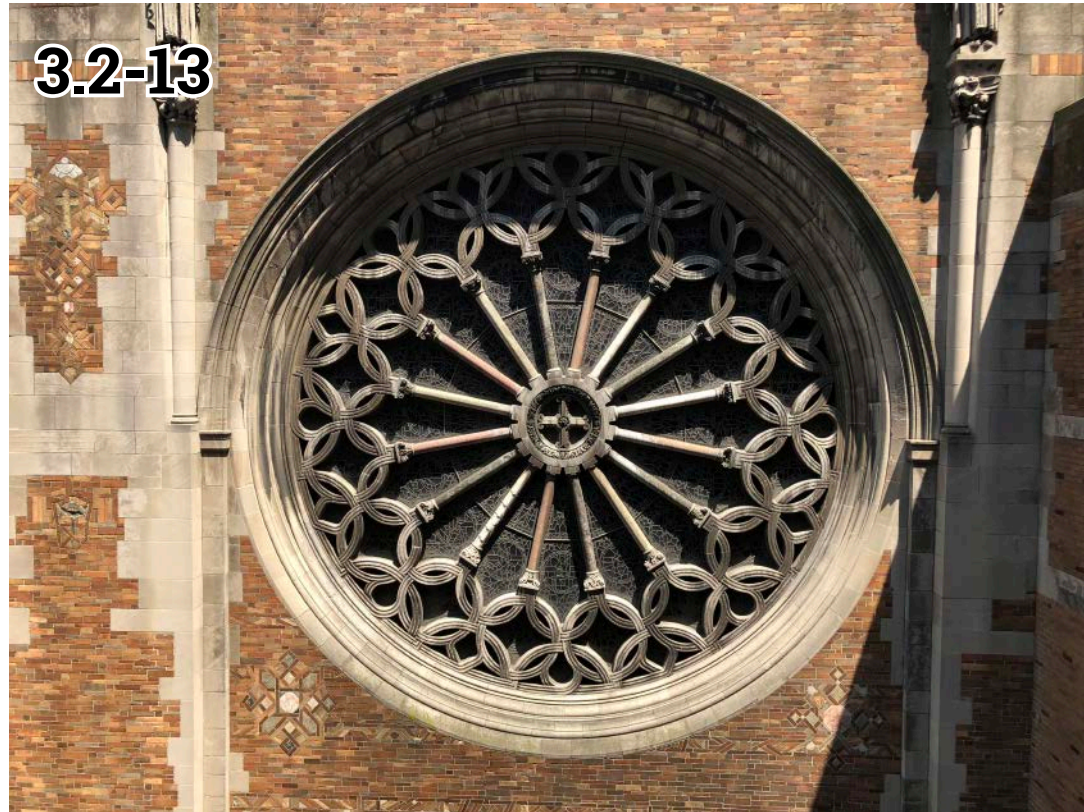
### 3.2-13 Rose Window

- Unprotected Stained Glass Window
- Minor Glazing and Mullion Deterioration
- Dirt and Debris Accumulation
- Damaged Stone Column
- Lack of Bird Deterrent Netting

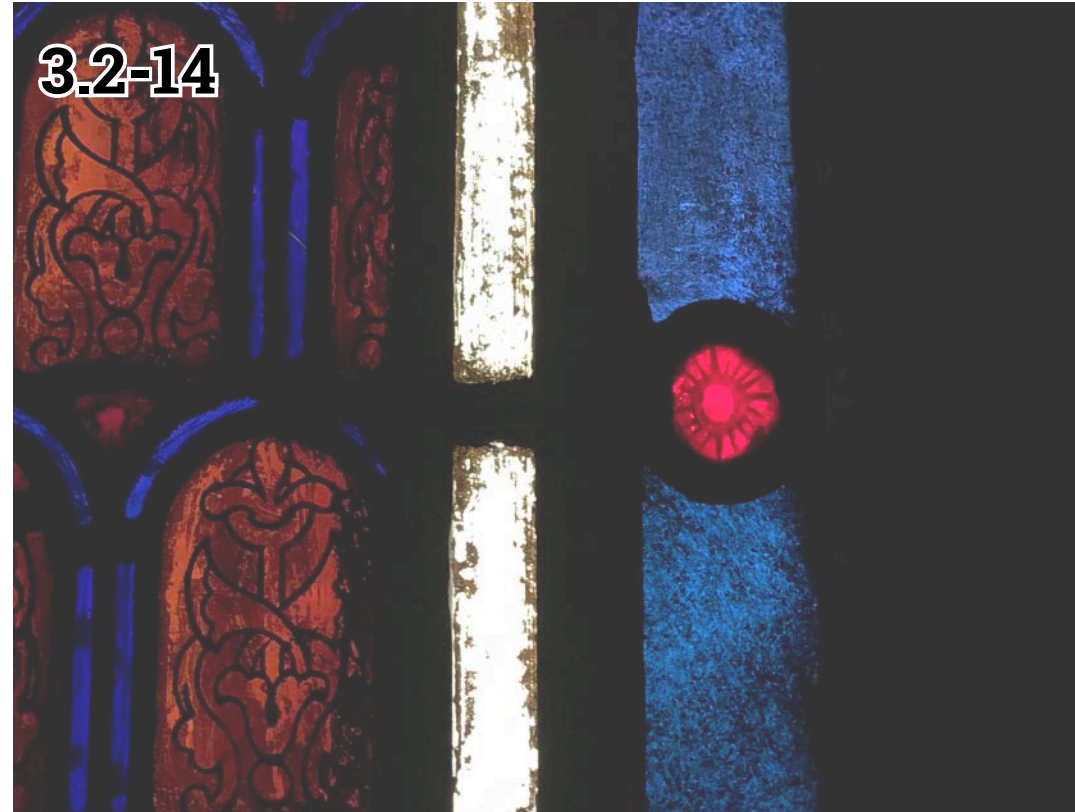
### 3.2-14 Stained Glass Window

Overall, the quality of the stained glass is in acceptable condition except for normal dirt and debris accumulation. The four main stained-glass windows were done by the famous female artist Hildreth Meiere with the rest by others.

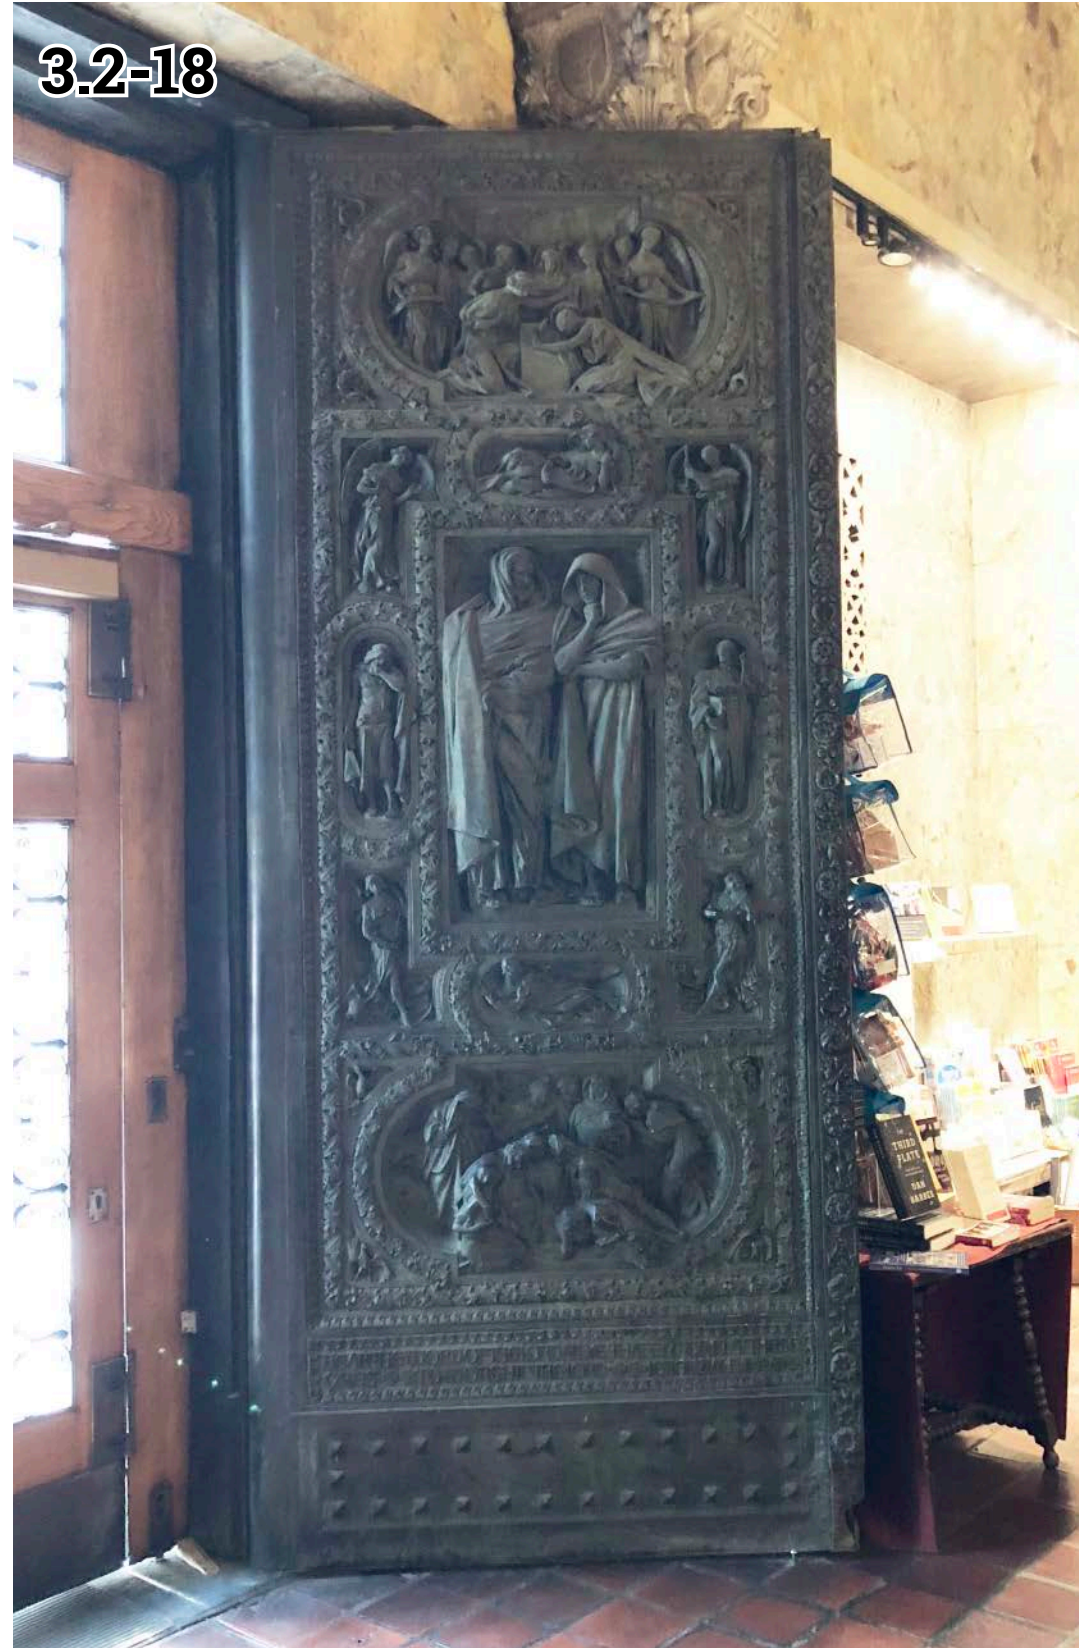
### 3.2-17 North Entrance Wood Doors

- Severe deterioration to both the natural wood and metal frame.
- Pocket operation no longer functions, and the movable frame is fixed in place.

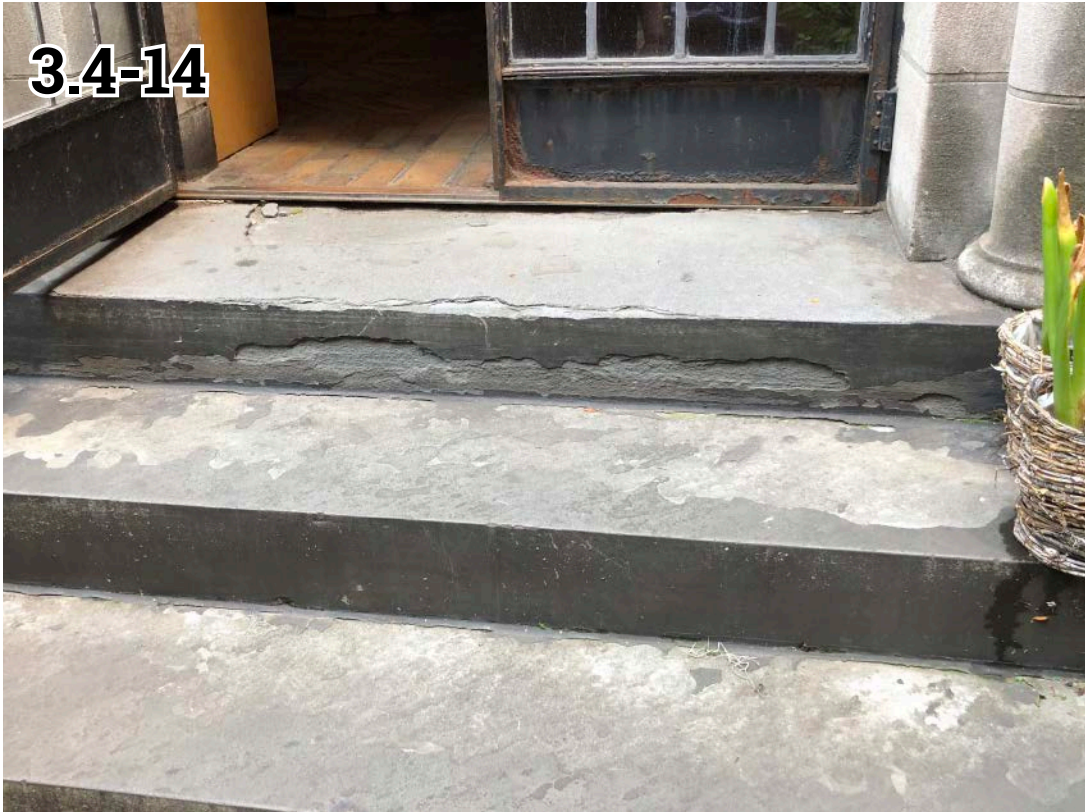
**3.4-14 Inner Courtyard**

- Spalling Stone Steps

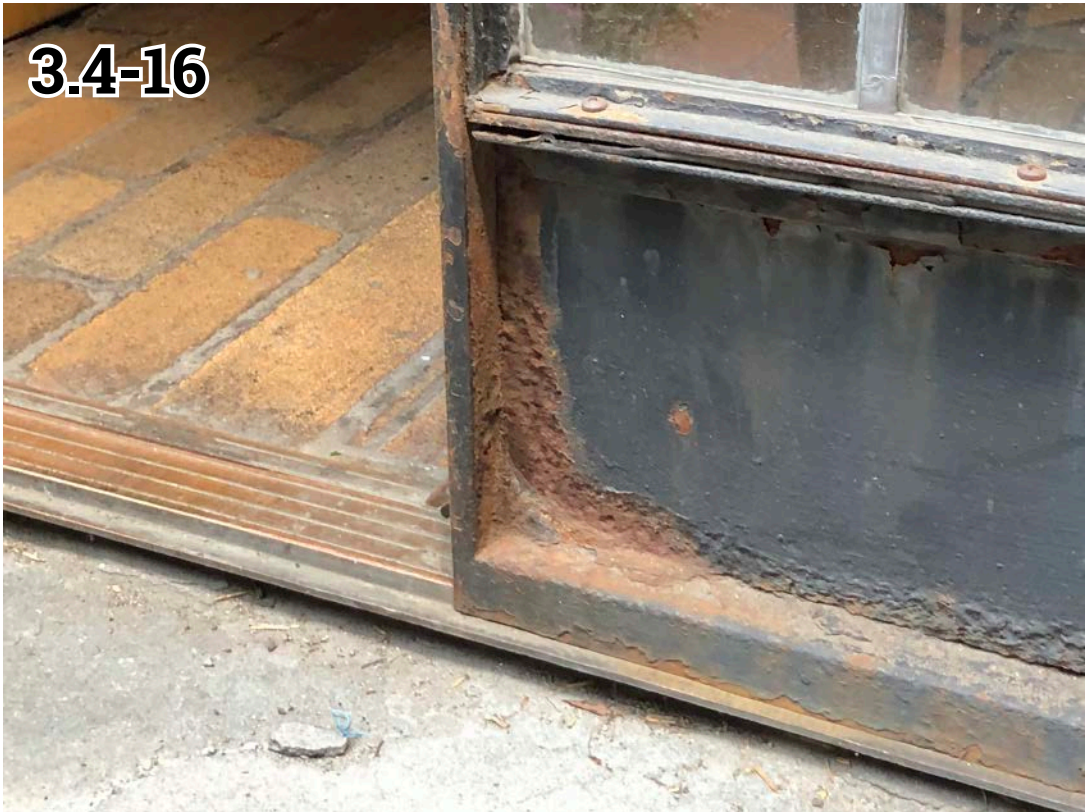
**3.4-15 Community House Entrance**

- Cracked Limestone

- Rusting Doors

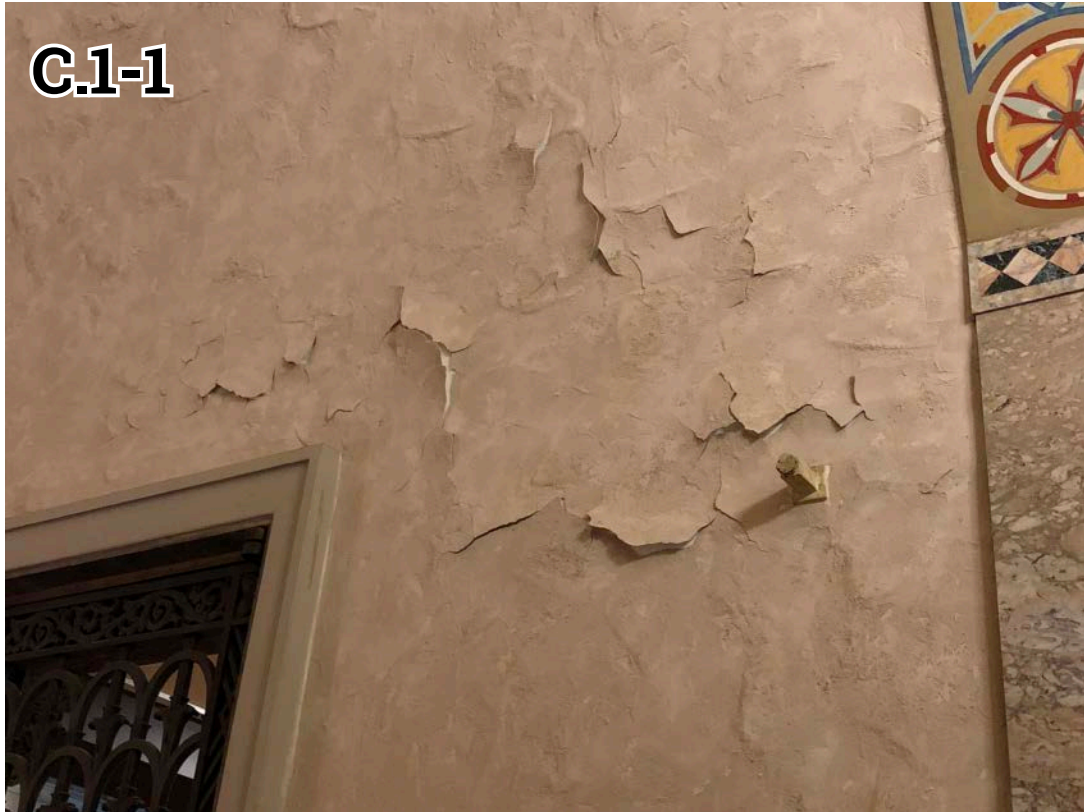
**C.1-1 Peeling Paint/Plaster**

- Peeling Paint/Plaster

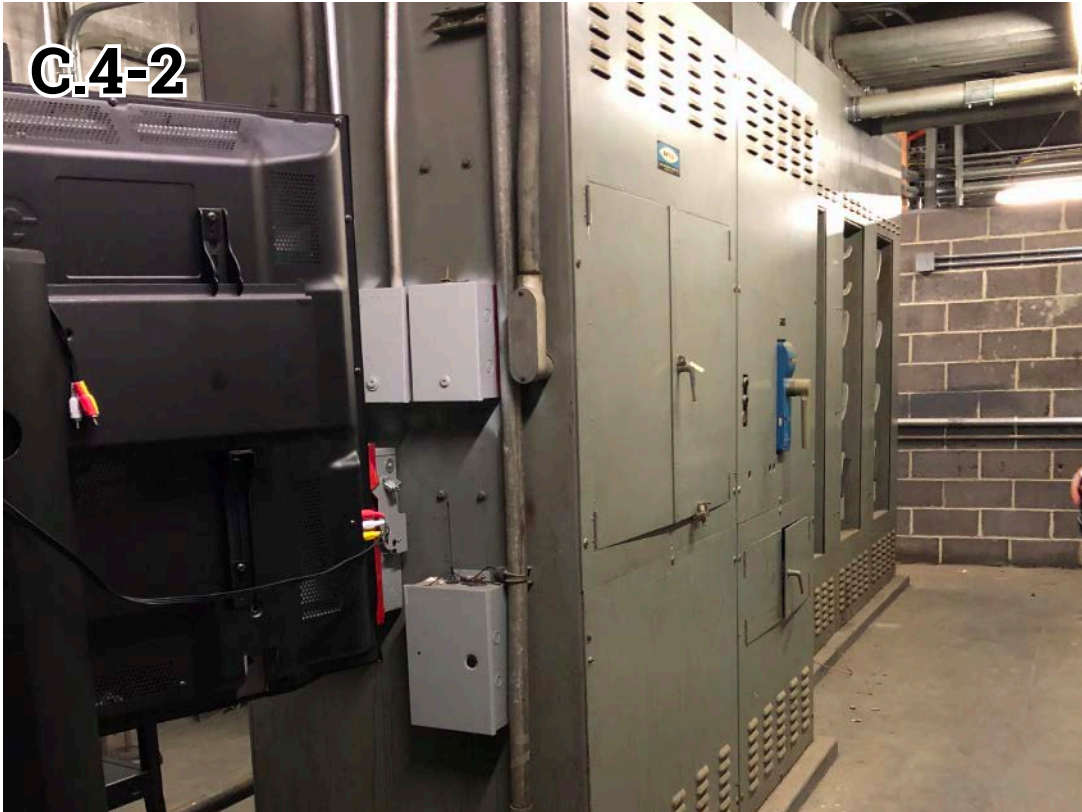
#### C.4-2 Electrical System

- Community House electrical distributed from church.
- Sub-metering to monitor Sub-tenant usage is not available.
- Branch circuit wiring, distribution panels, and devices are antiquated and in need of upgrades.
