**Preservation Department – Item 9, LPC-22-07597**

**270 West 89th Street – Riverside - West End Historic District**  
**Borough of Manhattan**

# B'NAI JESHURUN COMMUNITY HOUSE FIRE-RATED AND LOT-LINE WINDOW REPLACEMENT

REVISION#2 September 12<sup>th</sup>, 2022

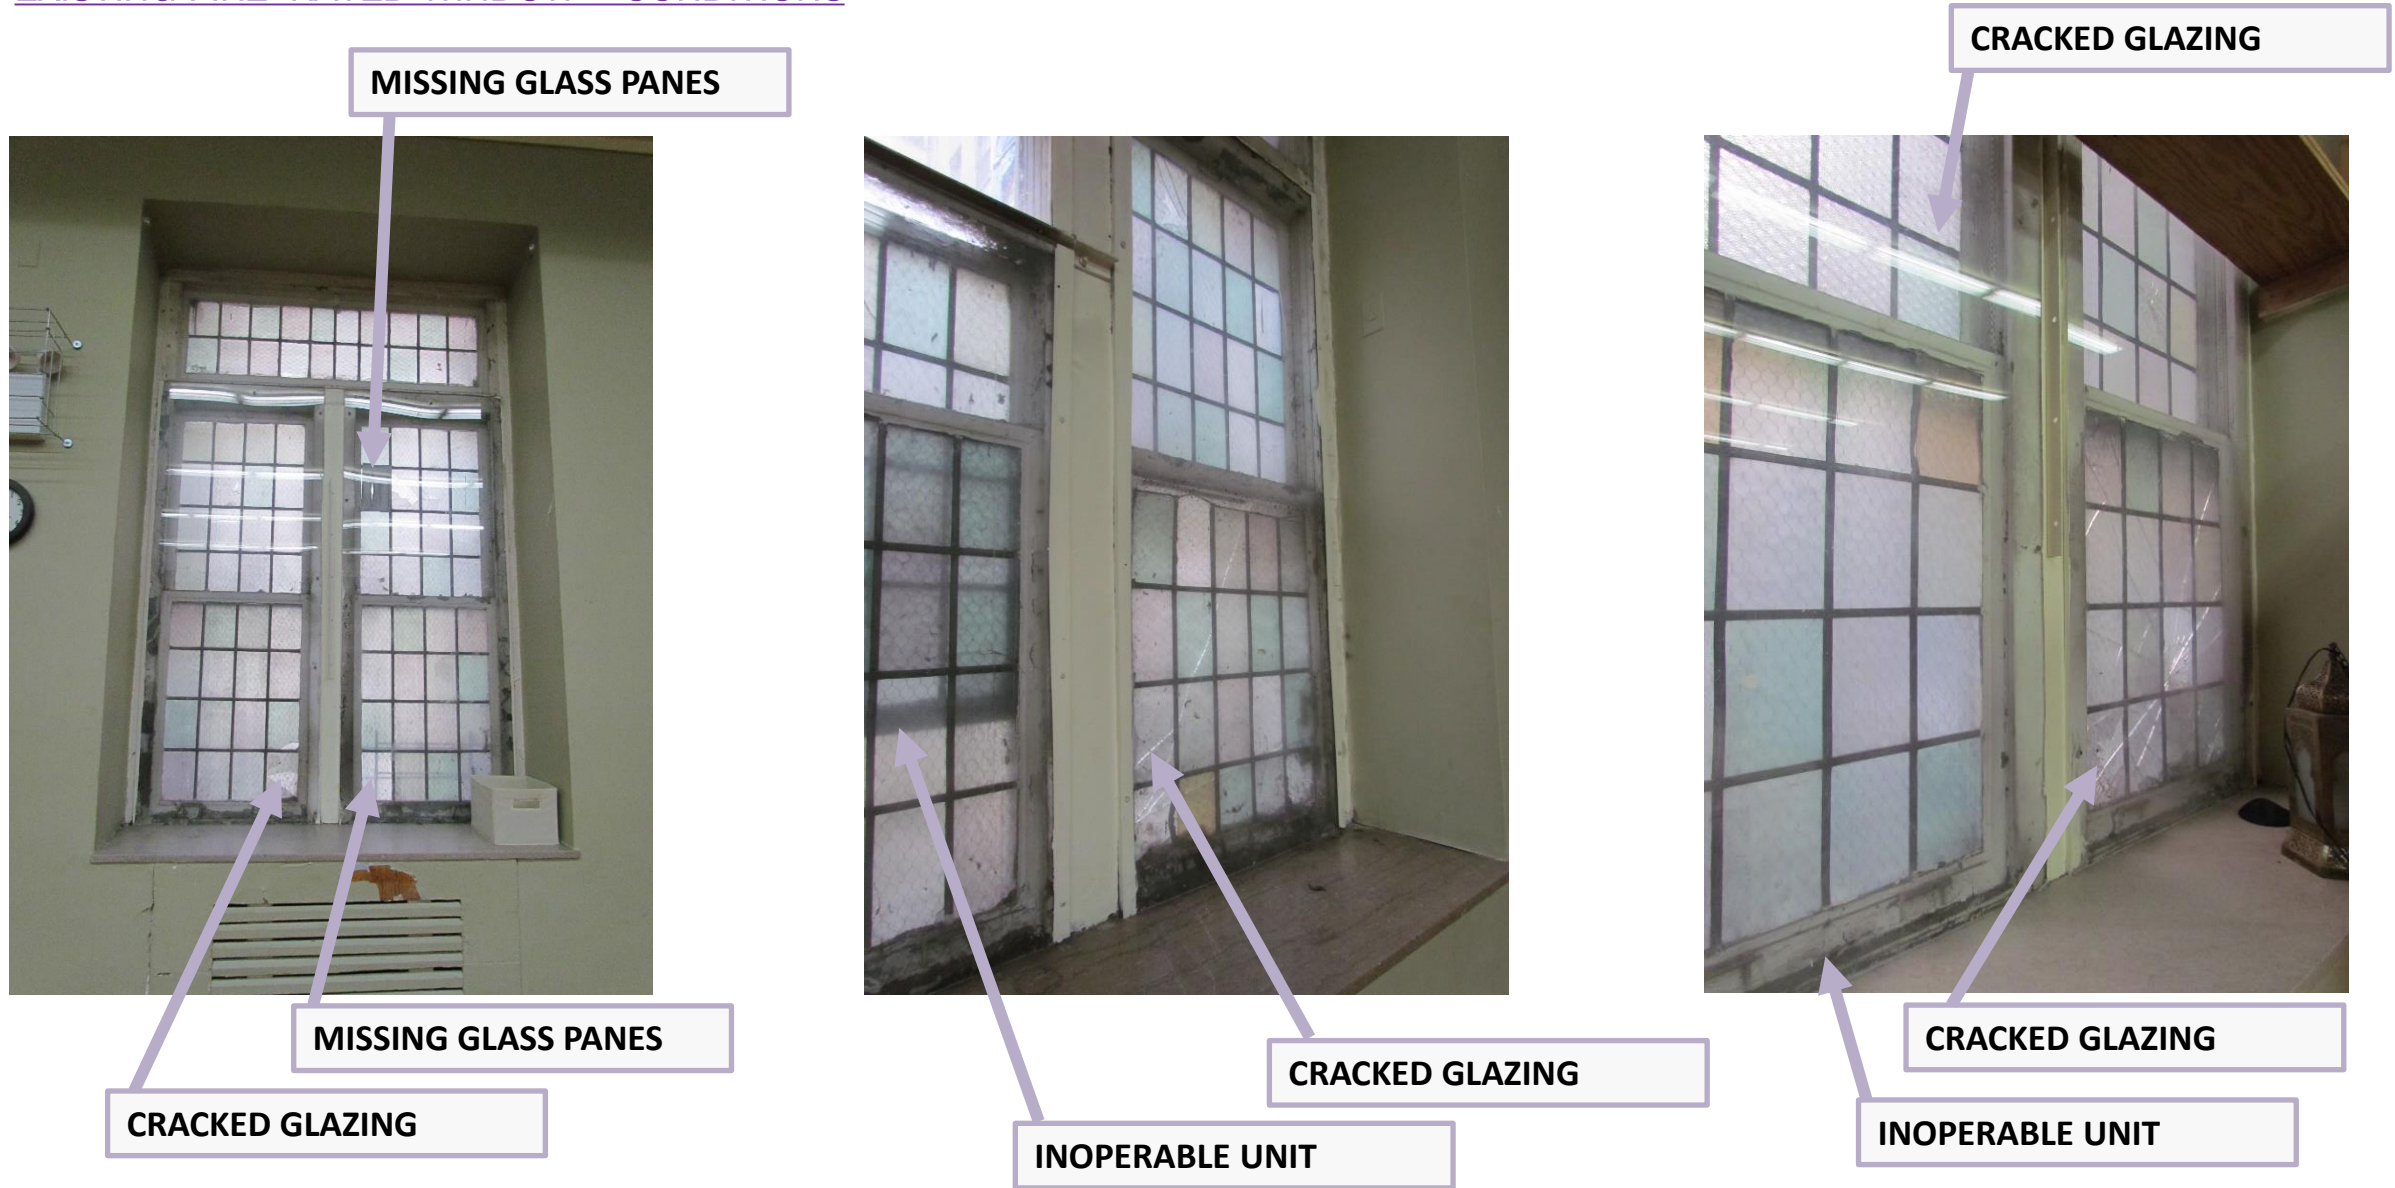
## EXISTING FIRE-RATED WINDOW – CONDITIONS

**CRACKED GLAZING**

**INOPERABLE UNIT**

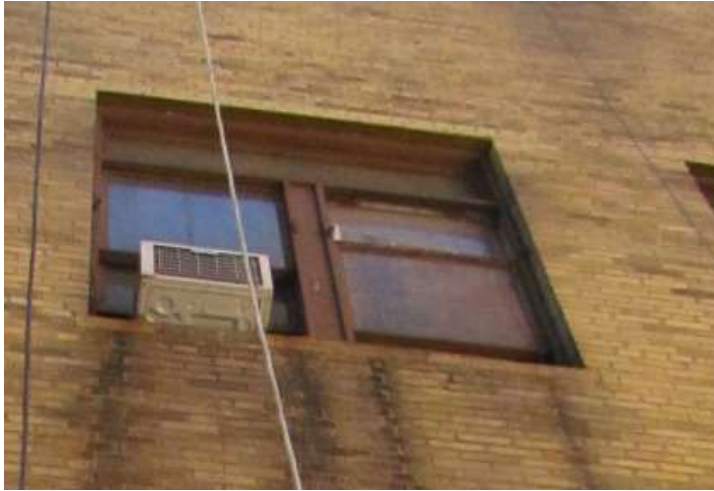
**Photo 20:**

ST9 existing conditions, exterior.

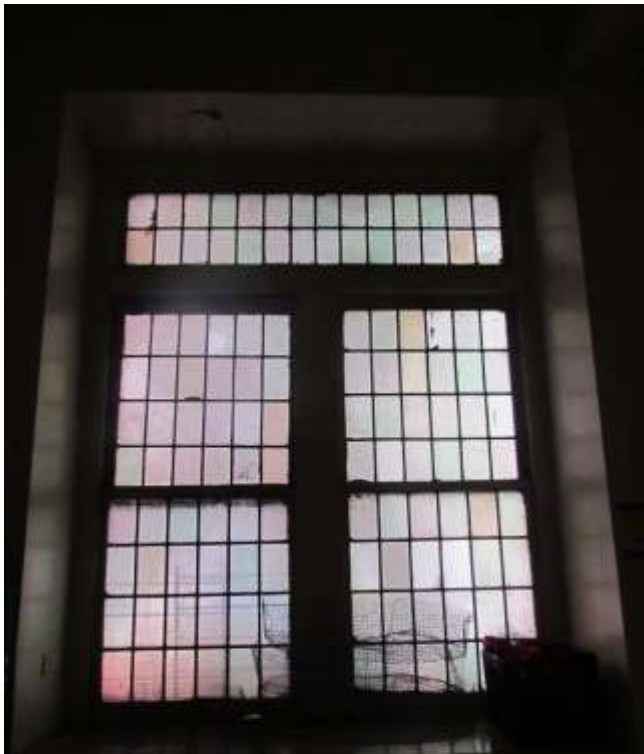
**Photo 21:**

ST9 existing conditions, interior.

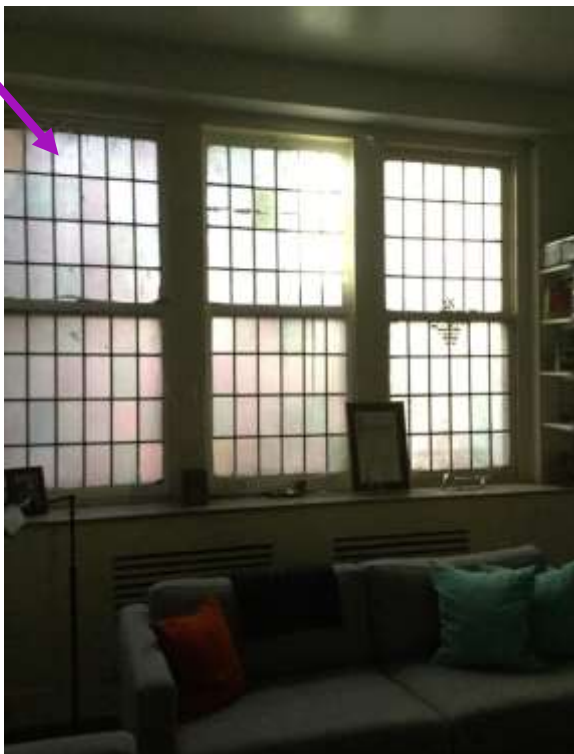
**Photo 28:**

ST28-2 existing conditions, interior:  
Cracked colored lites, gaps present  
between frame and sash (plastic  
adhered to mitigate draft)

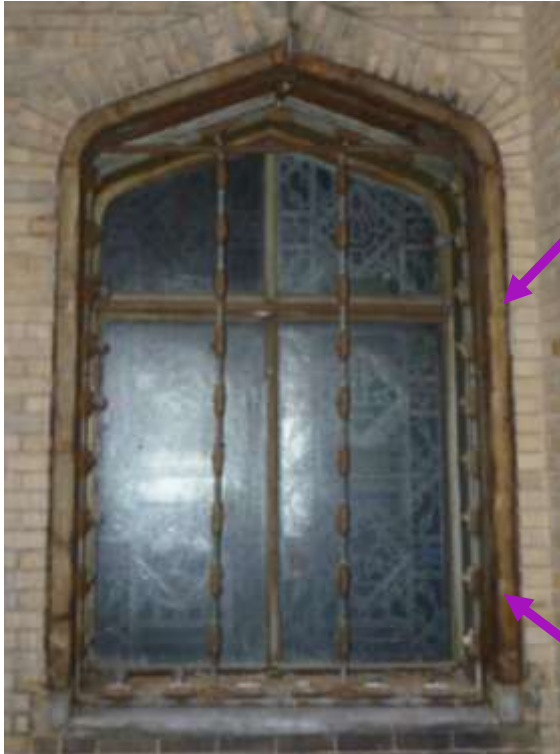
**Photo 29:**

ST51-1 existing conditions, exterior.  
Deteriorated exterior frame,  
corrosion present.

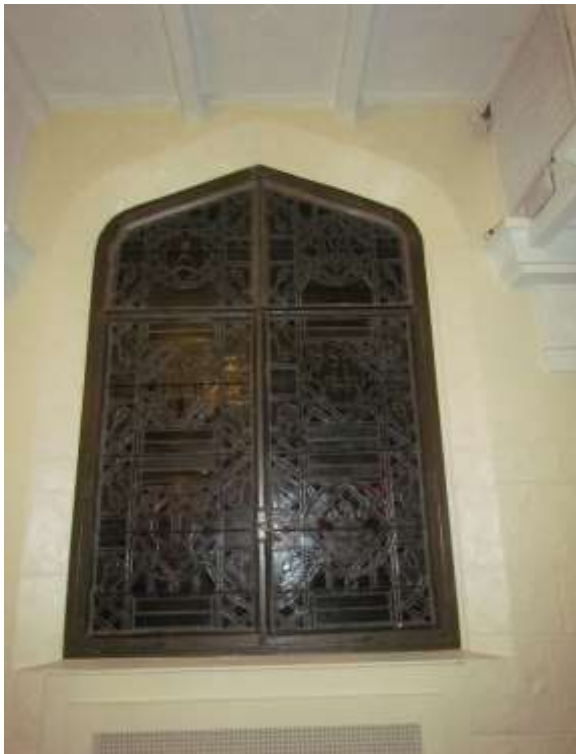
**Photo 30:**

ST51-1 existing conditions, interior.

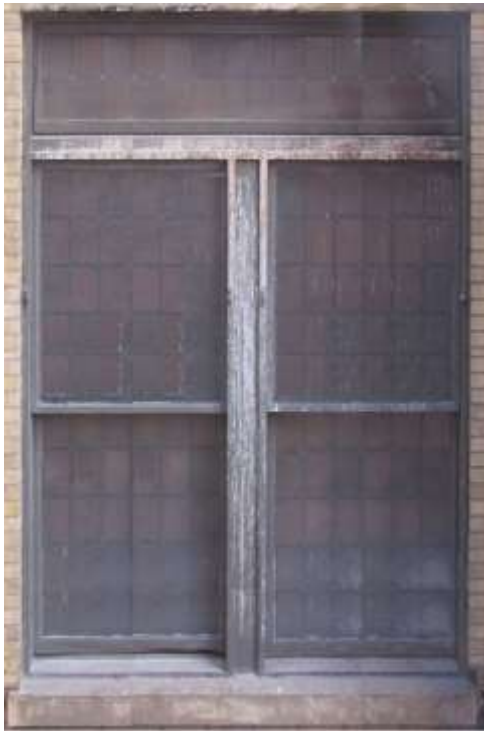
**Photo 31:**

ST1 existing conditions, exterior.

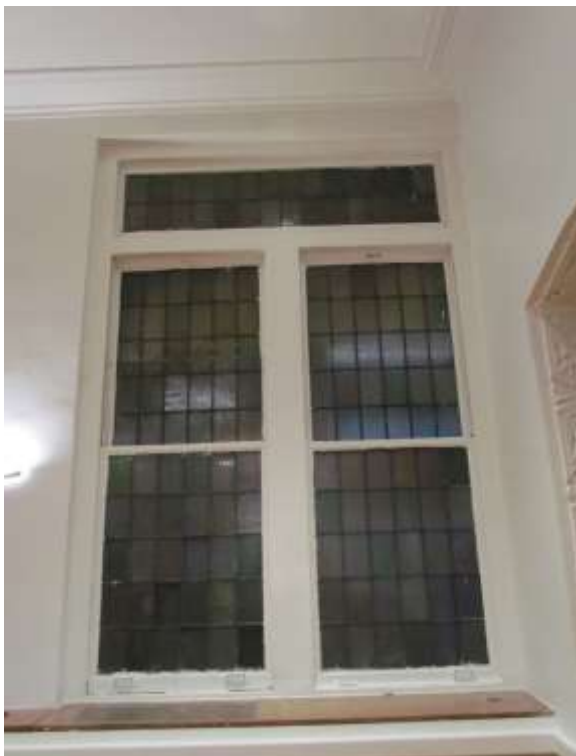
**Photo 32:**

ST1 existing conditions, interior.

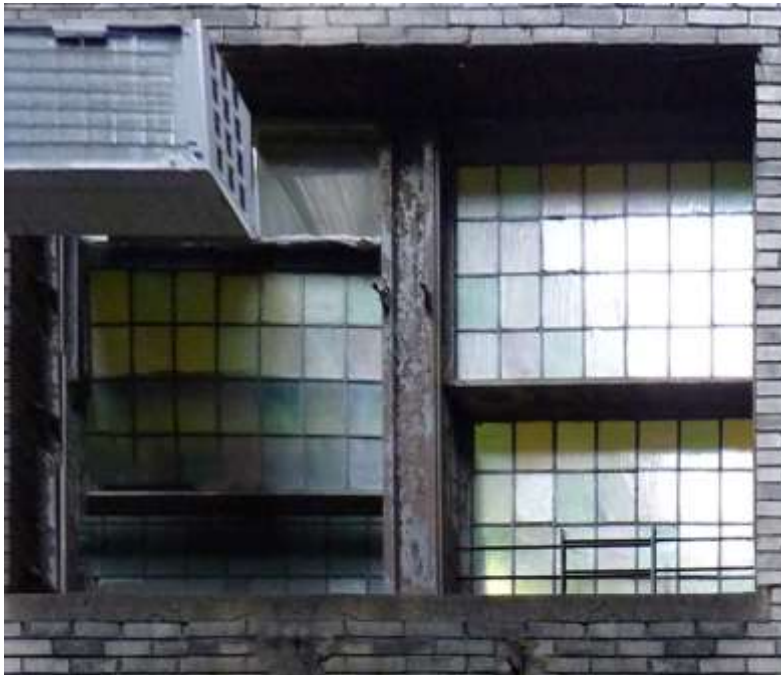
**Photo 36:**

ST3 existing conditions, exterior.

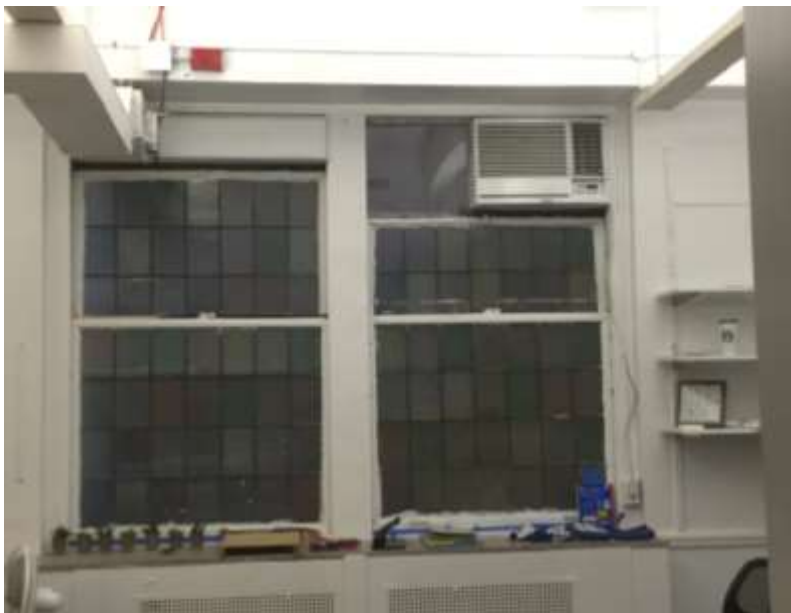
**Photo 37:**

ST3 existing conditions, interior.

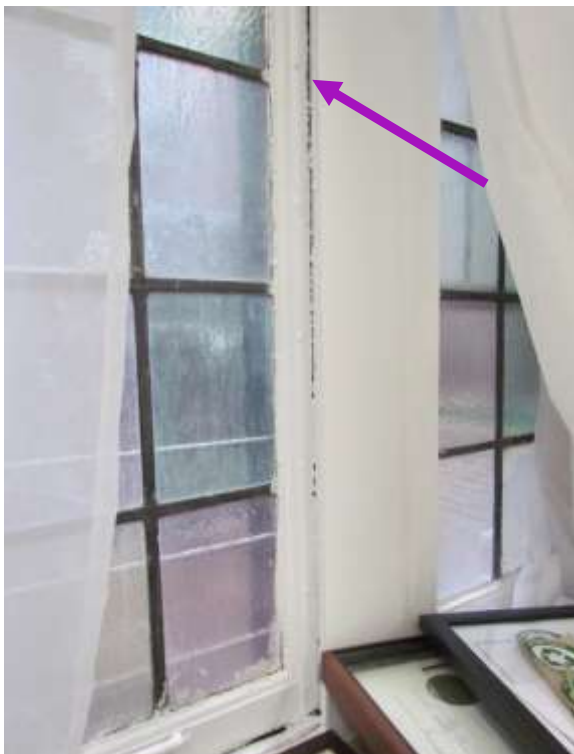
**Photo 39:**

ST3-2 existing conditions, interior:  
Gaps present at sash perimeter.

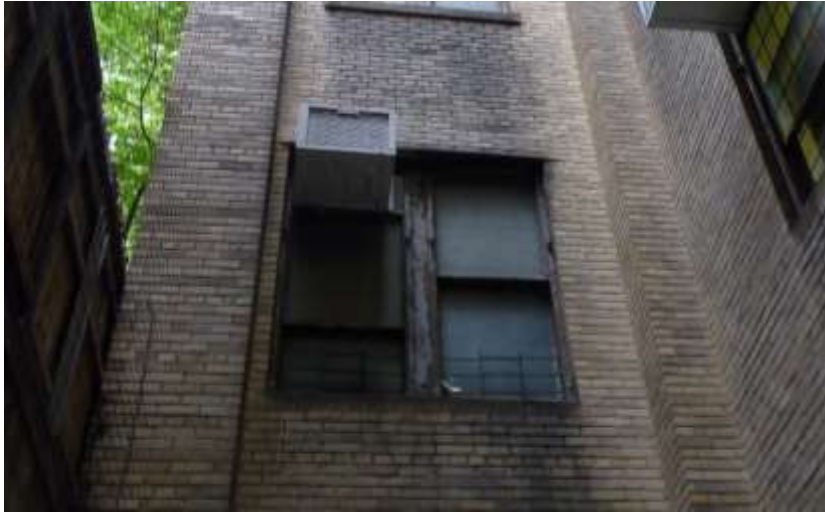
**Photo 40:**

ST4 existing conditions, exterior.

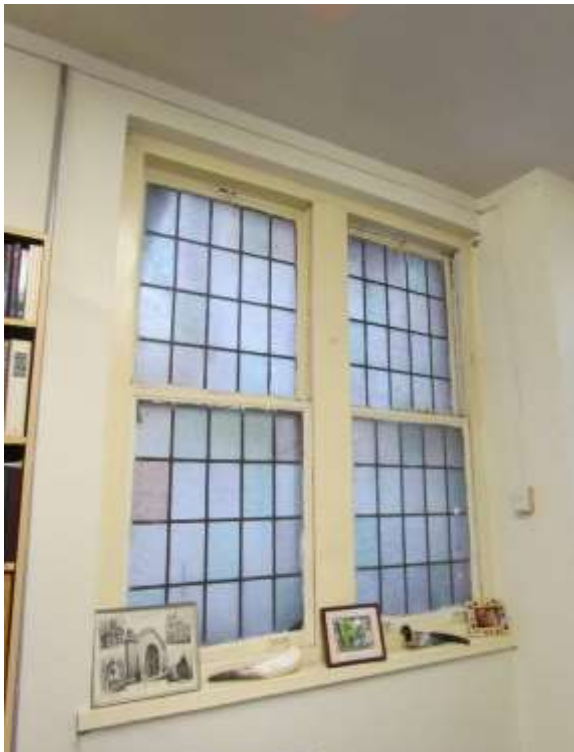
**Photo 41:**

ST4 existing conditions, interior.

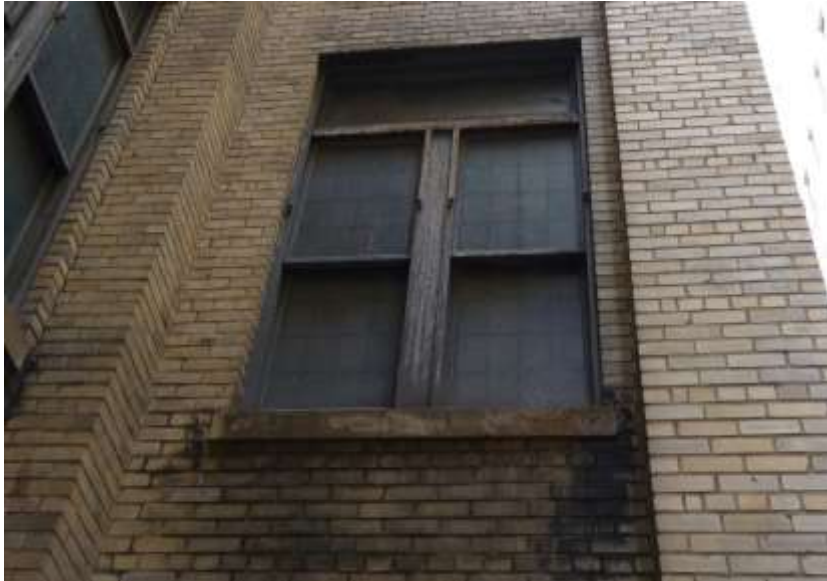
**Photo 44:**

ST6-1 existing conditions, exterior.

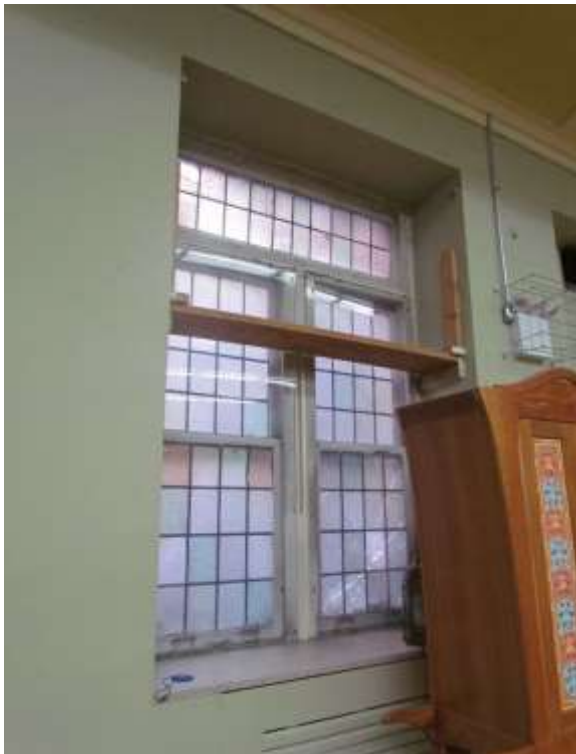
**Photo 45:**

ST6-1 existing conditions, interior.

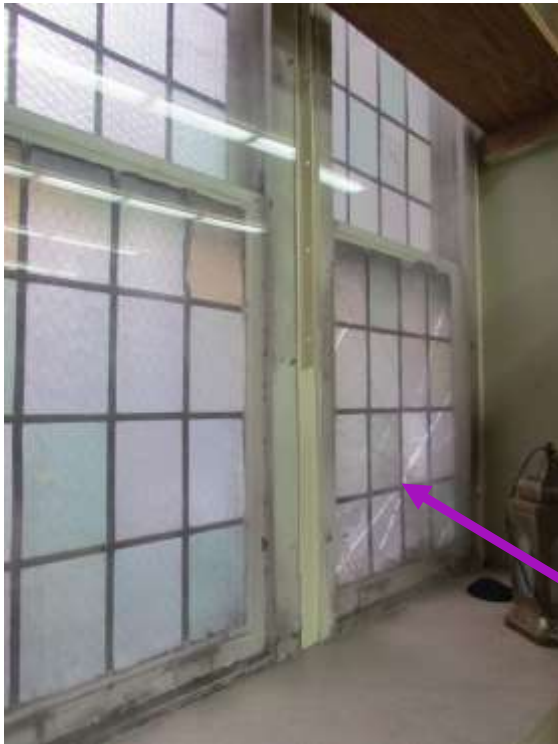
**Photo 46:**

ST6-1 existing conditions, interior.  
Cracked glass at sash and colored  
lites at lower sash.

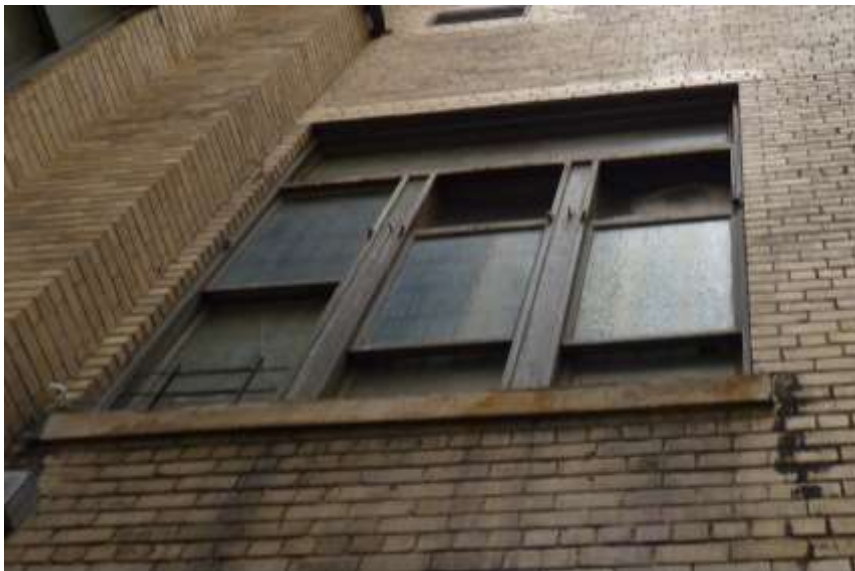
**Photo 47:**

ST7-1 existing conditions, exterior.

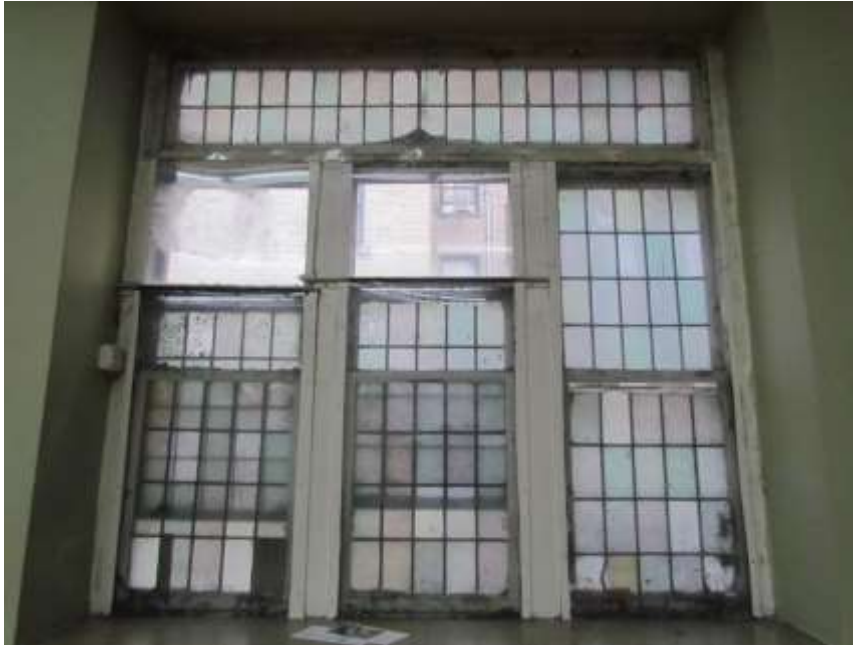
**Photo 48:**

ST7-1 existing conditions, interior:  
Replacement sashes installed.

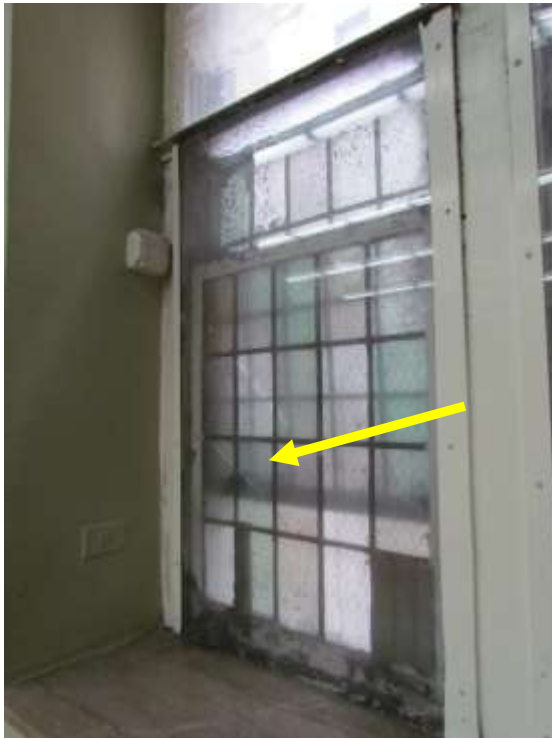
**Photo 50:**

ST7-1 existing conditions, interior:  
Deteriorated frames and sashes,  
cracked glass lites at lower sash.

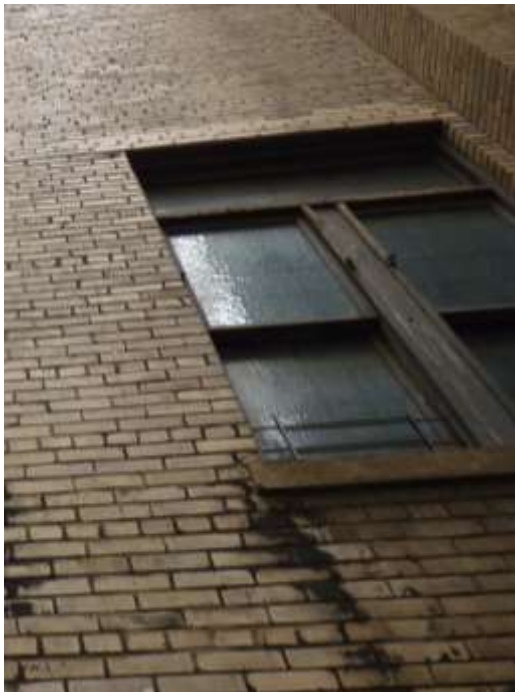
**Photo 51:**

ST8-1 existing conditions, exterior.

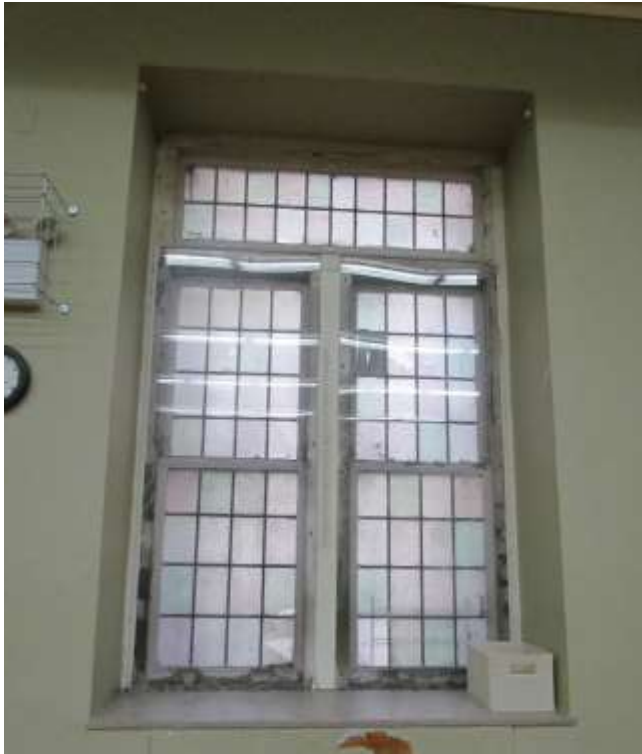
**Photo 52:**

ST8-1 existing conditions, interior.

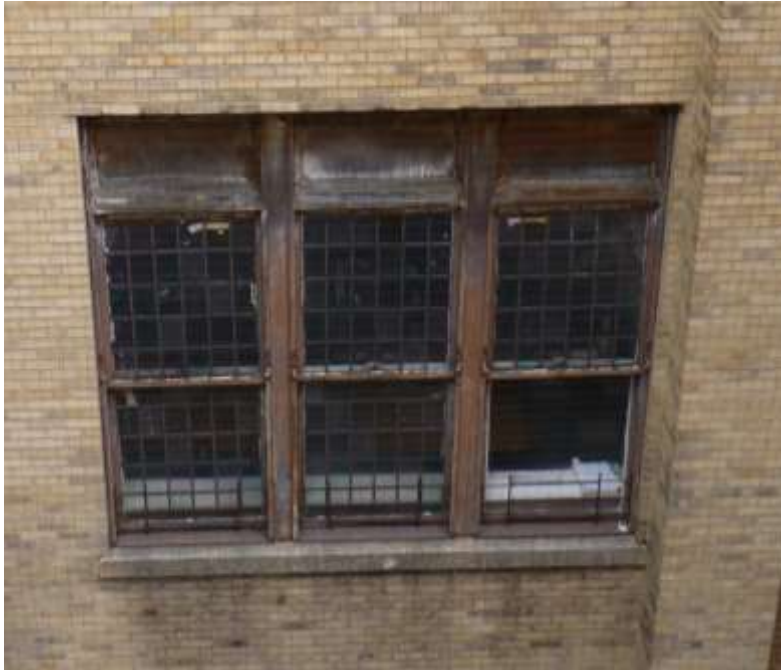
**Photo 54:**

ST11 existing conditions, exterior.

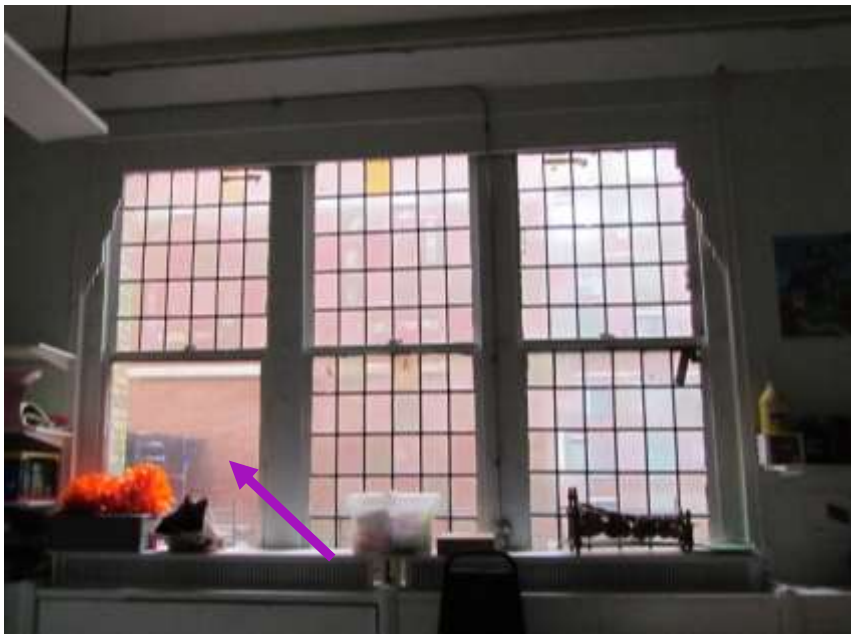
**Photo 55:**

ST11 existing conditions, interior:  
Replacement sash installed.

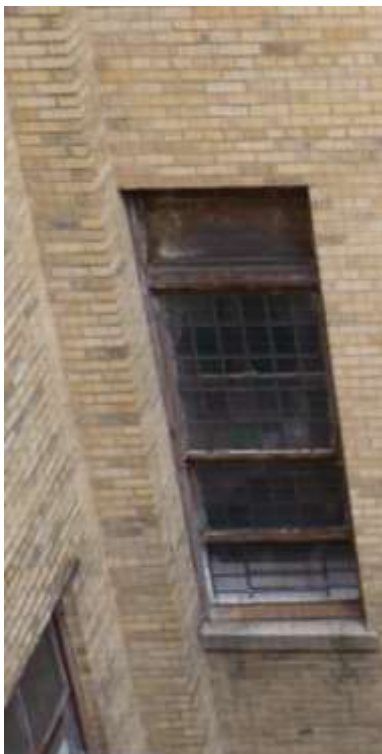
**Photo 57:**

ST12 existing conditions, exterior.

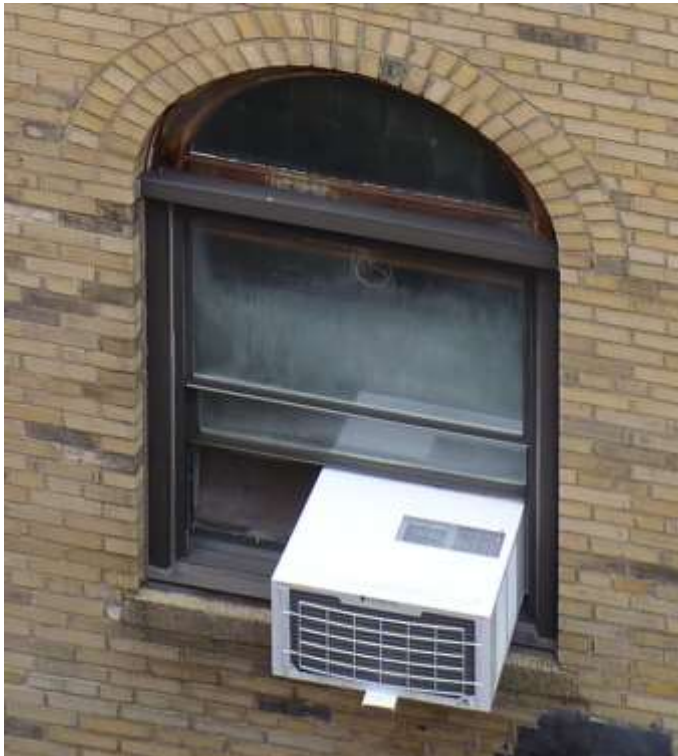
**Photo 59:**

ST30-2 existing conditions, exterior.

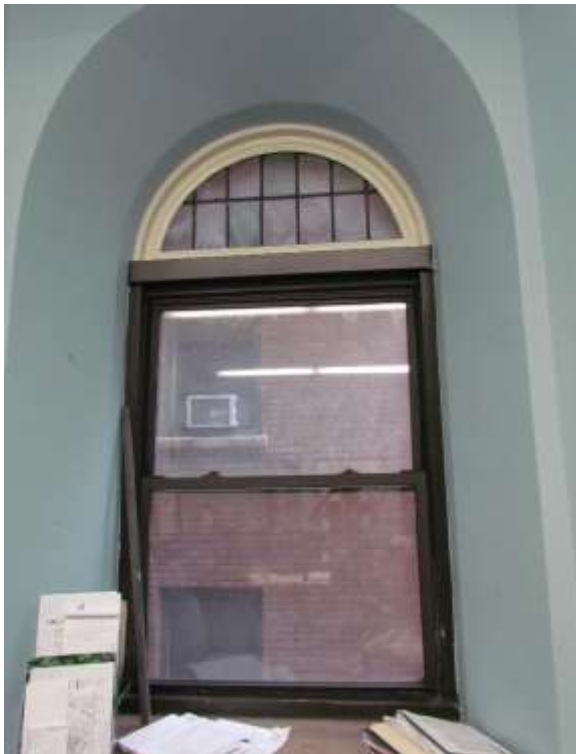
**Photo 60:**

ST30-2 existing conditions, interior.

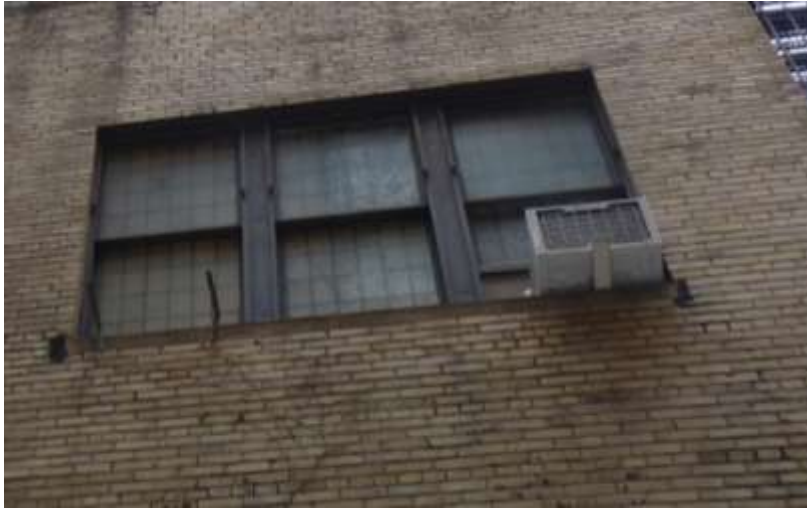
**Photo 63:**

ST28 existing conditions, exterior.

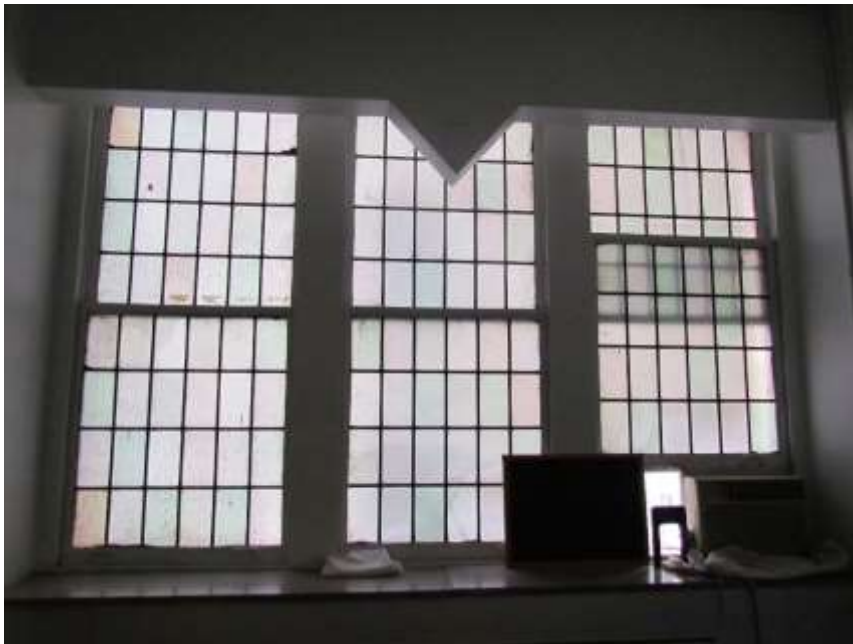
**Photo 64:**

ST28 existing conditions, interior.

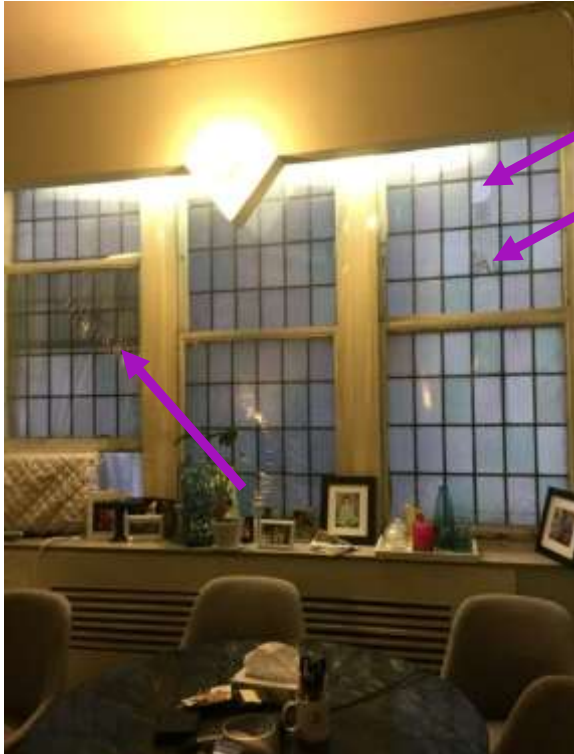
**Photo 65:**

ST27-3 existing conditions, interior:  
Cracked colored lites, gaps present  
between frame and sash (plastic  
adhered to mitigate draft).

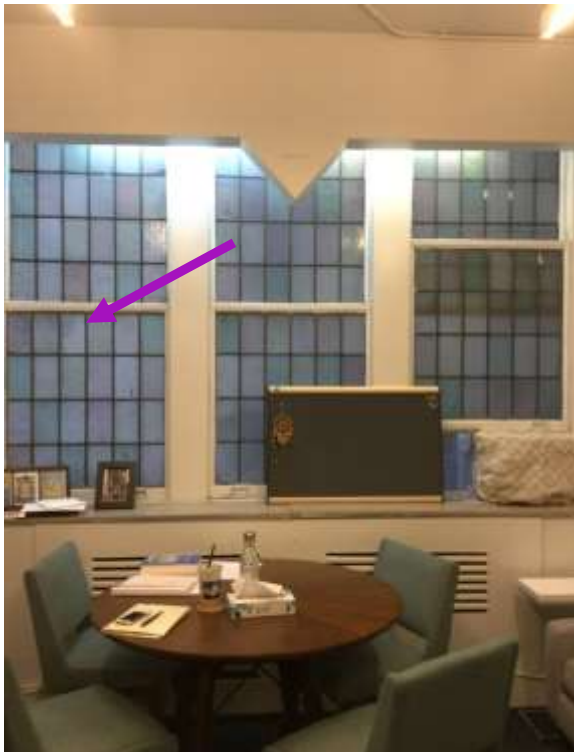
**Photo 66:**

ST27-4 existing conditions, interior:  
Deteriorated frames and sashes,  
cracked and broken colored glass  
lites.

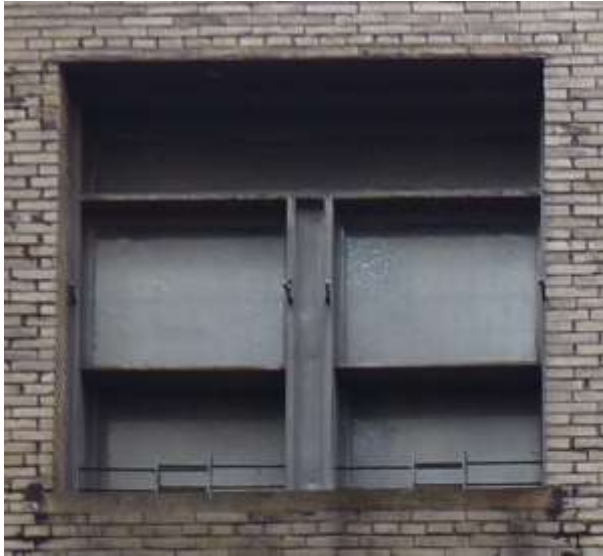
**Photo 67:**

ST27 existing conditions, exterior.

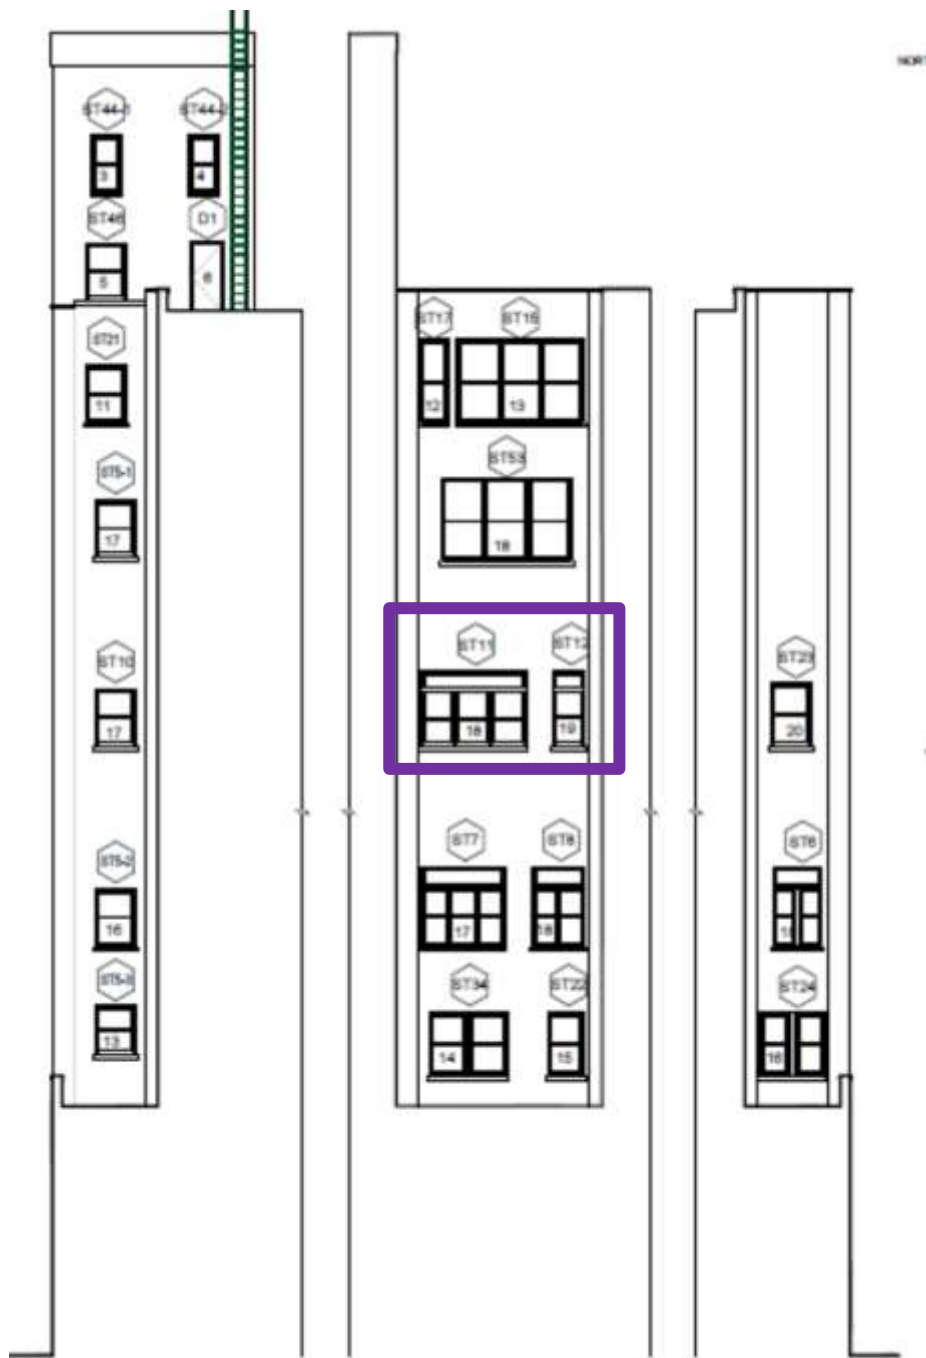
**Photo 73:**

ST8-2 existing conditions, interior:  
Deteriorated frames and sashes,  
cracked glass lites, some missing  
completely.

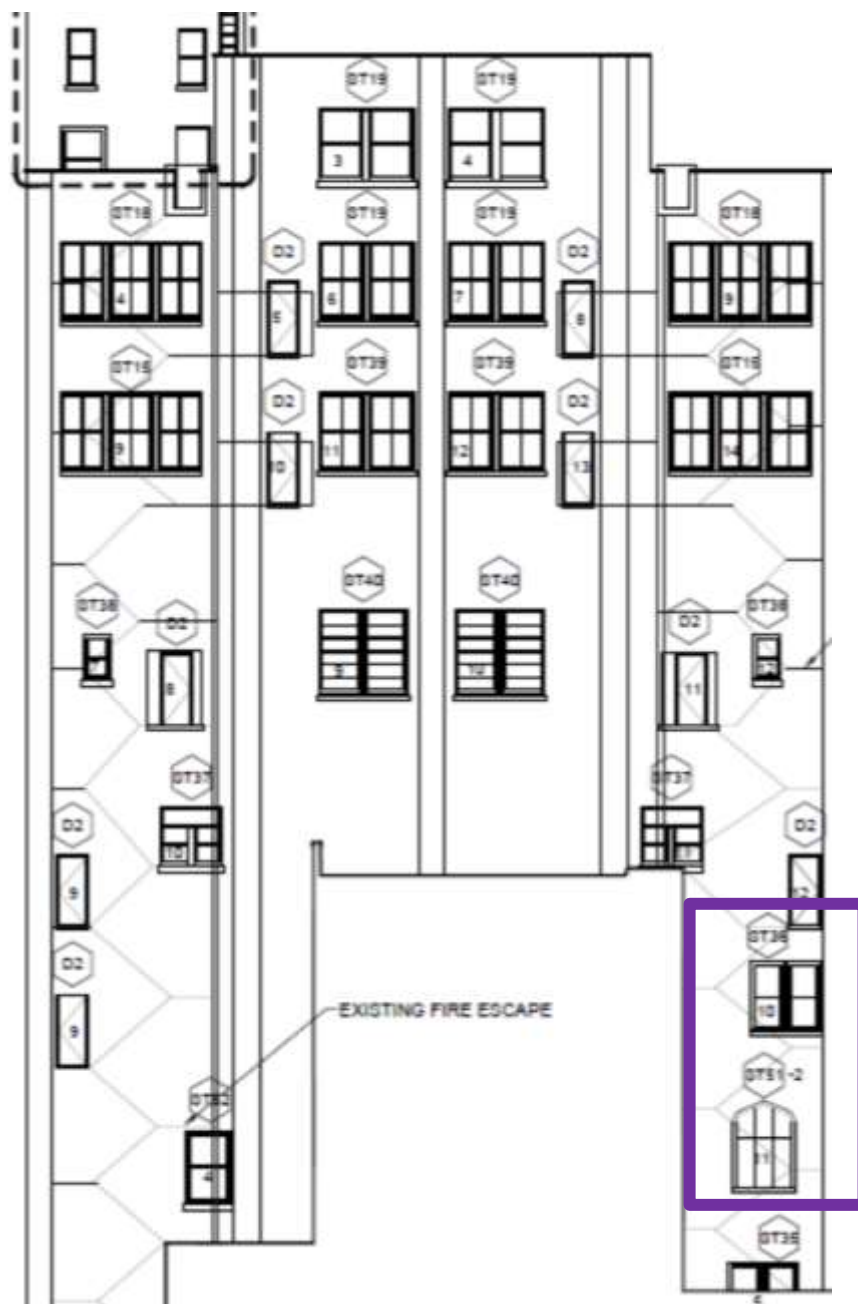
**Photo 75:**

ST12 existing conditions, interior:  
Deteriorated frames and sashes,  
cracked glass lites, some missing  
completely.

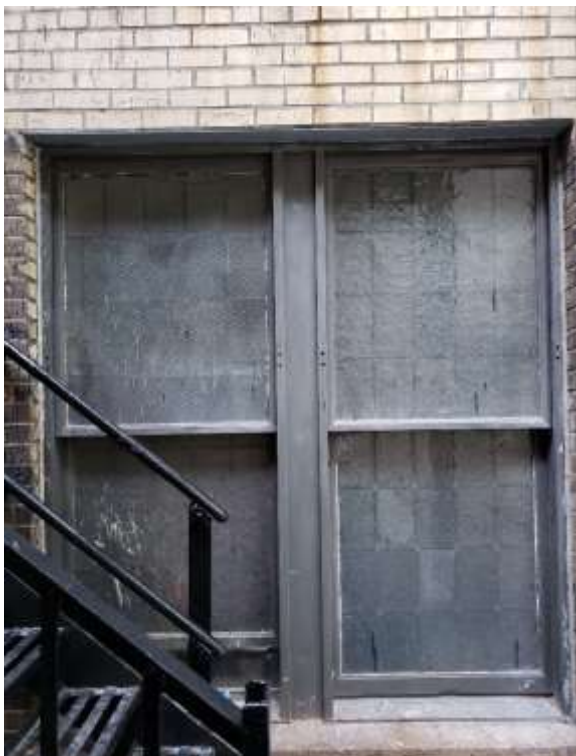
ST51-2 existing conditions, interior:  
Deteriorated exterior frame,  
corrosion present.

Note: exterior window covered by  
metal louver, to be removed during  
current façade repair campaign.

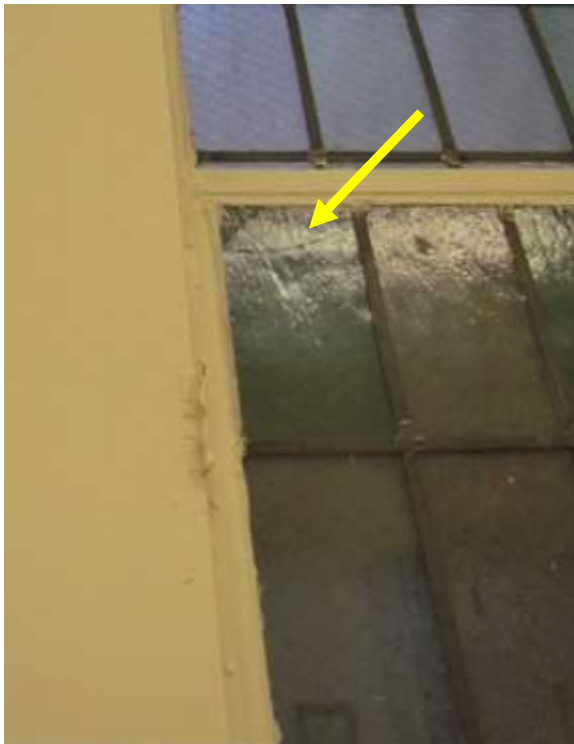
**Photo 78:**

SC1 existing conditions, interior.
