Preservation Department – Item 2, LPC-23-02975

**112 2nd Avenue – East Village/Lower East Side Historic District
Borough of Manhattan**

SUPPLEMENTAL PRESENTATION IN SUPPORT OF MCC APPLICATION

MIDDLE COLLEGIATE CHURCH

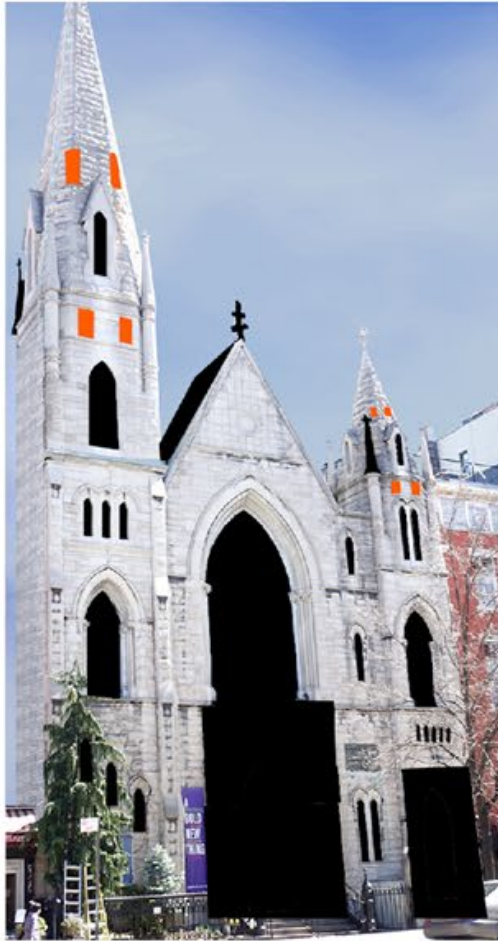
MINIMUM OF MATERIALS DESTROYED IN FIRE
OR REQUIRED TO BE REMOVED FOR EGRESS
AND SITE ACCESS OF EQUIPMENT

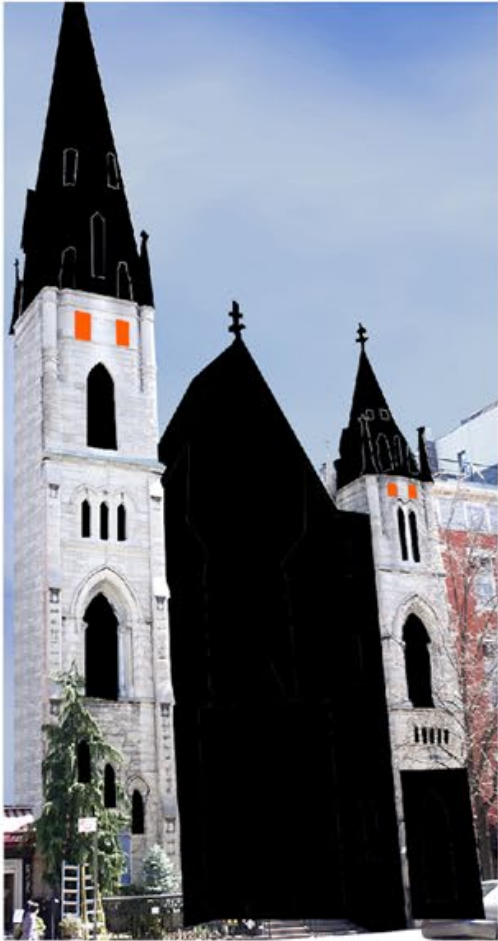
MINIMUM OF MATERIALS DAMAGED OR TO
BE REMOVED FOR SAFETY

ARCHITECTURAL FEATURES DESTROYED / DAMAGED / REQUIRED TO BE REMOVED

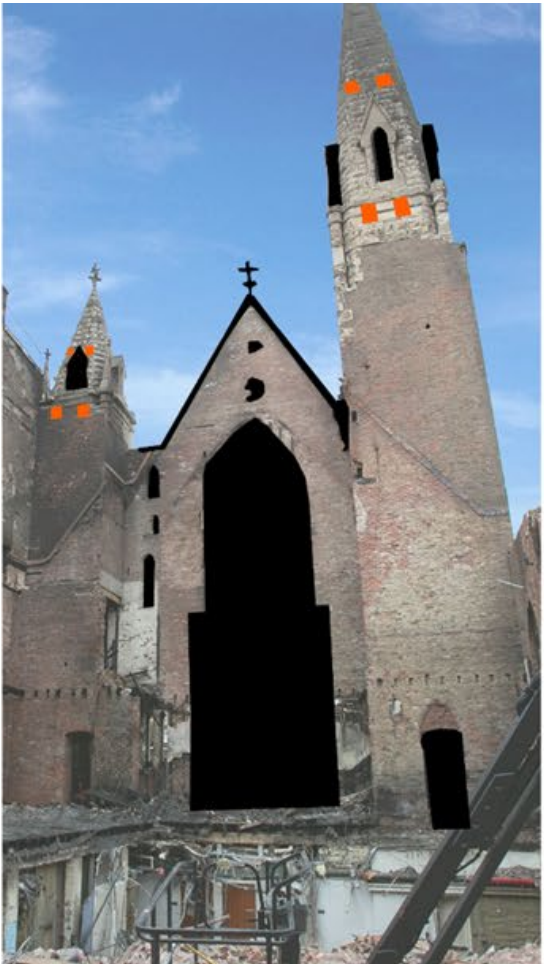
ORIGINAL MATERIALS LOST IN FIRE
OR REMOVED FOR EGRESS
& SITE ACCESS

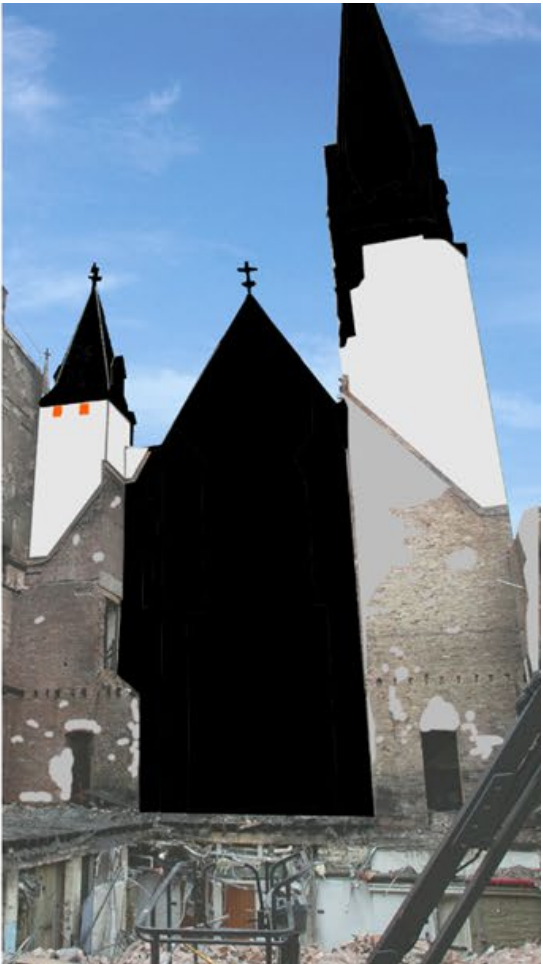
MINIMUM OF MATERIALS DAMAGED OR TO
BE REMOVED FOR SAFETY

DAMAGED/REMOVED MATERIAL

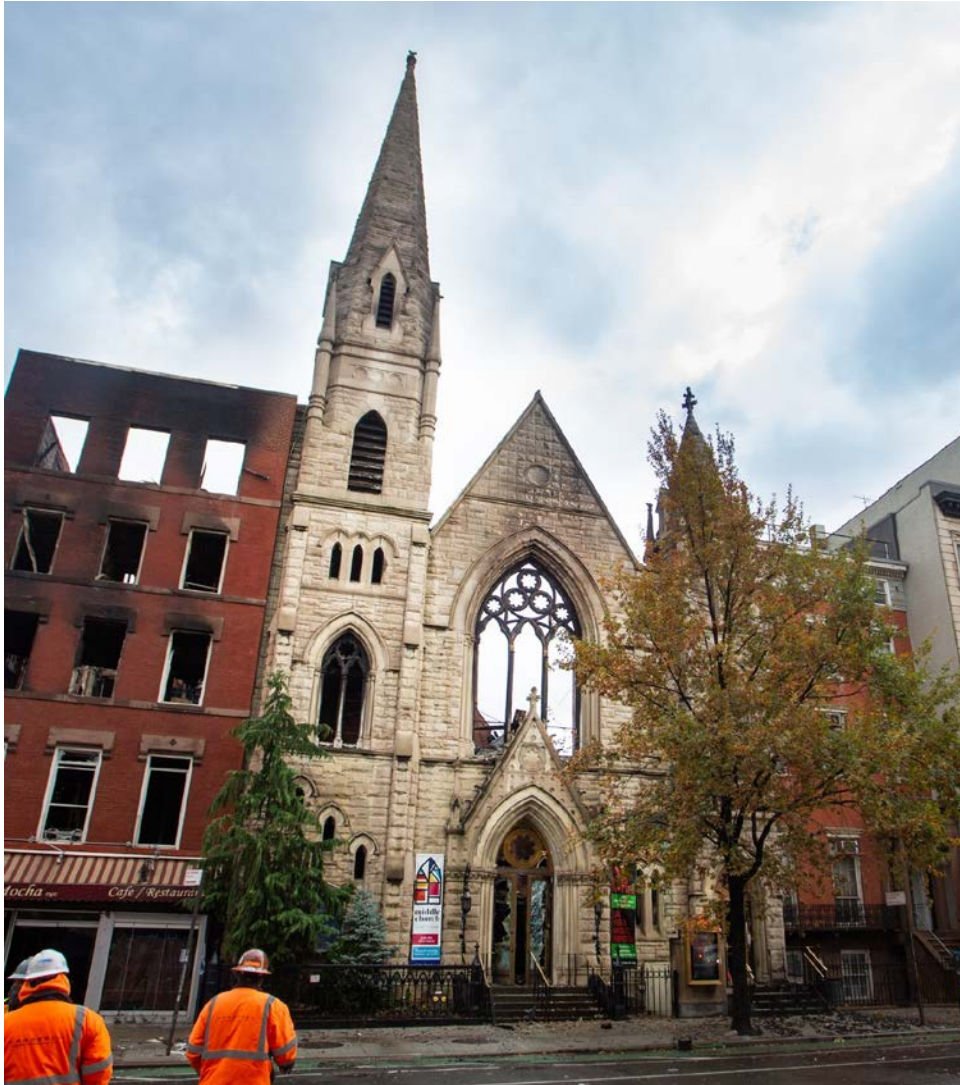
INDIANA LIMESTONE FAÇADE – *DAMAGED AND LOCALLY DESTABILIZED*

LIMESTONE BUTTRESSES – *CRACKS FORMED*

LIMESTONE FINIALS – *DAMAGED AND DESTROYED*

STAINED GLASS WINDOWS (POSSIBLY TIFFANY GLASS) – *DESTROYED*

WOOD AND BRONZE TRACERY – *DAMAGED, AND REMOVED BY ORDER NYC DOB*

GABLED CENTRAL BAY – *DAMAGED AND LOCALLY DESTABILIZED*

NORTHERN TOWER AND SPIRE – *MASONRY DAMAGED, LIMESTONE FRACTURED AND LOCALLY DESTABILIZED*

SOUTHERN TOWER AND SPIRE – *MASONRY DAMAGED, LIMESTONE FRACTURED AND LOCALLY DESTABILIZED*

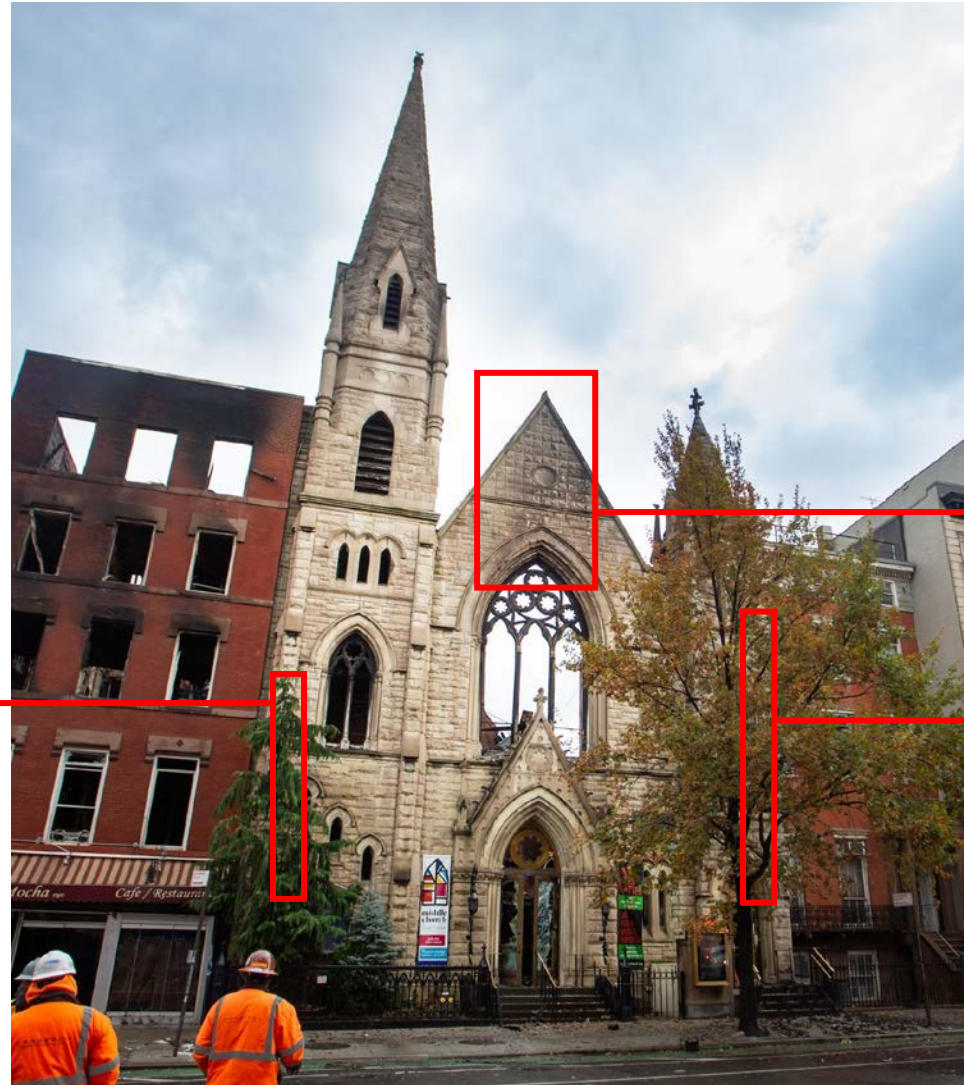
NORTH TOWER CRACK

GABLE ARCH

SOUTH TOWER CRACK

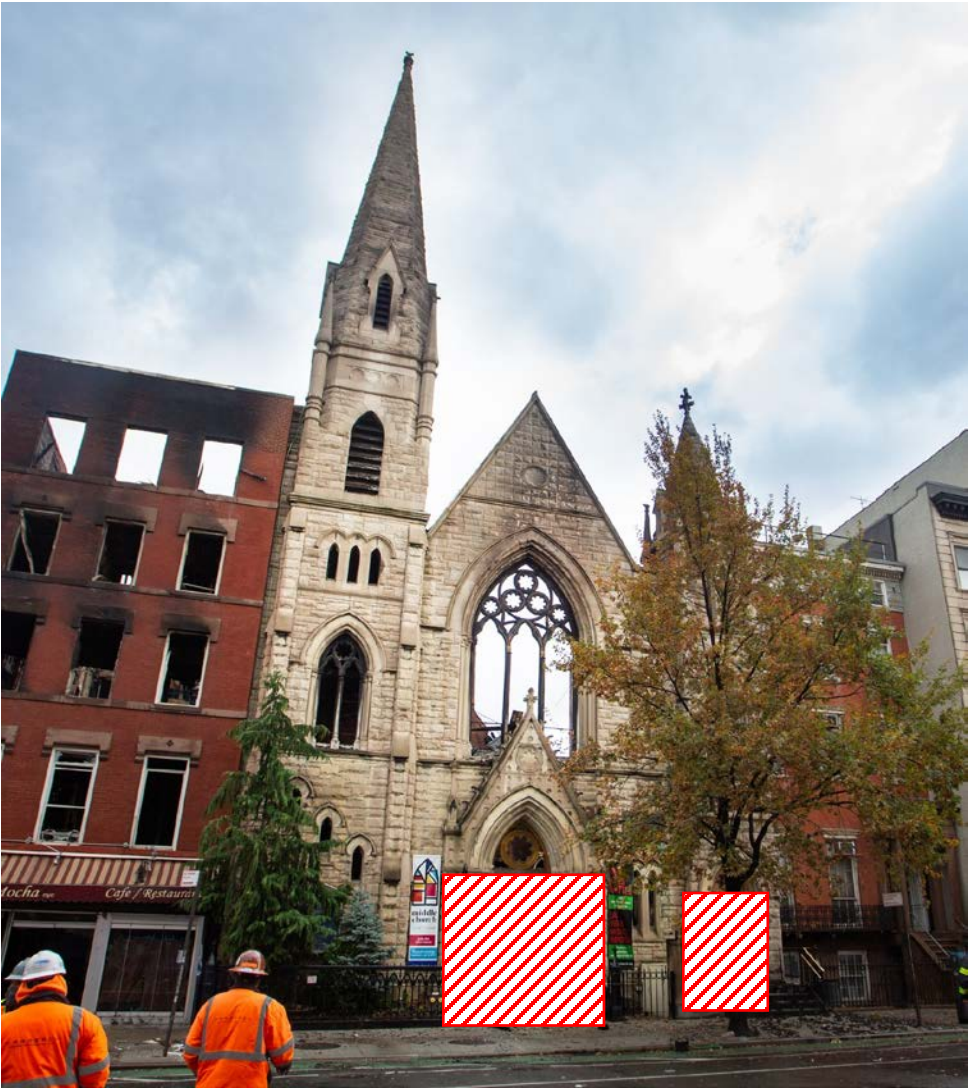
HISTORIC FABRIC TO BE REMOVED

2ND Ave. FAÇADE MODIFICATIONS REQUIRED FOR EGRESS BY NYC CODE

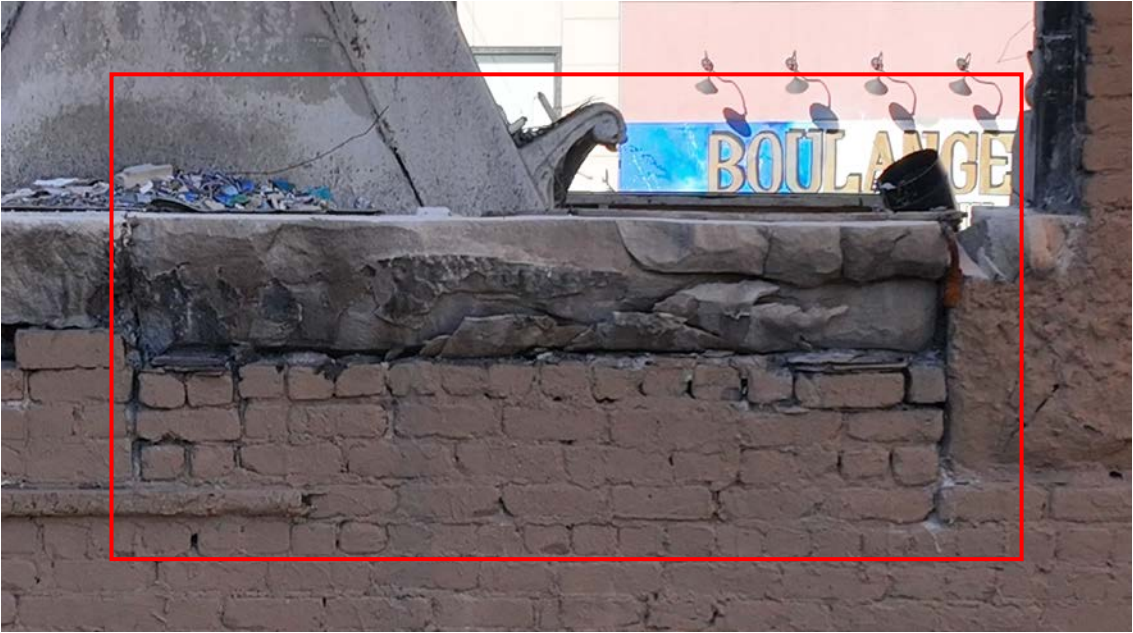
BACK OF GABLE SILL

DIMENSIONAL STONE
FRACTURED

MORTAR MISSING

MASONRY DAMAGED BY
THERMAL SHOCK

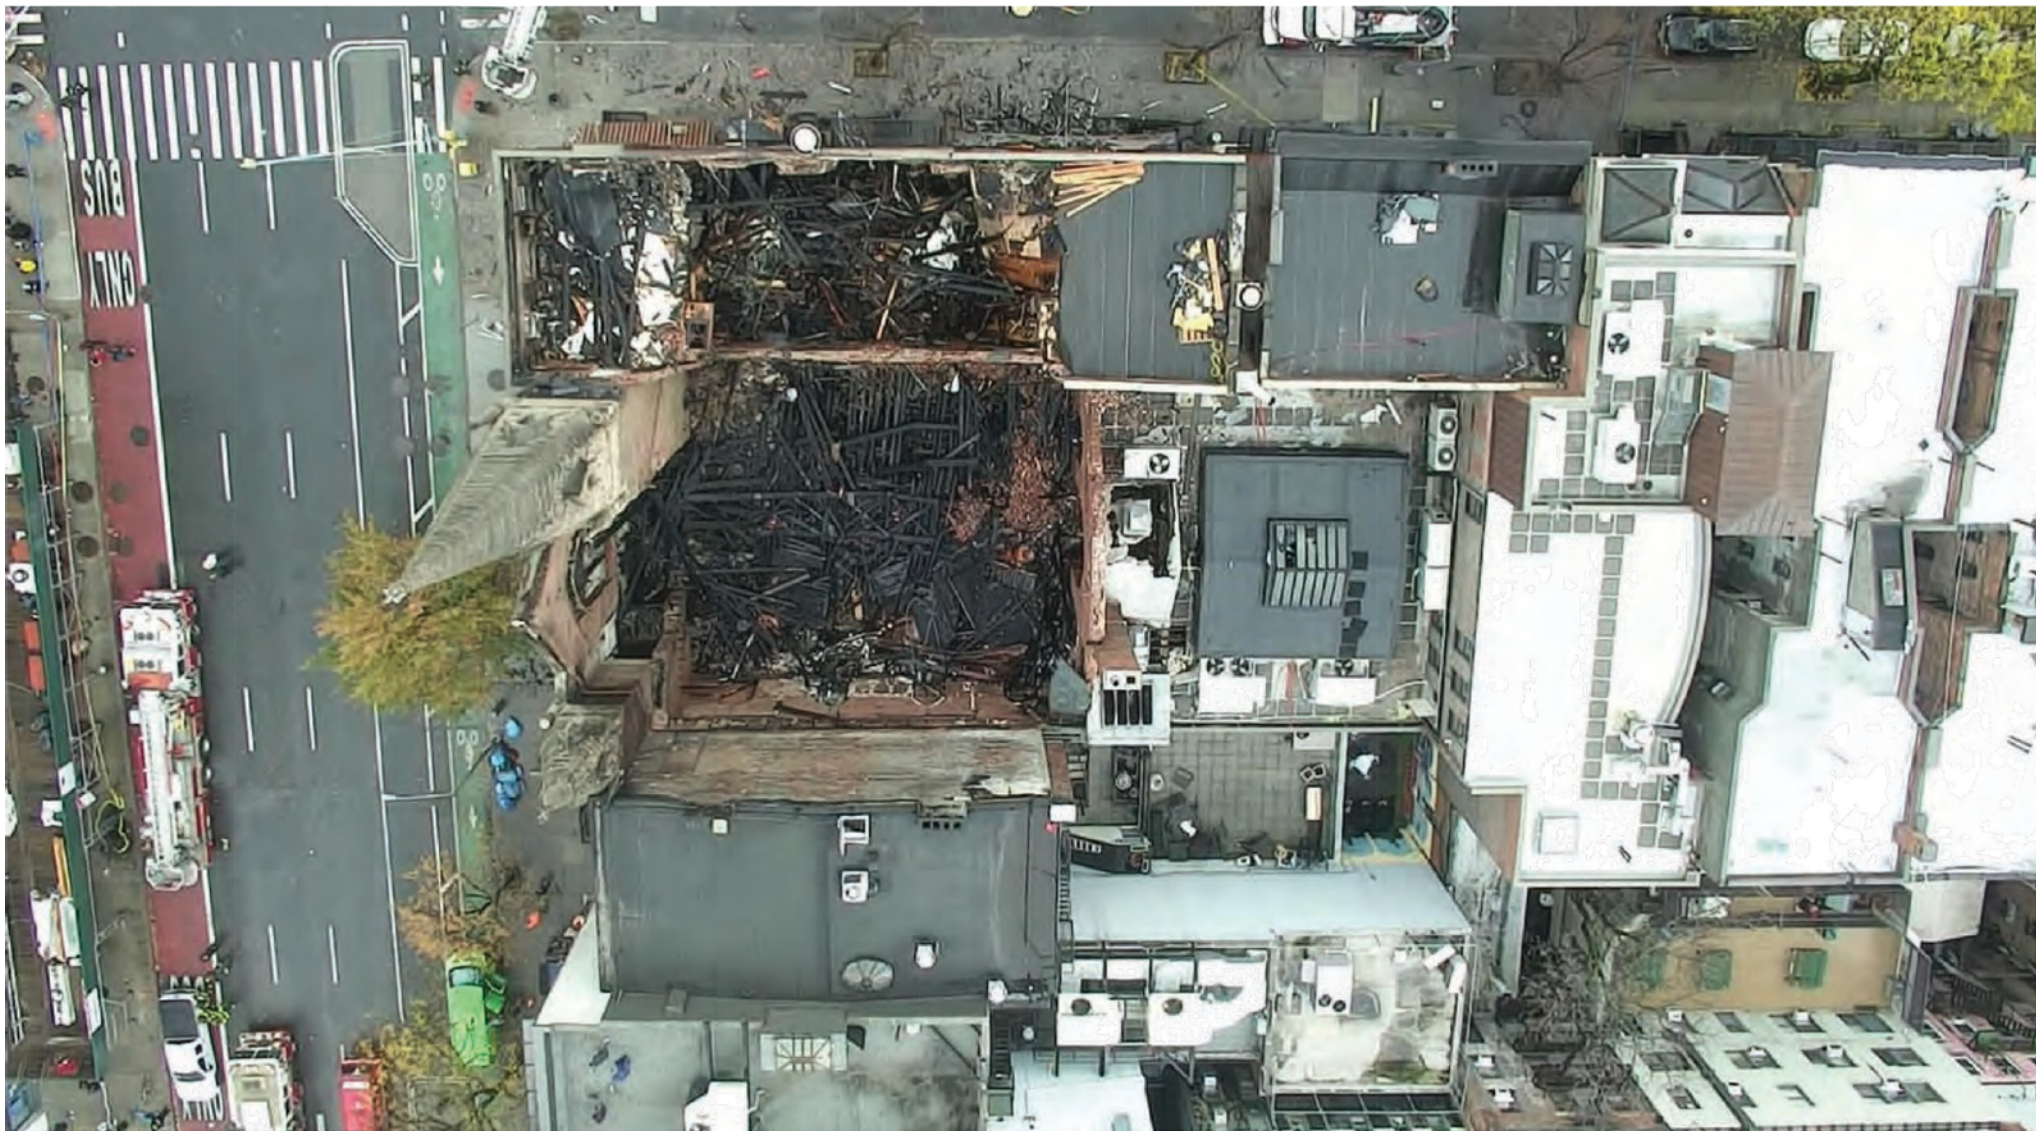
AERIAL VIEW – POST FIRE

LIMESTONE FAÇADE IS IN STATE OF DISREPAIR * DETERIORATED BEYOND USABLE LIFE * BRICK SUPPORT STRUCTURALLY COMPROMISED * NUMEROUS SAFETY AND LOGISTICAL CONCERNS * RETENTION MOVING FORWARD INTO CONSTRUCTION NOT WARRANTED

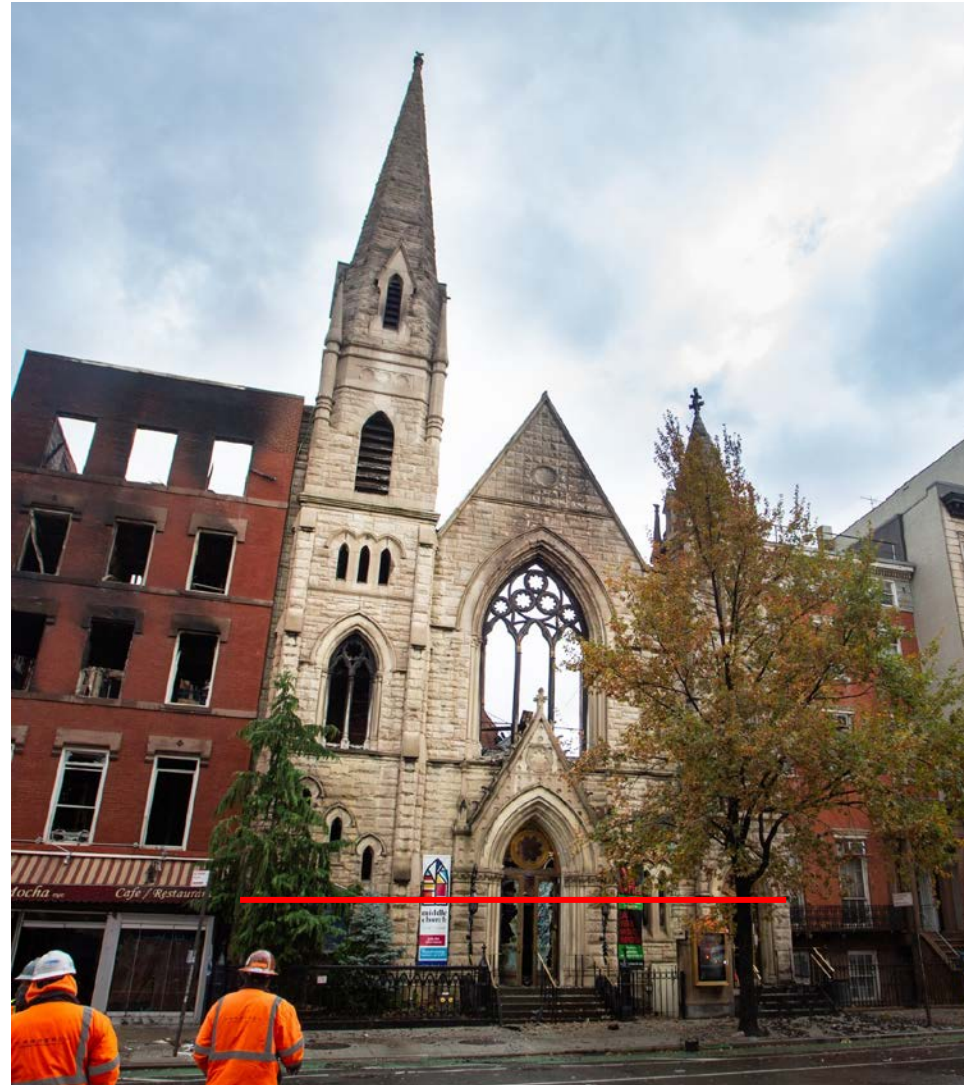
POSSIBLE SALVAGE OF STONE BELOW 8'-0"

DETERIORATING MORTAR

MISSING MORTAR

POROUS, HISTORY OF WATER LEAKS
