FLUSHING RKO KEITH'S

HISTORIC LOBBY REHABILITATION

135-35 NORTHERN BOULEVARD, FLUSHING, NEW YORK

MAY 16, 2017

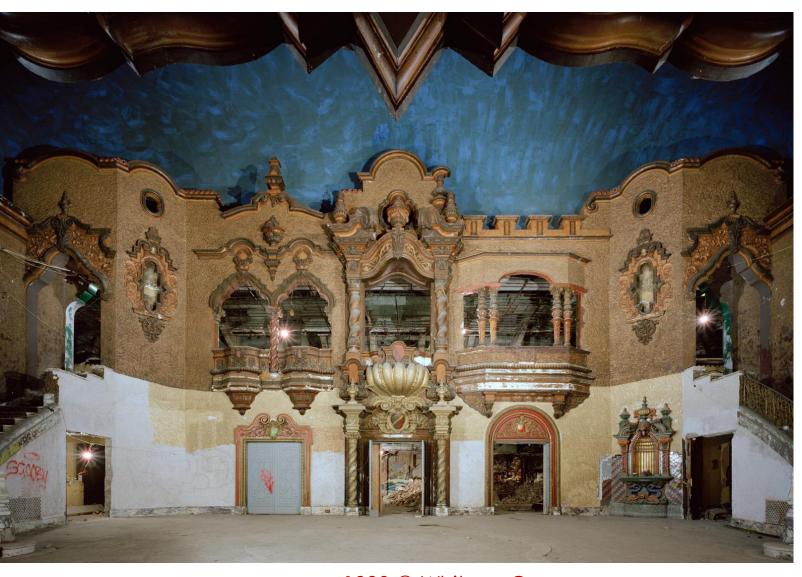
ca. 1990 @ Whitney Cox

July 2014 (Photo by RAZUM Media)

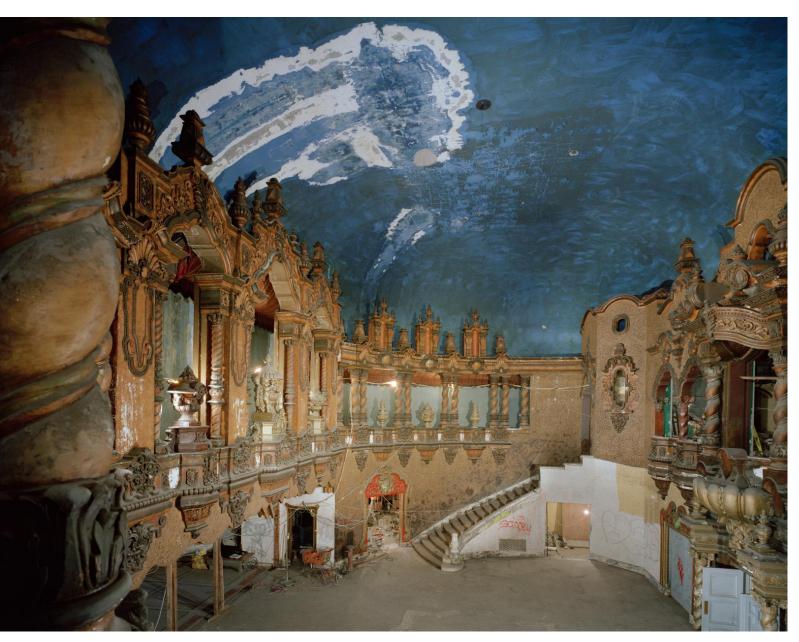
ca. 1990 @ Whitney Cox

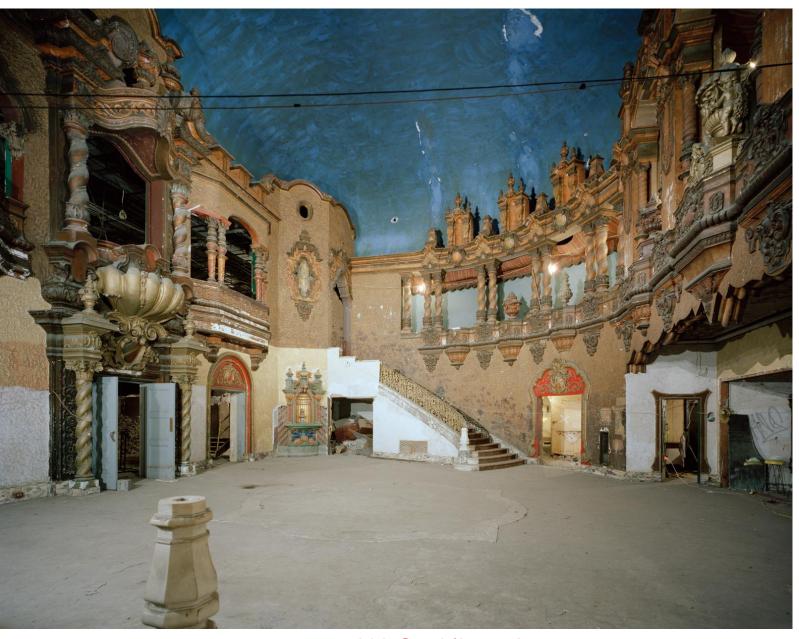
ca. 1990 @ Whitney Cox

July 2014 (Photo by RAZUM Media)

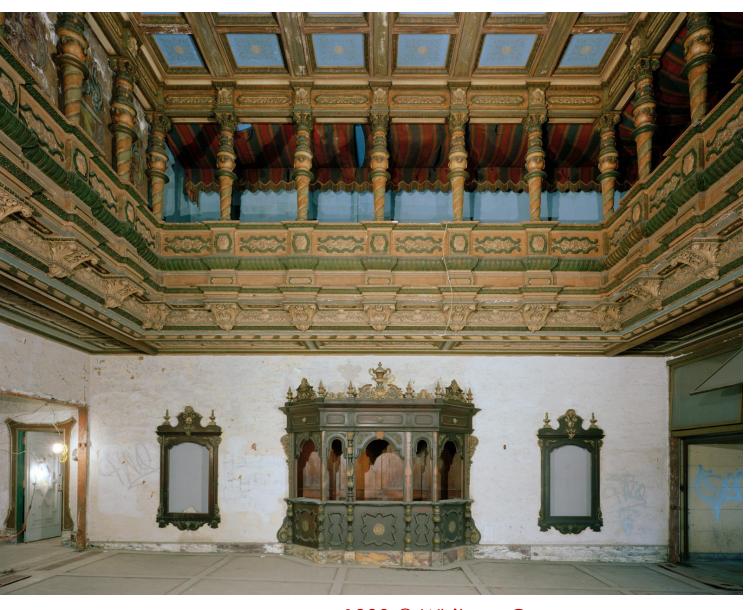
ca. 1990 @ Whitney Cox

July 2014 (Photo by RAZUM Media)

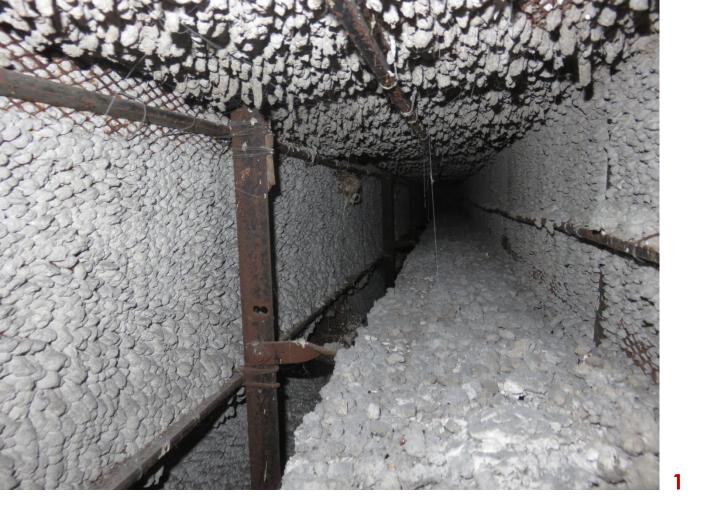
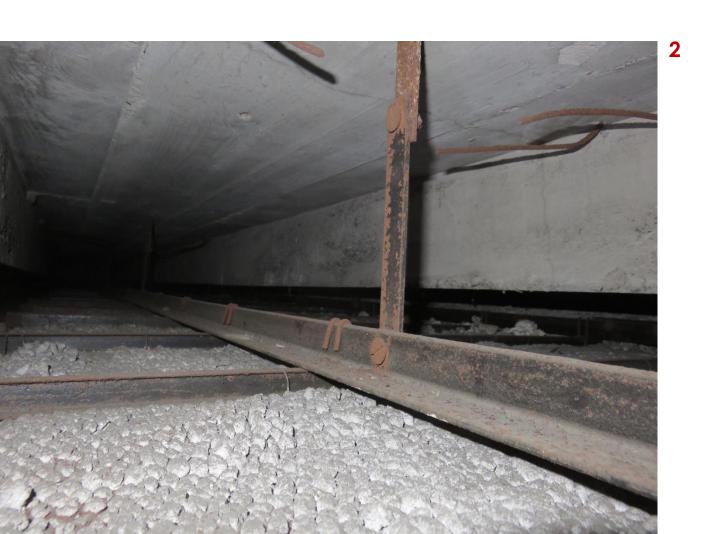
Ticket Lobby – Existing Typical East, South and West 2nd Floor Ceiling
Existing Conditions – January 2017

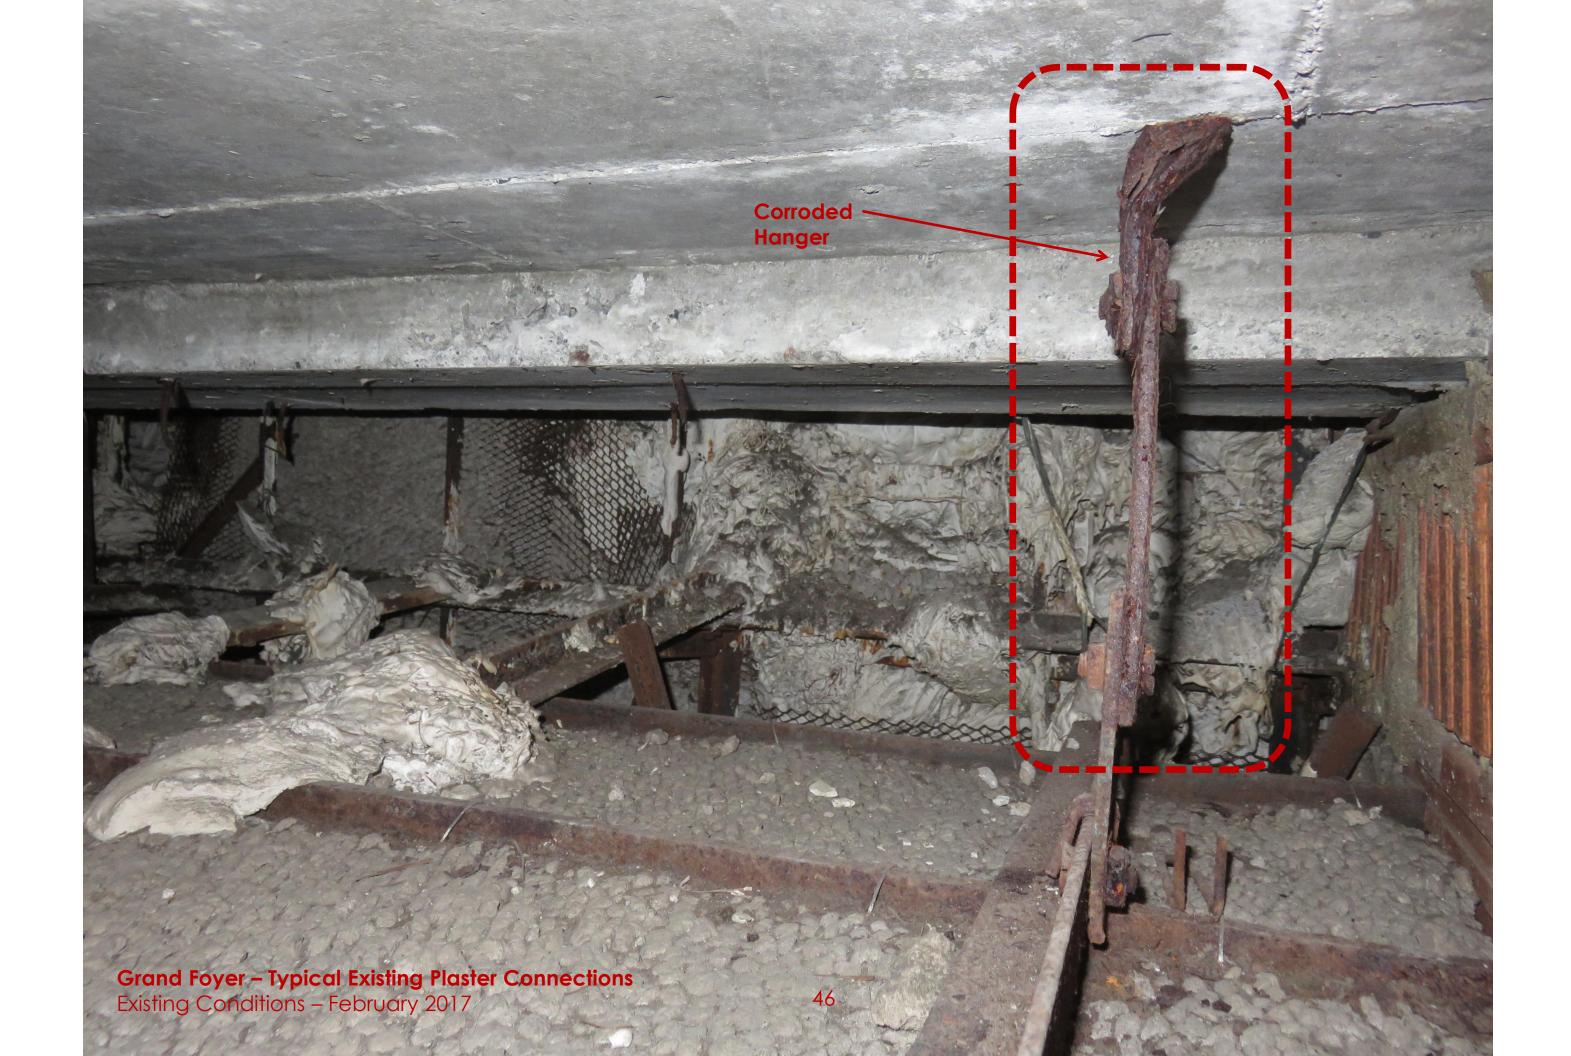
Supported Black Iron Armature

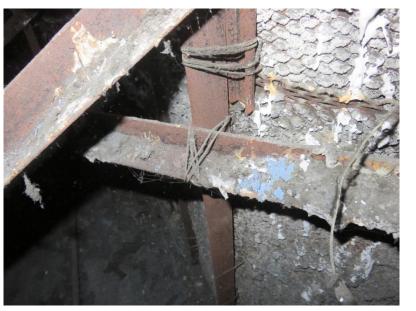
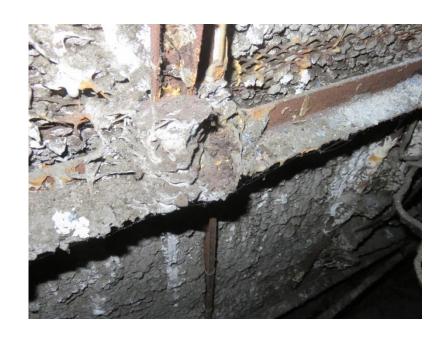
Existing Wire Connections

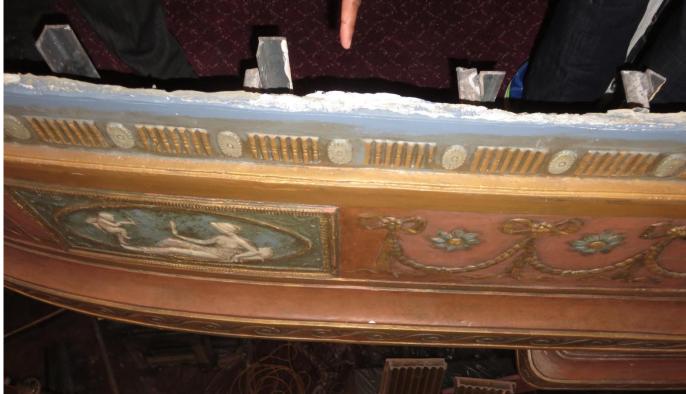
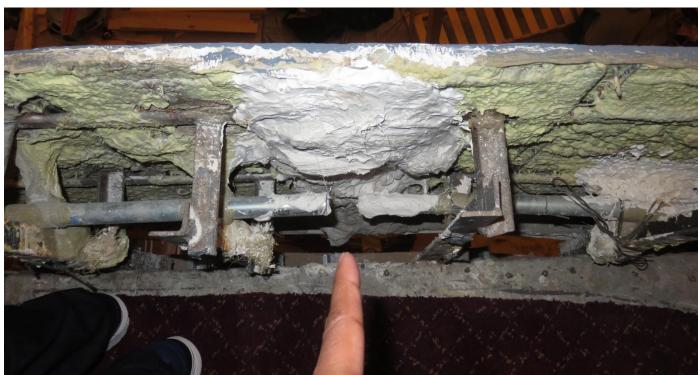
The Lyric Theater, Times Square – Temporary Plaster Removal, ca. 2009 Images Courtesy of Iconoplast, Inc.

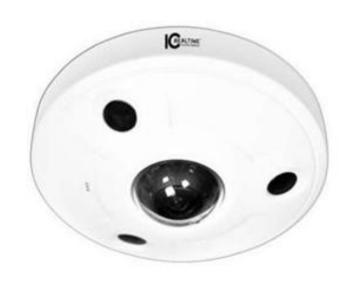
PROPOSED BUBBLE TYPE CAMERA PAINTED TO MATCH PLASTER

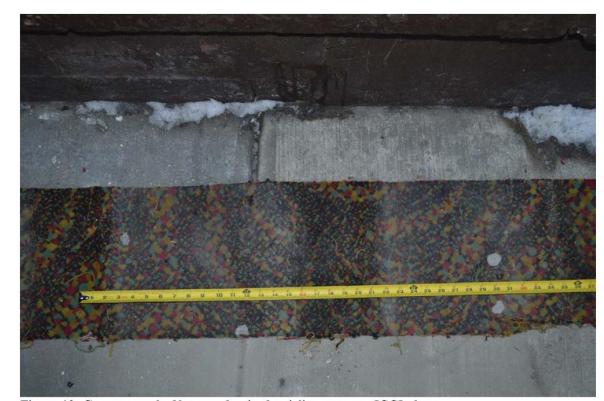
Figure 10: Carpet sample. Note randomized swirling pattern. JCCI photo

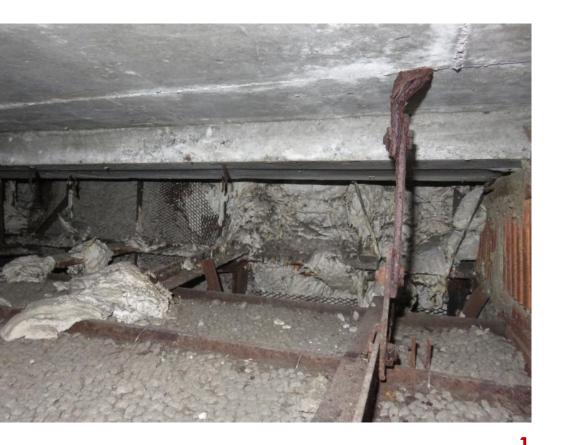
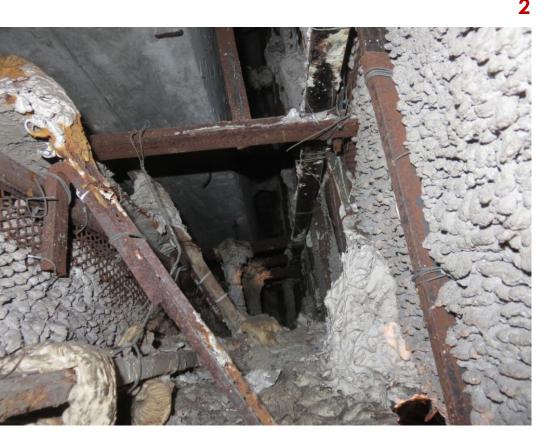
2nd Floor Grand Foyer – Existing South Wall Parapet Existing Conditions – January 2017

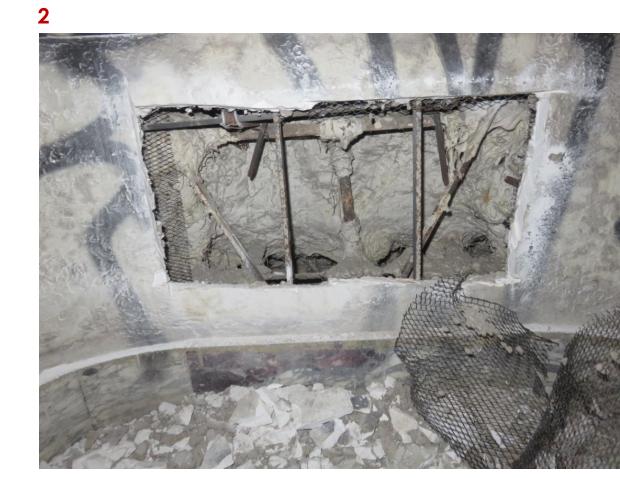
Grand Foyer 2nd Floor North Wall – Existing Center Balcony Section Existing Conditions – February 2017

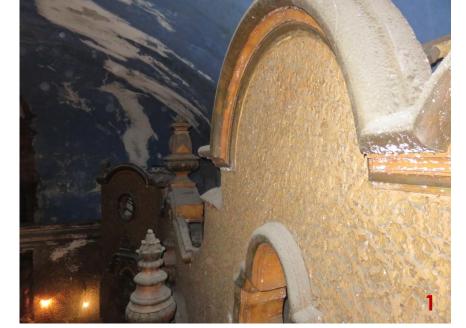
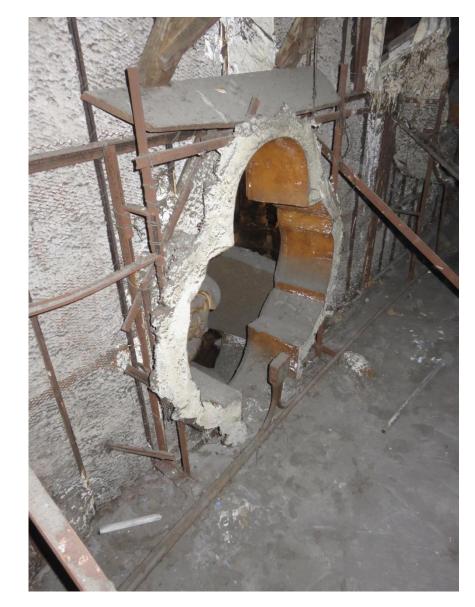
Grand Foyer 2nd Floor North Wall – Existing Center Balcony Section Existing Conditions – February 2017

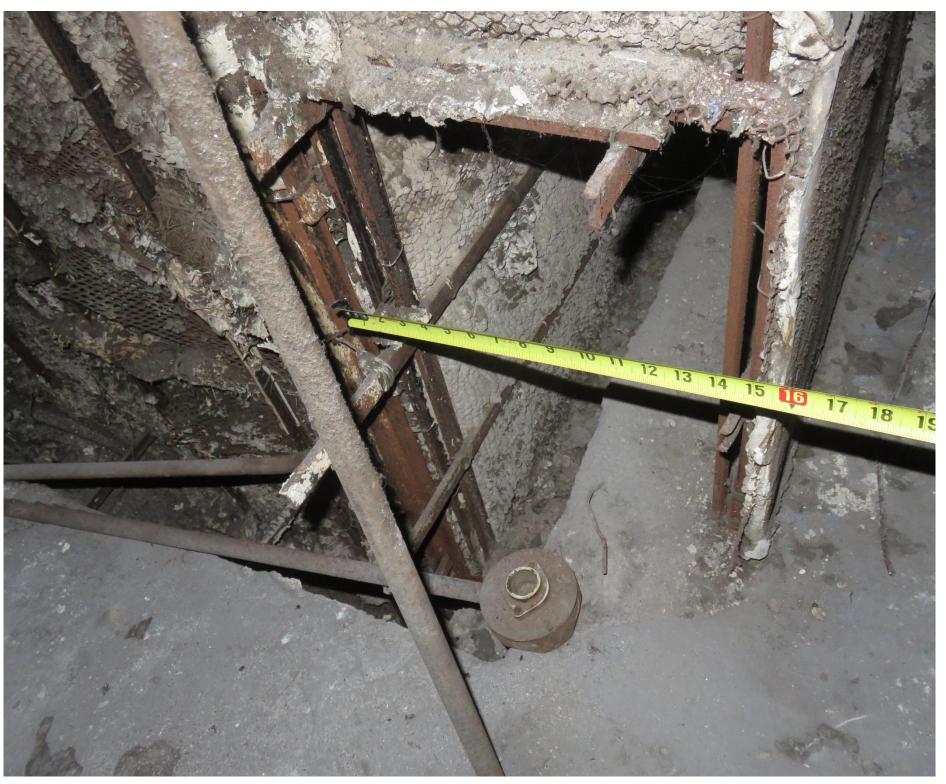
Grand Foyer 2nd Floor North Wall – Existing East Balcony Section Existing Conditions – February 2017

Existing Black Iron Armature
